### **TOTAL LOSS REPORT**

**RE: Road traffic Accident: Mrs Surinder Gill: 25/09/2025**

| Make | <b>MERCEDES-BENZ</b> | Registration | <b>LL65WNE</b> |
| Model | <b>A 180 D SPORT AUTO</b> | Status | <b>T/Loss</b> |

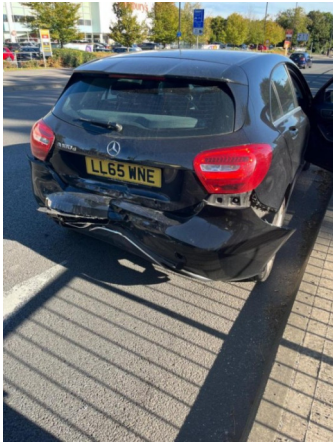
Impact Area

The vehicle has suffered heavy collision/impact damage to the rear.

Please note the vehicle is unroadworthy as the rear body has been compromised.

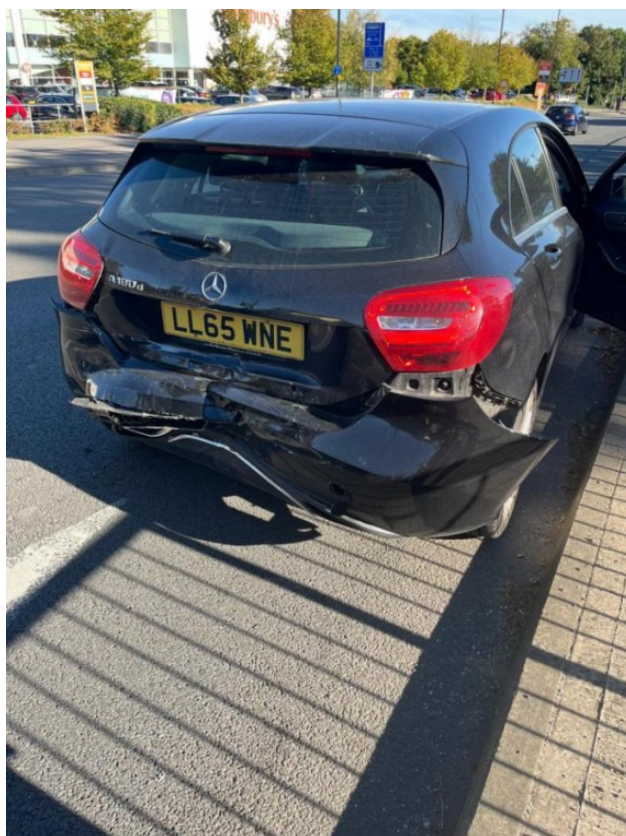
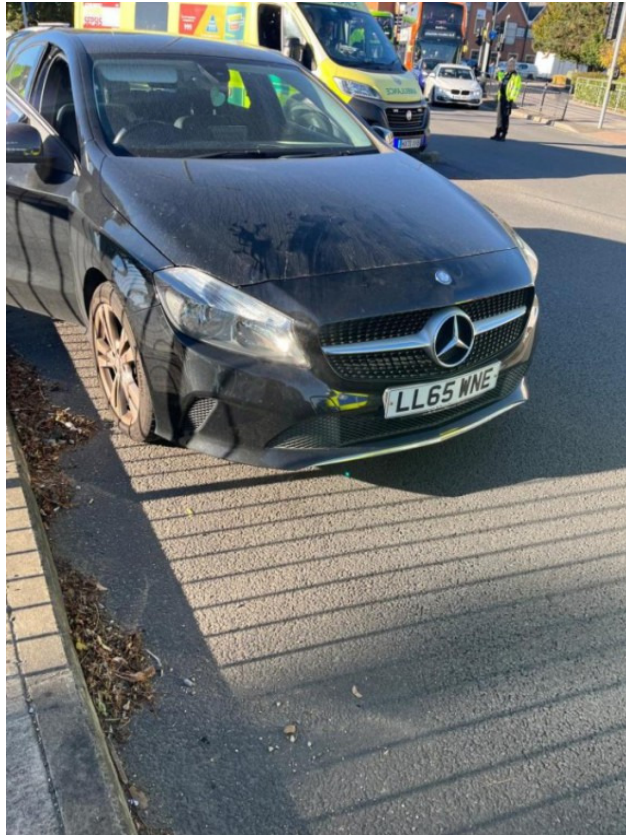
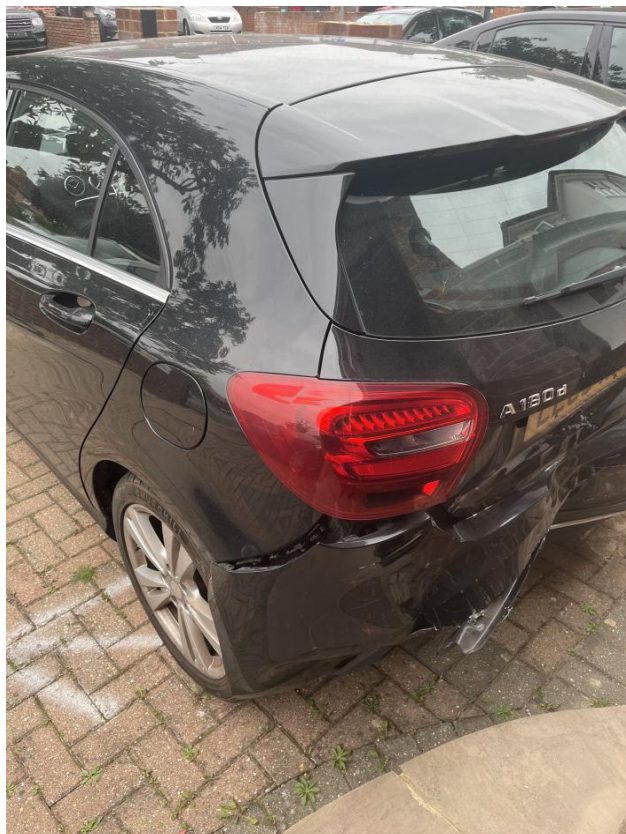
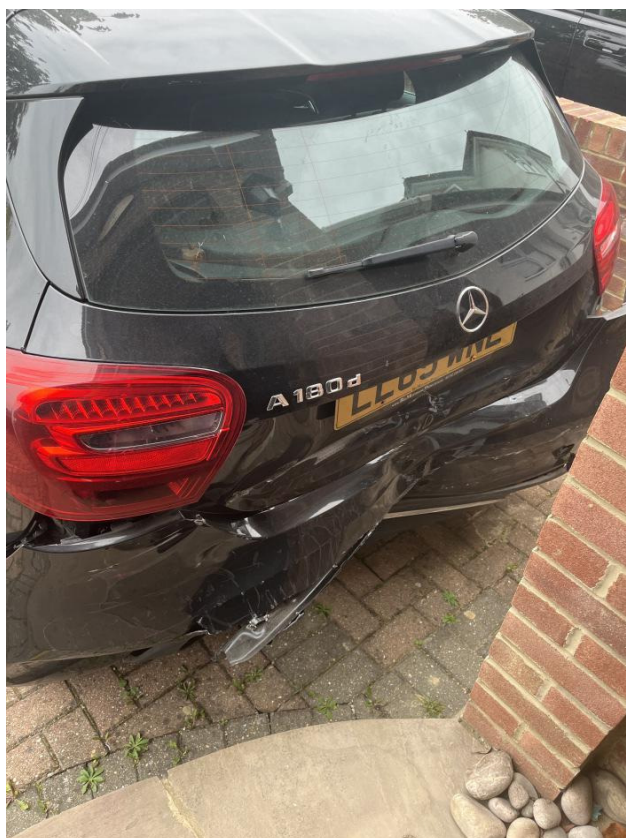
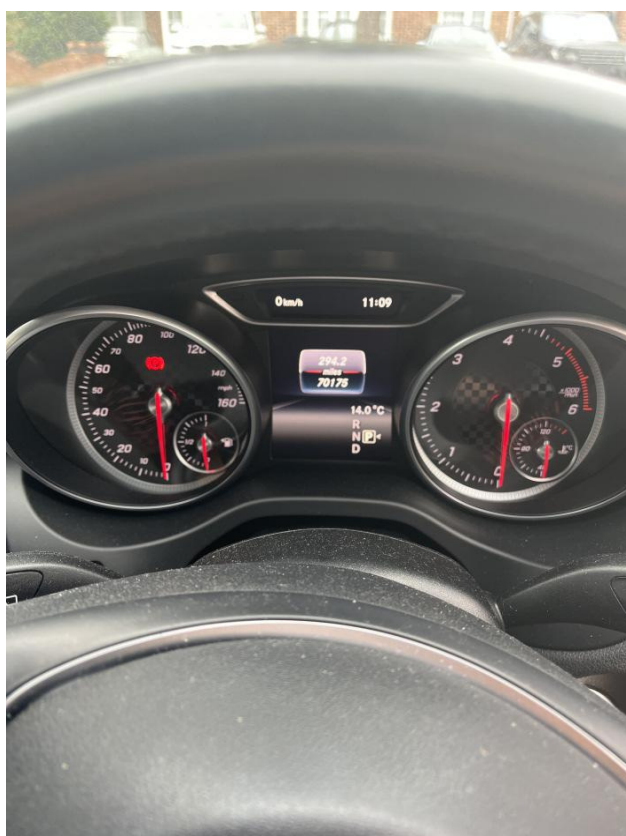
Under the current salvage categorisation matrix, **within the scope of our inspection**, we consider that this is Category S, (Structural damage) and can be sold as repairable salvage. Further information is available [www.abi.org.uk](http://www.abi.org.uk). We suggest that the sale of the salvage will realise in the order of £1,537.65. **We have not taken any action towards removal of the salvage at this time.**

Rear Bumper Lining  
Right Rear Bumper Side Impact Absorber/Filler  
Right Rear Bumper Side Impact Absorber (Tube)  
Rear Bumper Reinforcement  
Right Rear Bumper Side Upper Reinforcement  
Left Rear Bumper Spacer  
Rear Bumper Parking Aid Wiring  
Right Rear Lamp, Complete  
Right Side Panel Liner  
Tailgate  
Boot Lid/Back Door/Tailgate Striker  
Boot Lid/Back Door/Tailgate Badge  
Rear Window Repair/Bonding Kit (both)

Left Rear Bumper Side Impact Absorber/Filler  
Left Rear Bumper Side Impact Absorber (Tube)  
Rear Bumper Spoiler  
Left Rear Bumper Side Upper Reinforcement  
Rear Bumper Lower Reinforcement  
Right Rear Bumper Spacer  
Left Rear Lamp, Complete  
Left Side Panel Liner  
Rear Panel  
Latch with Central Locking  
Boot Lid/Tailgate Push Button  
Left Side Emblem (Engine Designation)  
Lower Tailgate/Back Door Trim

Spare Wheel Well

Jig set up, clamp and pull  
Assessment Damage Appraisal Charge  
Energy Cost Supplement  
Identify the presence of ADAS  
Panel Repair Sundries (including body fi  
Sundries  
System Diagnostic Check (Pre Repair)  
Wheel alignment  
Paint Right A-Post, Upper  
Paint Right Rear Side Panel, Complete  
Paint Rear Floor  
Paint Rear Skirt, Centre e  
Paint Prep. metal (on vehicle without pre-painting)  
Paint Colour mixing (1)
