### **TOTAL LOSS REPORT**

**RE: Road traffic Accident: Mrs Surinder Gill: 25/09/2025**

| Make | <b>MERCEDES-BENZ</b> | Registration | <b>LL65WNE</b> |
| Model | <b>A 180 D SPORT AUTO</b> | Status | <b>T/Loss</b> |

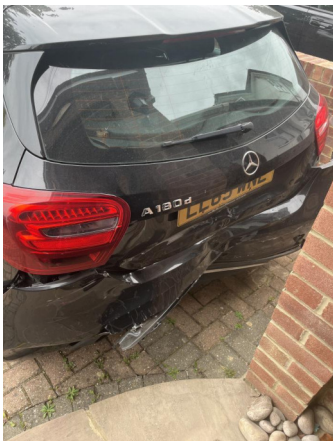
Impact Area

The vehicle has suffered heavy collision/impact damage to the rear.

Please note the vehicle is unroadworthy as the rear body has been compromised.
