**Our Ref:** kbs26011

### TOTAL LOSS REPORT

**RE: Road traffic Accident: Mohammad Irfan: 02/01/2026**

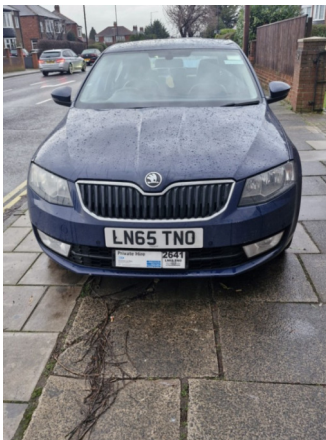
Impact Area

The vehicle has suffered light collision/impact damage to the rear.

we would advise that the rear bumper is secured before returning to use.
