### **TOTAL LOSS REPORT**

**RE: Road traffic Accident: Mr Sheinabia Dinani: 18/09/2025**

**Our Ref:** qdos251582

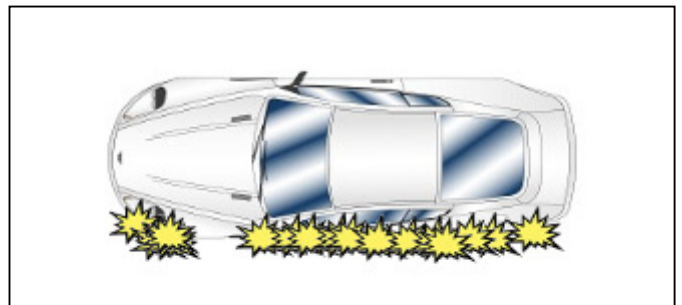
Impact Area

The vehicle has suffered moderate to heavy collision/impact damage to the left hand side.

25/9/2025 - Please note the vehicle is unroadworthy due to the extent of panel distortion sustained to the nearside front.
