### TOTAL LOSS REPORT

**RE: Road traffic Accident: Haawo Nadar Hassan : 17/02/2026**

| Make | <b>MERCEDES-BENZ</b> | Registration | <b>YE19UMR</b> |
| Model | <b>A 180 AMG LINE PREM</b> | Status | <b>T/Loss</b> |

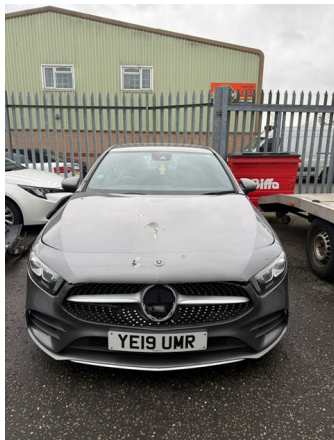
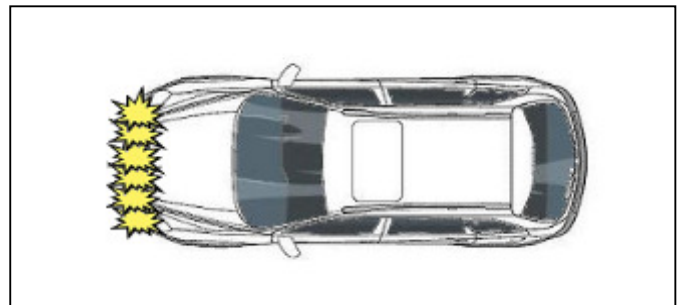
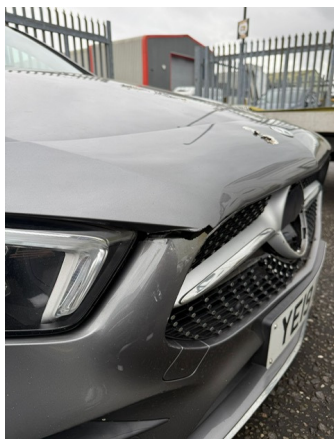
Impact Area

The vehicle has suffered moderate to heavy collision/impact damage to the front.

Please note the vehicle is unroadworthy due to the extent of panel distortion sustained to the front end.
