## To the Court REPAIRABLE REPORT

| Vehicle: <b>AUDI A4 S LINE BLACK EDITION TFSI</b> | | Colour: <b>White</b> | Speedo: <b>97195</b> Miles | |
| Reg No: <b>YH67TFO</b> | Registered: <b>Oct 2017</b> | Type: <b>Estate</b> | Trans: <b>Manual</b> | |
| Damage: <b>Light Collision/Impact LH Side Complete Vehicle</b> | Incident: <b>19/04/2026</b> | L/H/F Tyre <b>Not Kno</b> | L/H/R Tyre <b>Not Kno</b> | |

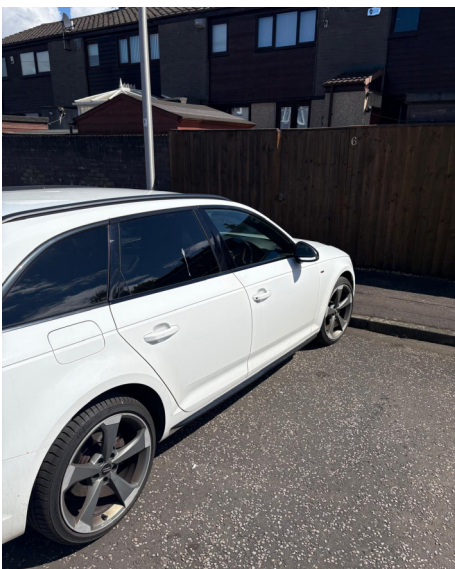
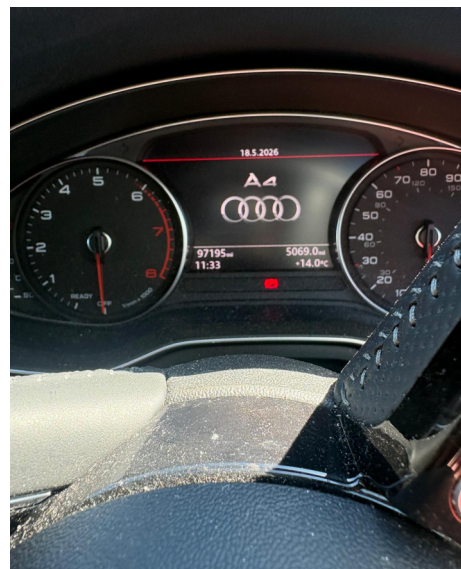
CLV rear 44928.jpeg

The vehicle has suffered light collision/impact damage to the left hand side complete vehicle.
