## To the Court REPAIRABLE REPORT

| Vehicle: <b>FORD GRAND C-MAX ZETEC TDCI AUT</b> | | Colour: <b>RED</b> | Speedo: <b>79133</b> Miles | |
| Reg No: <b>NL66ZKW</b> | Registered: <b>Nov 2016</b> | Type: <b>M.P.V.</b> | Trans: <b>Automatic</b> | |
| Damage: <b>Moderate Collision/Impact Rear</b> | Incident: <b>13/05/2026</b> | | | |

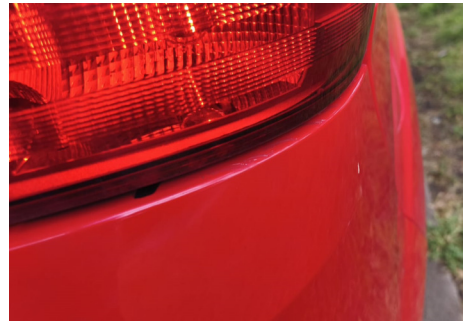
5\_CLVdamage445393jpeg-V1.jpeg

The vehicle has suffered moderate collision/impact damage to the rear.

**New parts required:-**Rear Bumper, Rear Bumper Spoiler, Car Care Kit, Sundry Parts
