### **TOTAL LOSS REPORT**

**RE: Road traffic Accident: Mr Joe Ray: 17/06/2025**

| Make | <b>VOLKSWAGEN</b> | Registration | <b>MC65MYZ</b> |
| Model | <b>POLO SE</b> | Status | <b>T/Loss</b> |

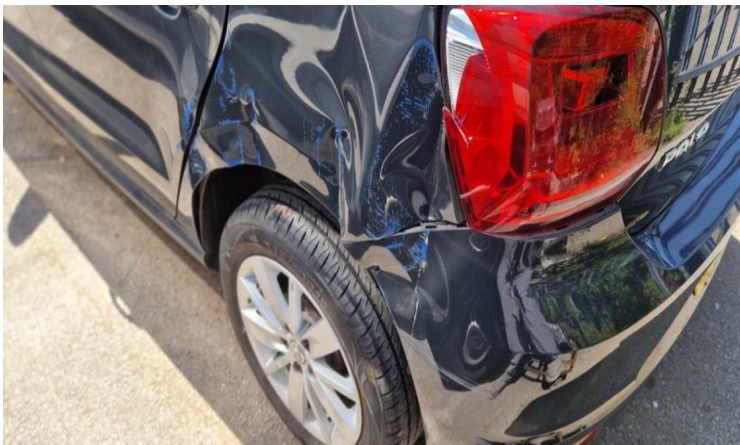
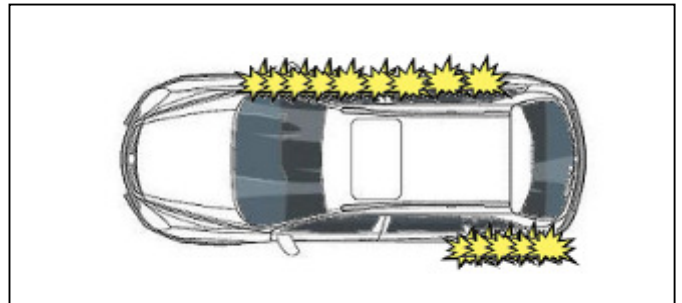
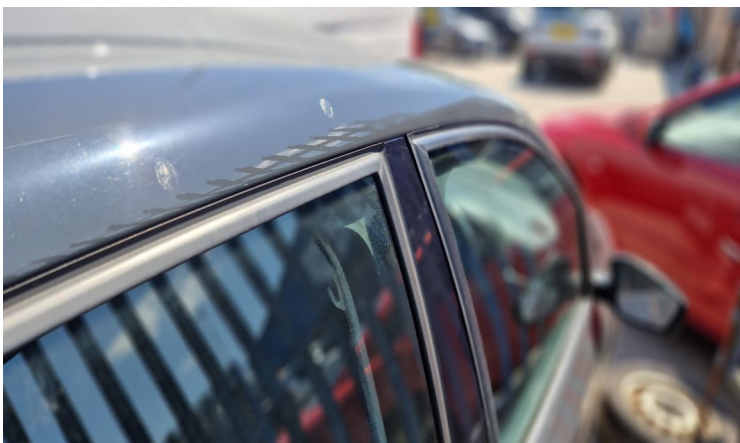
Impact Area

The vehicle has suffered heavy collision/impact damage to the left hand rear, and moderate to heavy collision/impact to the right hand side.

25/06/2025 - Please note the vehicle is unroadworthy due to the extent of panel distortion sustained to the nearside rear.
