**Our Ref:** qdos221402

## REPAIRABLE REPORT

### **RE: Road traffic Accident: Karen Reid: 17/08/2022**

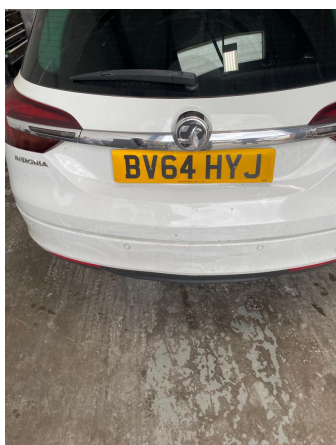
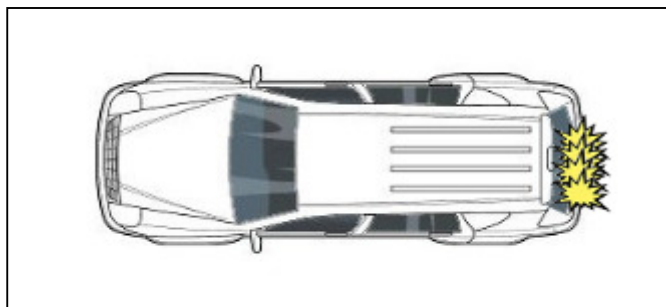
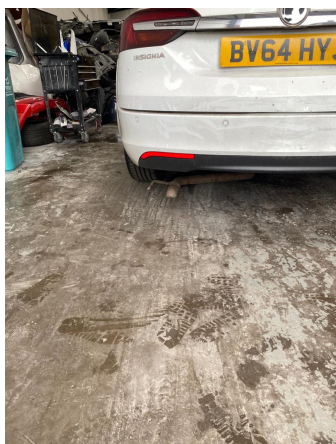
Impact Area

The vehicle has suffered moderate collision/impact damage to the rear.

23/08/2022 - Please note the vehicle is unroadworthy due to the damaged/insecure exhaust.
