**Our Ref:** qdos221403

## REPAIRABLE REPORT

**RE: Road traffic Accident: John Ferguson: 29/06/2022**

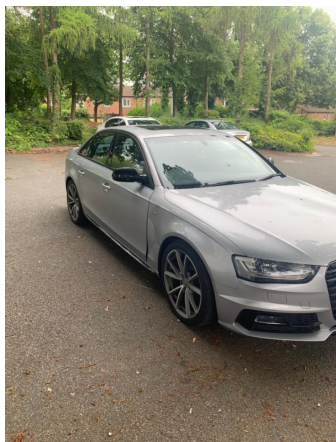
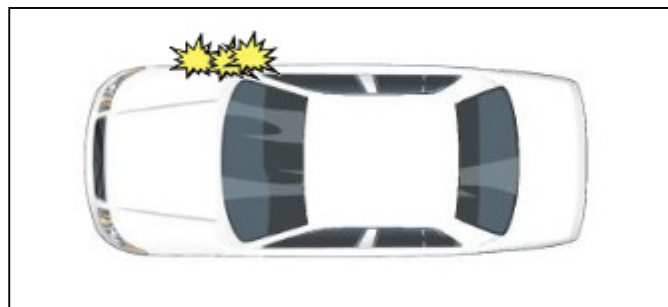
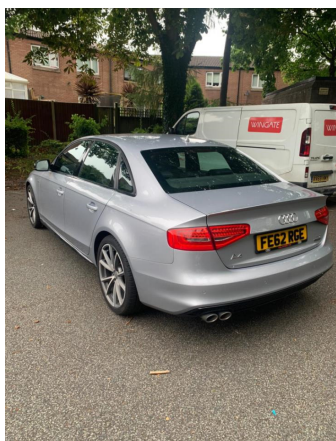
Impact Area

The vehicle has suffered moderate collision/impact damage to the right hand side.

Right Front Wing  
Right Front Wing Bracket (Front)  
Right Front Wing Repair Kit  
Right Front Wing Liner  
Right Front Wing Foam

Right Front Wing Upper Bracket  
Right Front Wing Upper Bracket (Rear)  
Right Front Wing Emblem (Letters)  
Right Front Wing Closing Panel

Right Front Door Shell
