**Our Ref:** qdos221408

### REPAIRABLE REPORT

**RE: Road traffic Accident: Malachy Cefai: 15/08/2022**

| Make | <b>VOLKSWAGEN</b> | Registration | <b>P18MCC</b> |

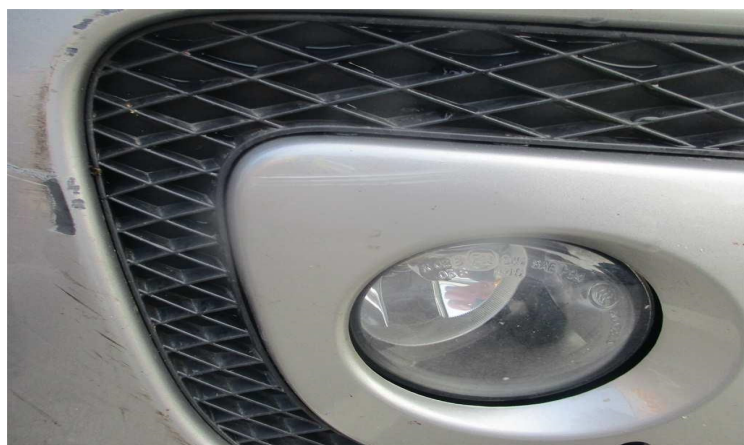
Impact Area

The vehicle has suffered moderate collision/impact damage to the right hand front.
