## **REPAIRABLE REPORT**

**RE: Road traffic Accident: Martin Robertson: 18/08/2022**

| Make | <b>FORD</b> | Registration | <b>ST65VNK</b> |
| Model | <b>FIESTA ST-3 TURBO</b> | Status | <b>Repair</b> |

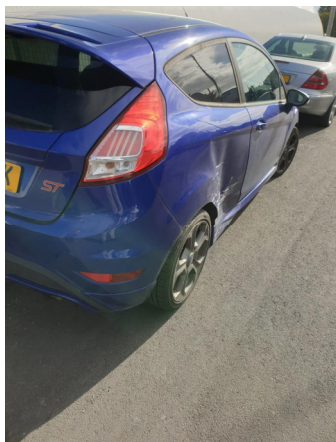
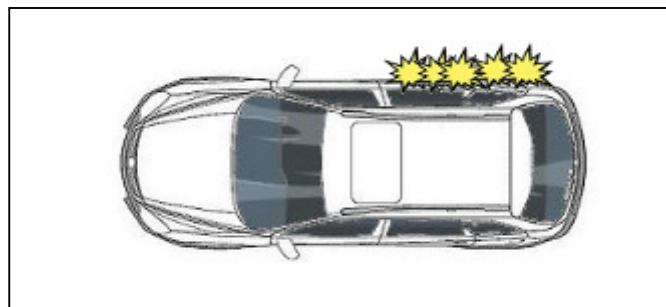
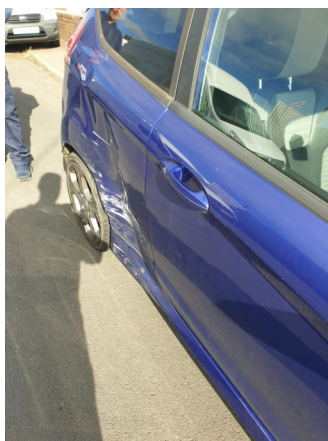
Impact Area

The vehicle has suffered moderate collision/impact damage to the right hand side.

24/08/2022 - Please note the vehicle is unroadworthy due to the extent of panel distortion sustained to the offside.
