## To the Court REPAIRABLE REPORT

| Vehicle: <b>VAUXHALL CORSA SE PREMIUM</b> | | Colour: <b>RED</b> | Speedo: <b>21084</b> Miles | |
| Reg No: <b>DL70CMY</b> | Registered: <b>Oct 2020</b> | Type: <b>5 Door Hatchback</b> | Trans: <b>Manual</b> | |
| Damage: <b>Light to Moderate Collision/Impact LH Front</b> | Incident: <b>06/05/2026</b> | L/H/F Tyre <b>Not Kno</b> | L/H/R Tyre <b>Not Kno</b> | |

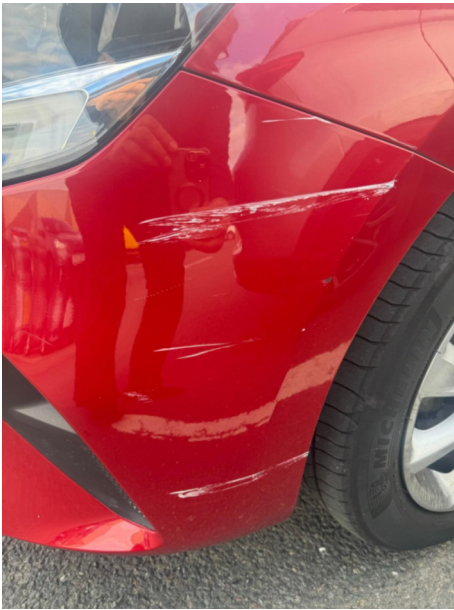
Imageofclientdamage-V1.jpg

The vehicle has suffered light to moderate collision/impact damage to the left hand front.
