### **TOTAL LOSS REPORT**

**RE: Road traffic Accident: Mr Stanley Matthew: 01/05/2026**

| Make | <b>VOLVO</b> | Registration | <b>KP15NRJ</b> |
| Model | <b>V40 R-DESIGN NAV D2</b> | Status | <b>T/Loss</b> |

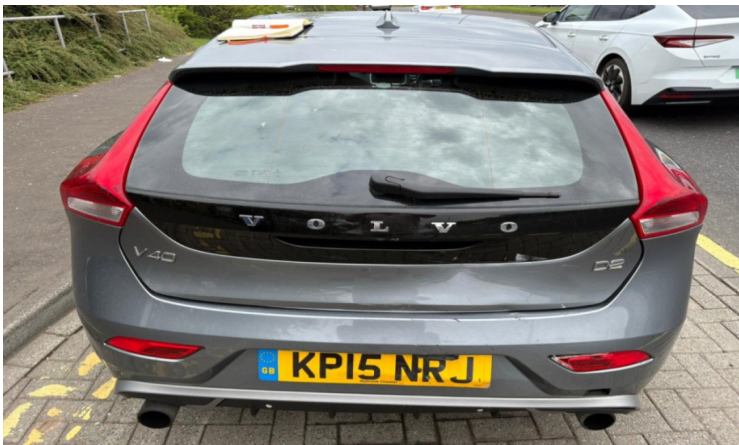
Impact Area

The vehicle has suffered moderate collision/impact damage to the rear.

Please note the vehicle is unroadworthy as the rear body has been compromised.
