### **TOTAL LOSS REPORT**

**RE: Road traffic Accident: Beryl Smith: 09/03/2026**

| Make | <b>VAUXHALL</b> | Registration | <b>KW57BKZ</b> |
| Model | <b>ASTRA DESIGN A</b> | Status | <b>T/Loss</b> |

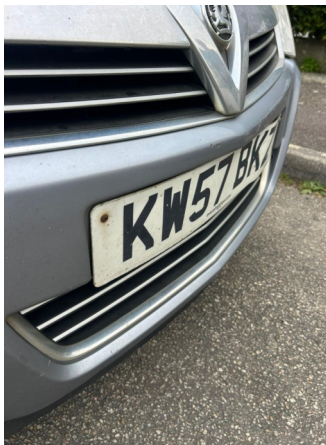
Impact Area

The vehicle has suffered moderate collision/impact damage to the front.
