### **TOTAL LOSS REPORT**

**RE: Road traffic Accident: Mr Imran Abid: 18/11/2024**

| Make | <b>MERCEDES-BENZ</b> | Registration | <b>OV17NXA</b> |
| Model | <b>E 220 D AMG LINE AUT</b> | Status | <b>T/Loss</b> |

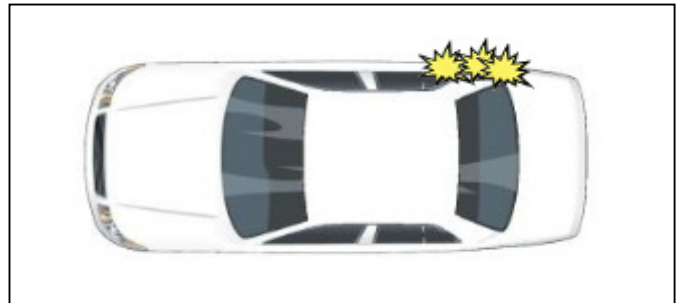
Impact Area

The vehicle has suffered moderate to heavy collision/impact damage to the right hand side.

20/11/2024 - Please note the vehicle is unroadworthy due to the extent of panel distortion sustained to the offside.
