**Our Ref:** oak25382

### TOTAL LOSS REPORT

**RE: Road traffic Accident: Craig McPhee: 14/11/2025**

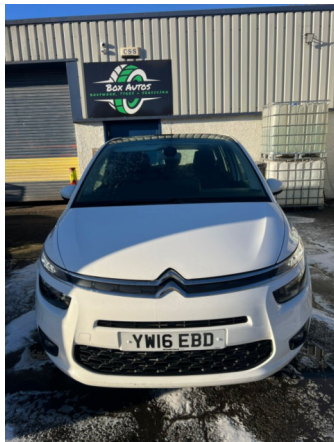
Impact Area

The vehicle has suffered moderate collision/impact damage to the right hand side.

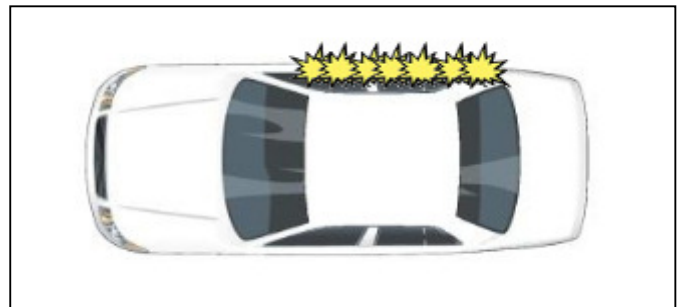
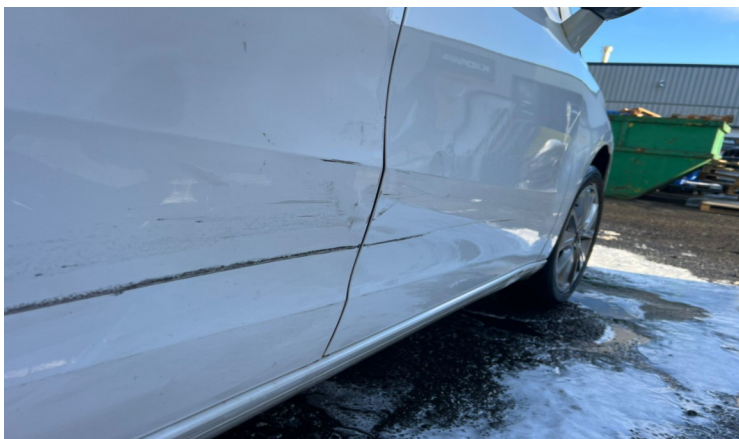
Please note the vehicle is unroadworthy as we are advised the offside door no longer correctly operates.

Right Front Door Membrane  
Right Rear Door Membrane  
Right Rear Door Trim Support Kit  
Right Rear Door Trim Screw

Right Rear Door Shell  
Right Rear Door Sealing Compound  
Right Rear Door Trim Clip

Right Front Door Shell
