## REPAIRABLE REPORT

### **RE: Road traffic Accident: Mr Dayle Longford: 15/05/2026**

| Make | <b>BMW</b> | Registration | <b>16DL</b> |
| Model | <b>X3 XDRIVE20D M SPO</b> | Status | <b>Repair</b> |

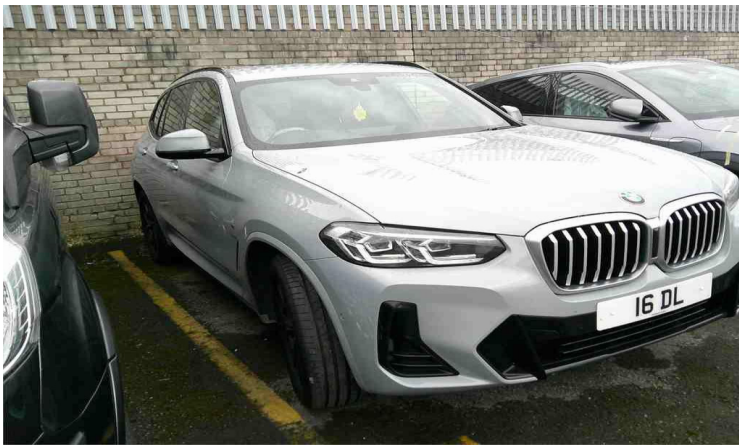
Impact Area

The vehicle has suffered moderate collision/impact damage to the right hand rear.

Please note the vehicle is unroadworthy due to the extent of panel distortion sustained to the offside rear / broken rear bumper.

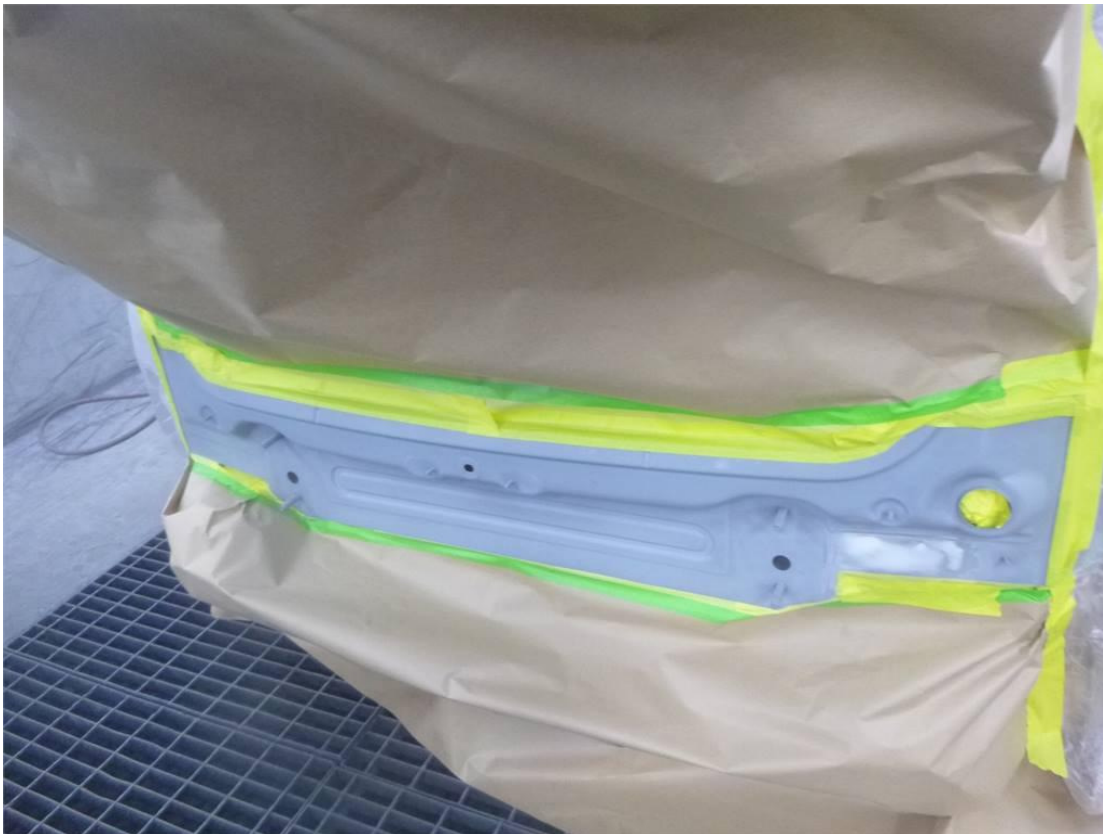
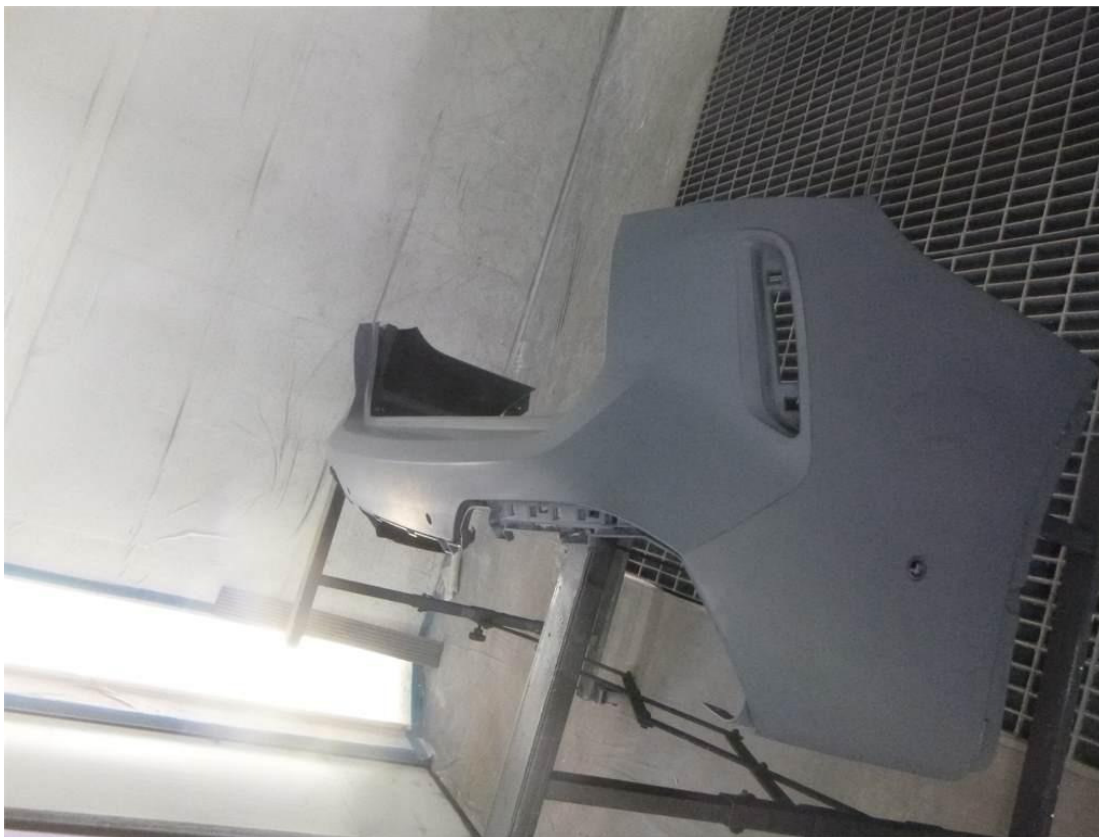
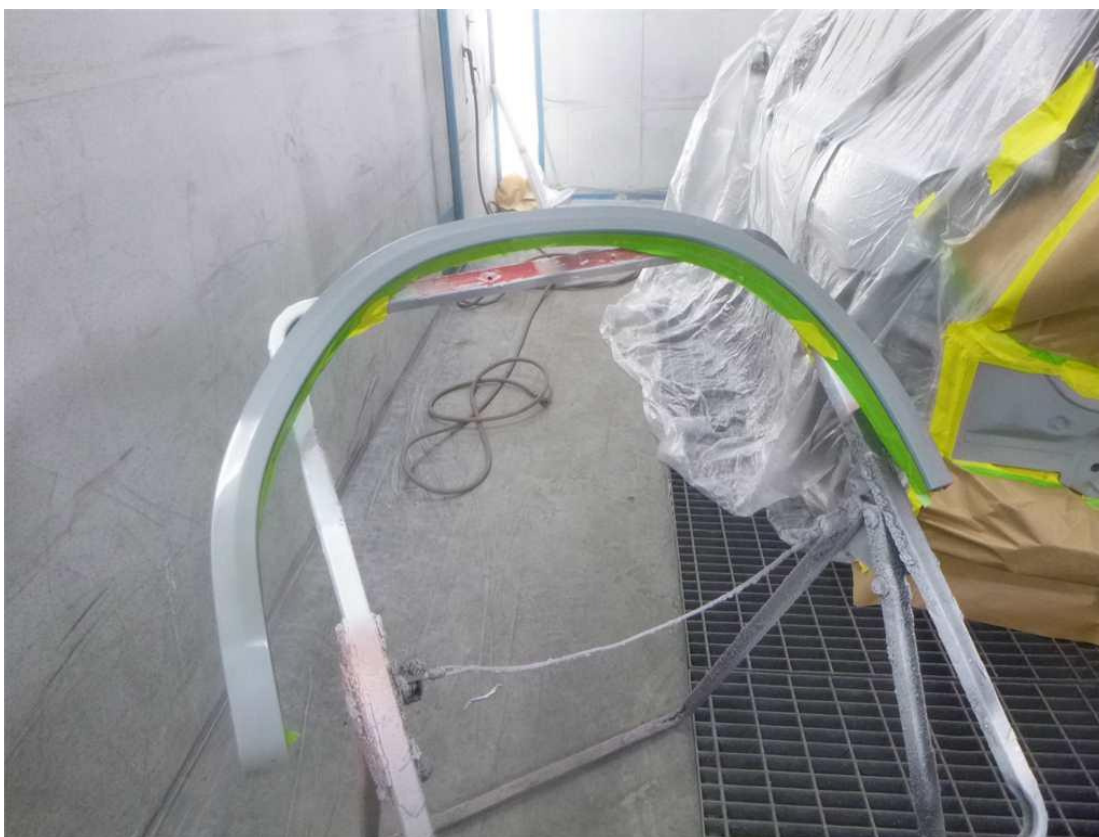
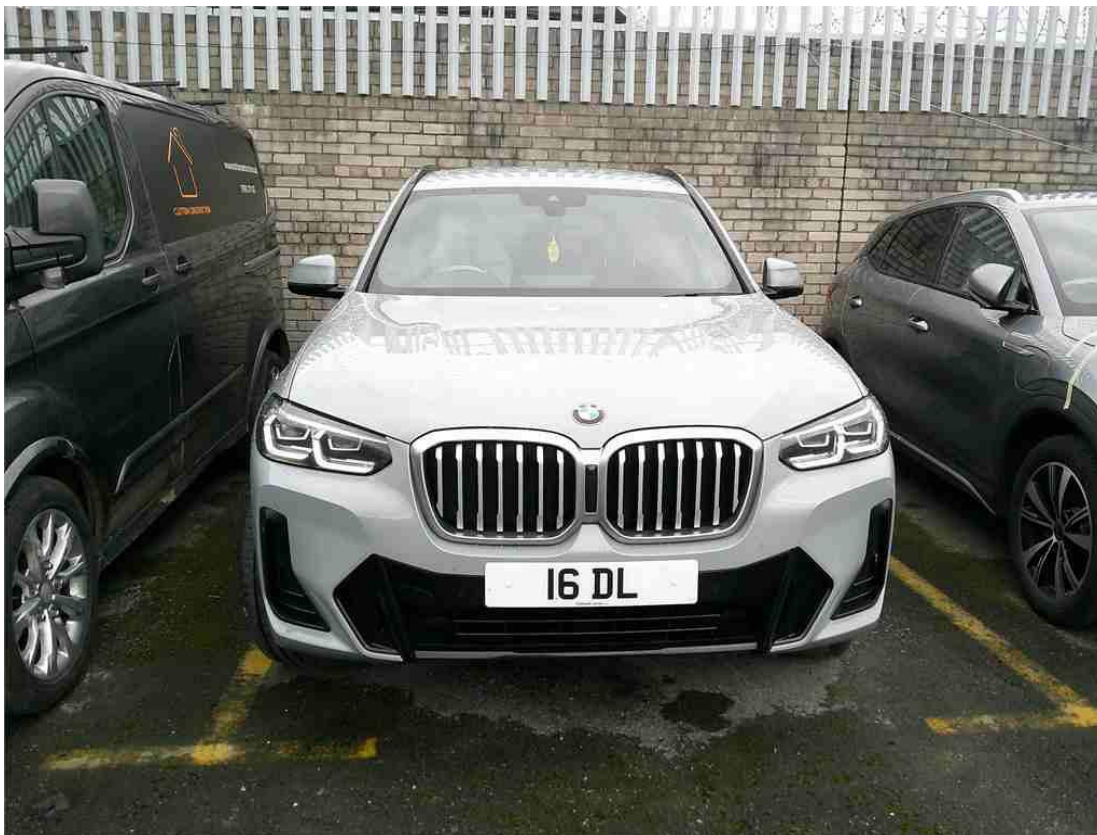
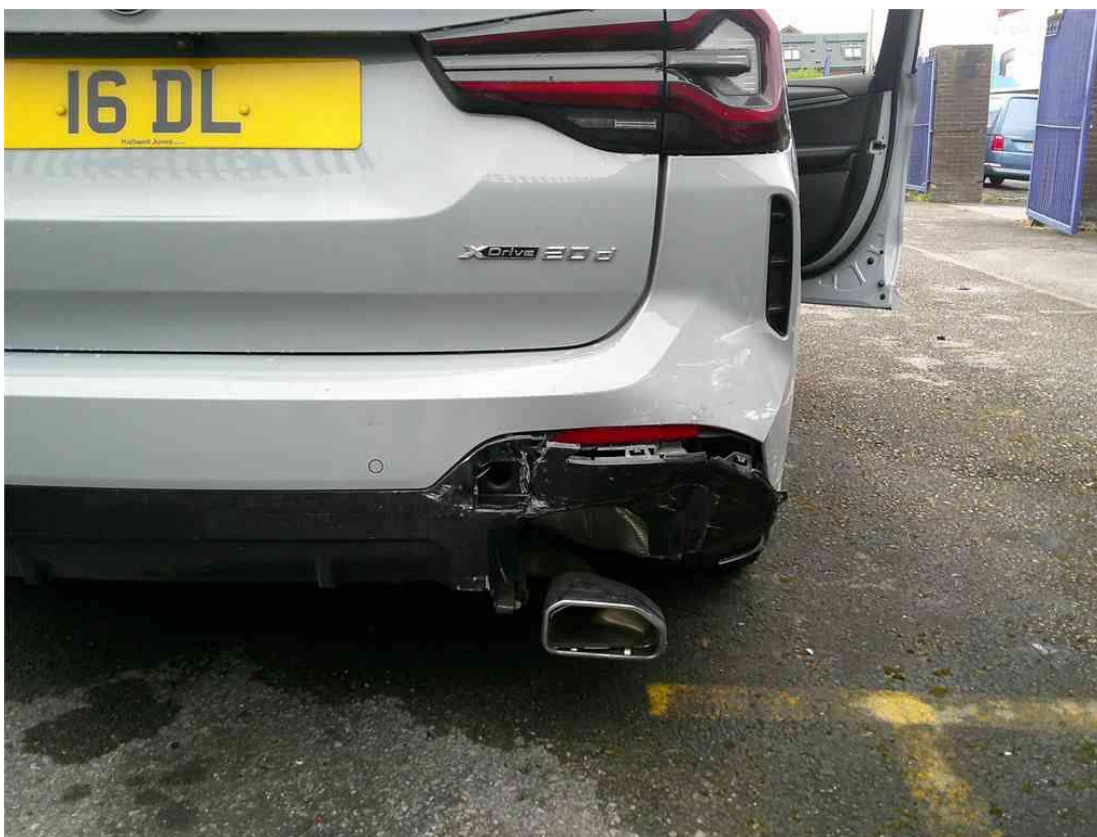
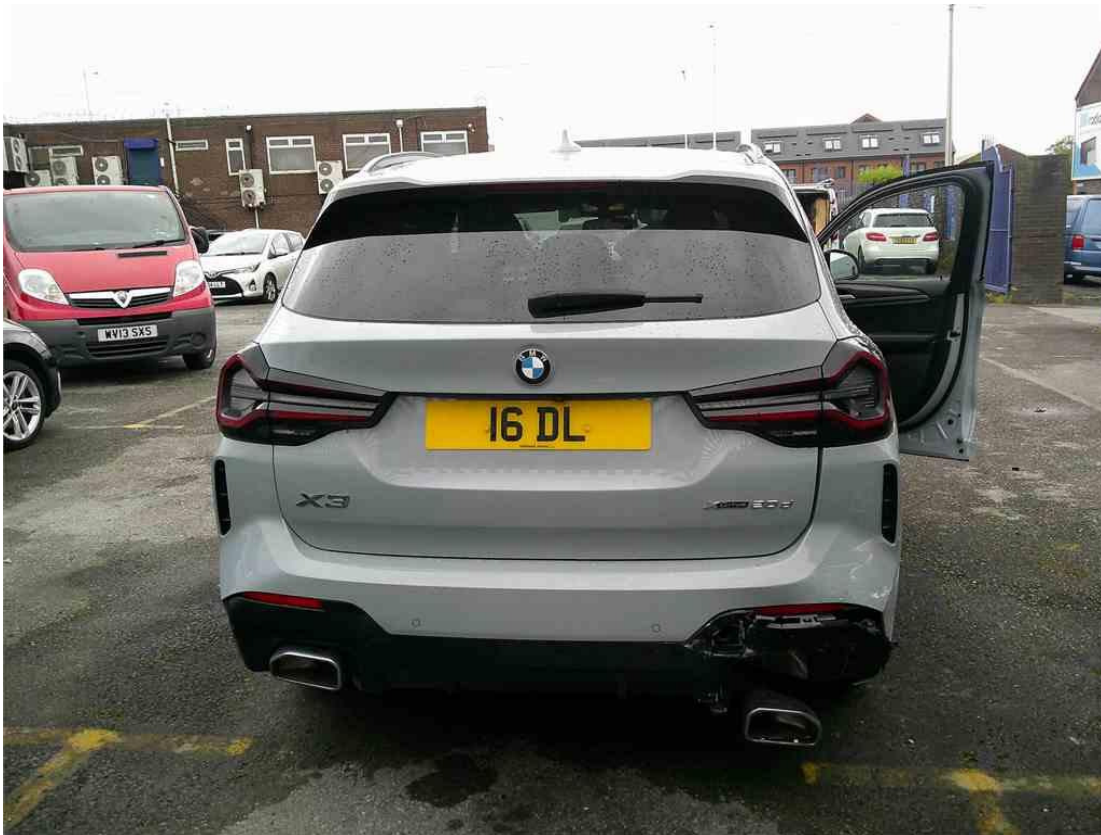
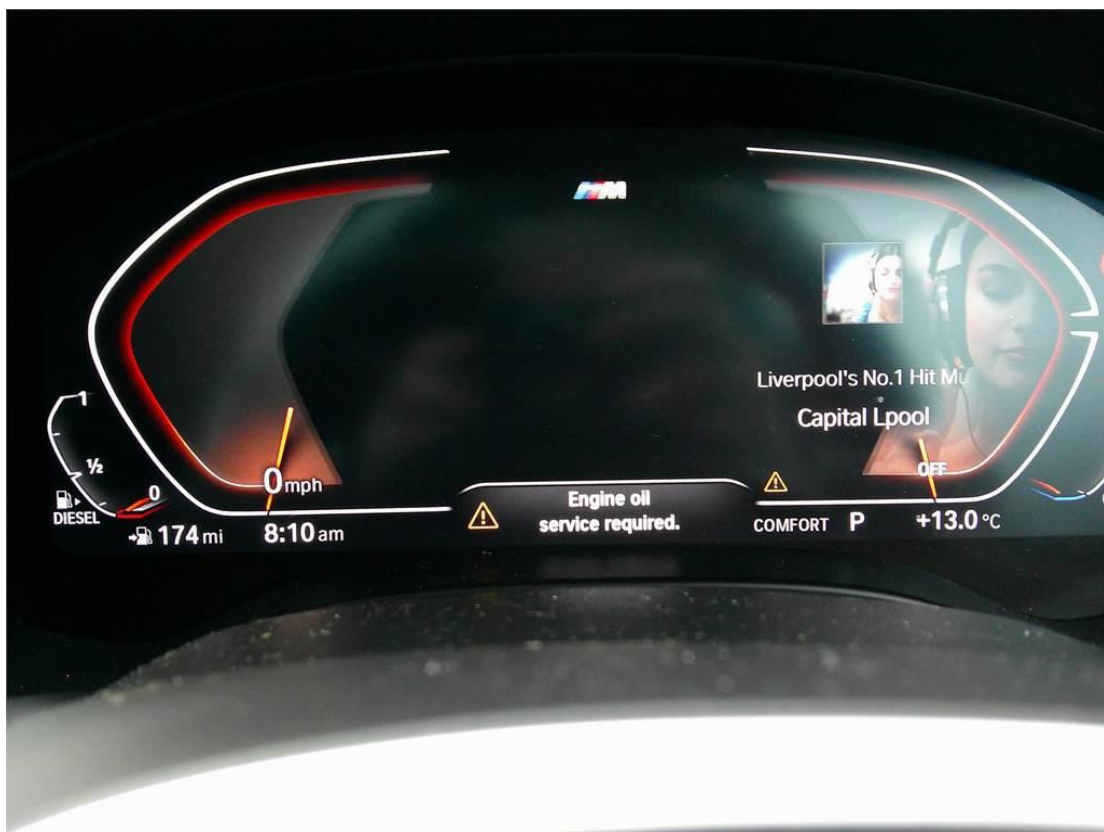
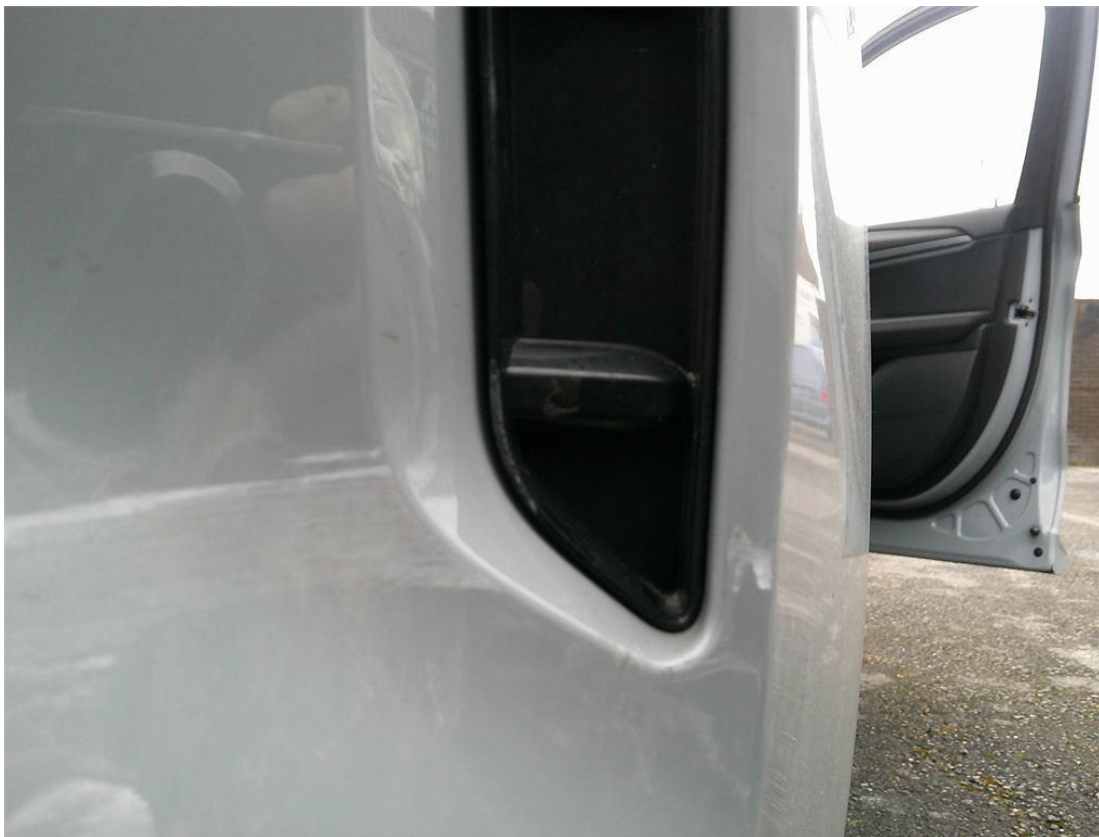
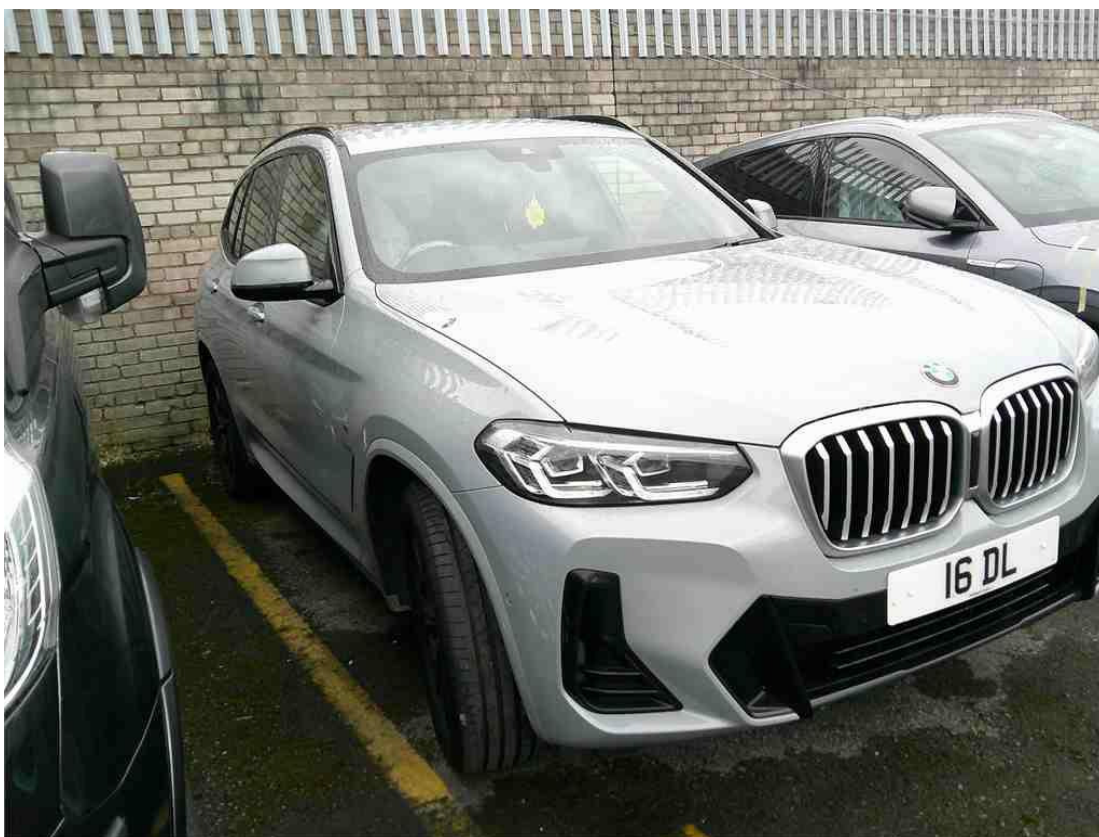
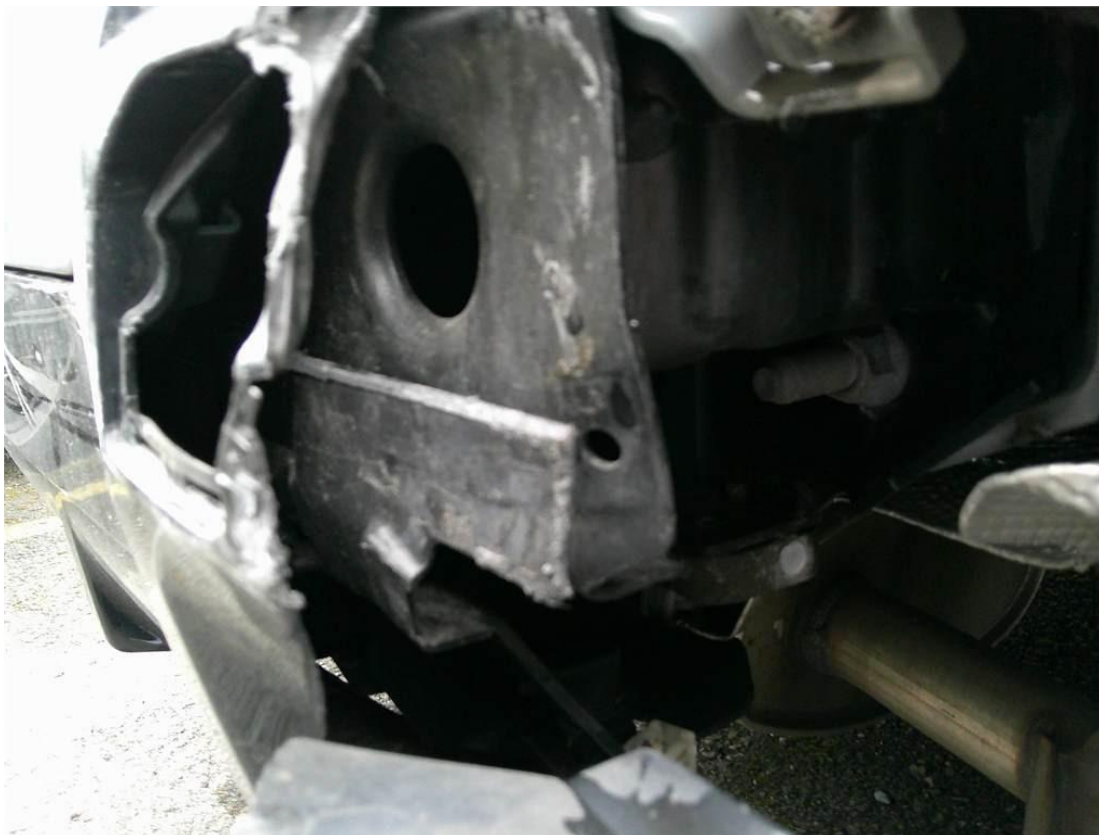
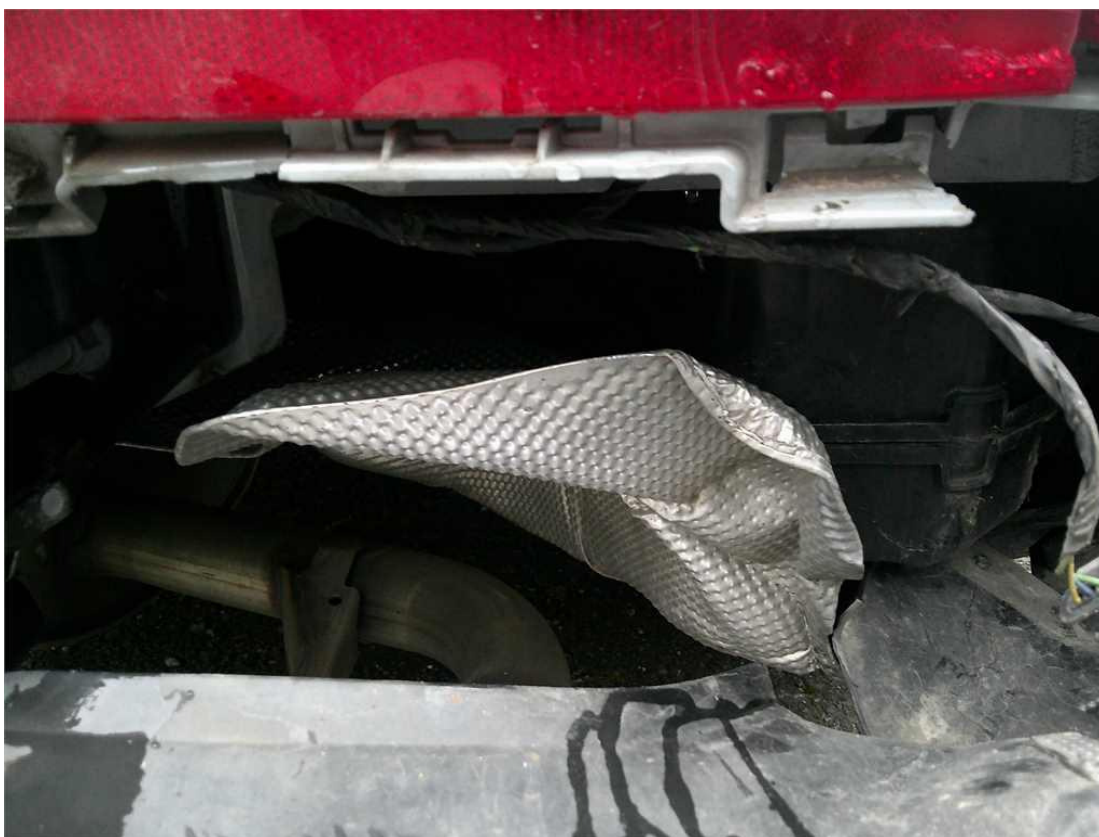
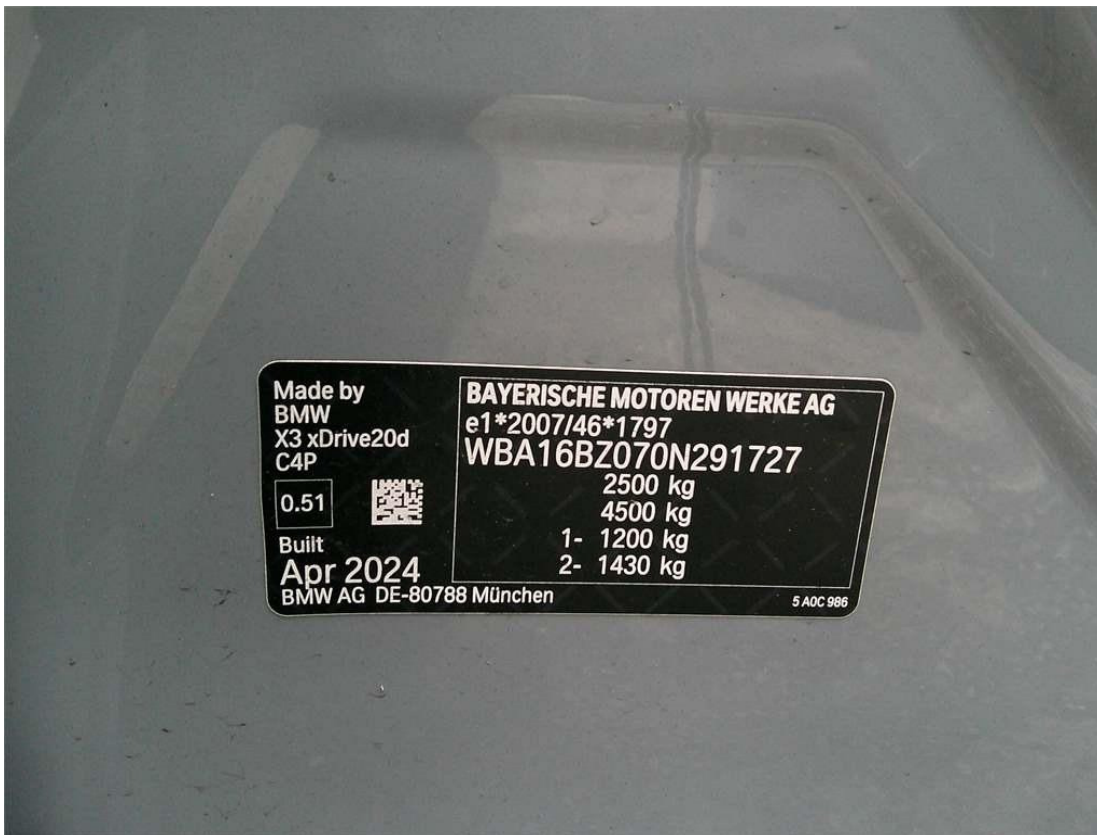
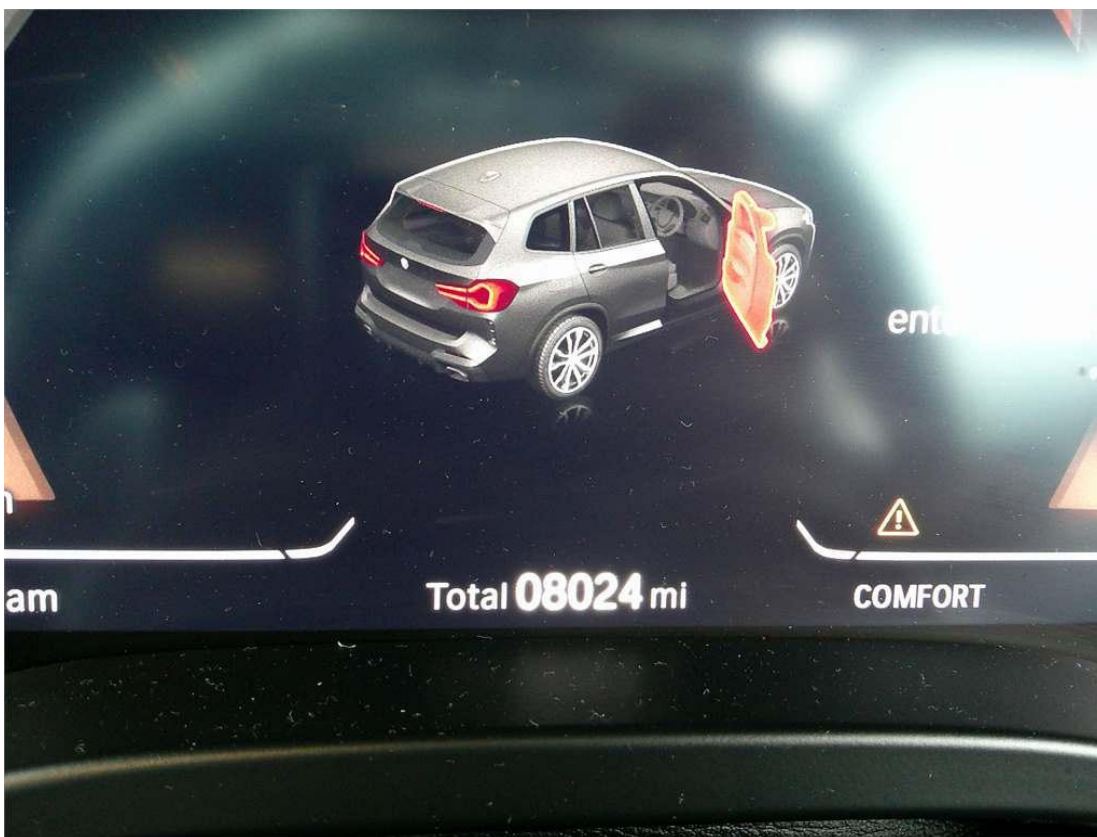
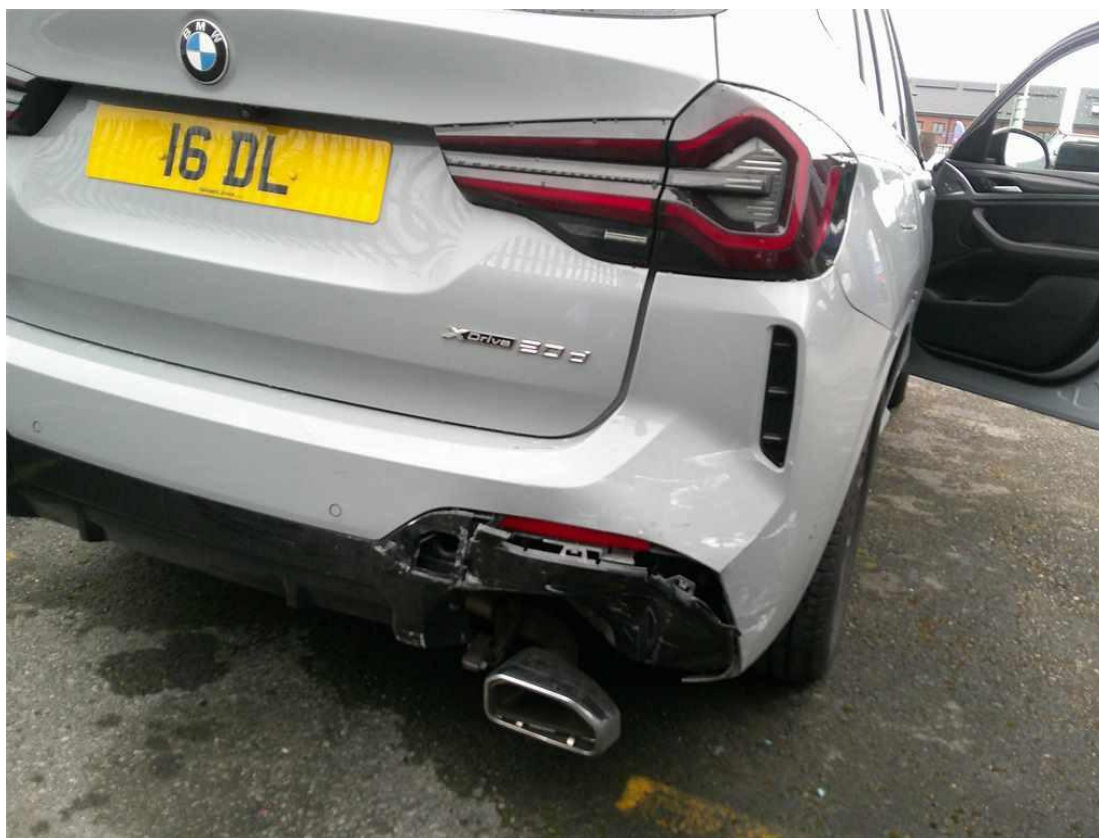
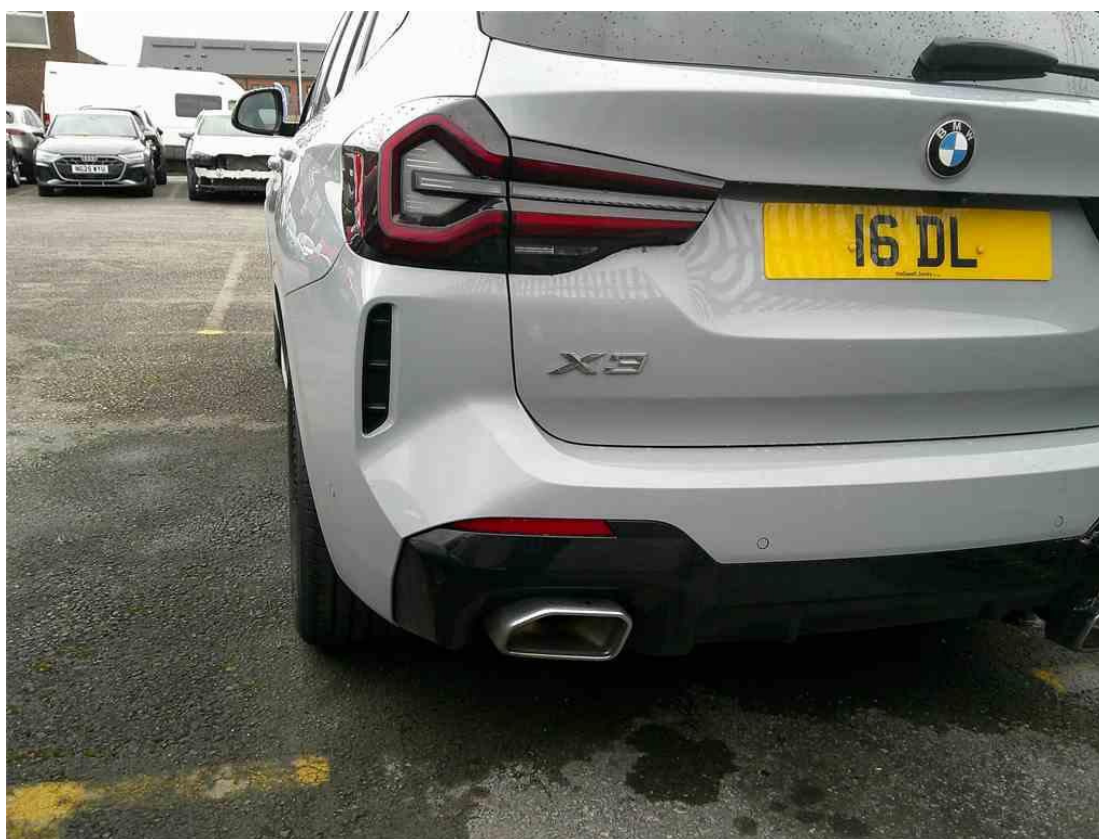
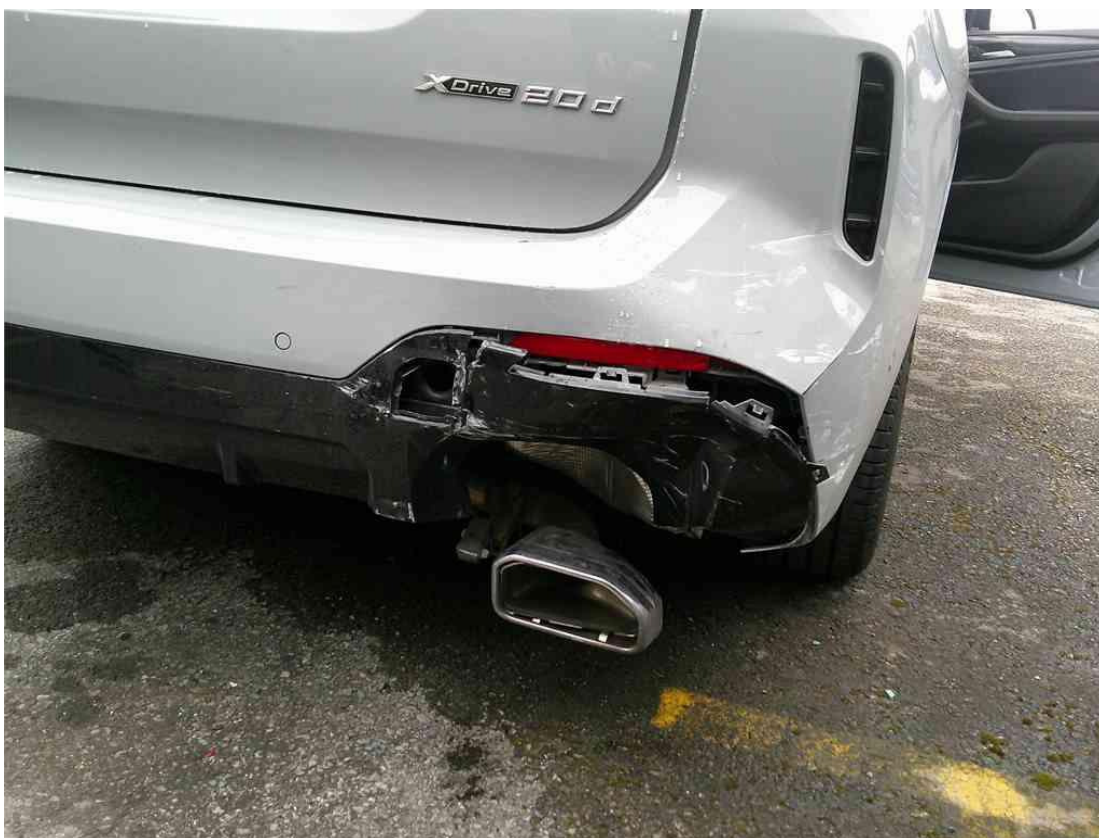
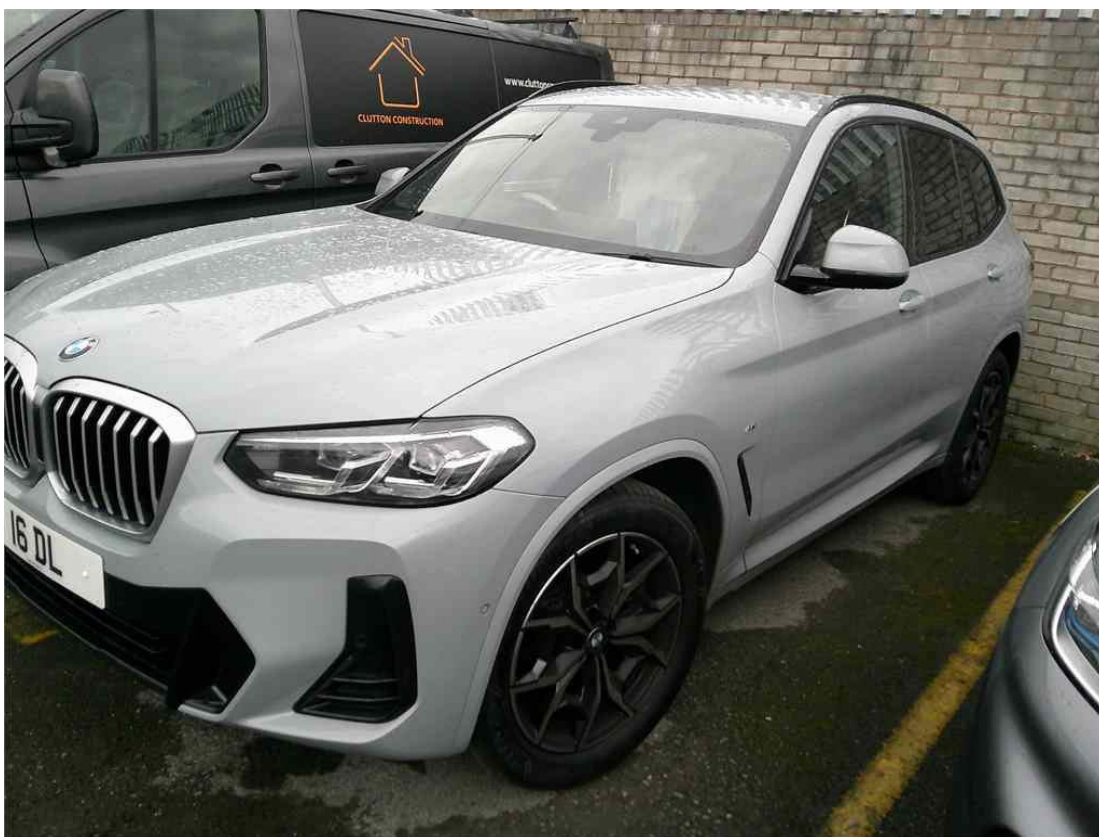
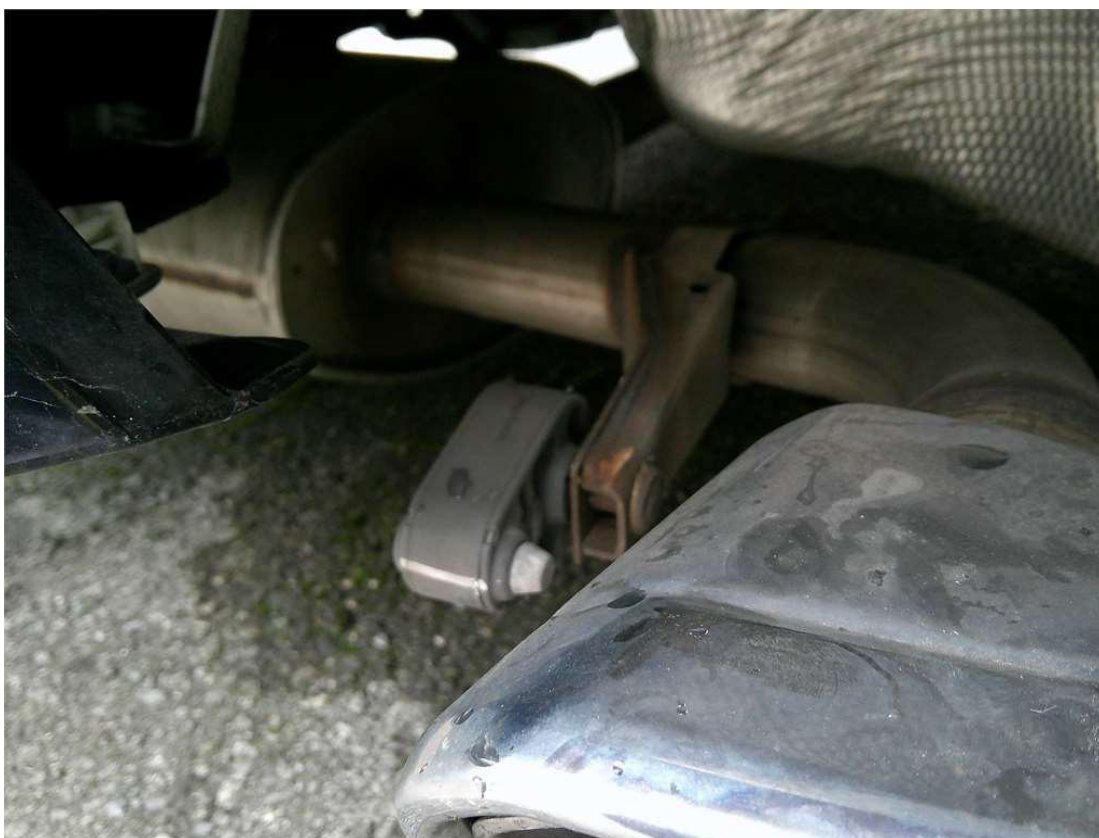
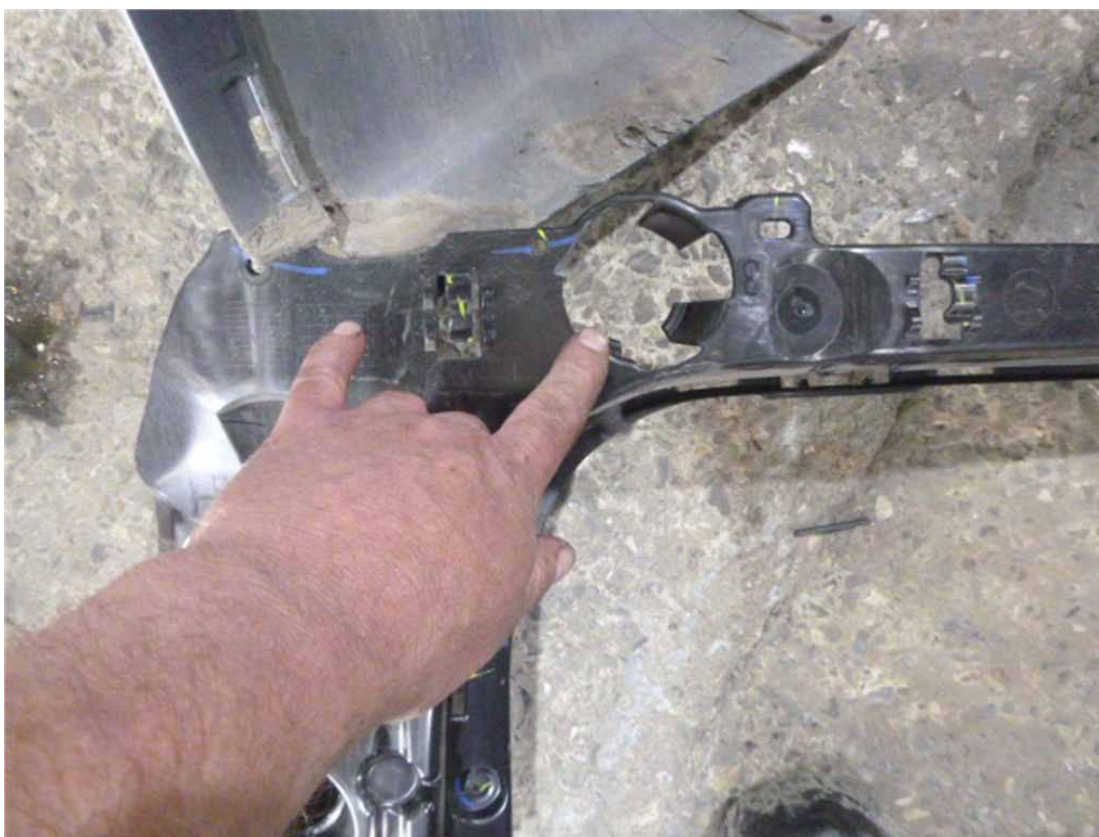
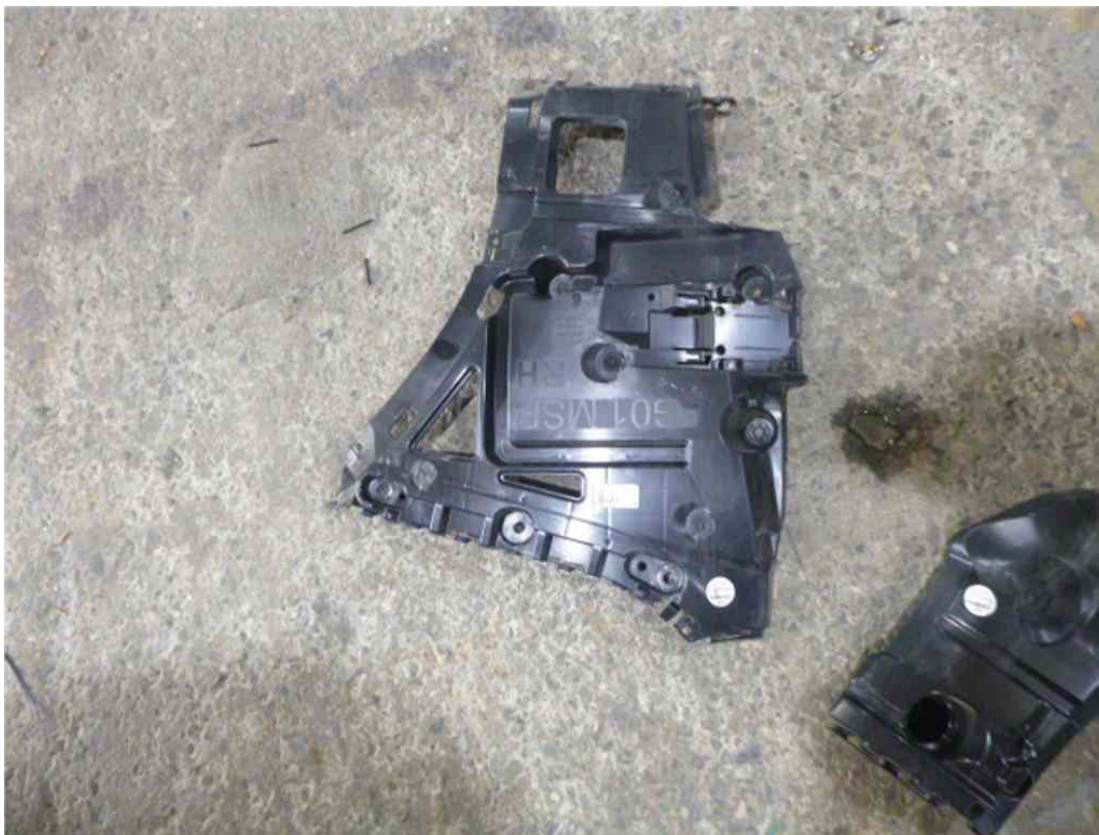
Right Rear Damage  
Lower Tailgate

Outer Rear Panel

Rear Bumper Cover  
Support Adapter  
R/R Reflector  
R/Air Intake Duct  
R/R Bumper Prot Foil  
Rear Bumper Carrier  
Nut  
R/R Carrier Seal  
R/Out U-Sonic Sender  
Rear Badge  
L/Rivet  
Tailgate Trim Clip  
L/R Exhaust Rubber  
Ctr Exh Pipe Rubber  
Rr Exhaust Silencer  
R/R Heat Insulation  
Trim Grill  
Sundry Parts

Rear Bumper Cover  
Clip Fastening  
R/R Out Bumper Brkt  
L/R Bumper Prot Foil  
R/Nut  
R/R Bumper Bracket  
L/R Carrier Seal  
Rr Sensor Brkt Set  
R/R Out Sensor Brkt  
Rear Model Badge  
R/Rivet  
Clip Fastening  
R/R Exhaust Rubber  
Exhaust Clamp  
R/Exhaust Cover  
Exhaust Paste  
Bracket

Paint Rear Bumper Cover New Part Paint K1r  
Paint Lower Tailgate Repair Painting <50%  
Blend R/R Wheelarch Trim Surface Paint Plast.  
Paint Additional Masking Tailgate  
Assessment Fee  
Vehicle Care Kit  
Corrosion Mat  
Hybrid Full

Paint Outer Rear Panel Repair Painting <50%  
Blend L/R Wheelarch Trim Surface Paint Plast.  
Paint Denib / Polish Paint  
Paint Preparation For Pre-Painting  
Epa Charge  
Paint Consumable  
Panel Sundries P/P Specialist  
Delivery To Client Returning Veh
