## EXCAVATOR EQUIPMENT INSPECTION CHECK LIST

Annex to certificate N°: ST-4542-22

Date of inspection: 19/May/2026

## Certificate of Thorough Examination & NDE for Hydraulic Excavator

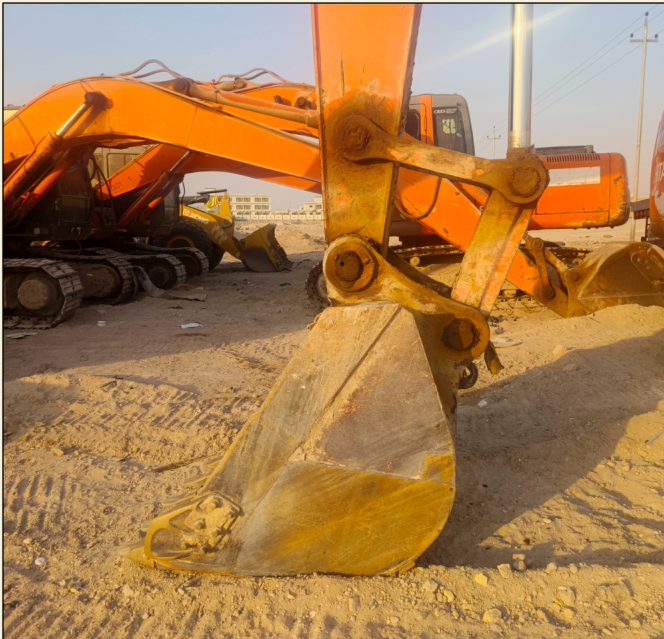
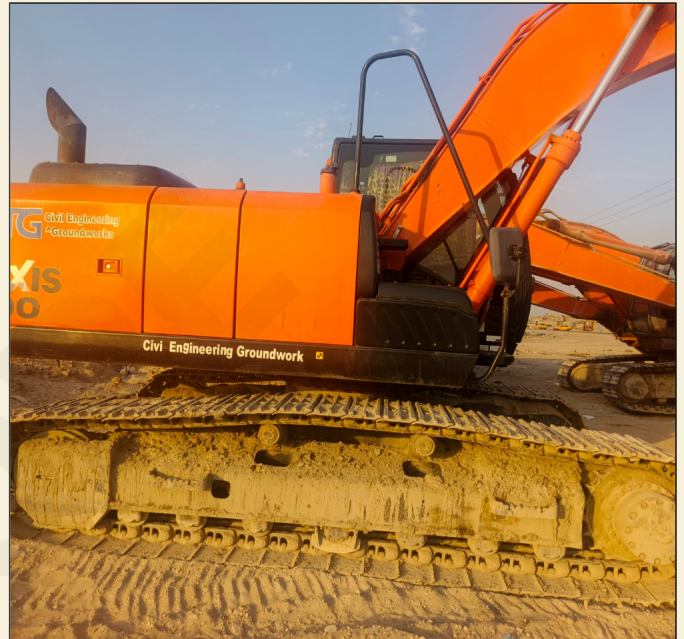
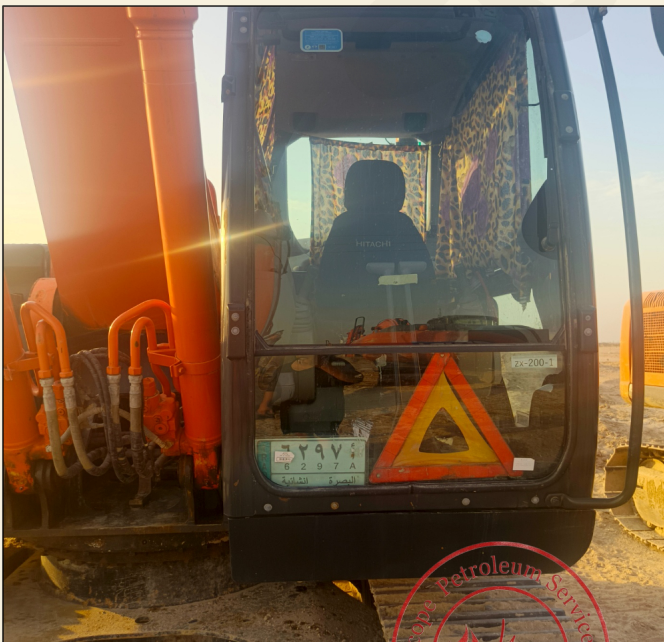
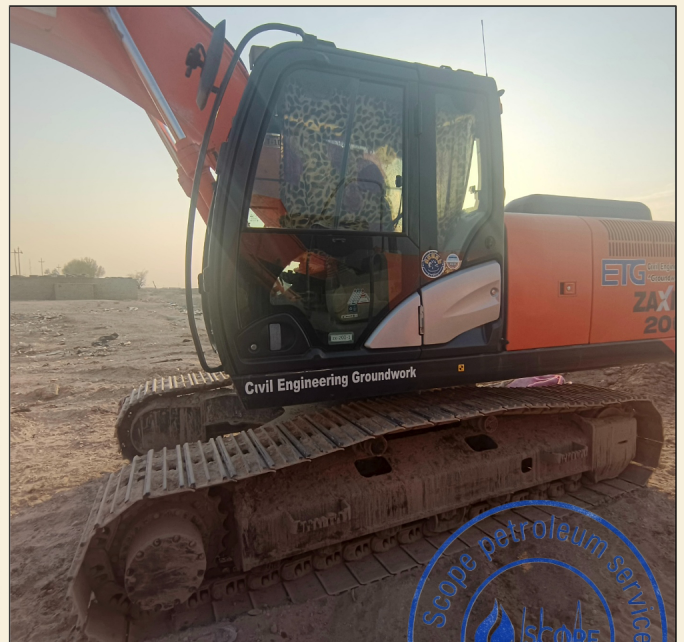
Comment:
