## EXCAVATOR EQUIPMENT INSPECTION CHECK LIST

Annex to certificate N°: ST-4542-33

Date of inspection: 30/May/2026

## Certificate of Thorough Examination & NDE for Hydraulic Excavator

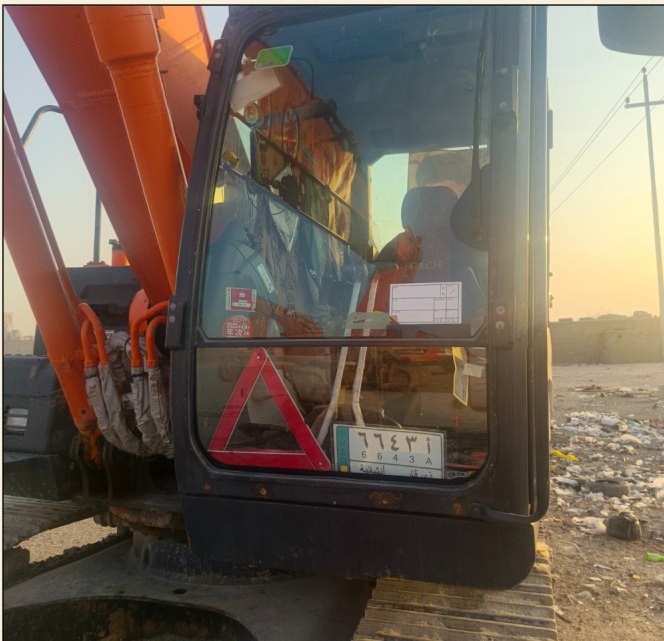
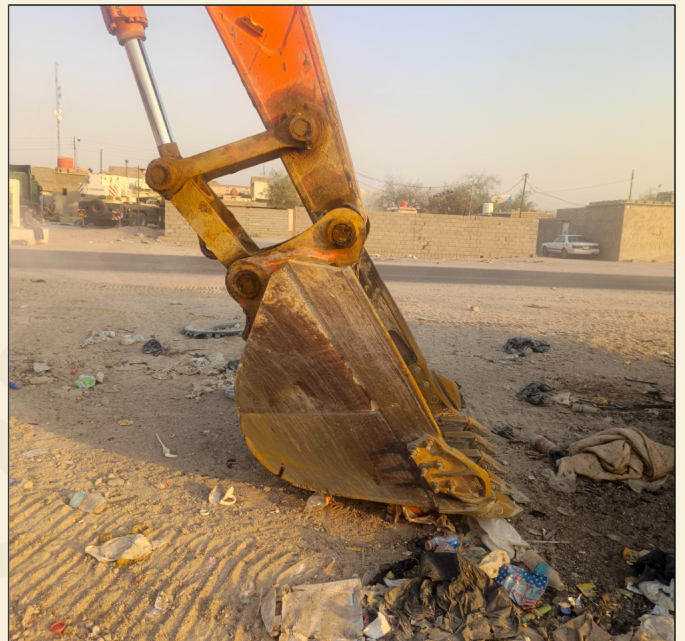
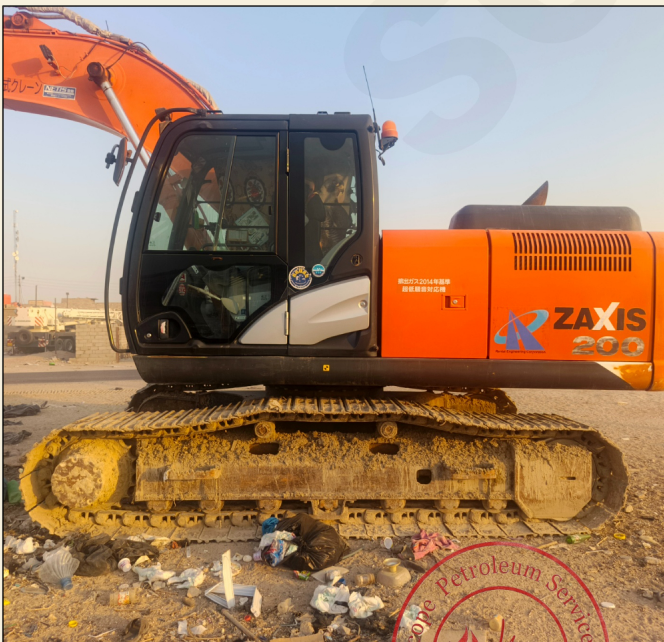
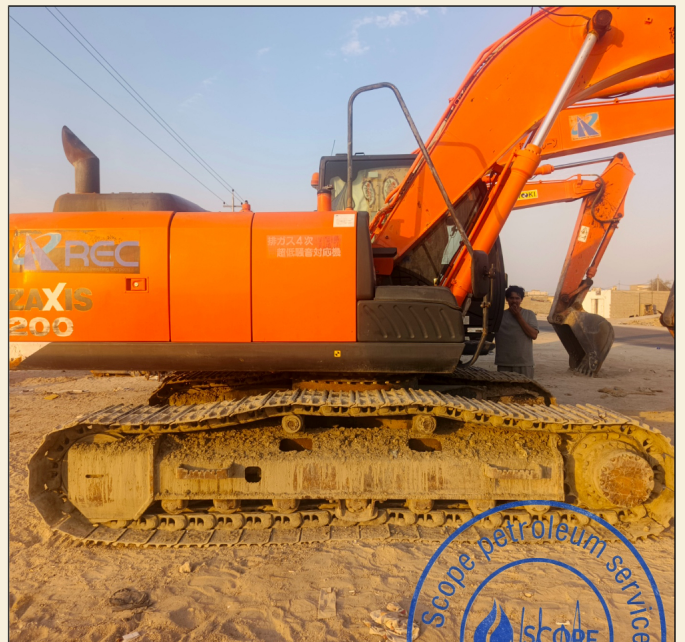
Comment:
