JOURNEY RISK MANAGEMENT (JRM) STUDY

IOCL Coimbatore Terminal to Kalpana Agencies

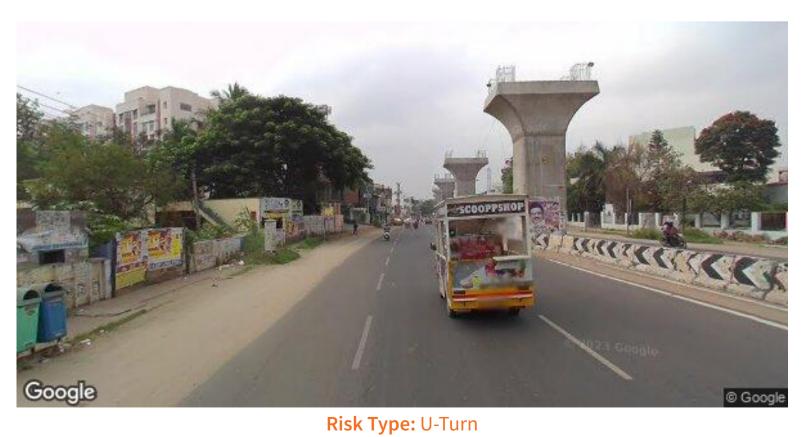
Coordinates: 11.0161282, 76.9896128

Risk Level: High
Speed Limit: 10 KM/Hr

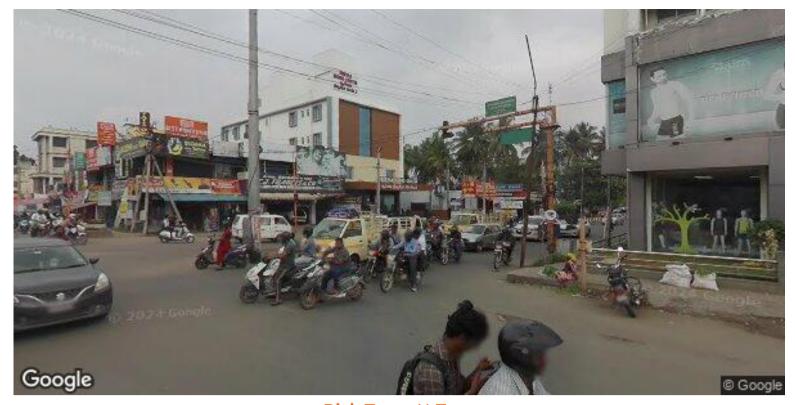
Coordinates: 11.0283074, 76.95130449999999

Risk Type: U-Turn
Risk Level: High
Speed Limit: 10 KM/Hr

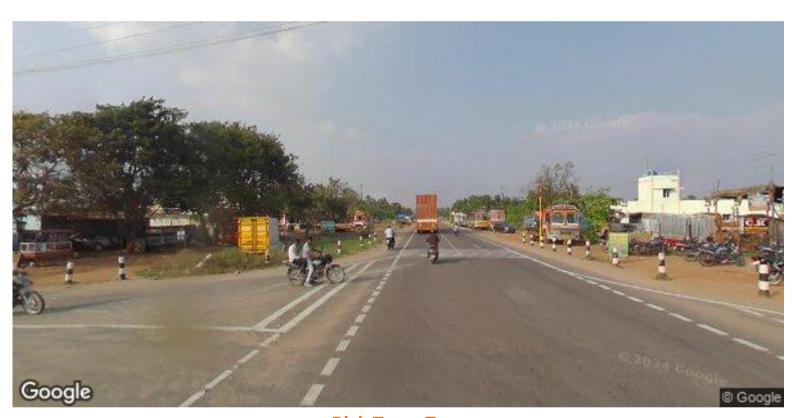
Coordinates: 11.03211, 77.07640

Risk Type: Turn
Risk Level: High
Speed Limit: 15 KM/Hr

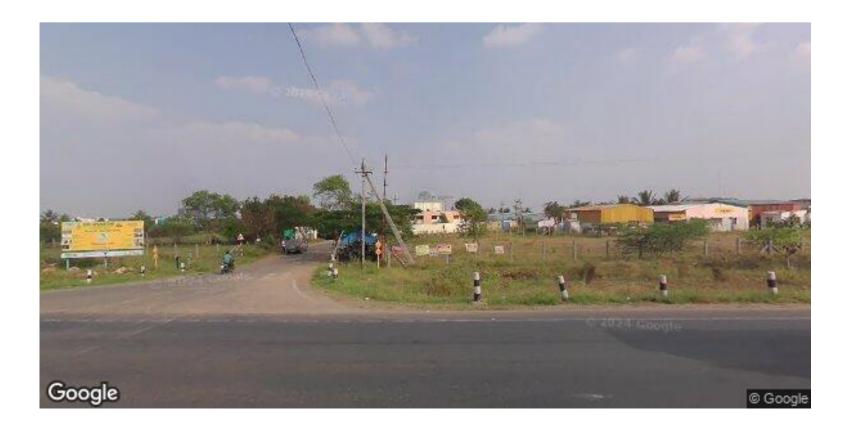
Coordinates: 11.05129, 77.07919

Risk Type: Turn
Risk Level: High
Speed Limit: 15 KM/Hr

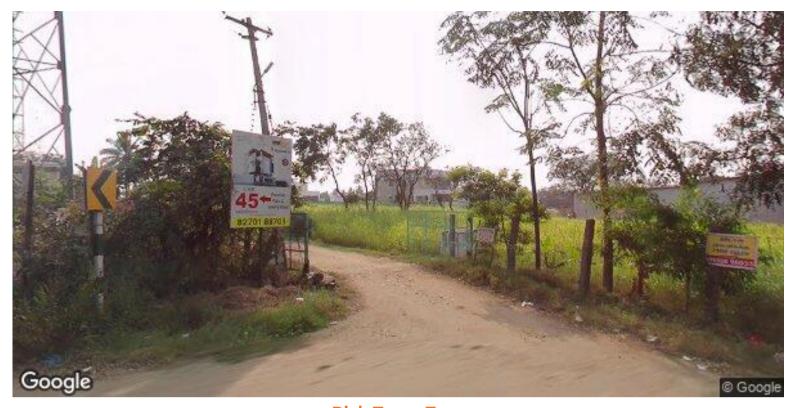
Risk Type: Turn
Risk Level: Medium
Speed Limit: 30 KM/Hr
Coordinates: 11.05181, 77.07696

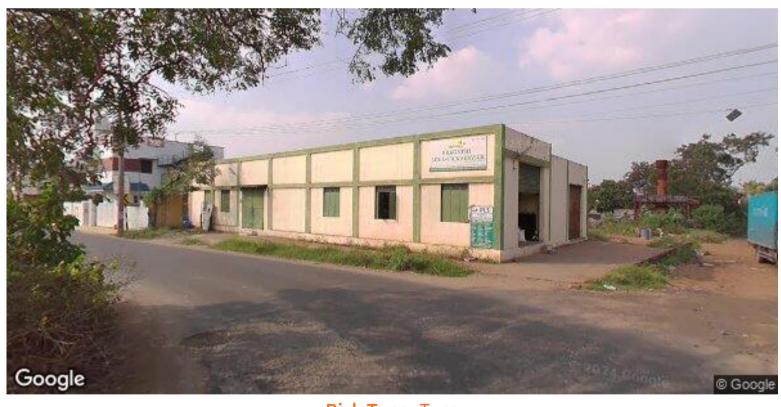
Risk Type: Turn
Risk Level: High
Speed Limit: 15 KM/Hr
Coordinates: 11.05222, 77.07690

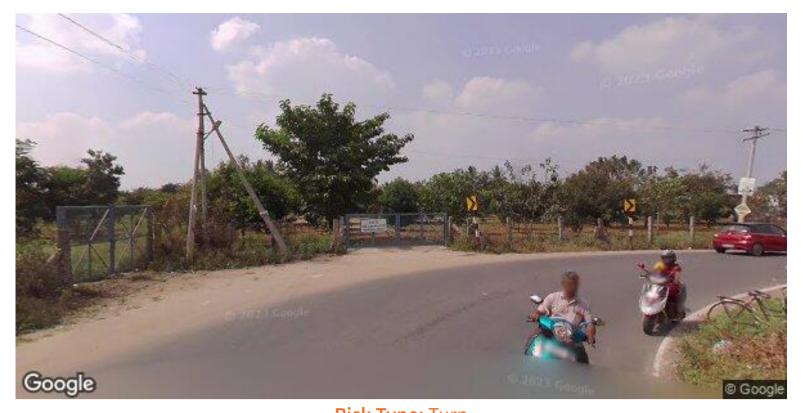
Risk Type: Turn
Risk Level: Medium
Speed Limit: 30 KM/Hr
Coordinates: 11.05343, 77.07106

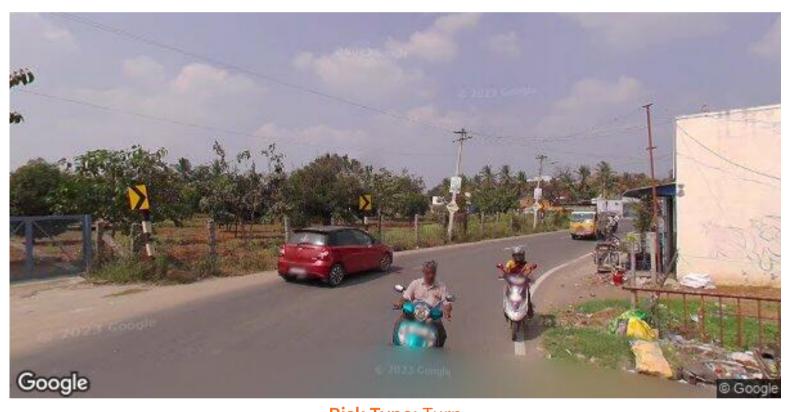
Risk Type: Turn
Risk Level: Medium
Speed Limit: 30 KM/Hr
Coordinates: 11.05351, 77.07099

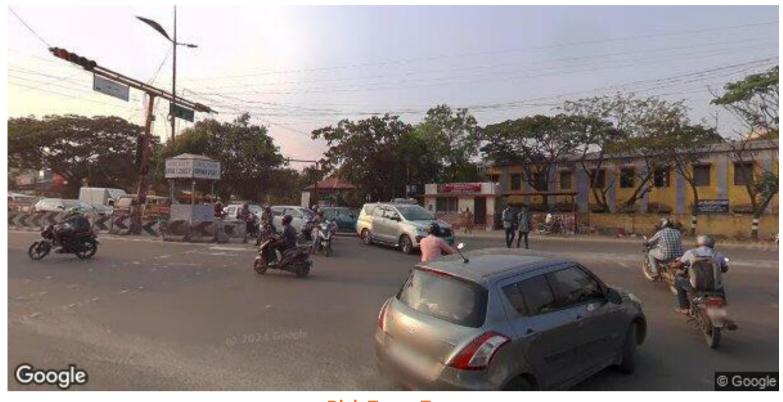
Coordinates: 11.05529, 77.06566

Risk Type: Turn
Risk Level: High
Speed Limit: 15 KM/Hr

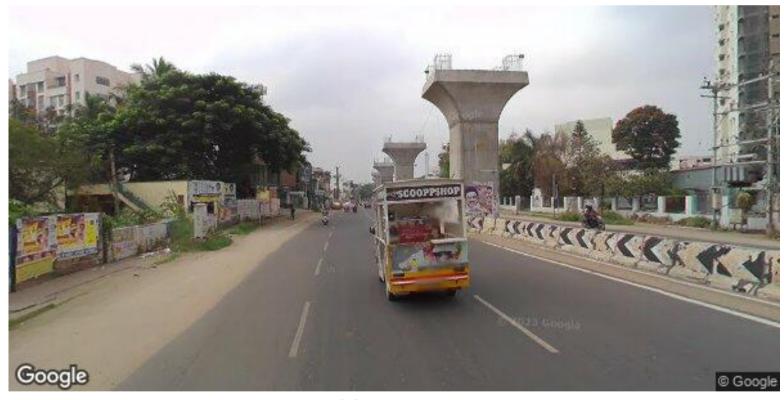
Coordinates: 11.01613, 76.98961

Risk Type: Turn
Risk Level: High
Speed Limit: 15 KM/Hr

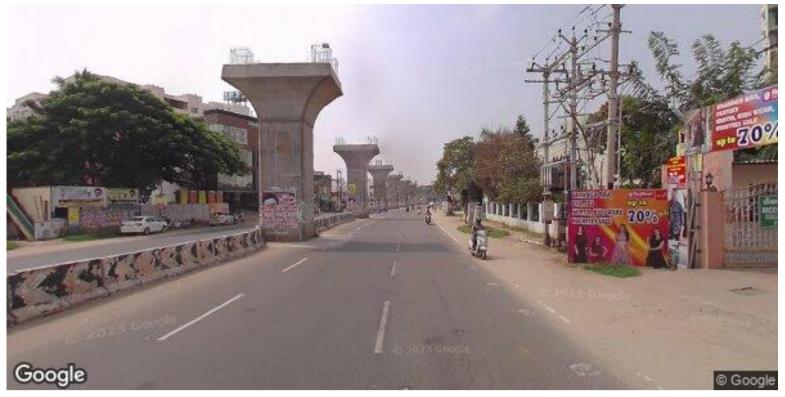
Risk Type: Blind Spot
Risk Level: Blind Spot
Speed Limit: 10 KM/Hr
Coordinates: 11.01618, 76.98951

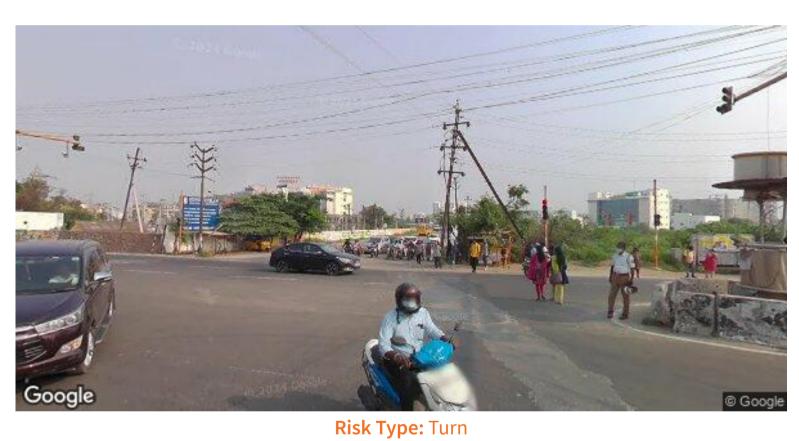
Risk Level: High
Speed Limit: 15 KM/Hr
Coordinates: 11.02014, 76.99212

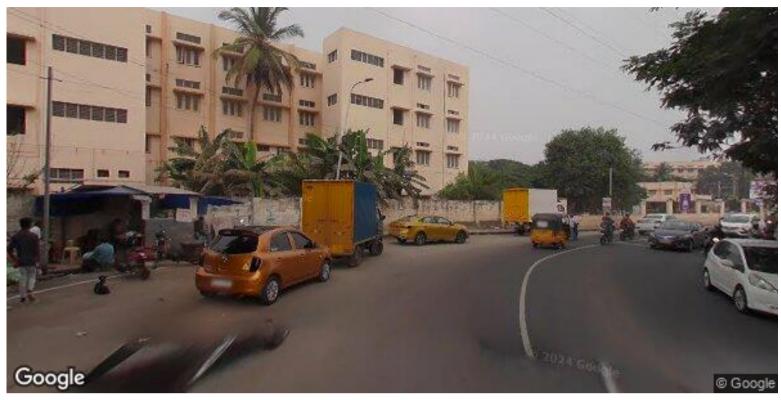
Coordinates: 11.02133, 76.98668

Risk Type: Turn
Risk Level: Medium
Speed Limit: 30 KM/Hr

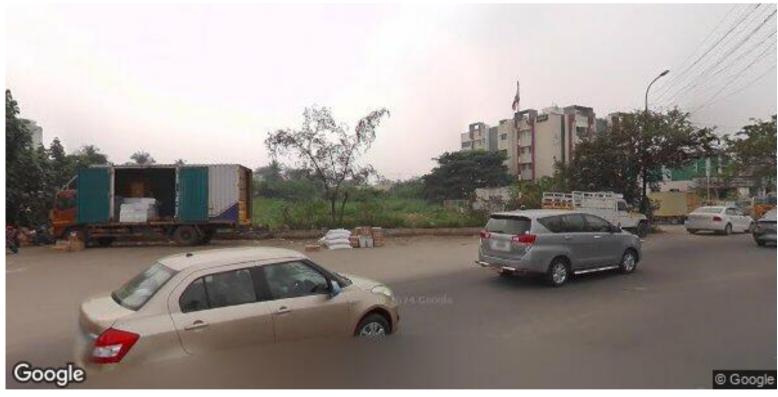
Coordinates: 11.02098, 76.98650

Risk Type: Turn
Risk Level: Medium
Speed Limit: 30 KM/Hr

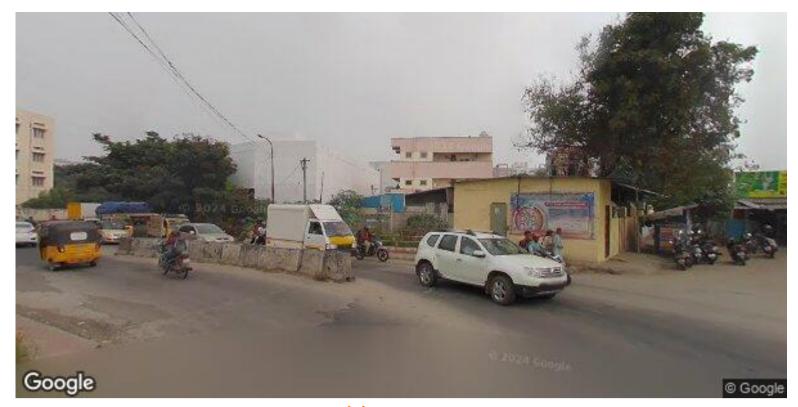
Risk Type: Turn
Risk Level: Medium
Speed Limit: 30 KM/Hr
Coordinates: 11.02095, 76.98646

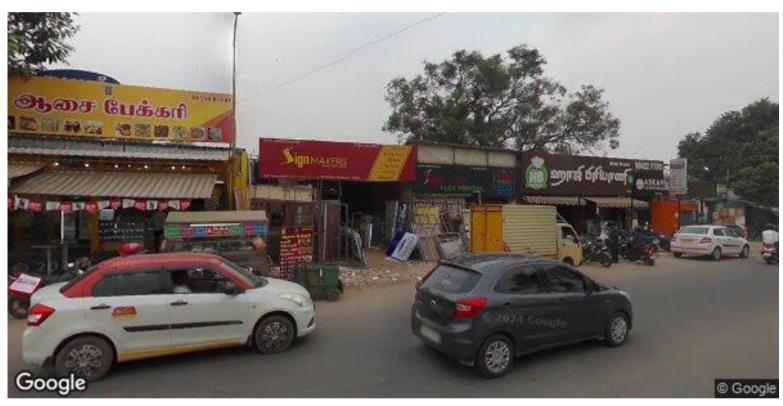
Risk Type: Turn
Risk Level: Medium
Speed Limit: 30 KM/Hr
Coordinates: 11.02132, 76.98270

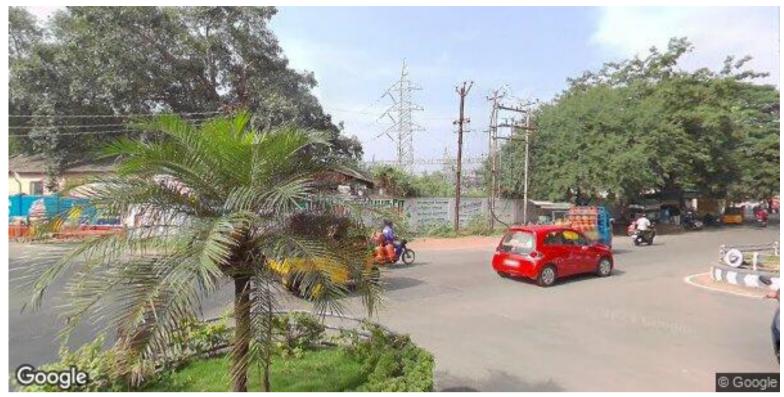
Coordinates: 11.01891, 76.96036

Risk Type: Turn
Risk Level: High
Speed Limit: 15 KM/Hr

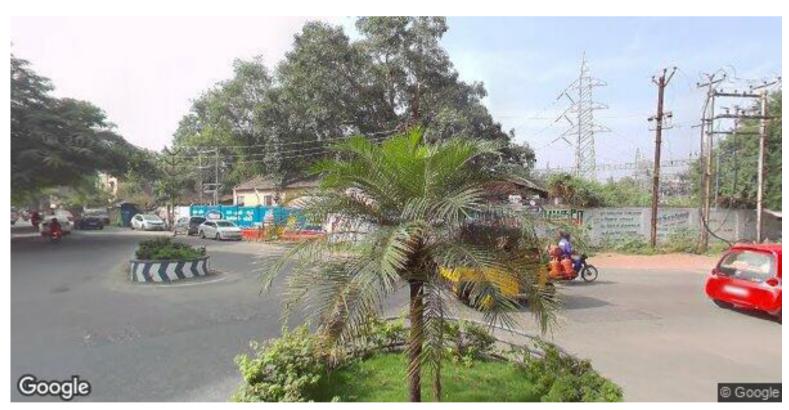
Risk Type: Turn
Risk Level: Medium
Speed Limit: 30 KM/Hr
Coordinates: 11.01890, 76.96035

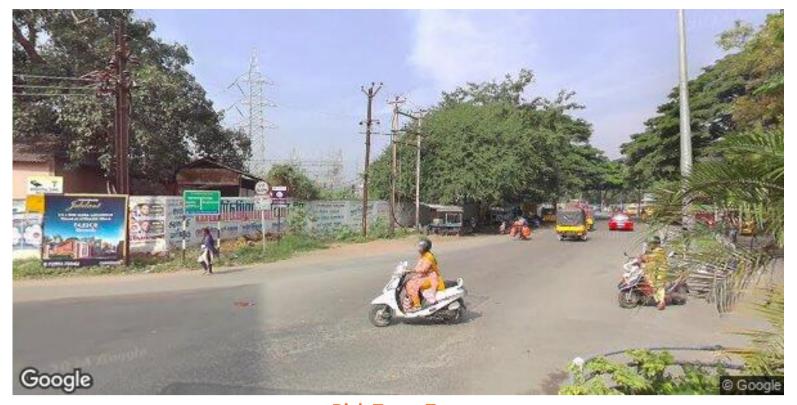
Risk Type: Turn
Risk Level: Medium
Speed Limit: 30 KM/Hr
Coordinates: 11.01889, 76.96029

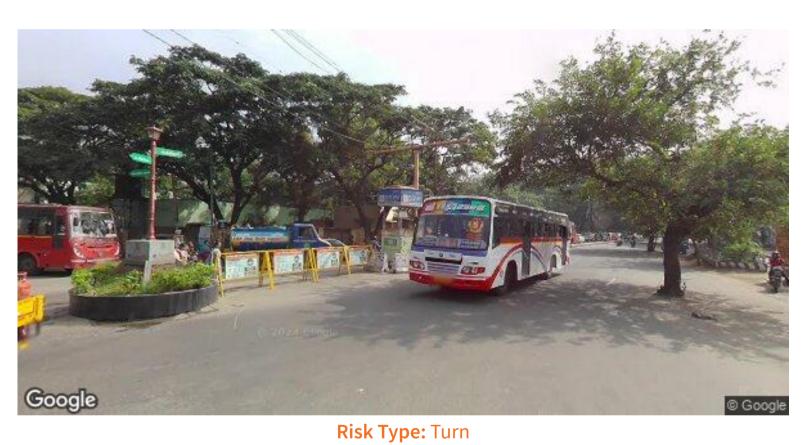
Risk Level: High
Speed Limit: 15 KM/Hr
Coordinates: 11.01944, 76.95923

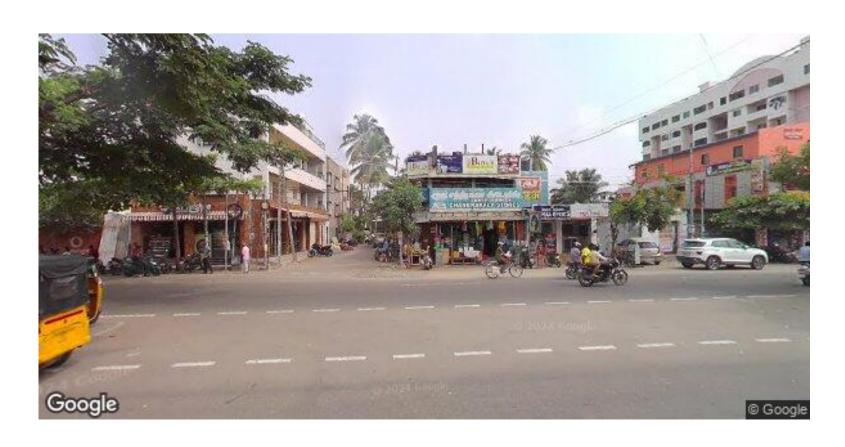
Coordinates: 11.02444, 76.95905

Risk Type: Turn
Risk Level: High
Speed Limit: 15 KM/Hr

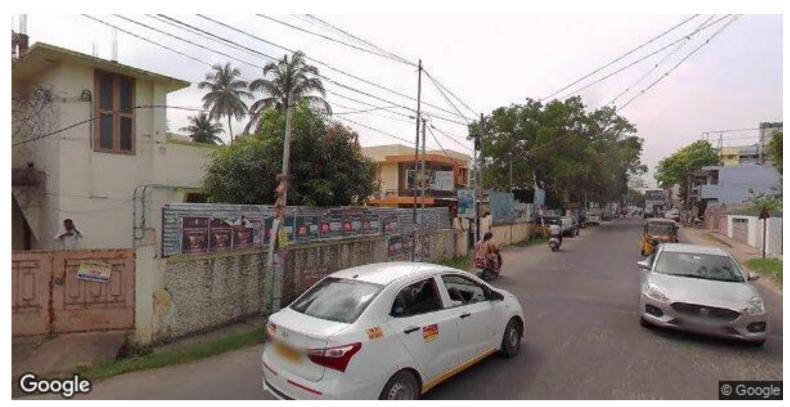
Coordinates: 11.02504, 76.95710

Risk Type: Turn
Risk Level: High
Speed Limit: 15 KM/Hr

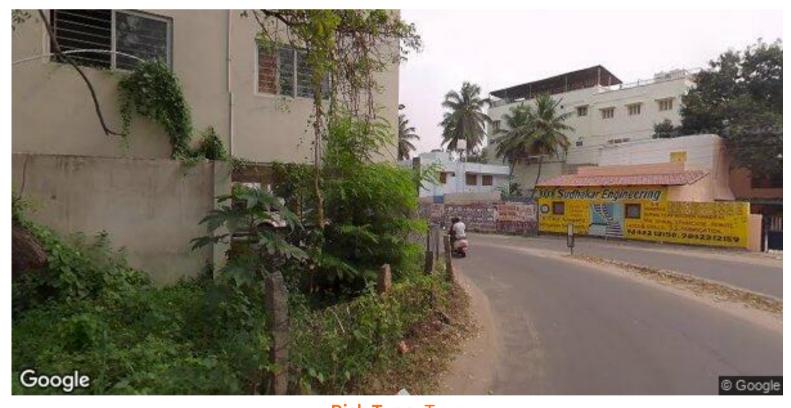
Coordinates: 11.02503, 76.95553

Risk Type: Turn
Risk Level: Medium
Speed Limit: 30 KM/Hr

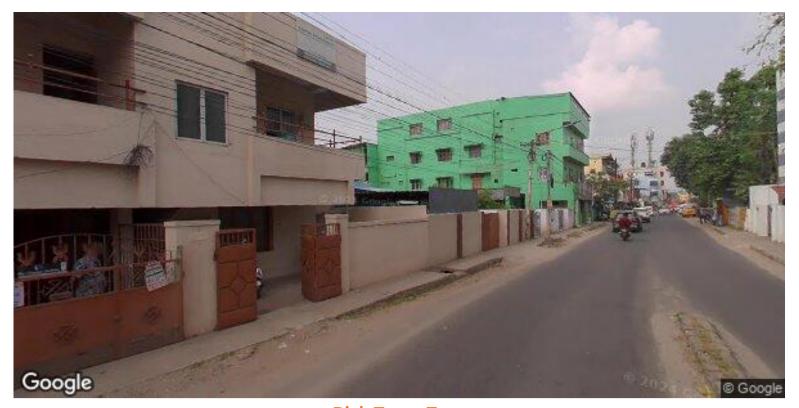
Risk Type: Turn
Risk Level: Medium
Speed Limit: 30 KM/Hr
Coordinates: 11.02514, 76.95541

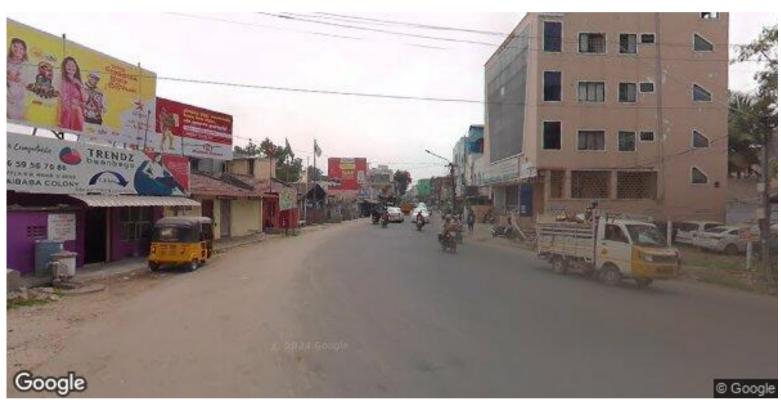
Coordinates: 11.02696, 76.95577

Risk Type: Turn
Risk Level: High
Speed Limit: 15 KM/Hr

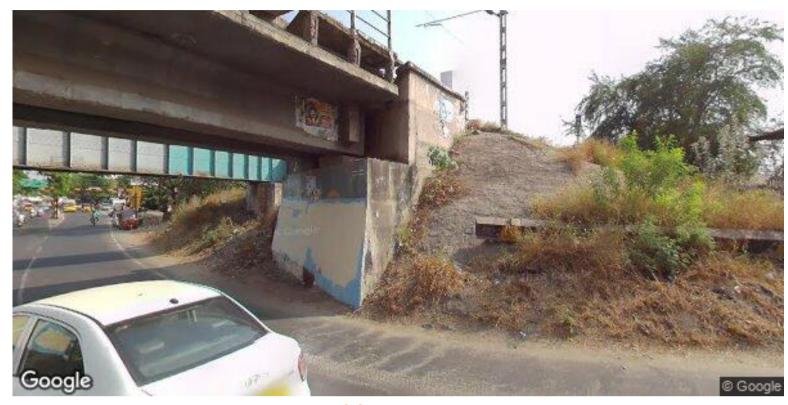
Risk Type: Turn
Risk Level: Medium
Speed Limit: 30 KM/Hr
Coordinates: 11.02847, 76.95462

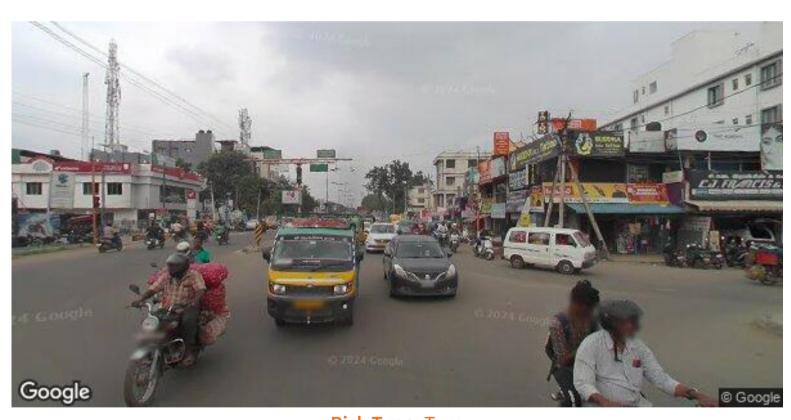
Coordinates: 11.02838, 76.95130

Risk Type: Turn
Risk Level: High
Speed Limit: 15 KM/Hr

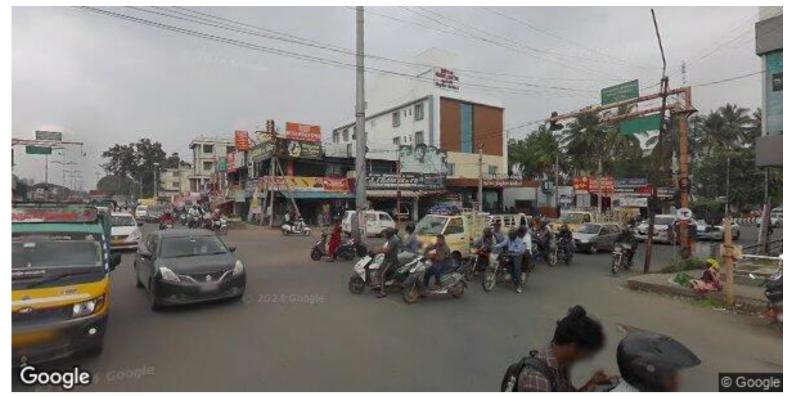
Risk Type: Turn
Risk Level: High
Speed Limit: 15 KM/Hr
Coordinates: 11.02831, 76.95130

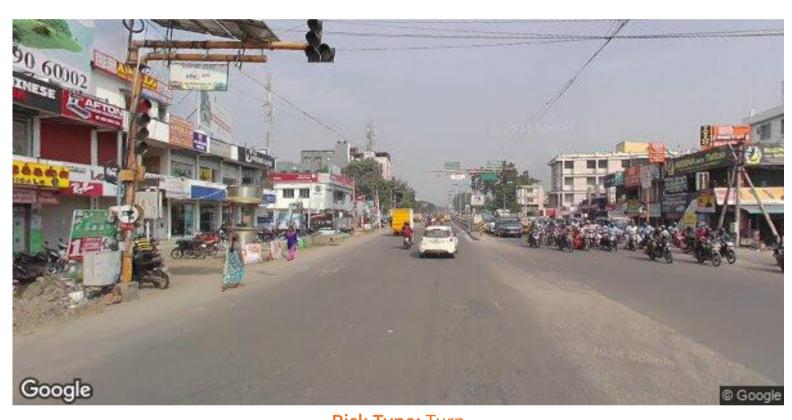
Risk Type: Turn
Risk Level: High
Speed Limit: 15 KM/Hr
Coordinates: 11.02831, 76.95120

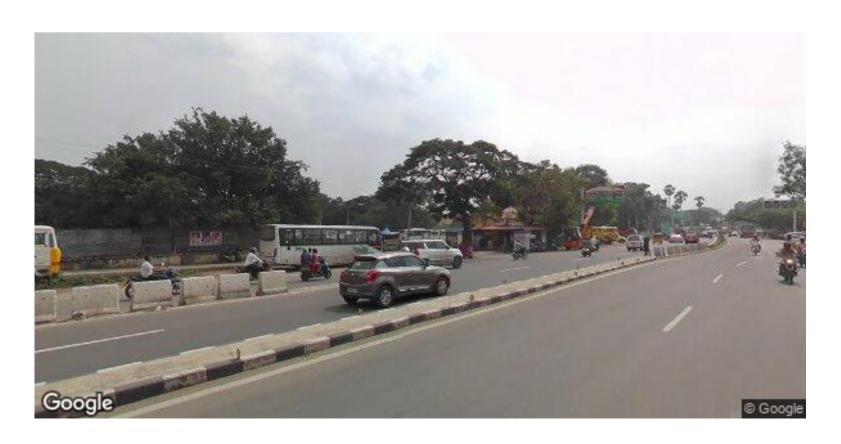
Coordinates: 11.03863, 76.94972

Risk Type: Turn
Risk Level: High
Speed Limit: 15 KM/Hr

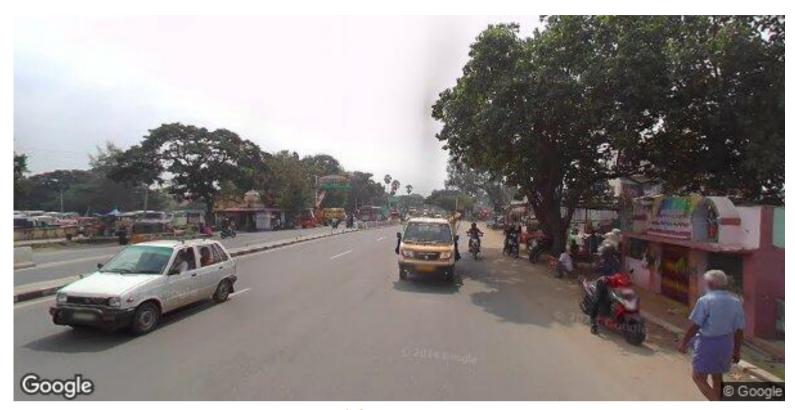
Risk Type: Turn
Risk Level: Medium
Speed Limit: 30 KM/Hr
Coordinates: 11.03865, 76.94966

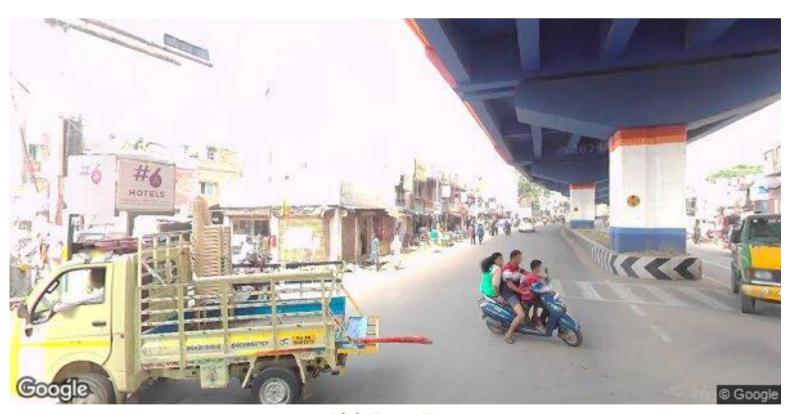
Risk Type: Turn
Risk Level: High
Speed Limit: 15 KM/Hr
Coordinates: 11.04488, 76.94741

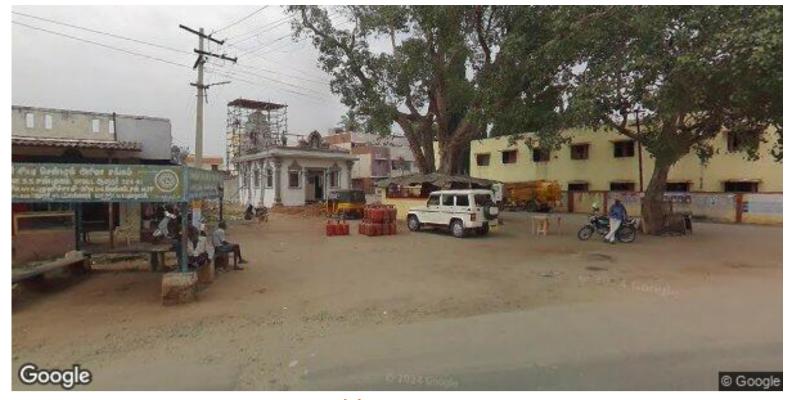
Risk Type: Turn
Risk Level: Medium
Speed Limit: 30 KM/Hr
Coordinates: 11.04405, 76.94077

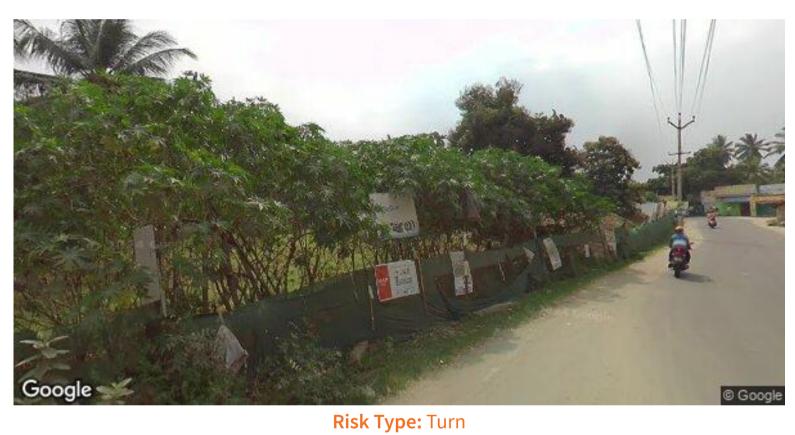
Risk Level: High
Speed Limit: 15 KM/Hr
Coordinates: 11.04361, 76.94066

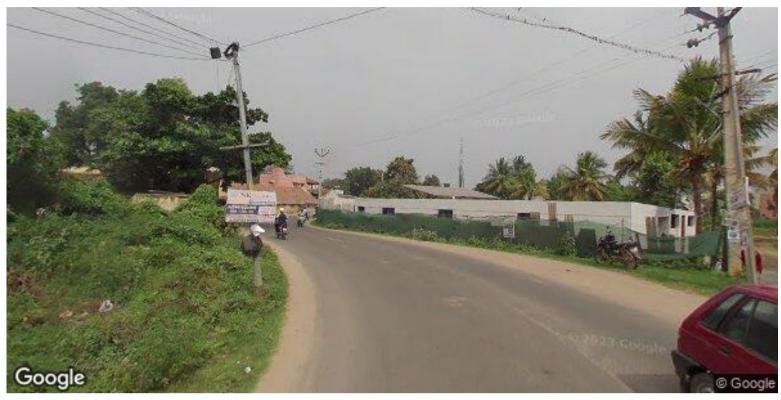
Risk Type: Turn
Risk Level: Medium
Speed Limit: 30 KM/Hr
Coordinates: 11.04313, 76.93992

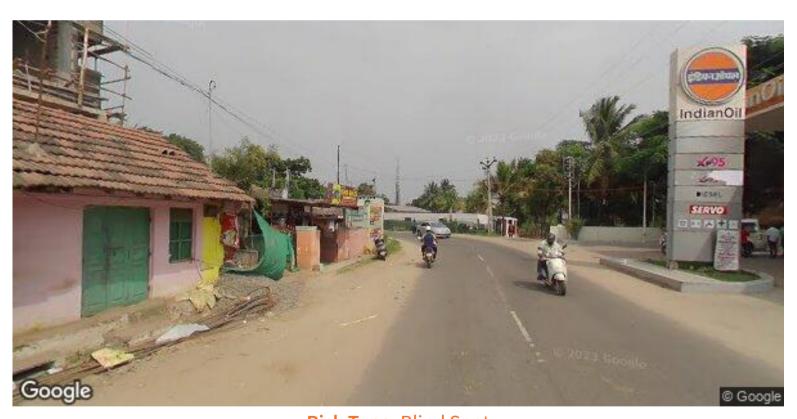
Coordinates: 11.04302, 76.93966

Risk Type: Blind Spot
Risk Level: Blind Spot
Speed Limit: 10 KM/Hr

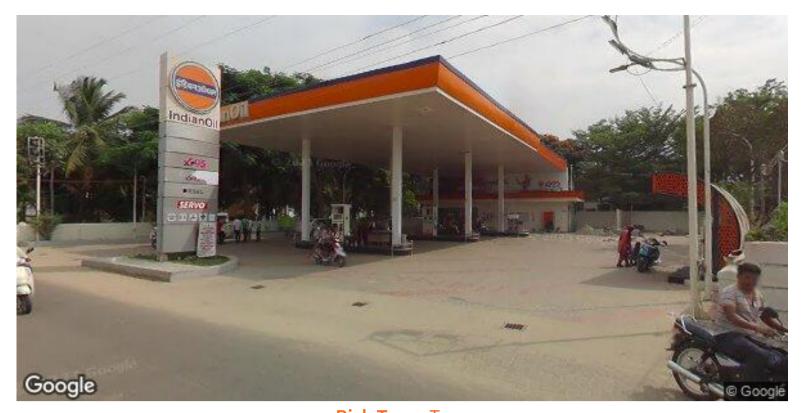
Risk Type: Turn
Risk Level: Medium
Speed Limit: 30 KM/Hr
Coordinates: 11.04296, 76.93970

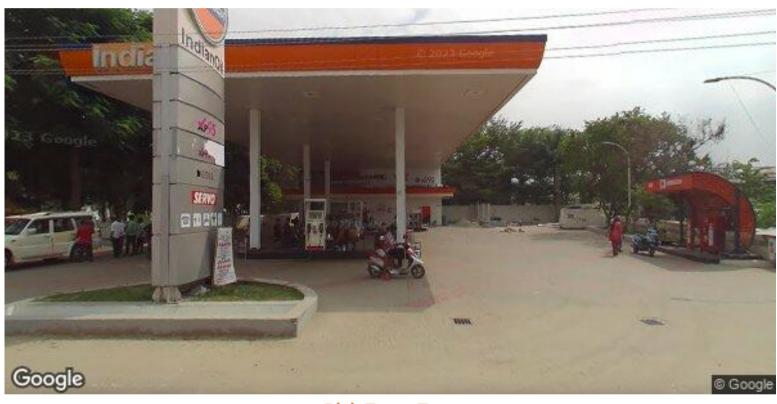
Coordinates: 11.04294, 76.93976

Risk Type: Turn
Risk Level: High
Speed Limit: 15 KM/Hr
