JOURNEY RISK MANAGEMENT (JRM) STUDY

Salem Terminal to THE ERODE DT CONS COOP WHOL STORES

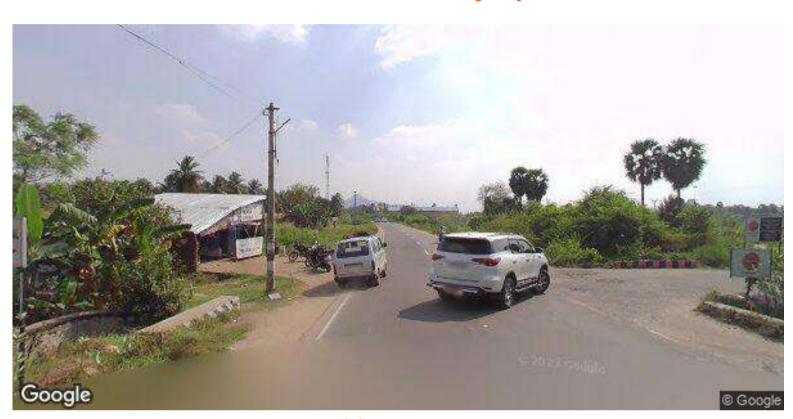
Risk Type: Turn
Risk Level: High
Speed Limit: 15 KM/Hr
Coordinates: 11.44029, 77.87544

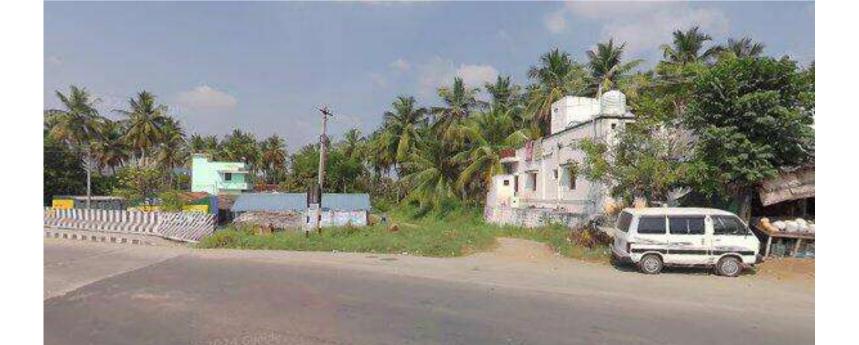
Risk Type: Turn
Risk Level: Medium
Speed Limit: 30 KM/Hr
Coordinates: 11.44898, 77.87410

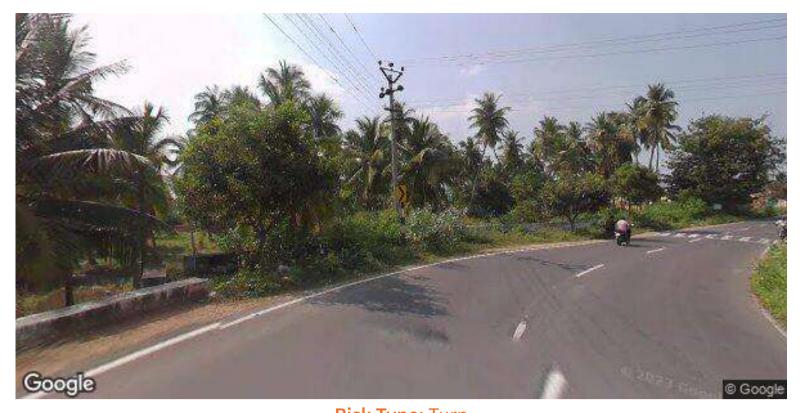
Risk Type: Turn
Risk Level: Medium
Speed Limit: 30 KM/Hr
Coordinates: 11.45348, 77.85706

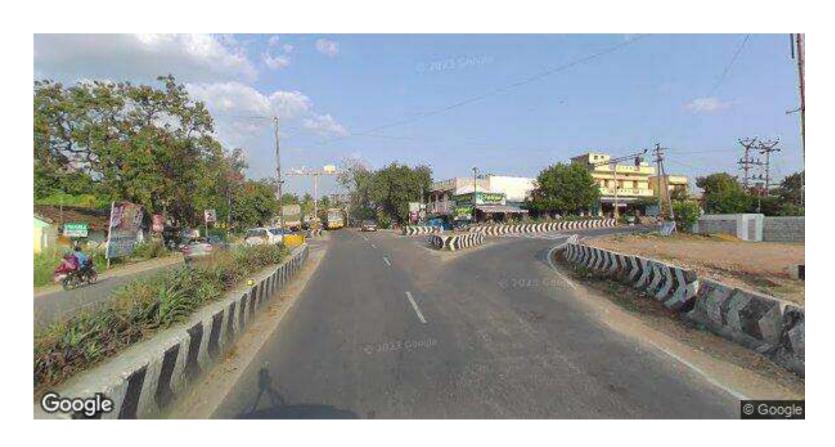
Risk Type: Turn
Risk Level: Medium
Speed Limit: 30 KM/Hr

Coordinates: 11.46318, 77.84913

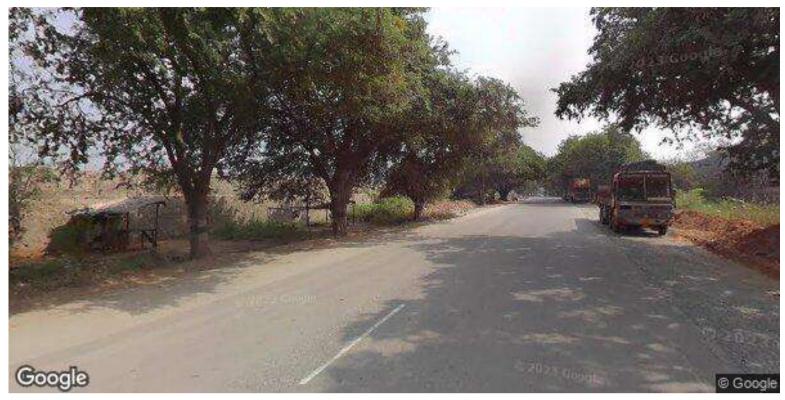
Risk Type: Turn
Risk Level: Medium
Speed Limit: 30 KM/Hr
Coordinates: 11.45697, 77.82719

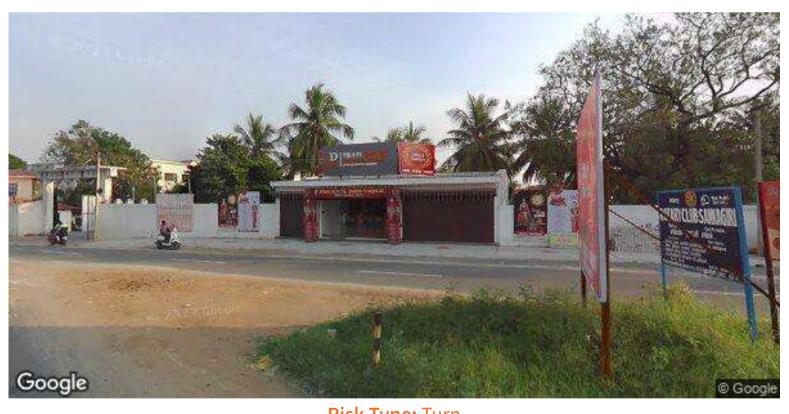
Risk Type: Turn
Risk Level: High
Speed Limit: 15 KM/Hr
Coordinates: 11.45516, 77.81346

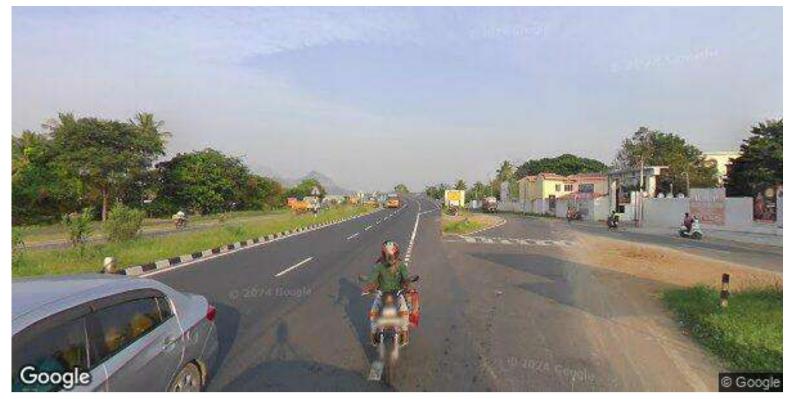
Risk Type: Turn
Risk Level: High
Speed Limit: 15 KM/Hr
Coordinates: 11.45521, 77.81343

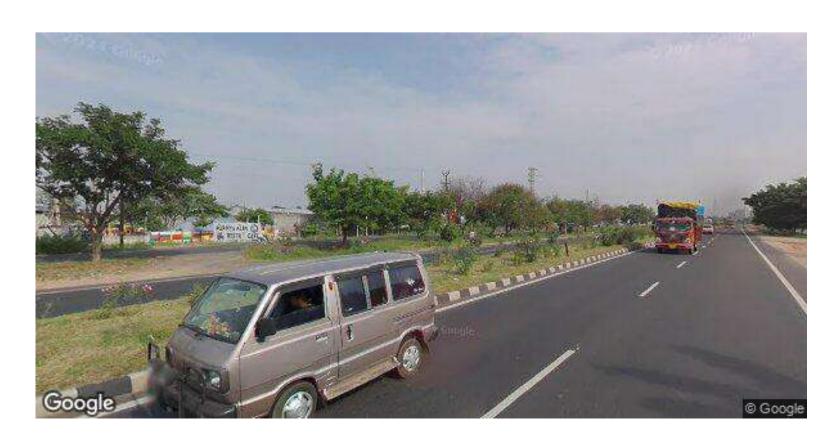
Risk Type: Turn
Risk Level: Medium
Speed Limit: 30 KM/Hr

Coordinates: 11.43982, 77.71084

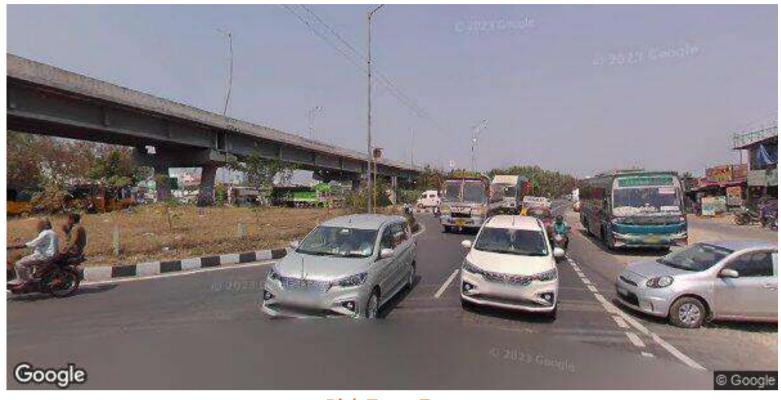
Risk Type: Turn
Risk Level: High
Speed Limit: 15 KM/Hr

Coordinates: 11.43001, 77.67575

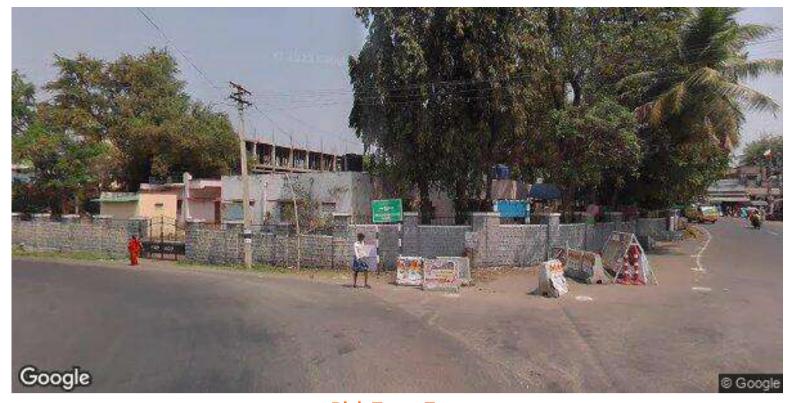
Risk Type: Turn
Risk Level: Medium
Speed Limit: 30 KM/Hr
Coordinates: 11.43865, 77.68226

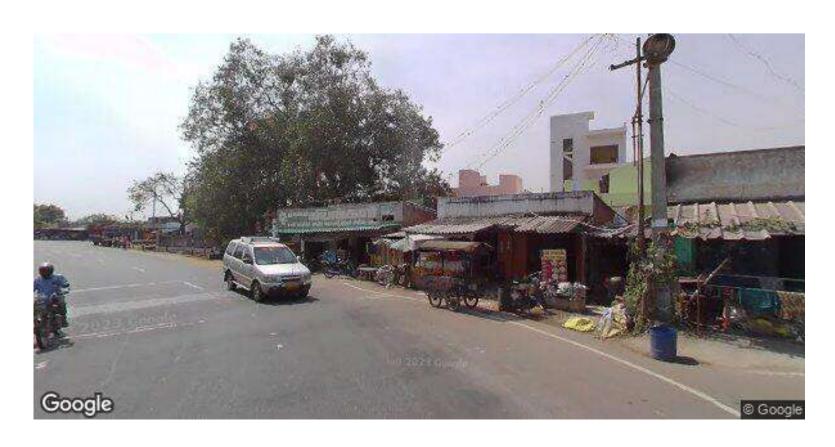
Risk Type: Turn
Risk Level: High
Speed Limit: 15 KM/Hr

Coordinates: 11.44105, 77.68187

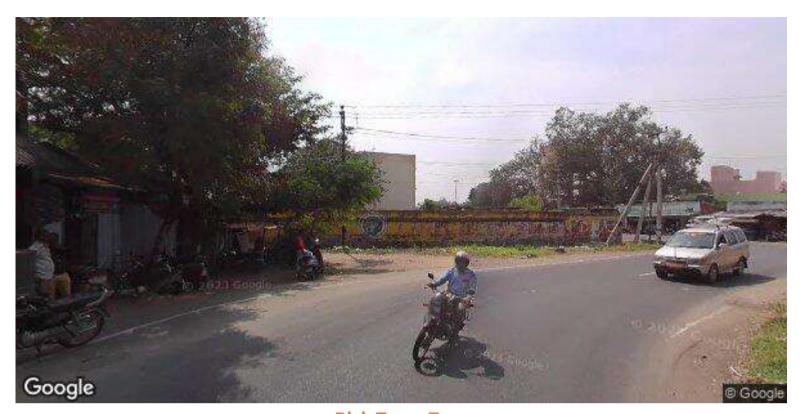
Risk Type: Turn
Risk Level: Medium
Speed Limit: 30 KM/Hr
Coordinates: 11.44122, 77.68219

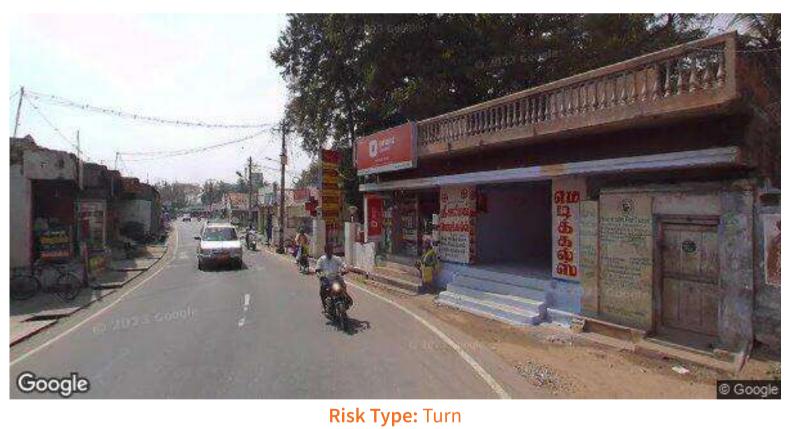
Risk Type. Turn
Risk Level: Medium
Speed Limit: 30 KM/Hr
Coordinates: 11.44291, 77.68256

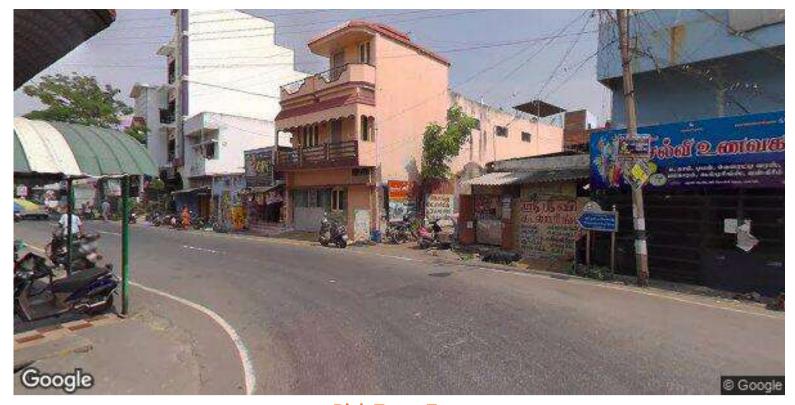
Risk Type: Turn
Risk Level: High
Speed Limit: 15 KM/Hr
Coordinates: 11.44300, 77.68275

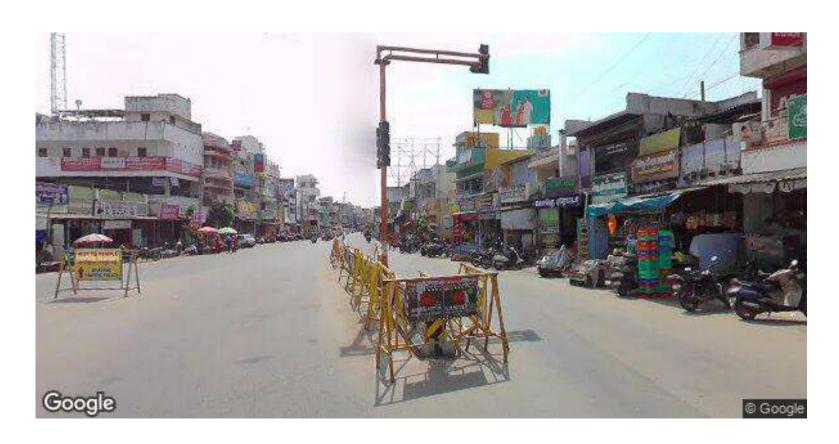
Risk Type: Turn
Risk Level: Medium
Speed Limit: 30 KM/Hr

Coordinates: 11.44710, 77.68396

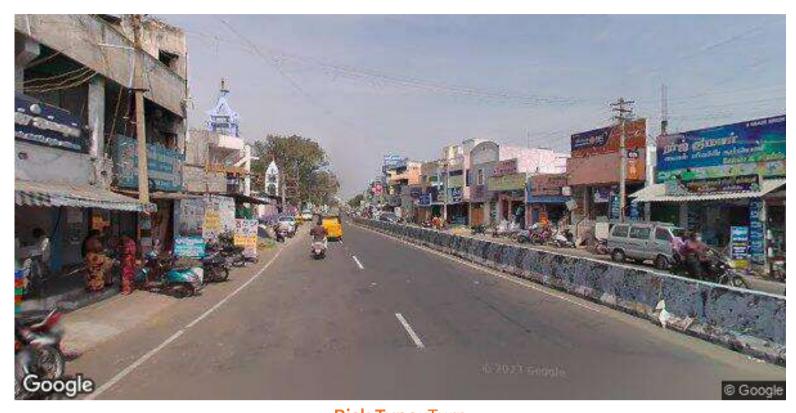
Risk Type: Turn
Risk Level: Medium
Speed Limit: 30 KM/Hr

Coordinates: 11.44725, 77.68412
