JOURNEY RISK MANAGEMENT (JRM) STUDY

Salem Terminal To SPK PETROLEUM

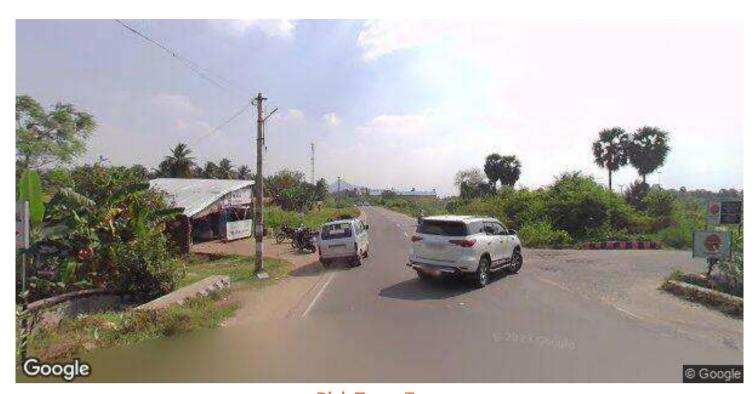
Risk Type: Turn
Risk Level: High
Speed Limit: 15 KM/Hr
Coordinates: 11.44029, 77.87544

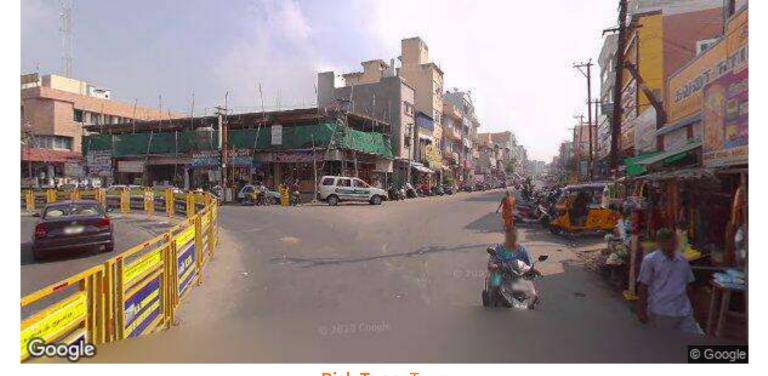
Risk Type: Turn
Risk Level: High
Speed Limit: 15 KM/Hr
Coordinates: 11.37862, 77.89488

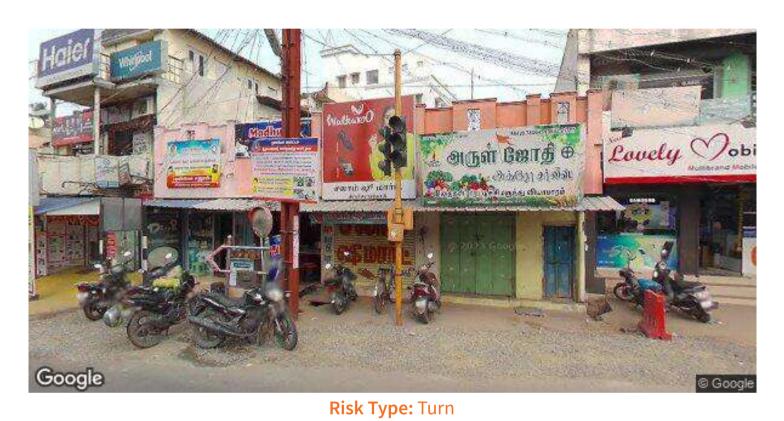
Risk Level: High
Speed Limit: 15 KM/Hr
Coordinates: 11.37850, 77.89453

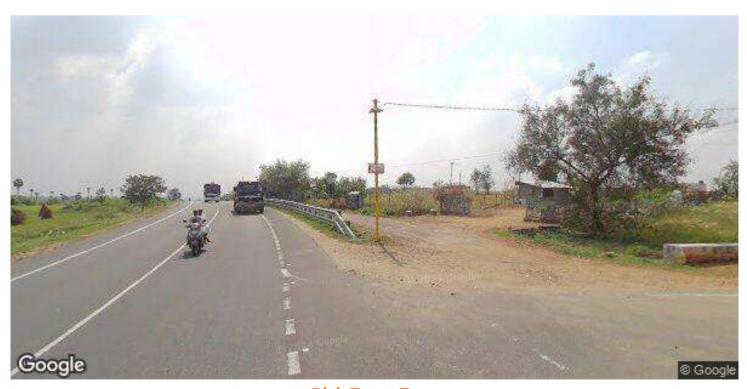
Risk Type: Turn
Risk Level: Medium

Speed Limit: 30 KM/Hr Coordinates: 11.34151, 77.90137

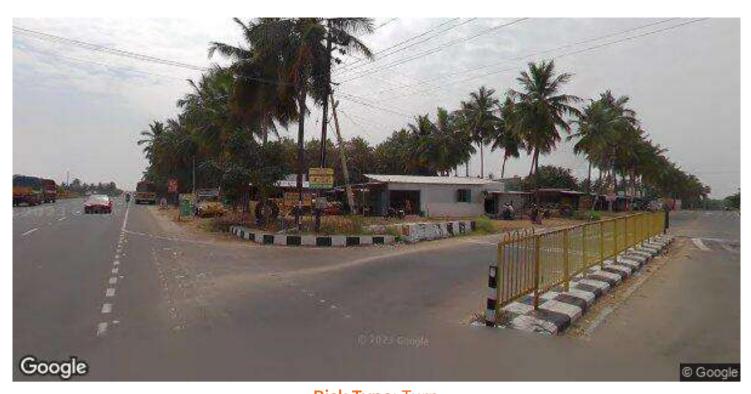
Risk Type: Turn
Risk Level: High
Speed Limit: 15 KM/Hr
Coordinates: 11.30859, 77.92918

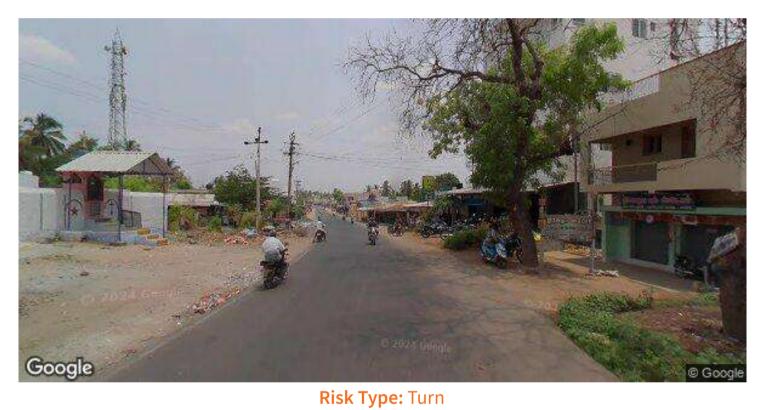
Risk Level: Medium
Speed Limit: 30 KM/Hr
Coordinates: 11.24421, 77.87541

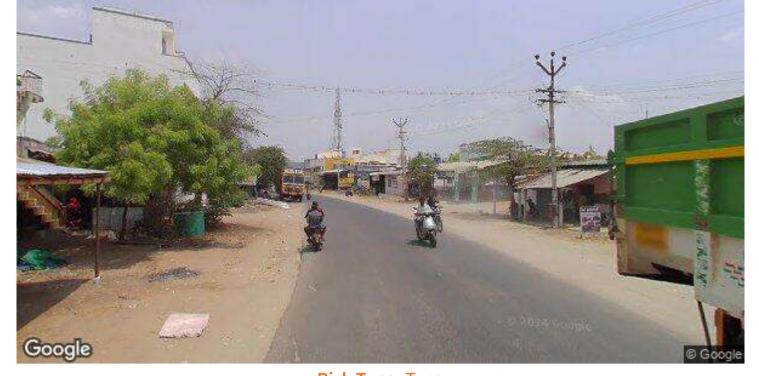
Risk Type: Turn
Risk Level: Medium
Speed Limit: 30 KM/Hr
Coordinates: 11.24192, 77.87363

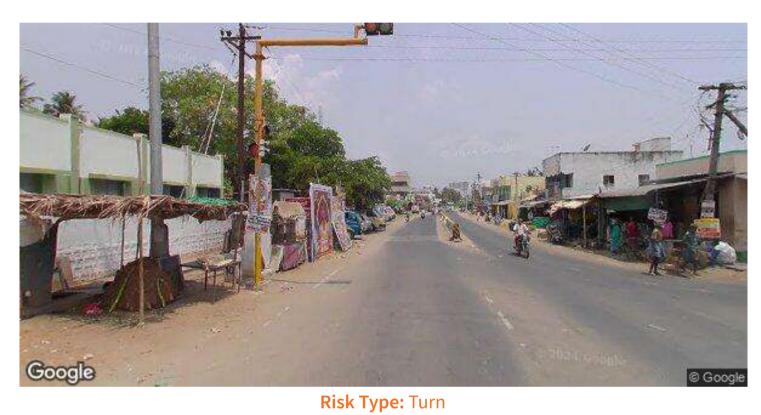
Risk Level: High
Speed Limit: 15 KM/Hr
Coordinates: 11.24001, 77.87368

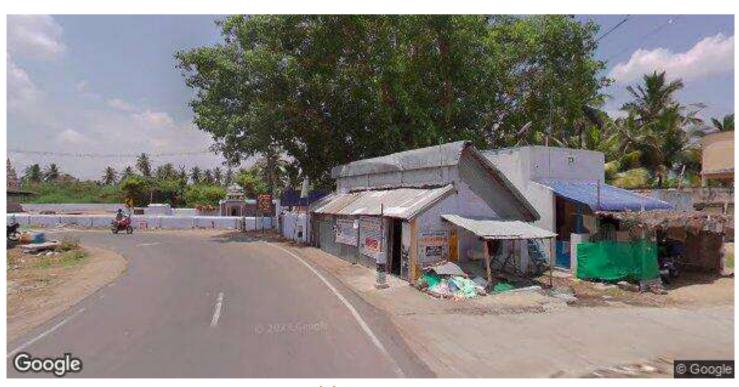
Risk Type: Turn Risk Level: High Speed Limit: 15 KM/Hr Coordinates: 11.24061, 77.86899

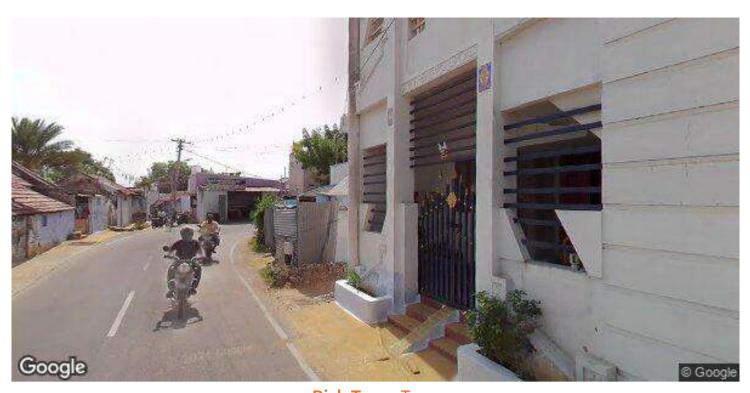
Risk Type: Turn
Risk Level: High
Speed Limit: 15 KM/Hr
Coordinates: 11.24157, 77.86876

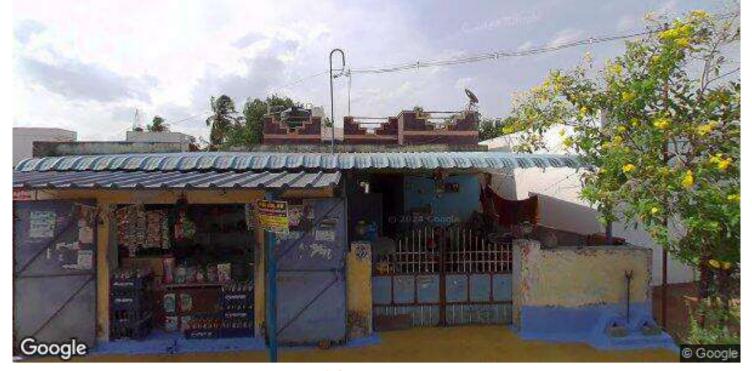
Risk Type: Turn
Risk Level: High
Speed Limit: 15 KM/Hr
Coordinates: 11.24242, 77.86833

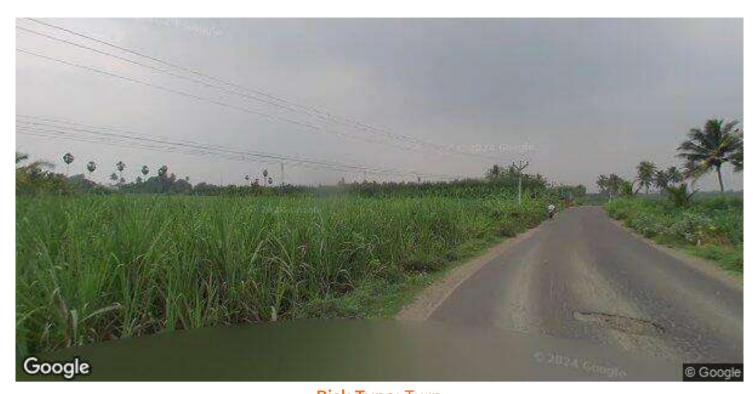
Risk Type: Turn
Risk Level: High
Speed Limit: 15 KM/Hr
Coordinates: 11.24101, 77.86023

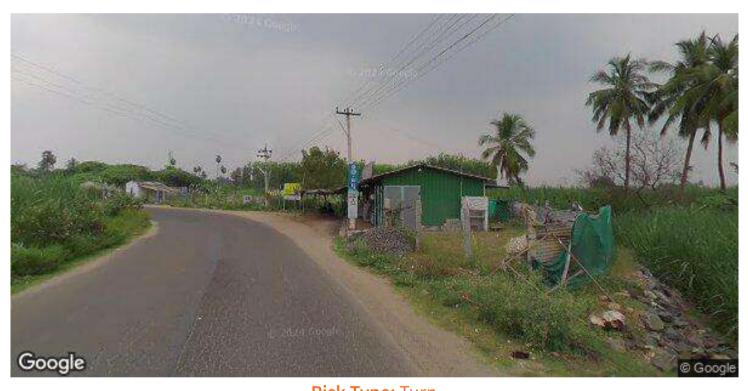
Risk Type: Turn
Risk Level: Medium
Speed Limit: 30 KM/Hr
Coordinates: 11.24198, 77.85893

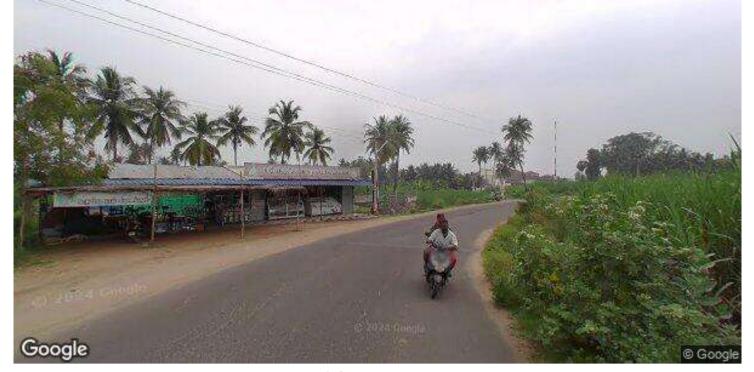
Risk Type: Turn
Risk Level: Medium
Speed Limit: 30 KM/Hr
Coordinates: 11.24198, 77.85860

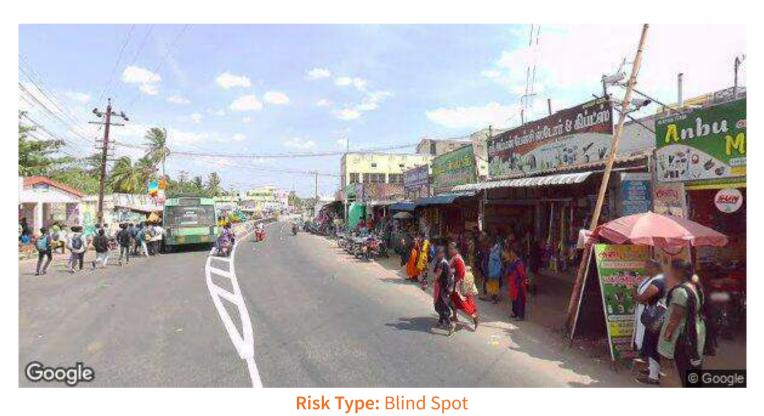
Risk Level: Blind Spot
Speed Limit: 10 KM/Hr
Coordinates: 11.18861, 77.77108

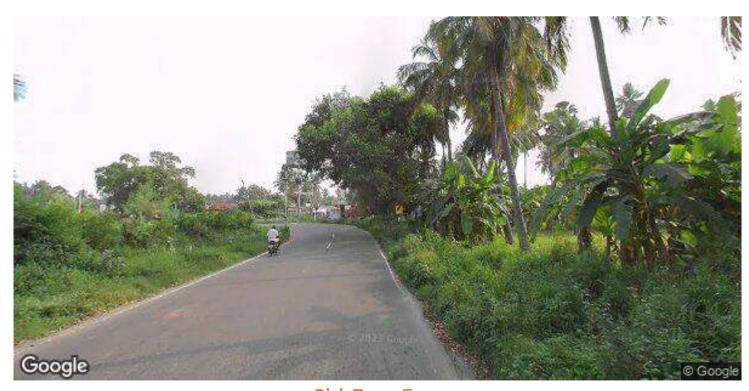
Risk Type: Turn
Risk Level: Medium

Speed Limit: 30 KM/Hr Coordinates: 11.16450, 77.77357

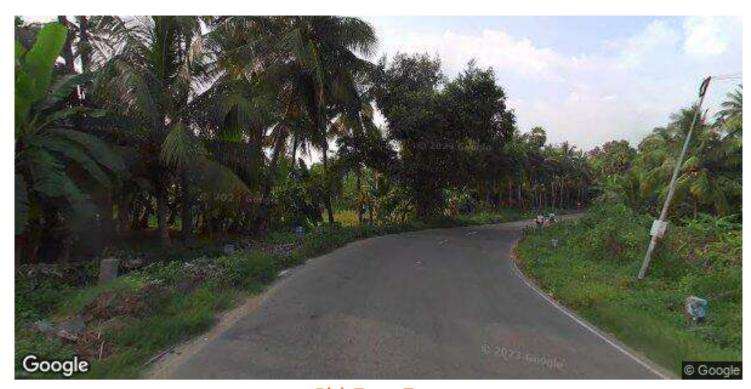
Risk Type: Turn
Risk Level: Medium
Speed Limit: 30 KM/Hr
Coordinates: 11.16407, 77.77376

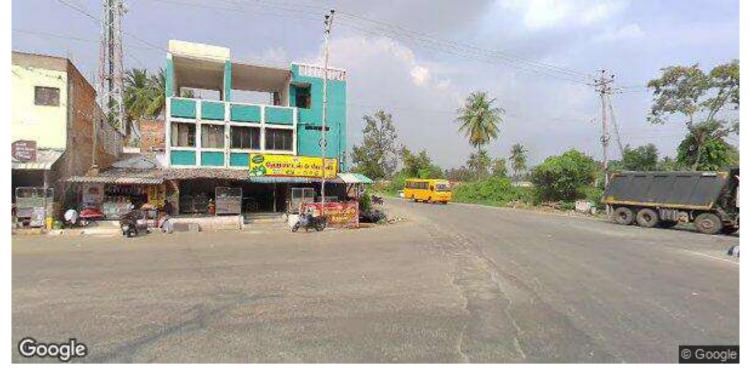
Risk Type: Turn
Risk Level: High
Speed Limit: 15 KM/Hr

Coordinates: 11.13667, 77.76526

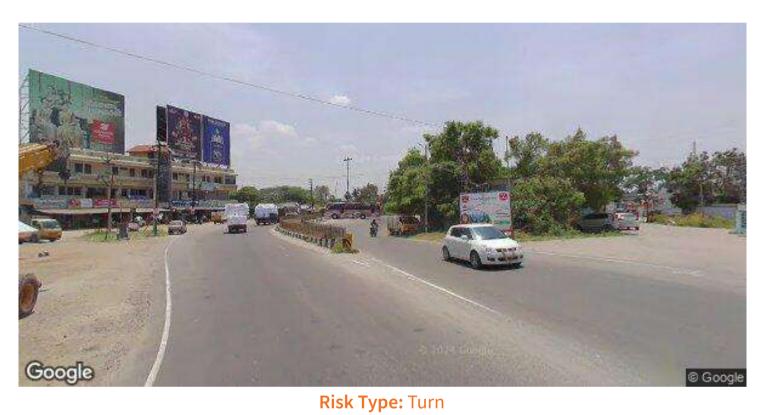
Risk Level: Medium
Speed Limit: 30 KM/Hr
Coordinates: 11.04703, 77.73745

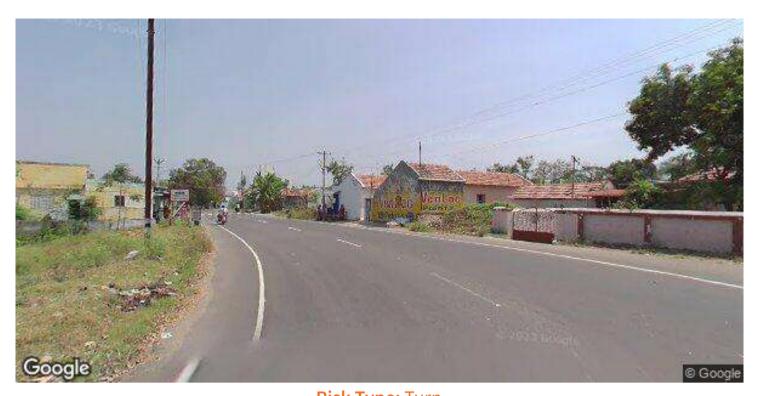
Risk Type: Turn
Risk Level: High
Speed Limit: 15 KM/Hr
Coordinates: 10.99029, 77.72513

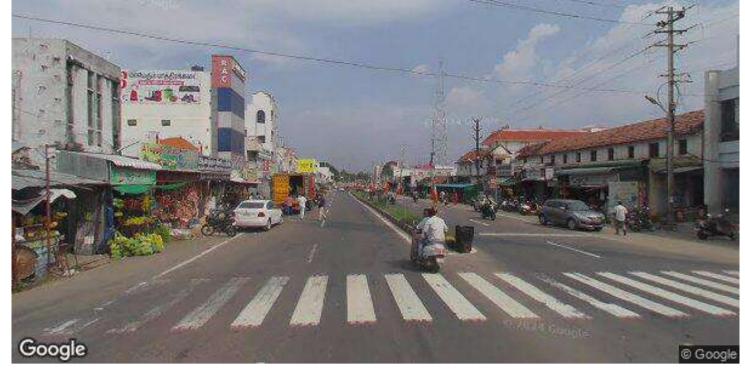
Risk Type: Turn
Risk Level: High
Speed Limit: 15 KM/Hr
Coordinates: 10.94597, 77.71319

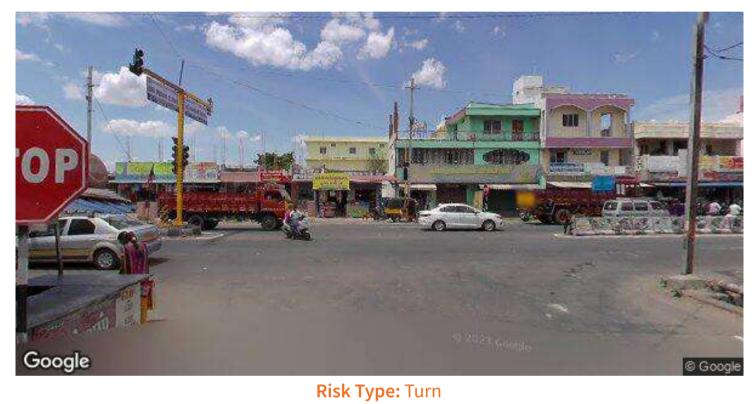
Risk Level: High
Speed Limit: 15 KM/Hr
Coordinates: 10.94582, 77.71257

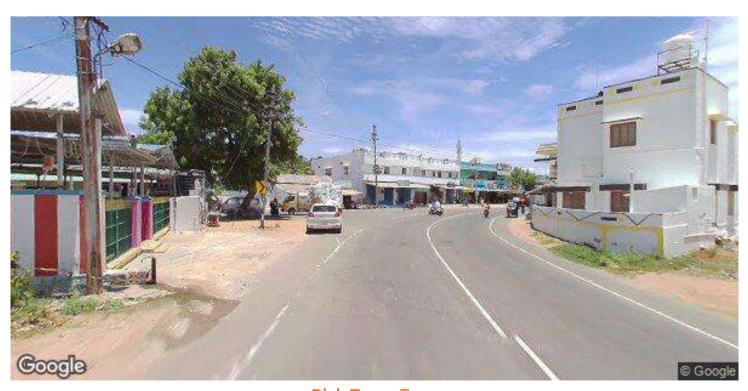
Risk Type: Turn
Risk Level: Medium

Speed Limit: 30 KM/Hr

Coordinates: 10.93825, 77.70342
