JOURNEY RISK MANAGEMENT (JRM) STUDY

Salem Terminal to AVS AGENCIES

Route Safety Analysis: Sangagiri to Tiruppur via SH 19A

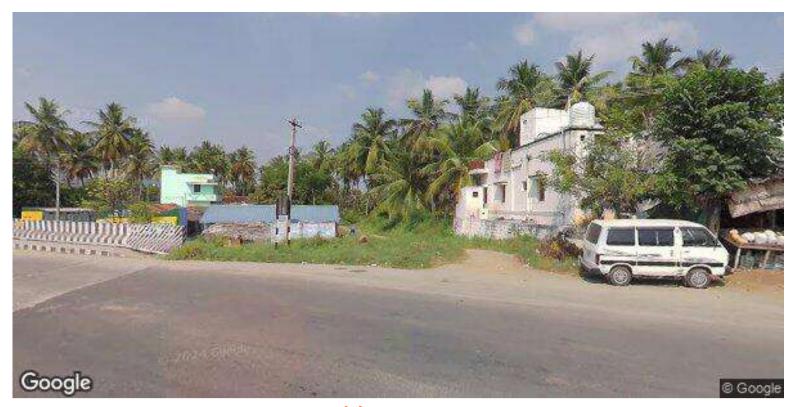
Risk Type: Turn
Risk Level: High
Speed Limit: 15 KM/Hr
Coordinates: 11.44898, 77.87410

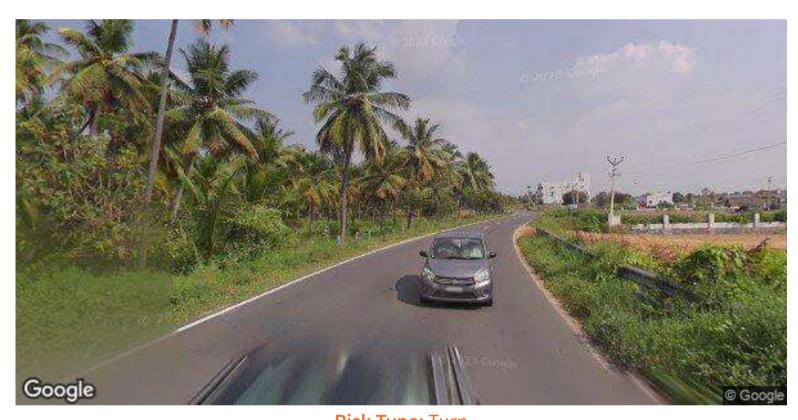
Risk Type: Turn
Risk Level: Medium
Speed Limit: 30 KM/Hr
Coordinates: 11.45357, 77.85789

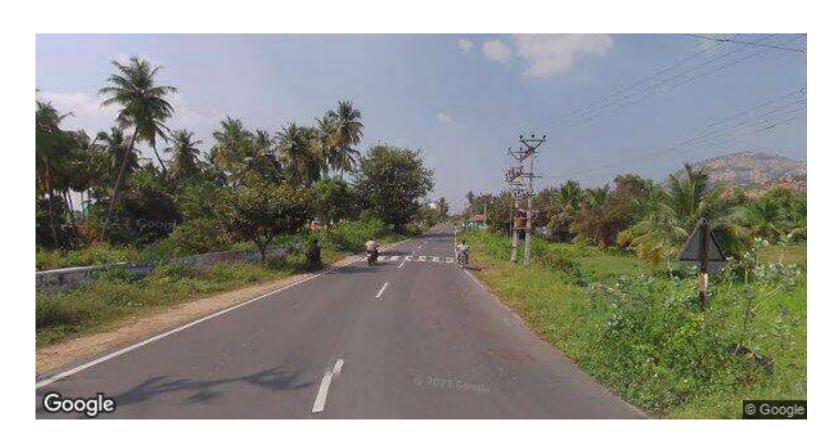
Coordinates: 11.45352, 77.85698

Risk Type: Turn
Risk Level: High
Speed Limit: 15 KM/Hr

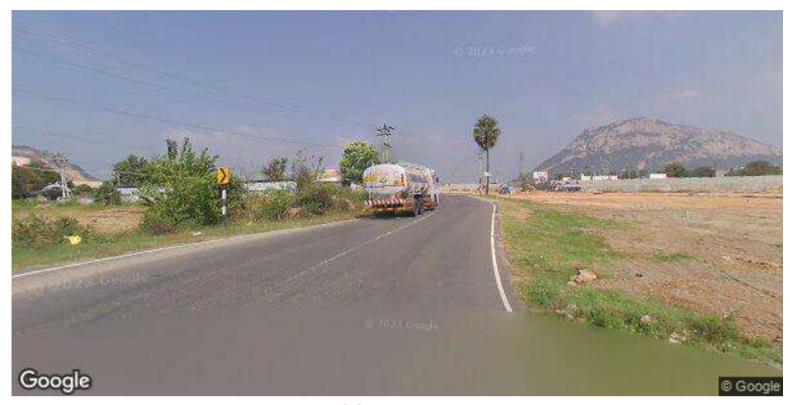
Risk Type: Turn
Risk Level: Medium
Speed Limit: 30 KM/Hr
Coordinates: 11.45847, 77.85140

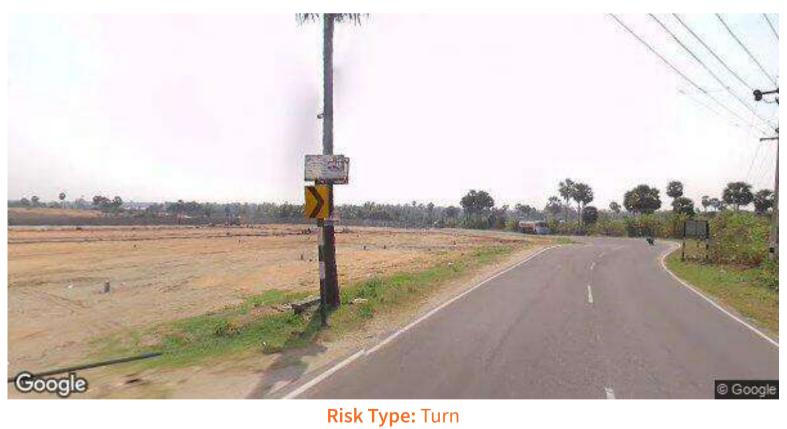
Risk Level: Medium
Speed Limit: 30 KM/Hr
Coordinates: 11.45898, 77.85135

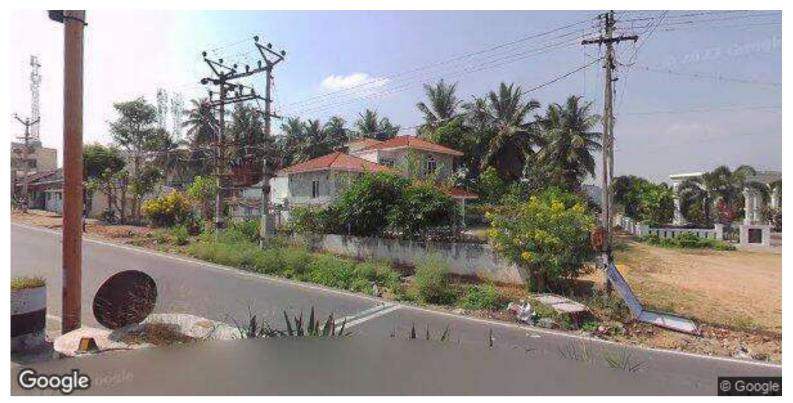
Risk Type: Turn
Risk Level: High
Speed Limit: 15 KM/Hr
Coordinates: 11.46303, 77.84945

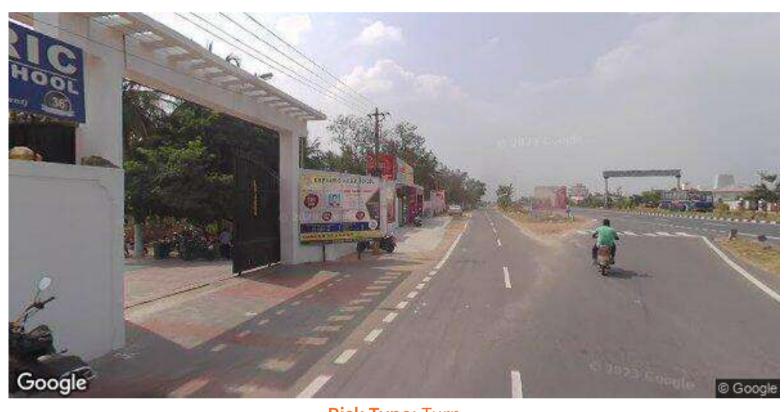
Risk Type: Turn
Risk Level: Medium
Speed Limit: 30 KM/Hr
Coordinates: 11.45509, 77.81383

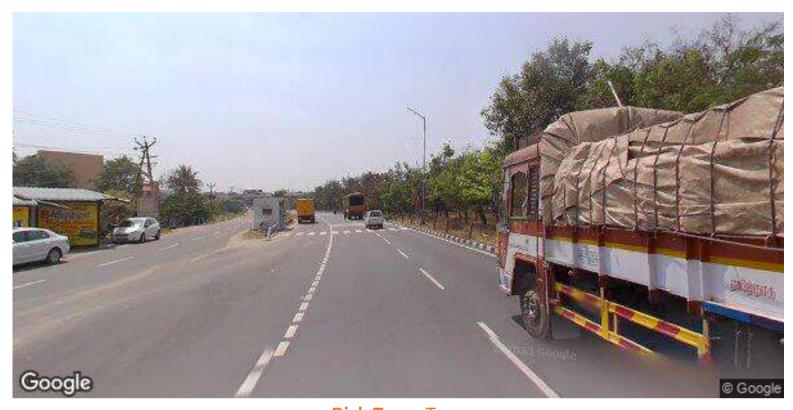
Risk Type: Turn
Risk Level: Medium
Speed Limit: 30 KM/Hr
Coordinates: 11.43165, 77.67734

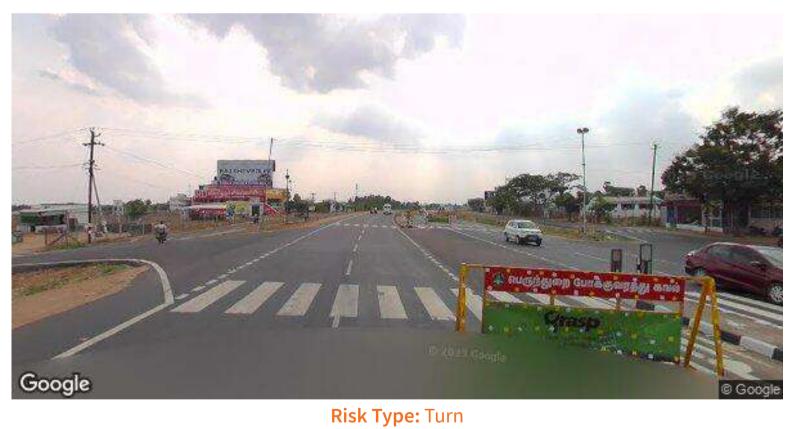
Risk Type. Turn
Risk Level: Medium
Speed Limit: 30 KM/Hr
Coordinates: 11.23724, 77.50686

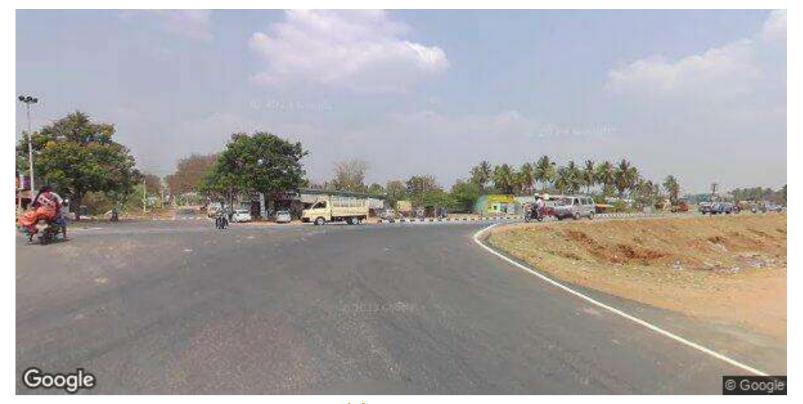
Risk Type: Turn
Risk Level: High
Speed Limit: 15 KM/Hr
Coordinates: 11.23704, 77.50676

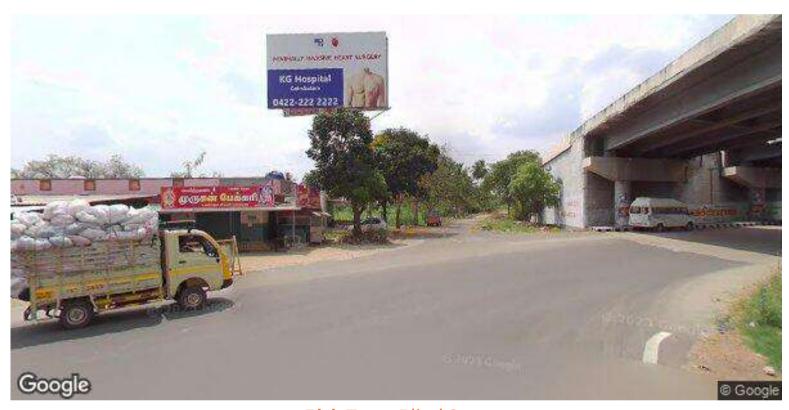
Risk Type: Blind Spot
Risk Level: Blind Spot
Speed Limit: 10 KM/Hr
Coordinates: 11.23686, 77.50216

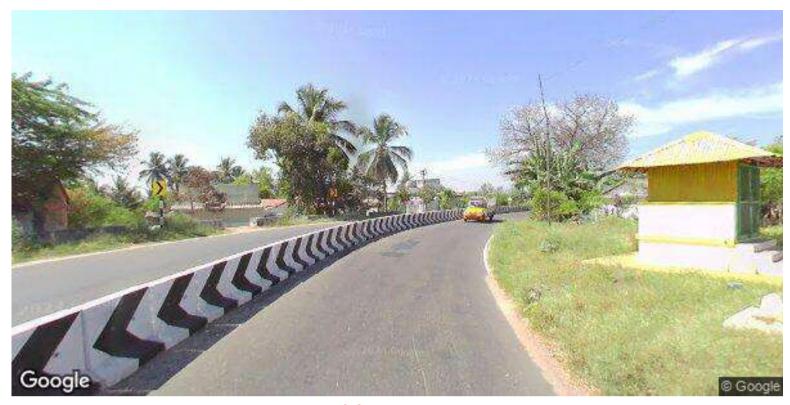
Coordinates: 11.23396, 77.50105

Risk Type: Turn
Risk Level: High
Speed Limit: 15 KM/Hr

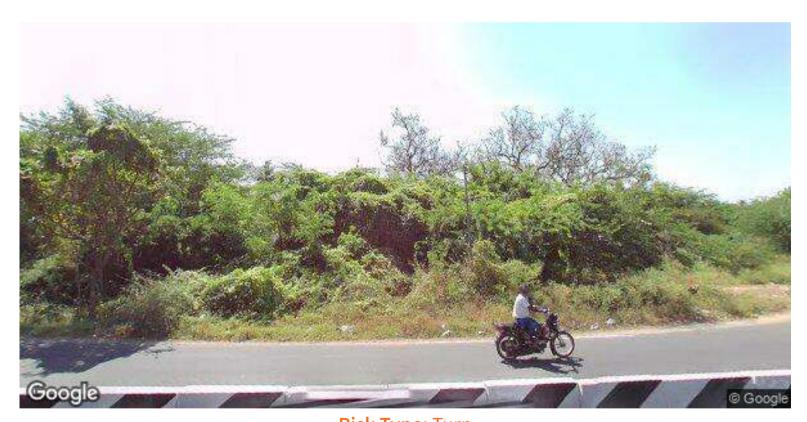
Coordinates: 11.23329, 77.49966

Risk Type: Turn
Risk Level: Medium
Speed Limit: 30 KM/Hr

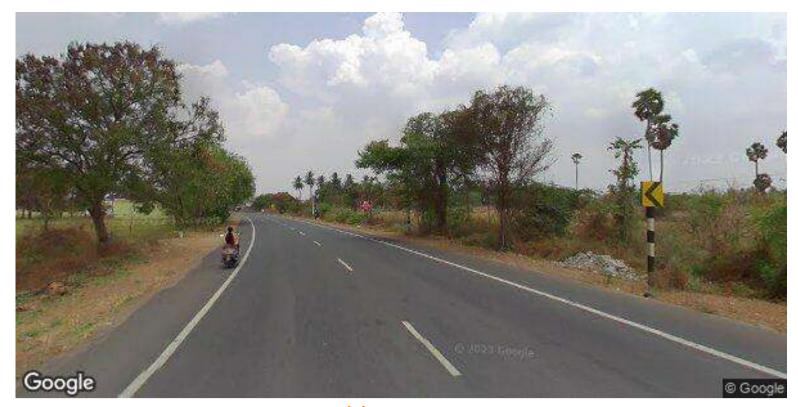
Risk Type: Turn
Risk Level: Medium
Speed Limit: 30 KM/Hr
Coordinates: 11.17869, 77.46175

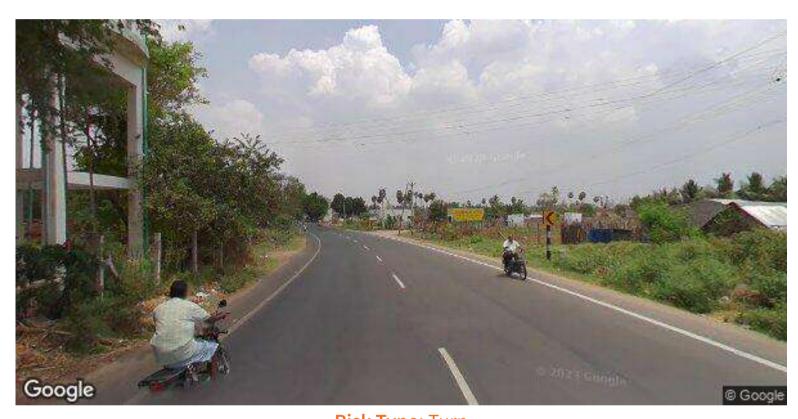
Risk Type: Turn
Risk Level: Medium
Speed Limit: 30 KM/Hr
Coordinates: 11.17528, 77.45982

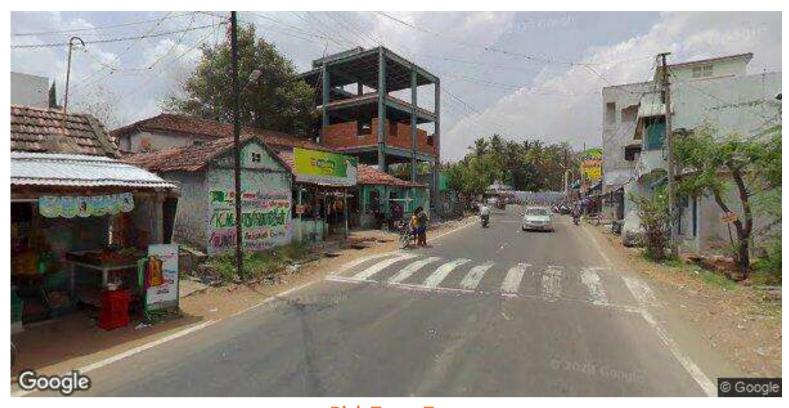
Risk Type: Turn
Risk Level: Medium
Speed Limit: 30 KM/Hr
Coordinates: 11.17120, 77.45567

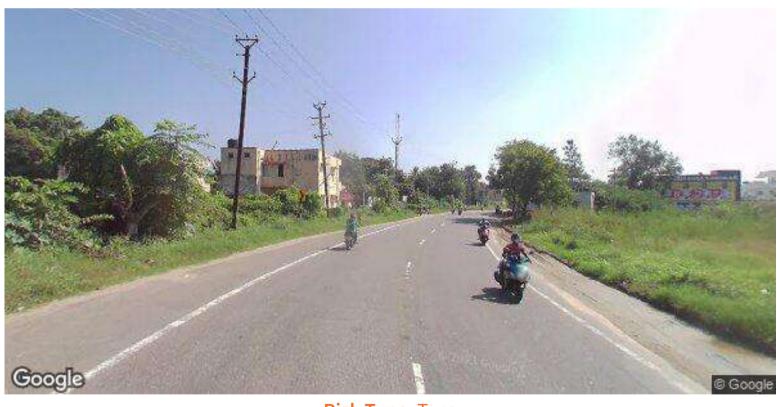
Coordinates: 11.16960, 77.44406

Risk Type: Turn
Risk Level: High
Speed Limit: 15 KM/Hr

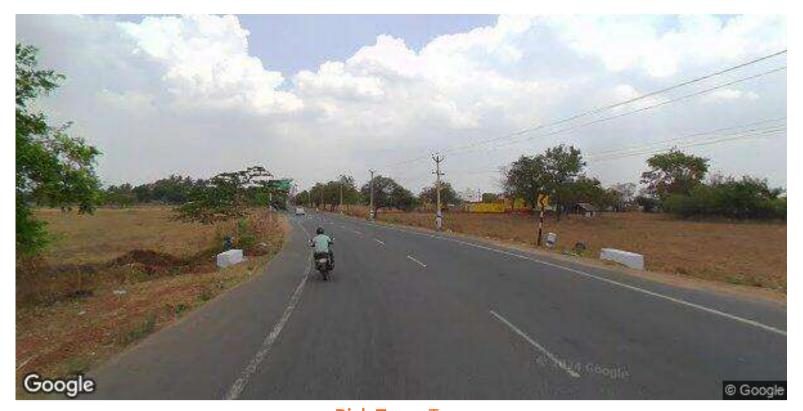
Risk Type: Turn
Risk Level: Medium
Speed Limit: 30 KM/Hr
Coordinates: 11.16385, 77.43707

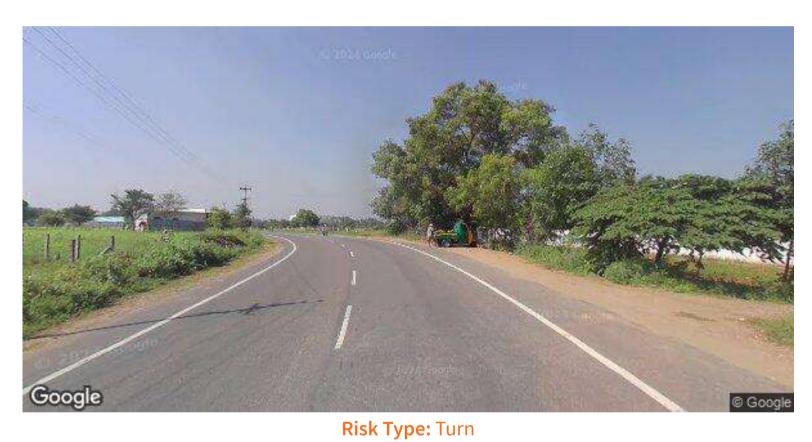
Risk Level: Medium
Speed Limit: 30 KM/Hr
Coordinates: 11.16282, 77.43145

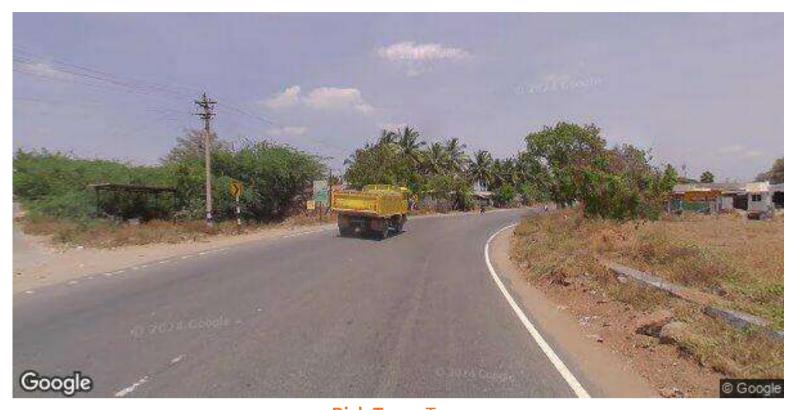
Risk Type: Turn
Risk Level: Medium
Speed Limit: 30 KM/Hr
Coordinates: 11.14904, 77.42031

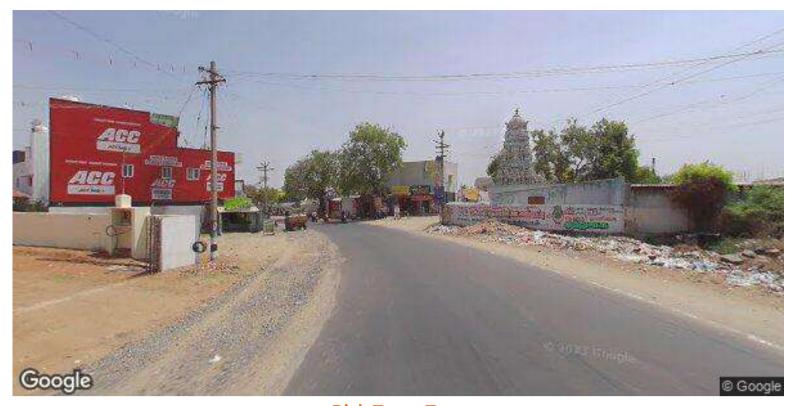
Risk Type: Turn
Risk Level: Medium
Speed Limit: 30 KM/Hr
Coordinates: 11.12993, 77.40310

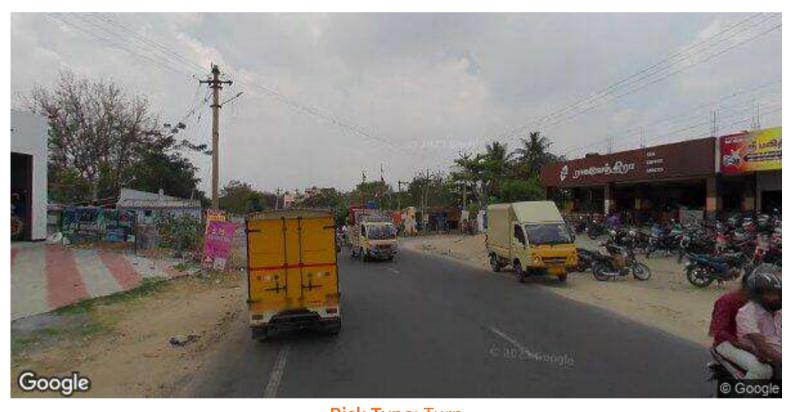
Risk Type: Turn
Risk Level: Medium
Speed Limit: 30 KM/Hr
Coordinates: 11.12467, 77.38652

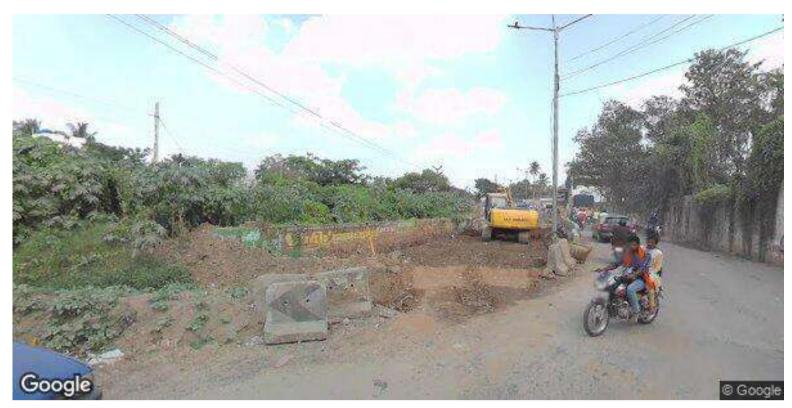
Coordinates: 11.11160, 77.35231

Risk Type: Turn
Risk Level: High
Speed Limit: 15 KM/Hr

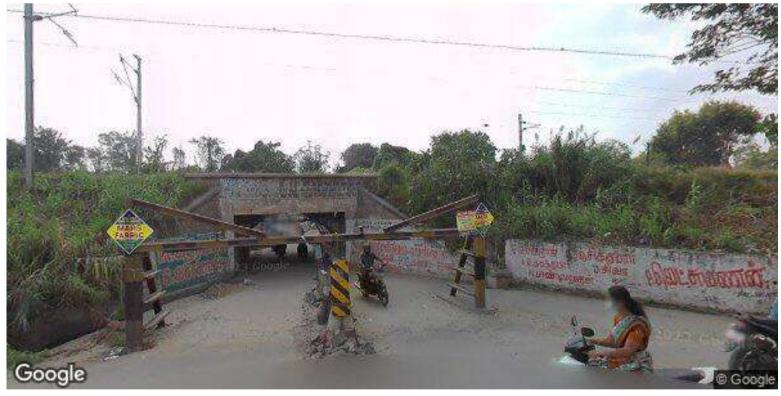
Risk Type: Turn
Risk Level: High
Speed Limit: 15 KM/Hr
Coordinates: 11.11209, 77.35220

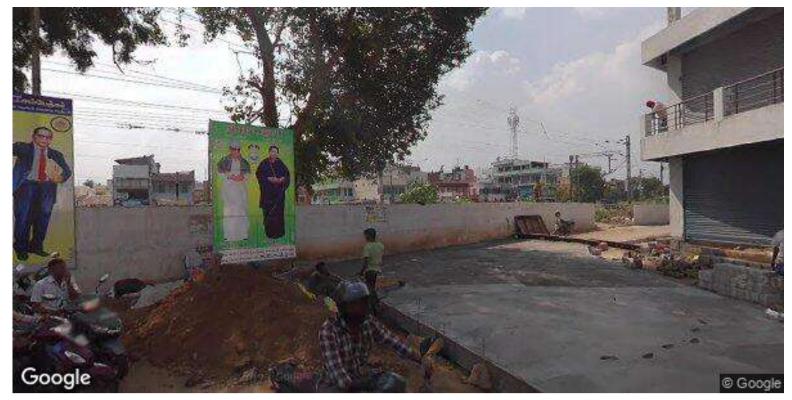
Risk Type: Blind Spot
Risk Level: Blind Spot
Speed Limit: 10 KM/Hr
Coordinates: 11.11159, 77.34993

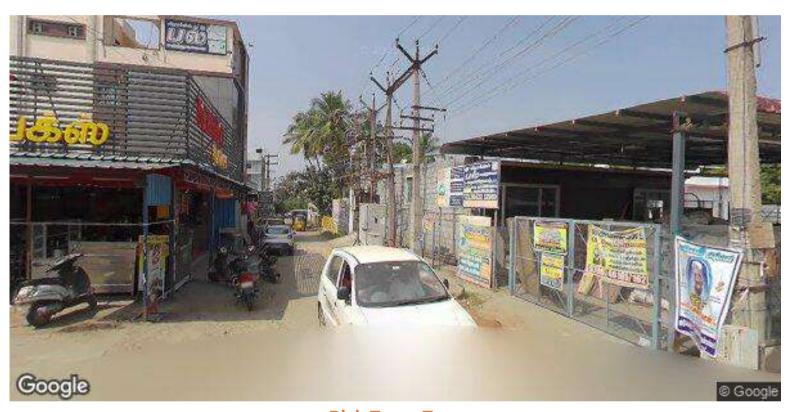
Risk Type: Turn
Risk Level: High
Speed Limit: 15 KM/Hr
Coordinates: 11.11840, 77.34951

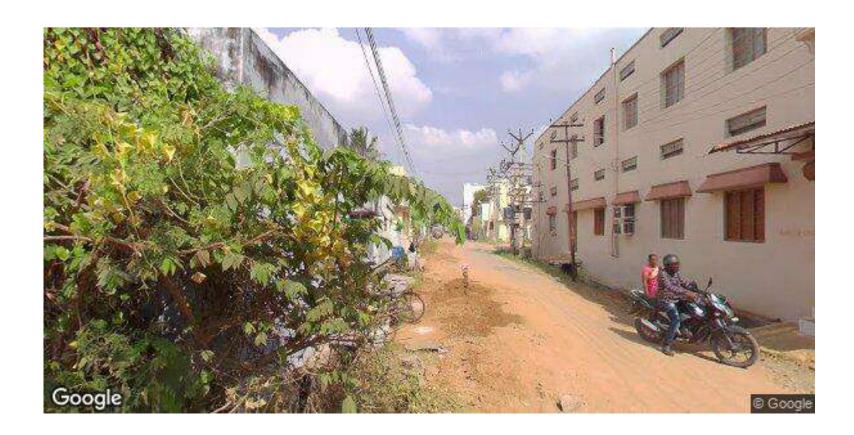
Coordinates: 11.11837, 77.34764

Risk Type: Turn
Risk Level: High
Speed Limit: 15 KM/Hr
