JOURNEY RISK MANAGEMENT (JRM) STUDY

Salem Terminal to SRI SIVASELVI AGENCIES

Route Safety Analysis: CVQF+23W, Sangagiri to 573/1B, Rakkiya Palayam Road, Avinashi

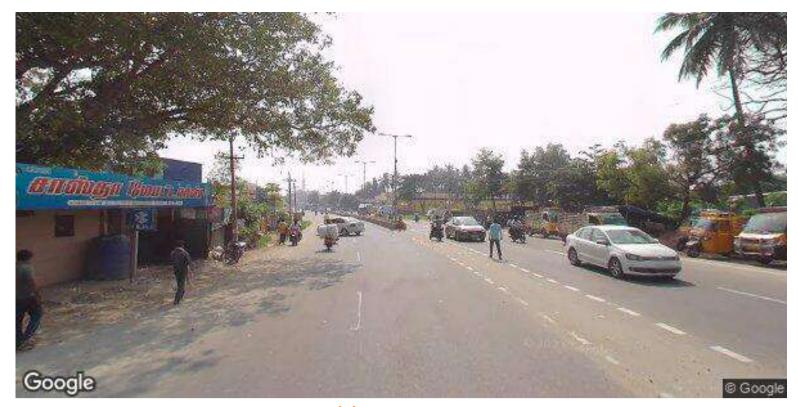
Coordinates: 11.1485866, 77.3133702

Risk Type: U-Turn
Risk Level: High
Speed Limit: 10 KM/Hr

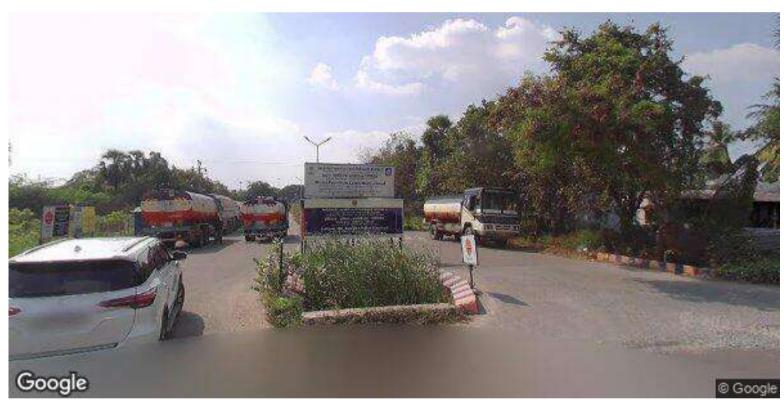
Risk Type: Turn
Risk Level: High
Speed Limit: 15 KM/Hr
Coordinates: 11.44024, 77.87528

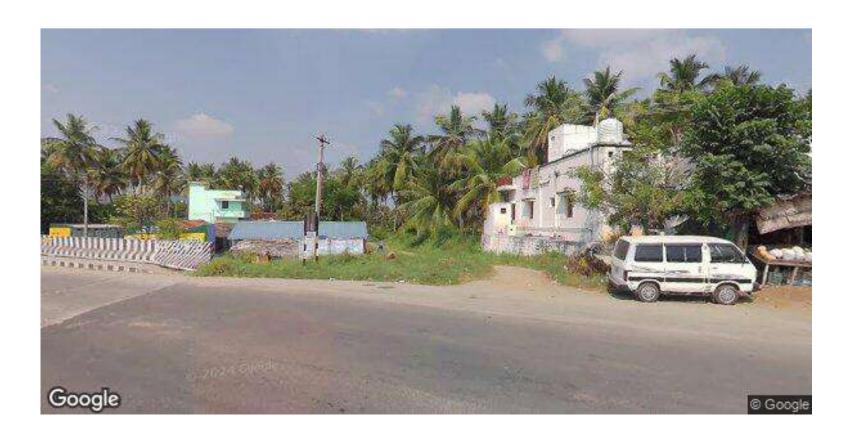
Coordinates: 11.44898, 77.87410

Risk Type: Turn
Risk Level: High
Speed Limit: 15 KM/Hr

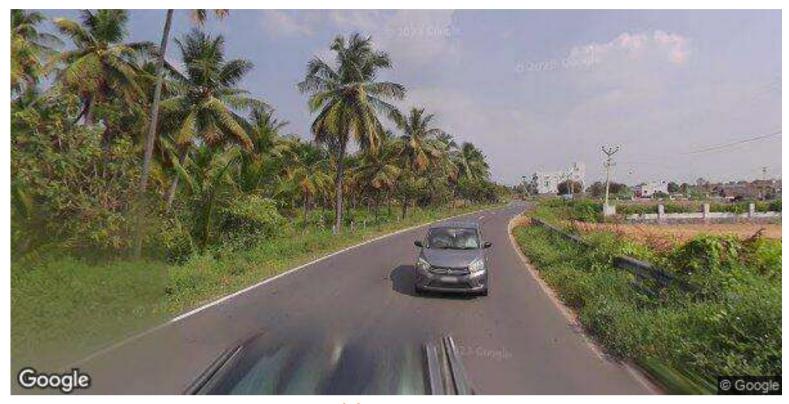
Coordinates: 11.45357, 77.85789

Risk Type: Turn
Risk Level: Medium
Speed Limit: 30 KM/Hr

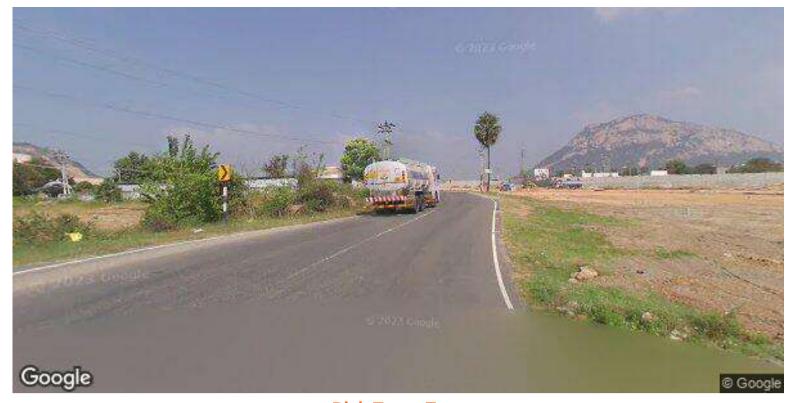
Coordinates: 11.45847, 77.85140

Risk Type: Turn
Risk Level: Medium
Speed Limit: 30 KM/Hr

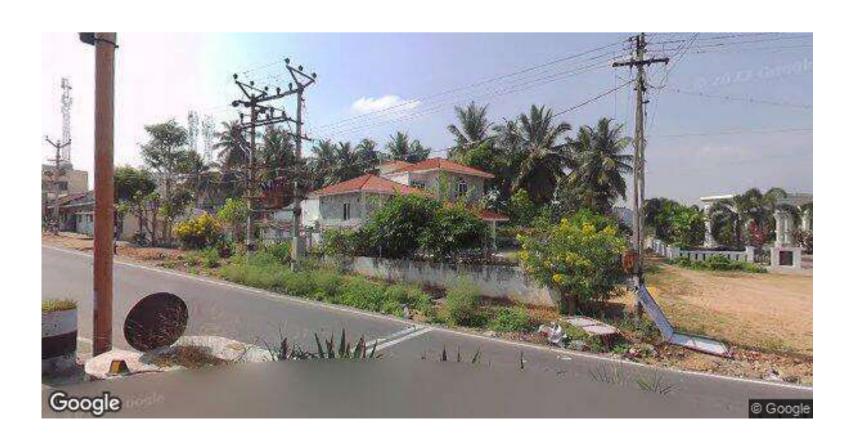
Coordinates: 11.46303, 77.84945

Risk Type: Turn
Risk Level: Medium
Speed Limit: 30 KM/Hr

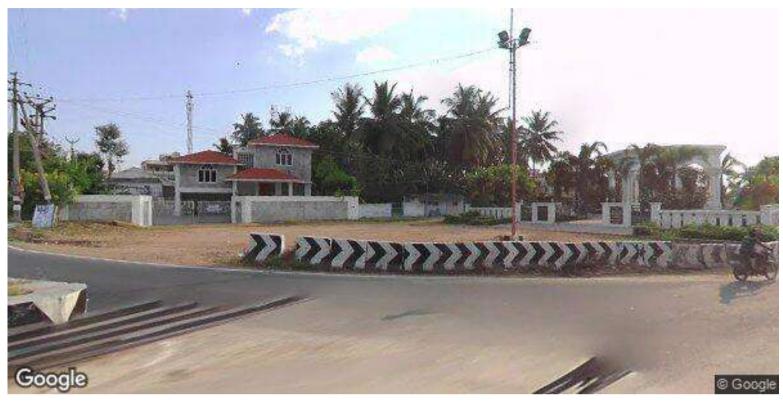
Coordinates: 11.46314, 77.84928

Risk Type: Turn
Risk Level: Medium
Speed Limit: 30 KM/Hr

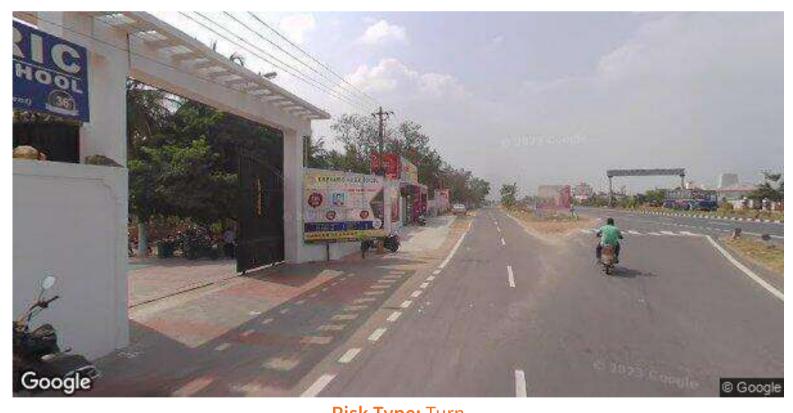
Coordinates: 11.45509, 77.81383

Risk Type: Turn
Risk Level: Medium
Speed Limit: 30 KM/Hr

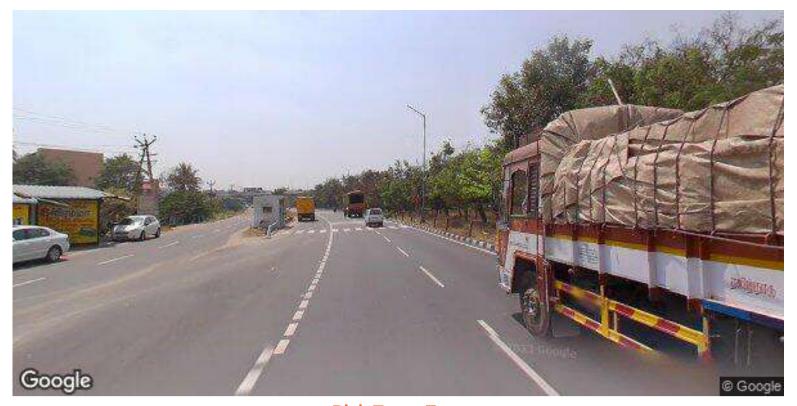
Risk Type: Turn
Risk Level: Medium
Speed Limit: 30 KM/Hr
Coordinates: 11.43165, 77.67734

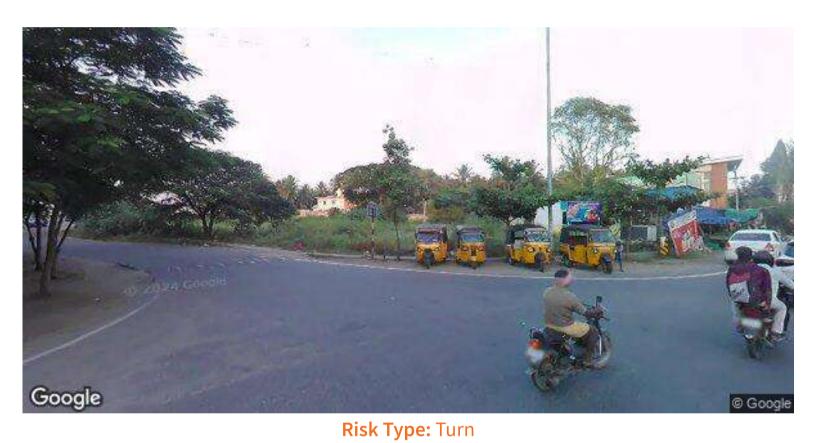
Risk Level: High
Speed Limit: 15 KM/Hr
Coordinates: 11.18254, 77.28529

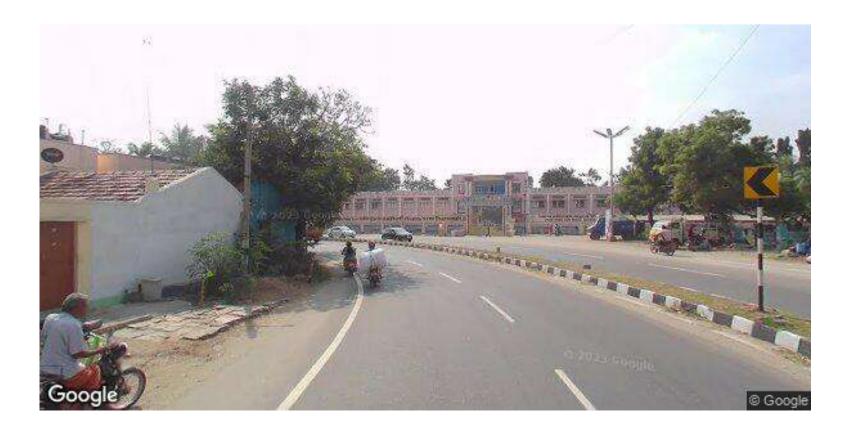
Coordinates: 11.15202, 77.30879

Risk Type: Turn
Risk Level: High
Speed Limit: 15 KM/Hr

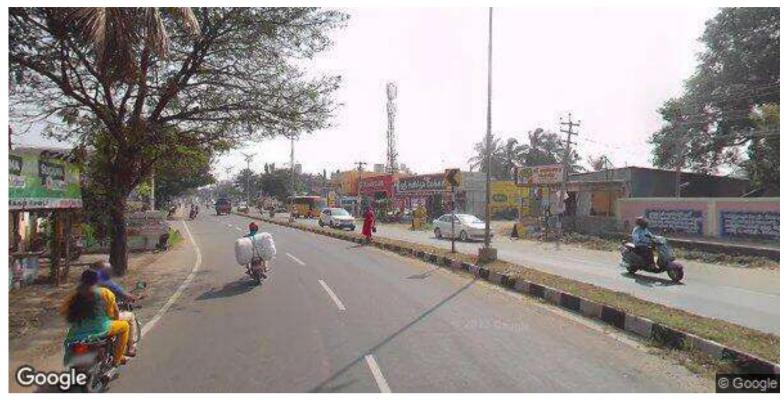
Coordinates: 11.15167, 77.30915

Risk Type: Turn
Risk Level: High
Speed Limit: 15 KM/Hr

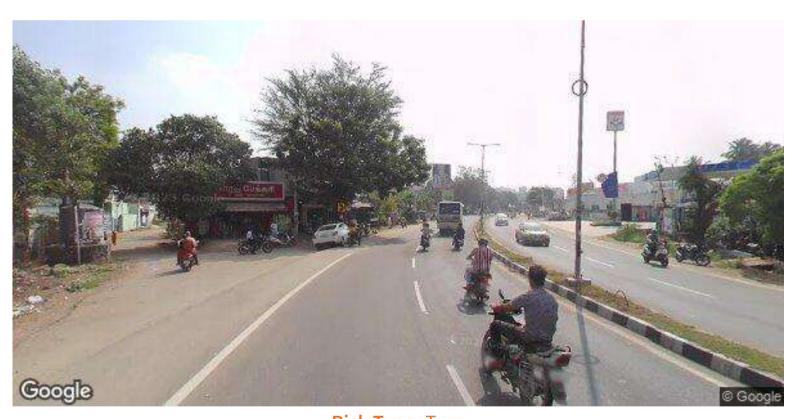
Risk Type: Turn
Risk Level: Medium
Speed Limit: 30 KM/Hr
Coordinates: 11.15169, 77.31145

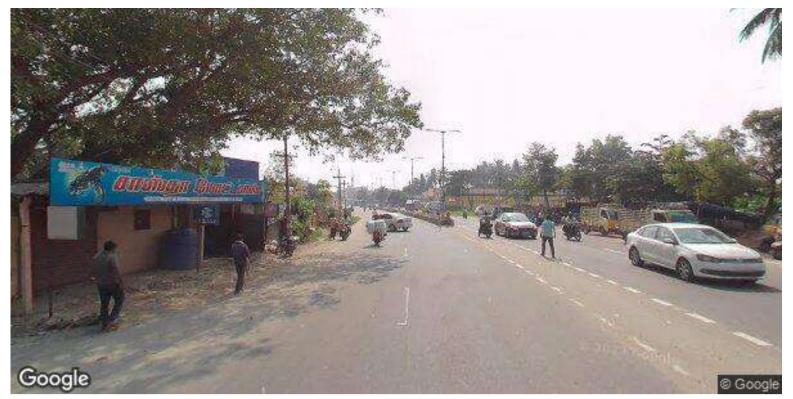
Coordinates: 11.14859, 77.31337

Risk Type: Blind Spot Risk Level: Blind Spot Speed Limit: 10 KM/Hr

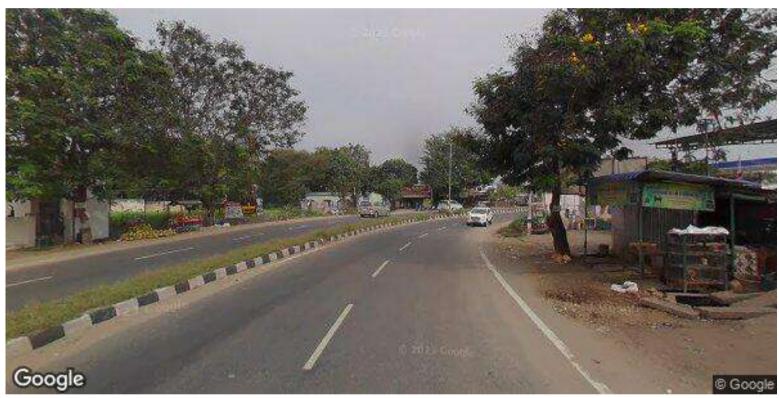
Coordinates: 11.15169, 77.31110

Risk Type: Turn
Risk Level: Medium
Speed Limit: 30 KM/Hr
