JOURNEY RISK MANAGEMENT (JRM) STUDY

Salem Terminal to ARA ENTERPRISES

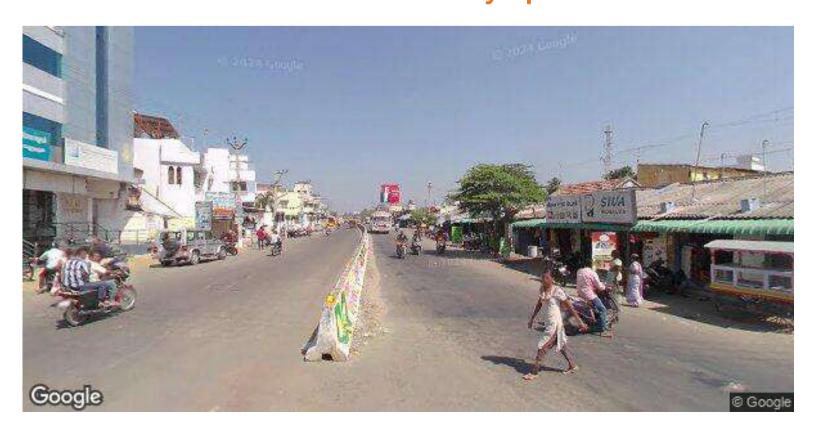
Coordinates: 11.37086, 77.74828

Risk Type: Roundabout
Risk Level: High
Speed Limit: 15 KM/Hr

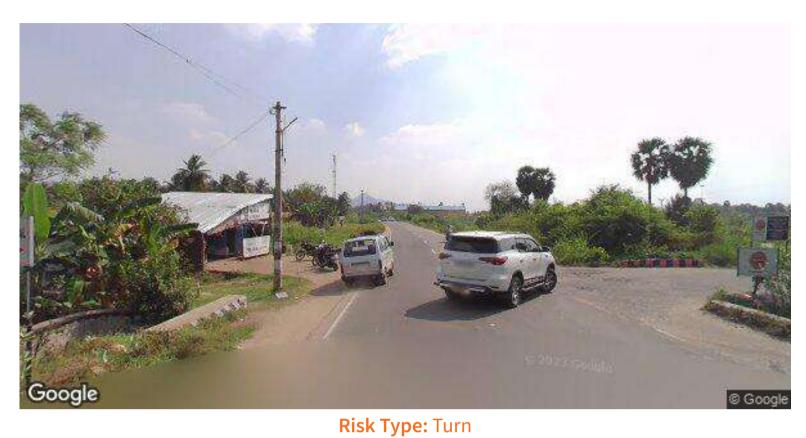
Risk Type: Turn
Risk Level: High
Speed Limit: 15 KM/Hr
Coordinates: 11.44029, 77.87544

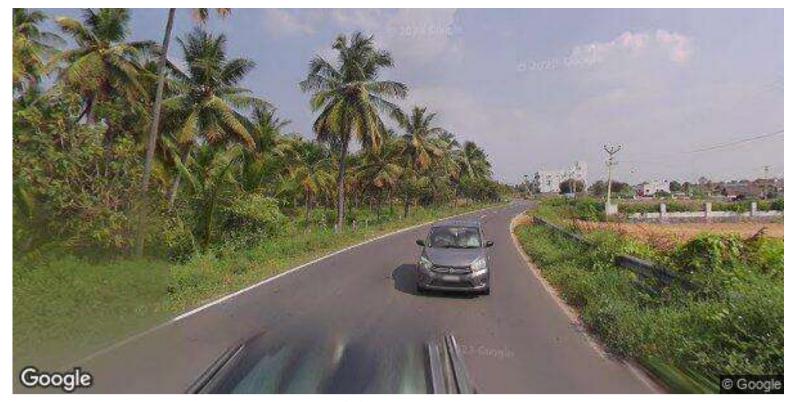
Risk Type: Turn
Risk Level: Medium
Speed Limit: 30 KM/Hr
Coordinates: 11.45357, 77.85789

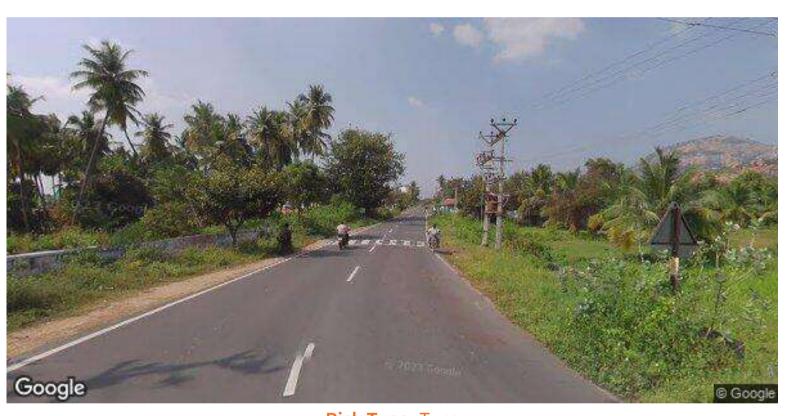
Risk Type: Turn
Risk Level: Medium
Speed Limit: 30 KM/Hr
Coordinates: 11.45352, 77.85698

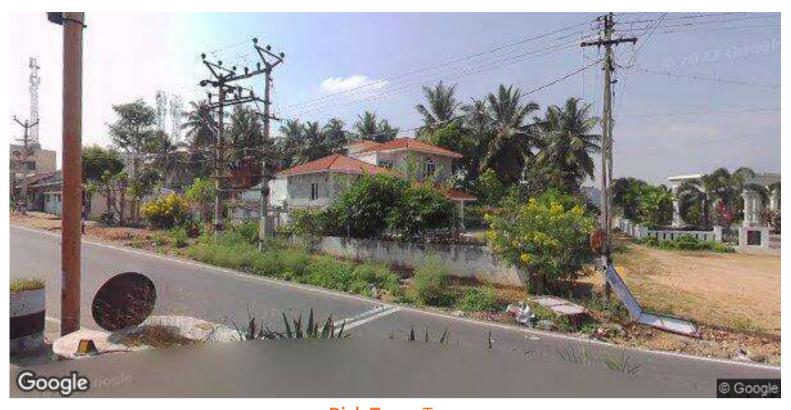
Coordinates: 11.46303, 77.84945

Risk Type: Turn
Risk Level: Medium
Speed Limit: 30 KM/Hr

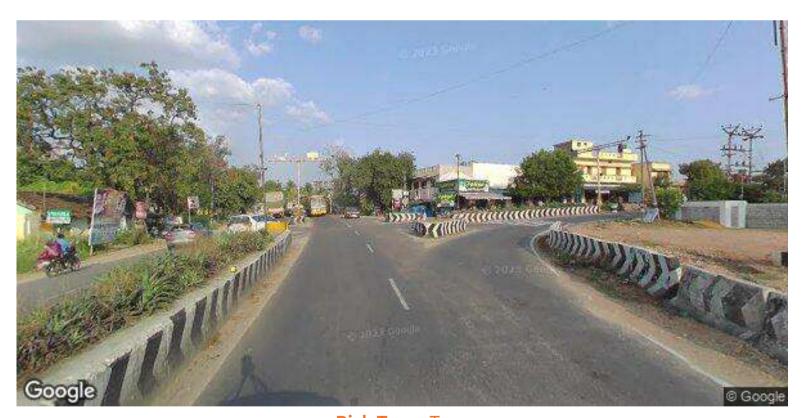
Risk Type: Turn
Risk Level: Medium
Speed Limit: 30 KM/Hr
Coordinates: 11.46318, 77.84913

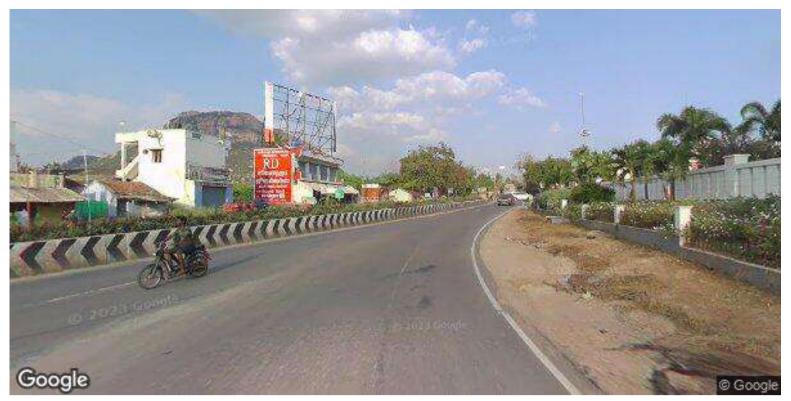
Risk Type: Turn
Risk Level: Medium
Speed Limit: 30 KM/Hr
Coordinates: 11.46302, 77.84874

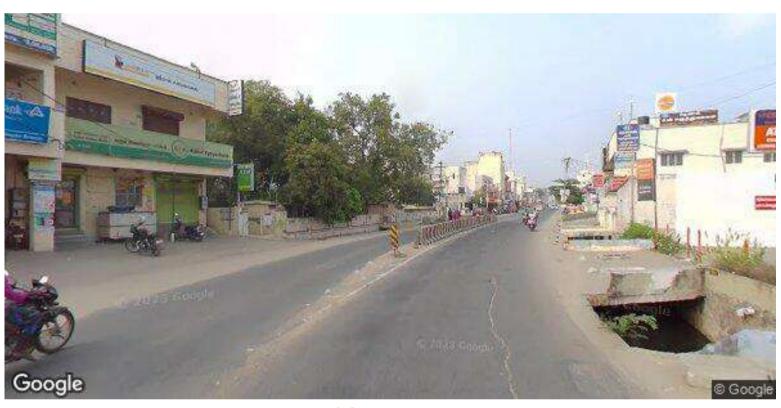
Risk Type: Turn
Risk Level: Medium
Speed Limit: 30 KM/Hr
Coordinates: 11.36622, 77.74789

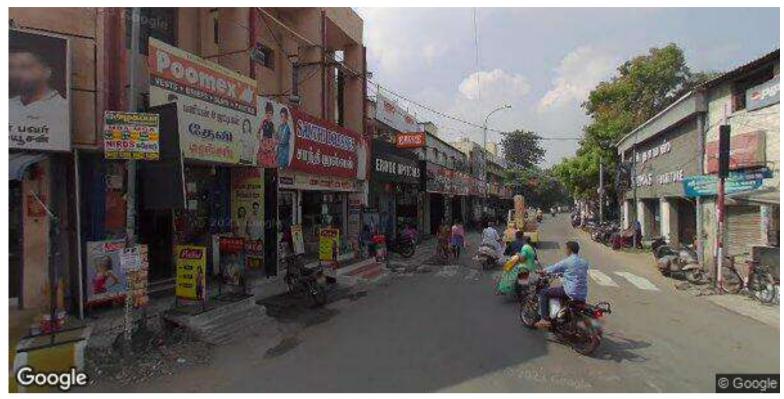
Coordinates: 11.33920, 77.72902

Risk Type: Blind Spot Risk Level: Blind Spot Speed Limit: 10 KM/Hr

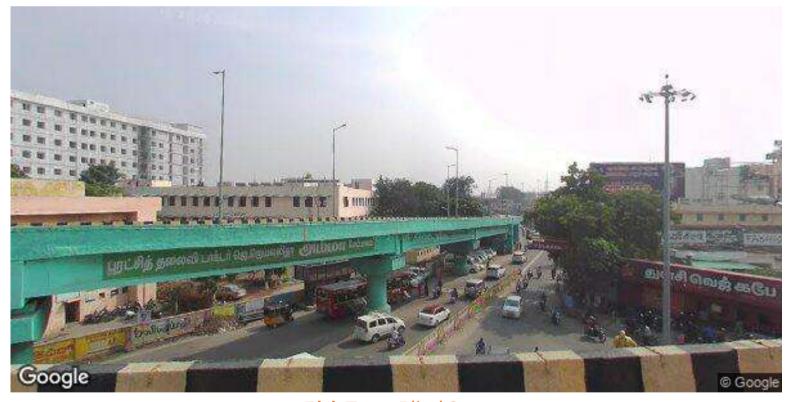
Coordinates: 11.34068, 77.71709

Risk Type: Blind Spot
Risk Level: Blind Spot
Speed Limit: 10 KM/Hr

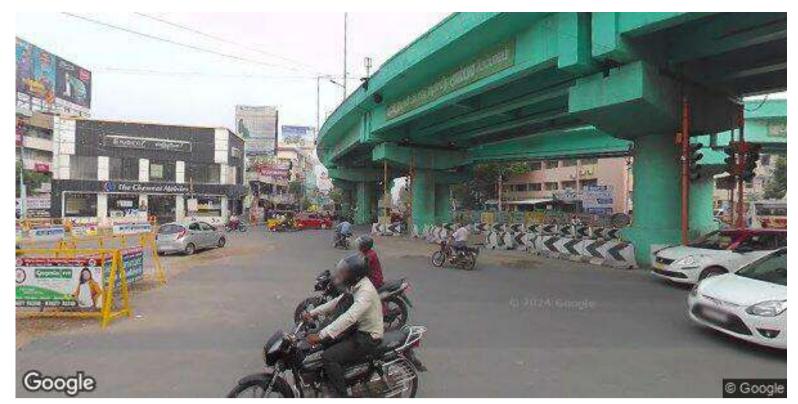
Risk Type: Blind Spot
Risk Level: Blind Spot
Speed Limit: 10 KM/Hr
Coordinates: 11.34097, 77.71715

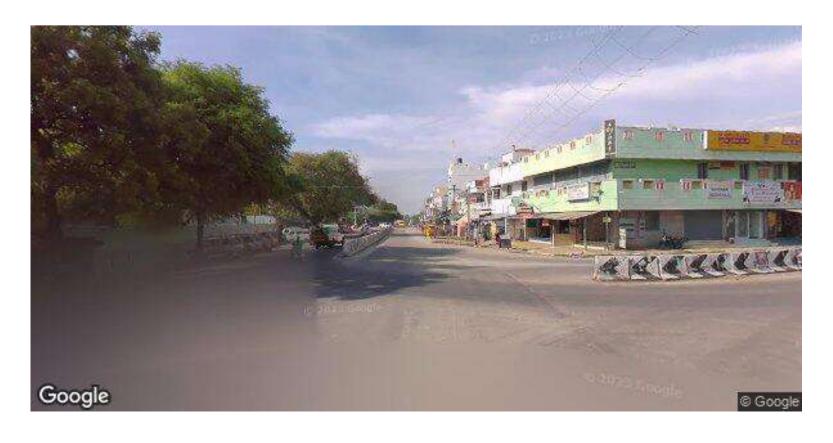
Coordinates: 11.33828, 77.63811

Risk Type: Turn
Risk Level: High
Speed Limit: 15 KM/Hr

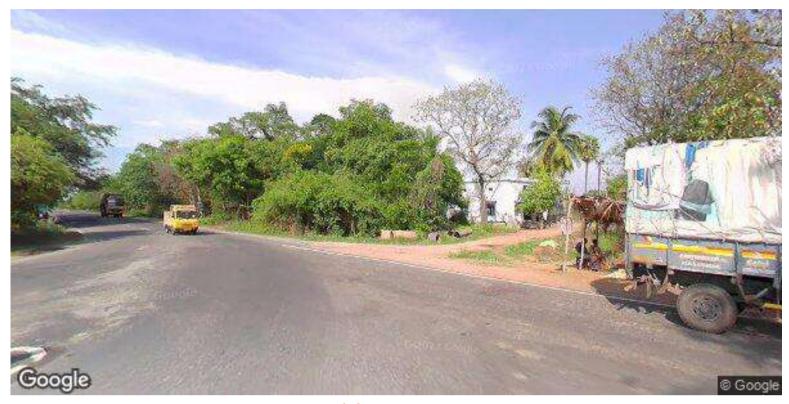
Coordinates: 11.32831, 77.62967

Risk Type: Turn
Risk Level: High
Speed Limit: 15 KM/Hr

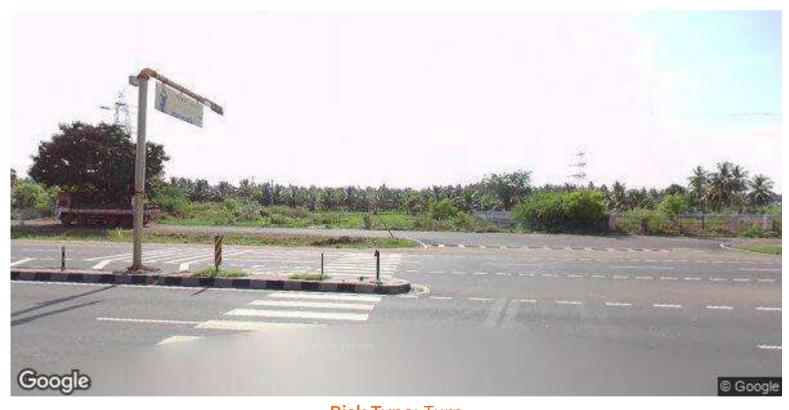
Coordinates: 11.32841, 77.62931

Risk Type: Turn
Risk Level: High
Speed Limit: 15 KM/Hr

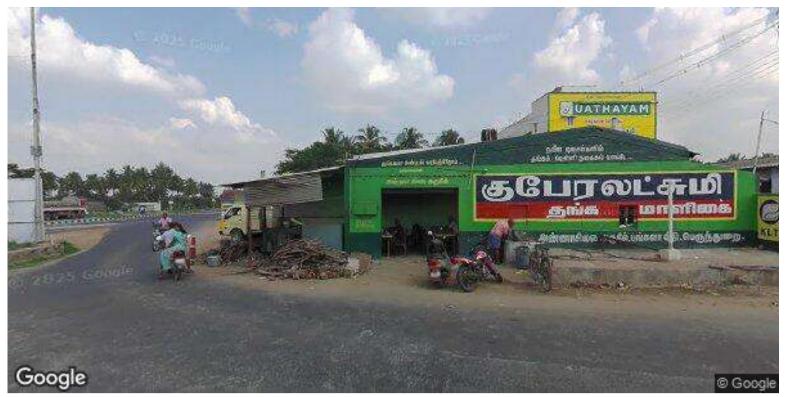
Risk Type: Turn
Risk Level: High
Speed Limit: 15 KM/Hr
Coordinates: 11.29158, 77.58600

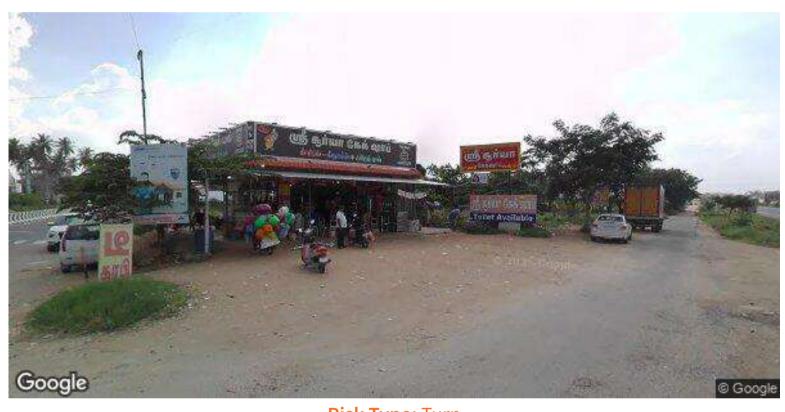
Risk Type: Turn
Risk Level: Medium
Speed Limit: 30 KM/Hr
Coordinates: 11.29163, 77.58591

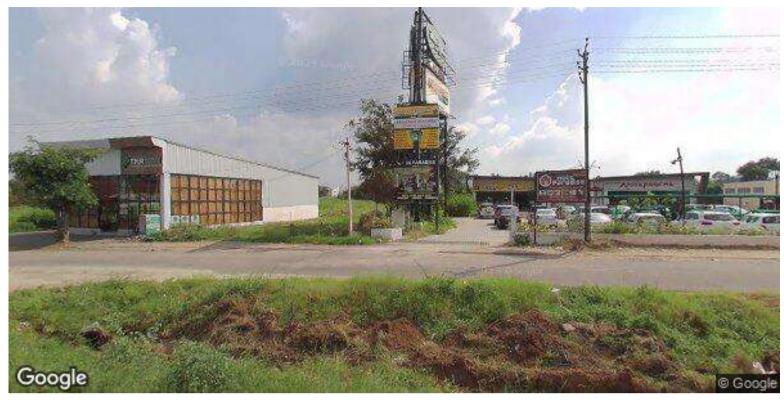
Risk Type: Turn
Risk Level: Medium
Speed Limit: 30 KM/Hr
Coordinates: 11.29154, 77.58236

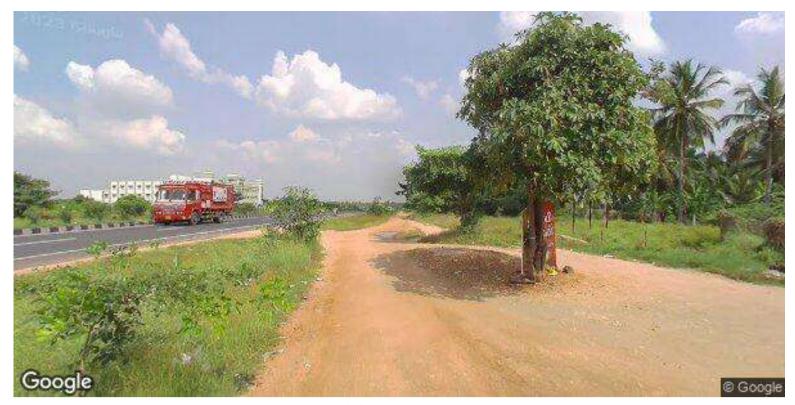
Risk Type: Turn
Risk Level: Medium
Speed Limit: 30 KM/Hr
Coordinates: 11.28994, 77.56861

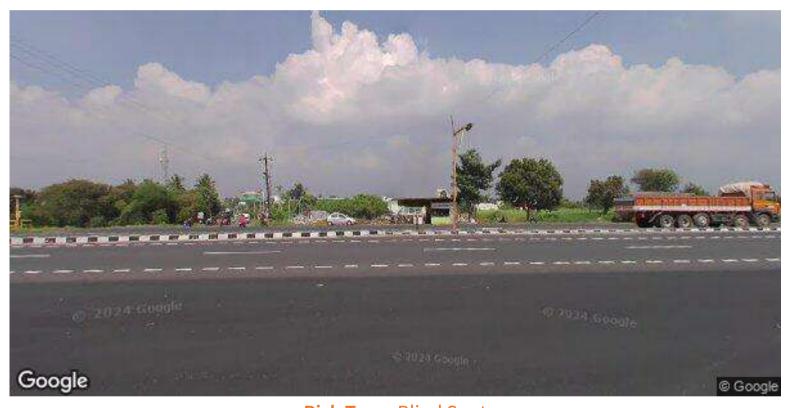
Risk Type: Blind Spot
Risk Level: Blind Spot
Speed Limit: 10 KM/Hr
Coordinates: 11.28888, 77.56550

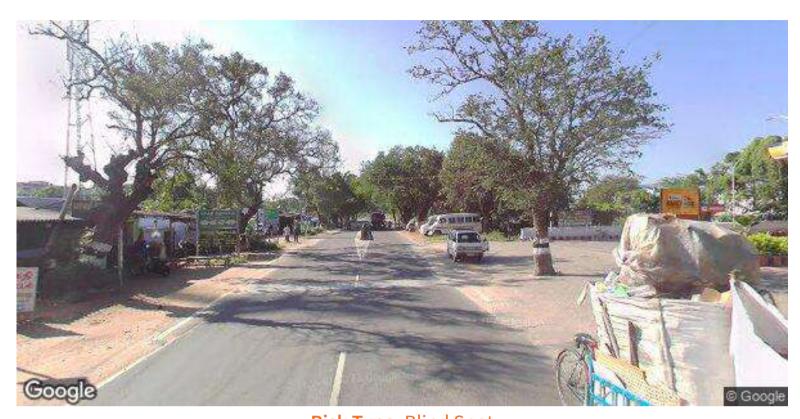
Coordinates: 11.28152, 77.57025

Risk Type: Blind Spot Risk Level: Blind Spot Speed Limit: 10 KM/Hr
