JOURNEY RISK MANAGEMENT (JRM) STUDY

Salem Terminal To SRI KUPPANNA PETROLIUM

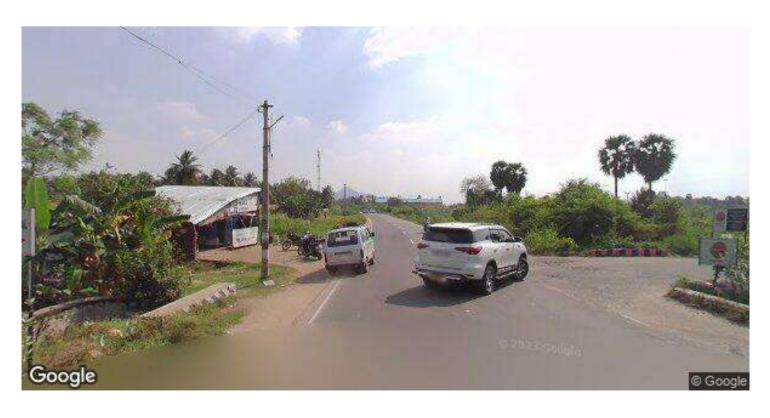
Risk Type: Blind Spot
Risk Level: Blind Spot
Speed Limit: 10 KM/Hr
Coordinates: 11.44029, 77.87544

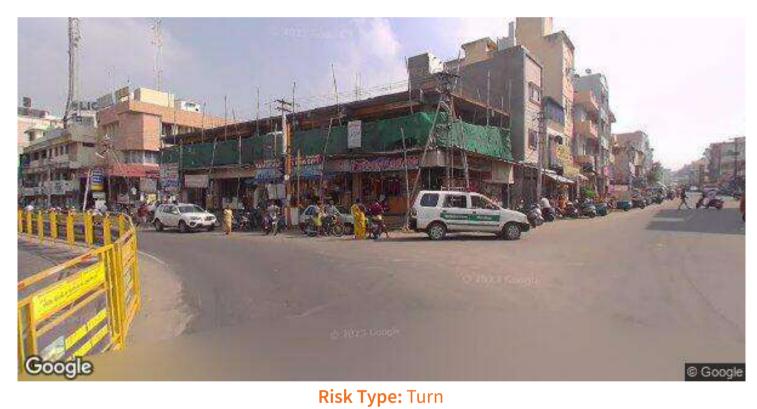
Risk Level: High
Speed Limit: 15 KM/Hr
Coordinates: 11.37868, 77.89498

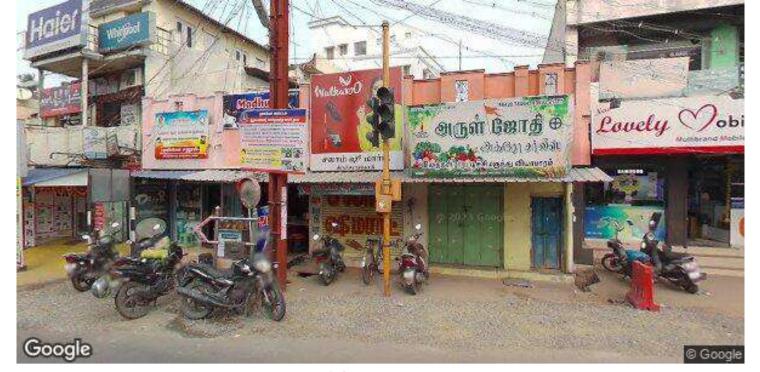
Risk Type: Turn
Risk Level: High
Speed Limit: 15 KM/Hr
Coordinates: 11.37850, 77.89453

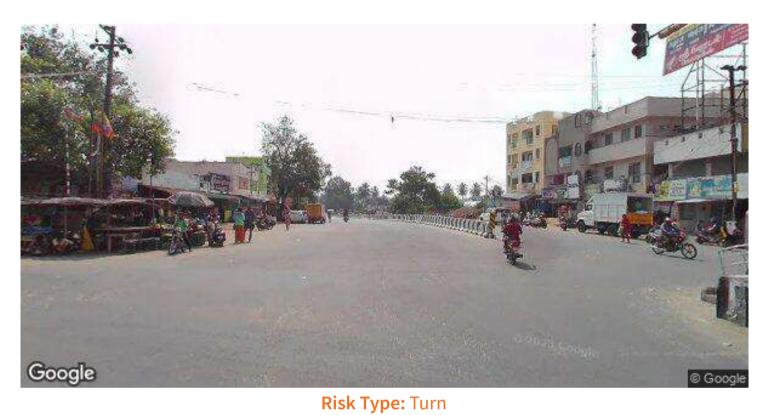
Risk Level: High
Speed Limit: 15 KM/Hr
Coordinates: 11.36604, 77.88887

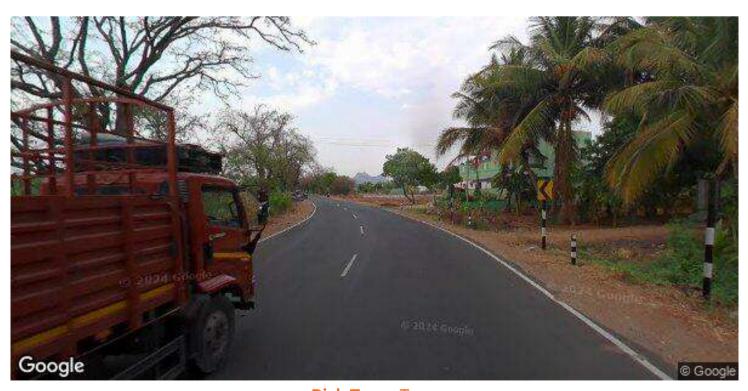
Risk Type: Turn
Risk Level: Medium

Speed Limit: 30 KM/Hr Coordinates: 11.34105, 77.86426

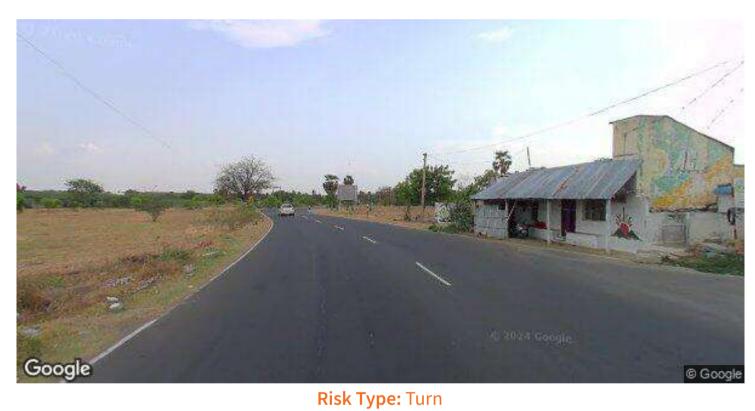
Risk Level: Medium
Speed Limit: 30 KM/Hr
Coordinates: 11.33865, 77.86216

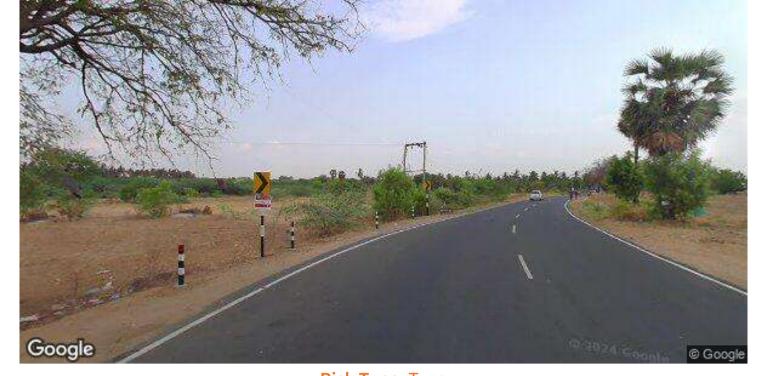
Risk Type: Turn
Risk Level: Medium
Speed Limit: 30 KM/Hr
Coordinates: 11.33794, 77.86235

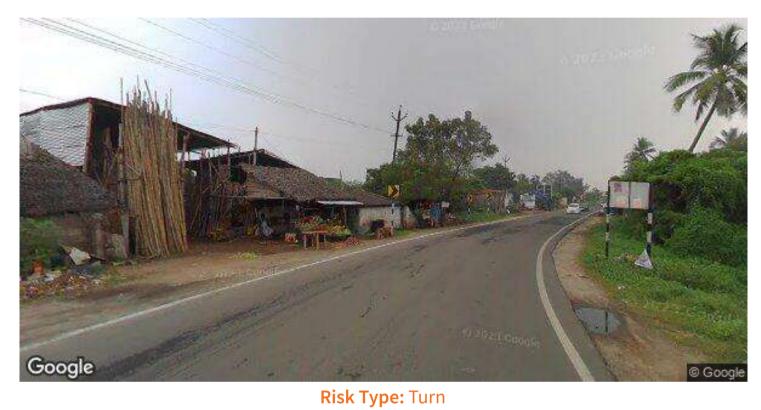
Risk Level: Medium
Speed Limit: 30 KM/Hr
Coordinates: 11.30968, 77.76701

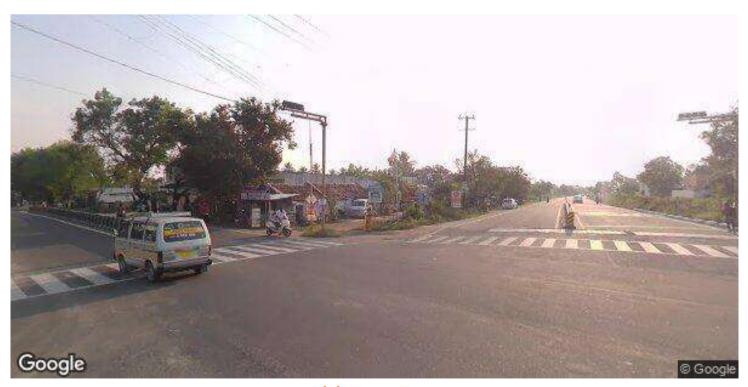
Risk Type: Turn Risk Level: High

Speed Limit: 15 KM/Hr Coordinates: 11.29899, 77.75806

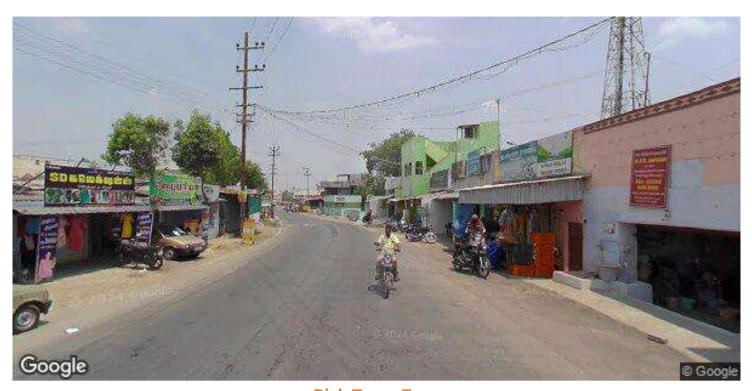
Risk Type: Turn
Risk Level: Medium
Speed Limit: 30 KM/Hr
Coordinates: 11.18947, 77.77076

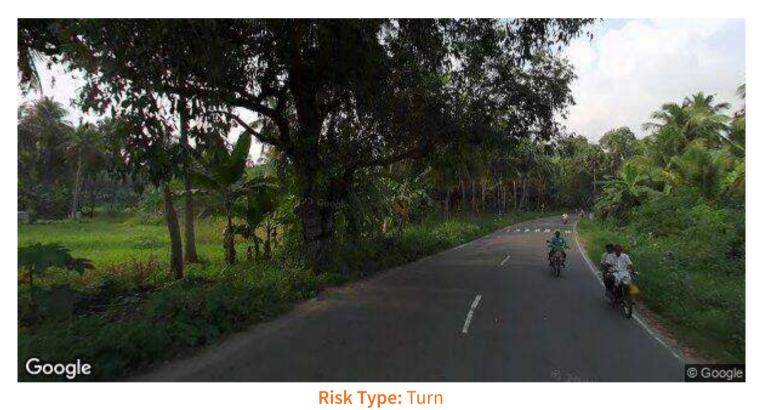
Risk Level: Medium
Speed Limit: 30 KM/Hr
Coordinates: 11.16419, 77.77365

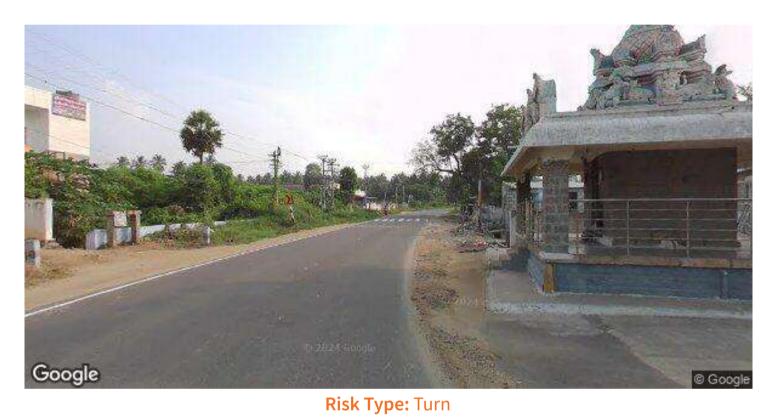
Risk Level: Medium
Speed Limit: 30 KM/Hr
Coordinates: 11.16354, 77.77435

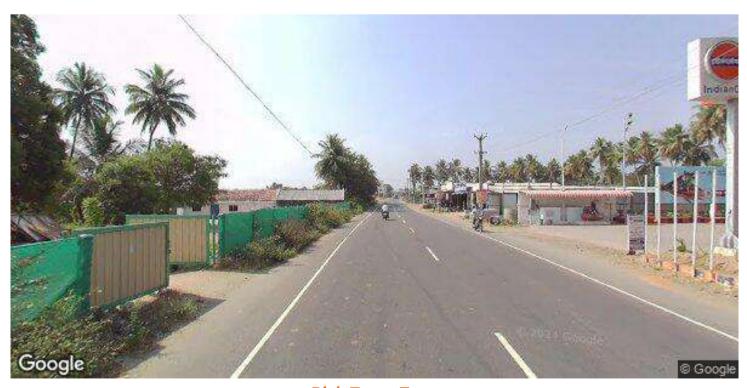
Coordinates: 11.05276, 77.73776

Risk Type: Turn Risk Level: High

Speed Limit: 15 KM/Hr
