JOURNEY RISK MANAGEMENT (JRM) STUDY

Salem Terminal To SONA BALAN FUEL SERVICE

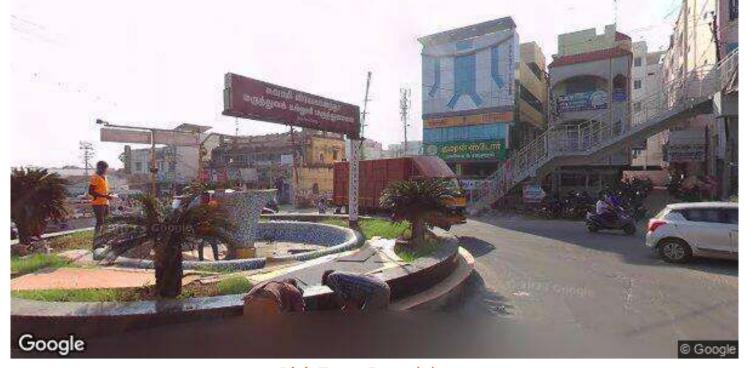
Risk Type: Roundabout
Risk Level: High
Speed Limit: 15 KM/Hr
Coordinates: 11.38395, 77.89480

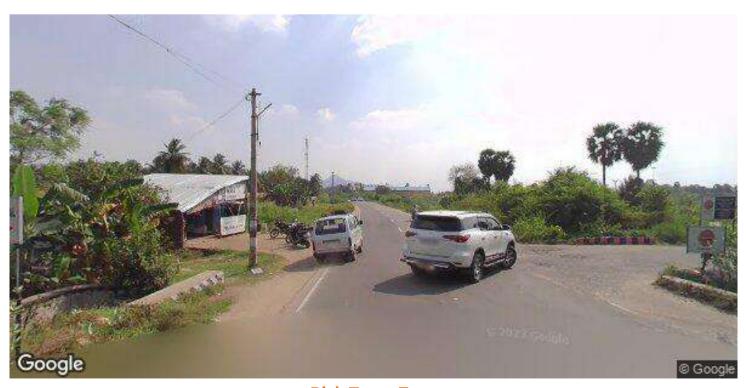
Risk Type: Turn Risk Level: High

Speed Limit: 15 KM/Hr Coordinates: 11.44029, 77.87544

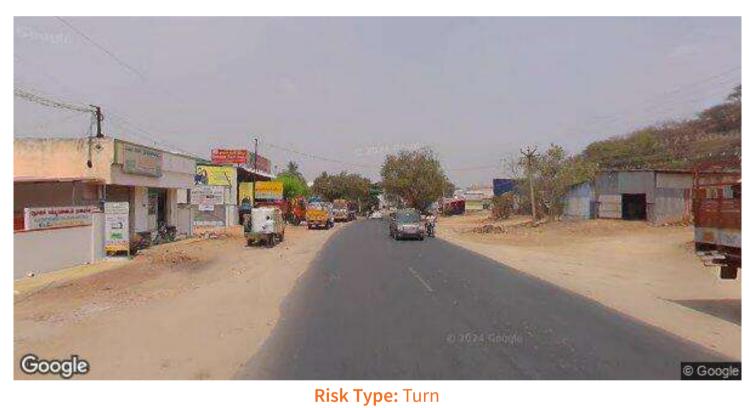
Risk Type. Turn
Risk Level: Medium
Speed Limit: 30 KM/Hr
Coordinates: 11.39983, 77.88377

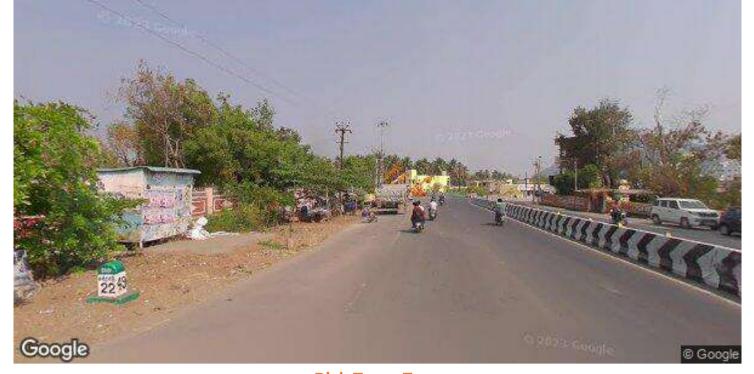
Risk Type: Turn
Risk Level: Medium
Speed Limit: 30 KM/Hr
Coordinates: 11.39706, 77.88825

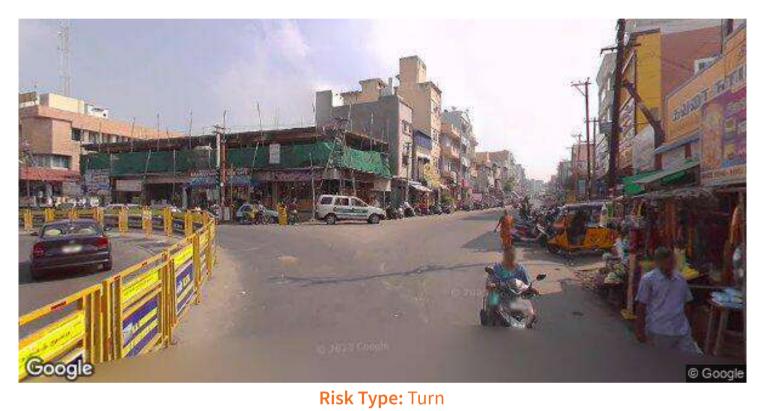
Risk Level: Medium
Speed Limit: 30 KM/Hr
Coordinates: 11.37862, 77.89488

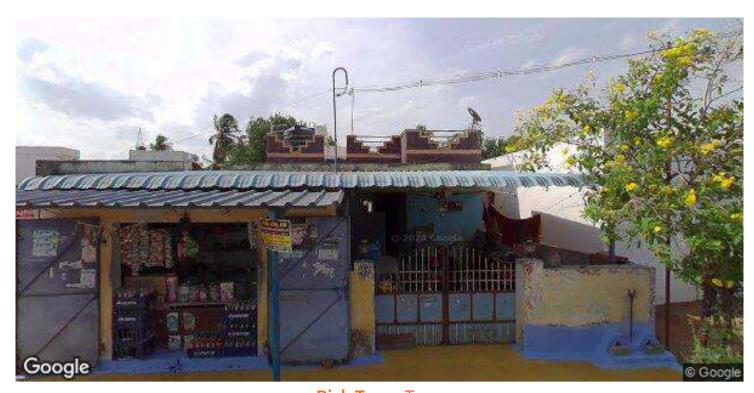
Risk Type: Turn
Risk Level: High
Speed Limit: 15 KM/Hr
Coordinates: 11.24242, 77.86833

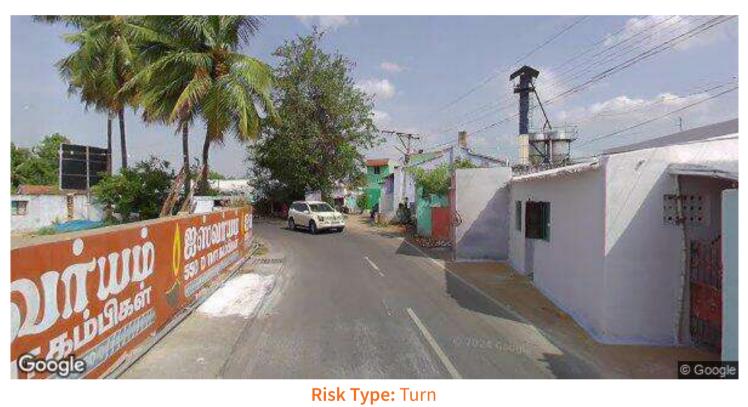
Risk Type: Turn
Risk Level: Medium
Speed Limit: 30 KM/Hr
Coordinates: 11.24252, 77.86780

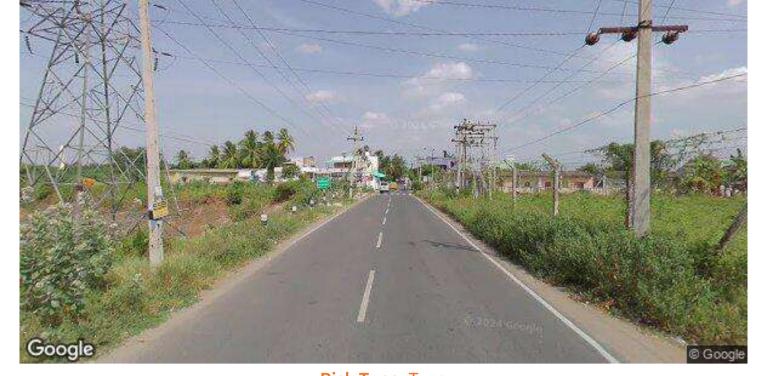
Risk Type: Turn
Risk Level: Medium
Speed Limit: 30 KM/Hr
Coordinates: 11.24343, 77.86716

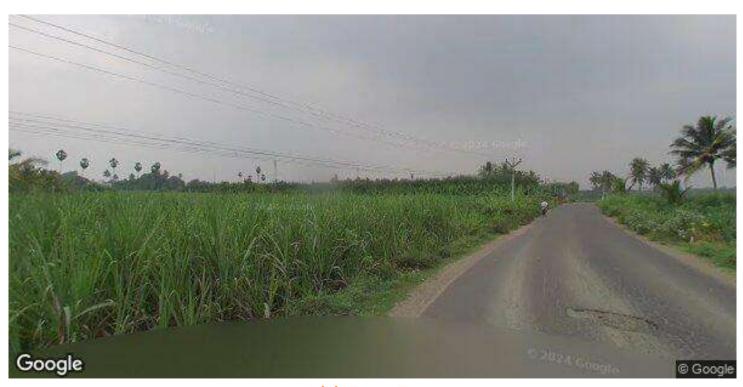
Risk Type: Turn Risk Level: High

Speed Limit: 15 KM/Hr Coordinates: 11.24101, 77.86023

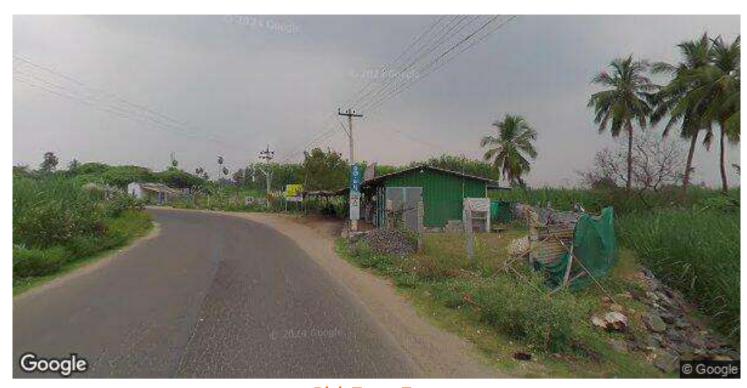
Risk Type: Turn
Risk Level: High
Speed Limit: 15 KM/Hr
Coordinates: 11.24198, 77.85893

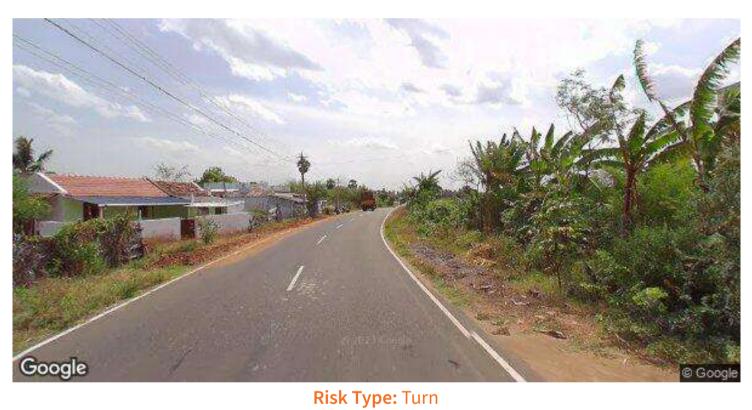
Risk Level: Medium
Speed Limit: 30 KM/Hr
Coordinates: 11.21416, 77.81761

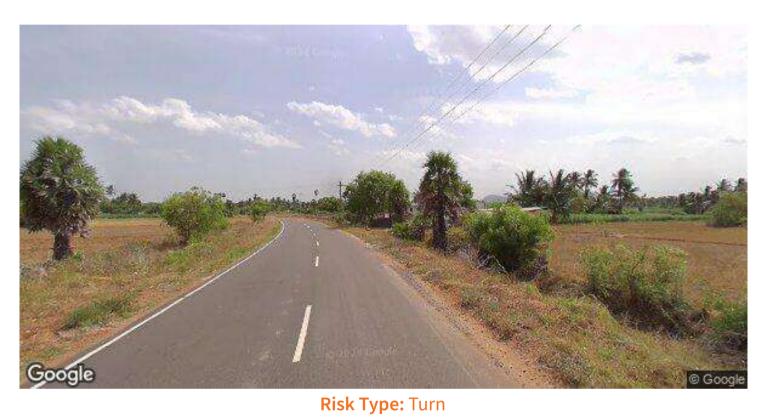
Risk Level: Medium
Speed Limit: 30 KM/Hr
Coordinates: 11.21372, 77.81372

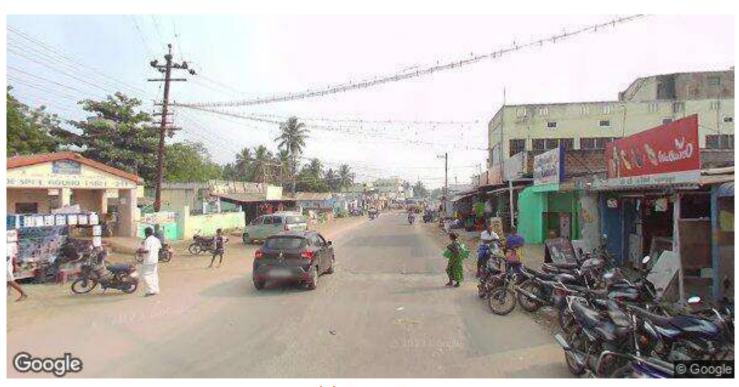
Risk Type: Turn Risk Level: High

Speed Limit: 15 KM/Hr Coordinates: 11.18850, 77.77113

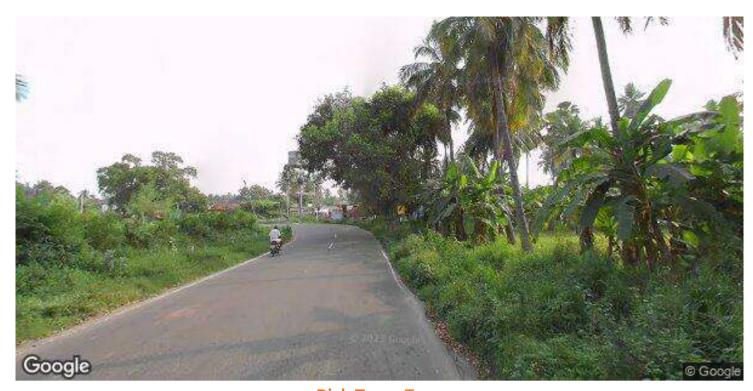
Risk Type: Turn
Risk Level: Medium
Speed Limit: 30 KM/Hr
Coordinates: 11.16450, 77.77357

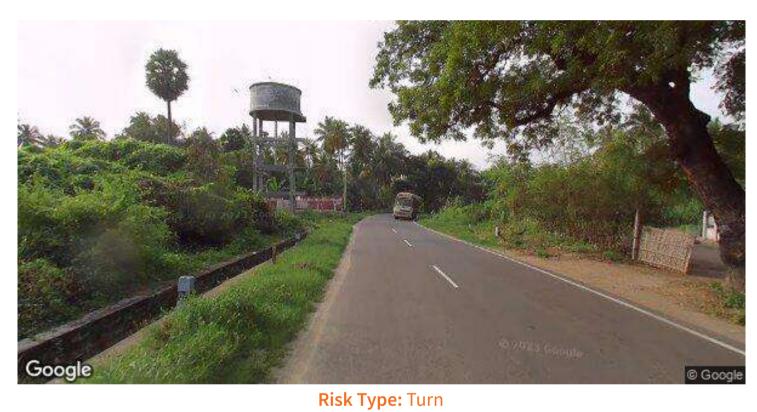
Risk Level: Medium
Speed Limit: 30 KM/Hr
Coordinates: 11.16380, 77.77417

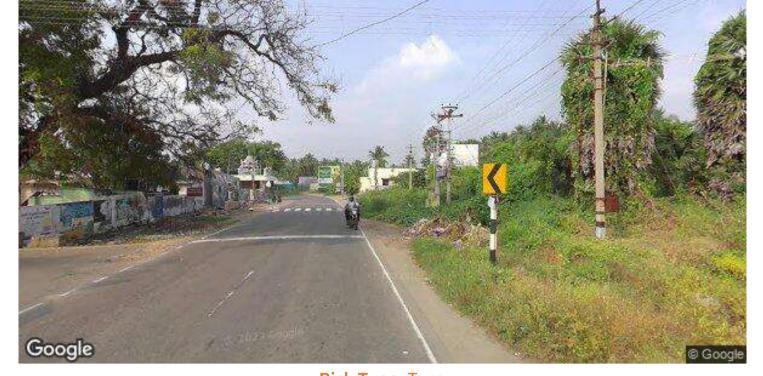
Risk Type: Turn
Risk Level: Medium
Speed Limit: 30 KM/Hr
Coordinates: 11.16294, 77.77438

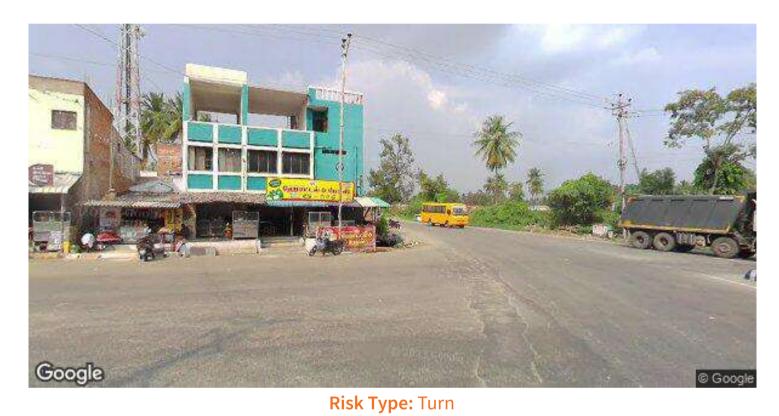
Risk Level: Medium
Speed Limit: 30 KM/Hr
Coordinates: 11.13667, 77.76526

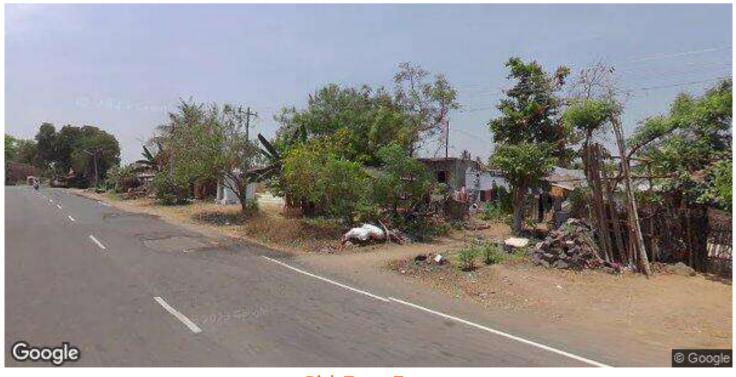
Risk Type: Turn
Risk Level: Medium

Speed Limit: 30 KM/Hr Coordinates: 11.07709, 77.74277

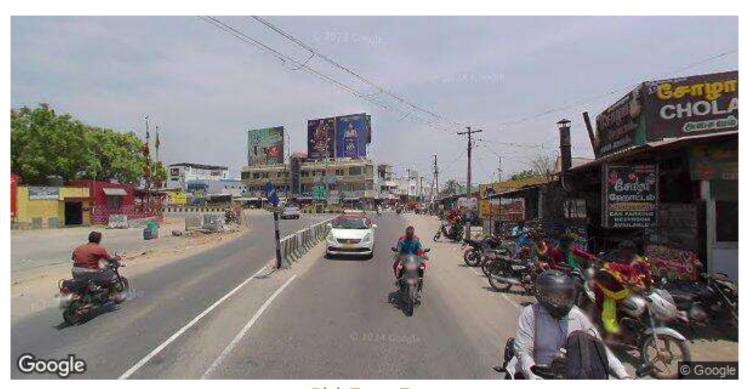
Risk Type: Turn
Risk Level: Medium
Speed Limit: 30 KM/Hr
Coordinates: 11.04618, 77.73719

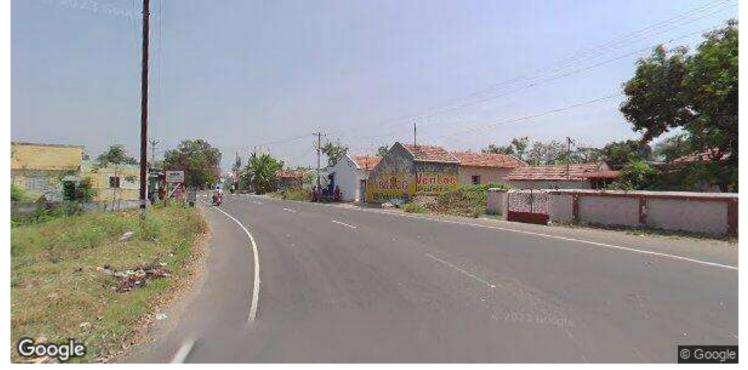
Risk Type: Turn
Risk Level: High
Speed Limit: 15 KM/Hr
Coordinates: 10.99029, 77.72513

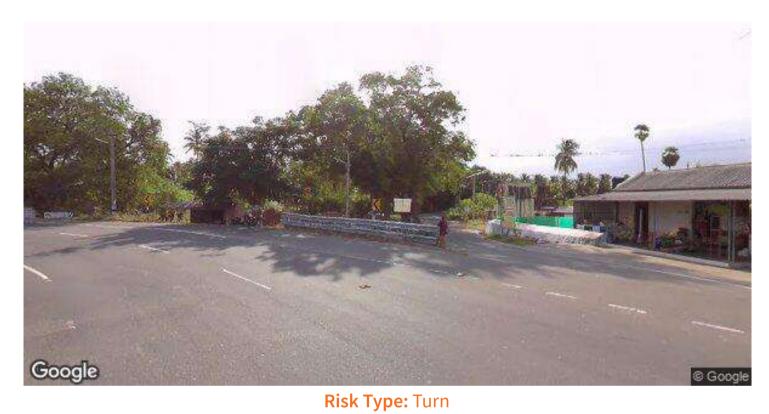
Risk Level: High
Speed Limit: 15 KM/Hr
Coordinates: 10.98982, 77.72400

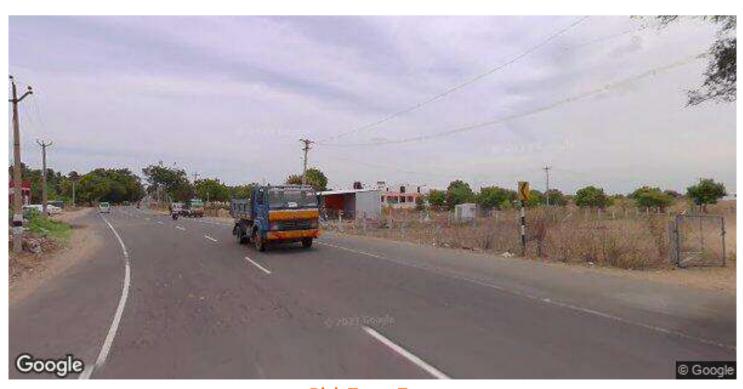
Risk Type: Turn
Risk Level: Medium

Speed Limit: 30 KM/Hr Coordinates: 10.96598, 77.71682

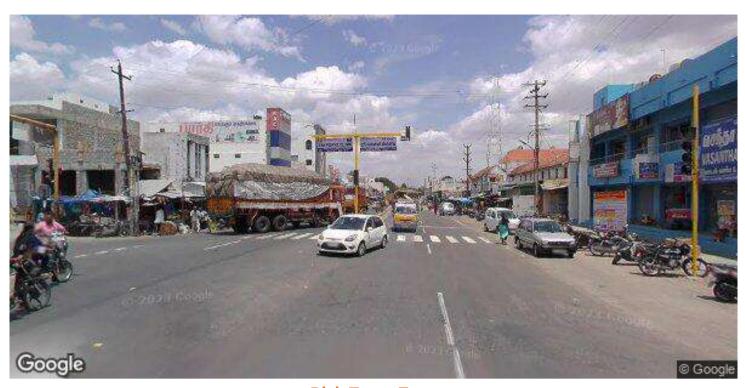
Risk Type: Turn
Risk Level: High
Speed Limit: 15 KM/Hr
Coordinates: 10.94591, 77.71309

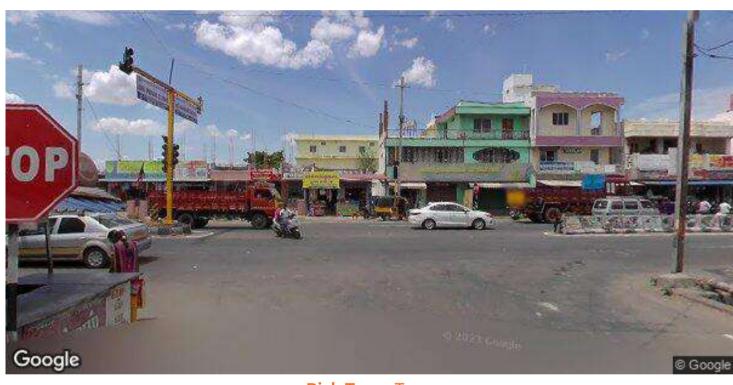
Risk Type: Turn
Risk Level: High
Speed Limit: 15 KM/Hr
Coordinates: 10.94582, 77.71257

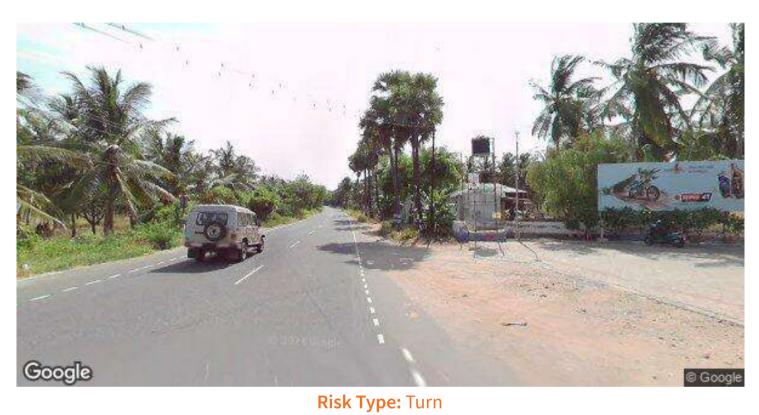
Risk Level: High
Speed Limit: 15 KM/Hr
Coordinates: 10.87230, 77.64948

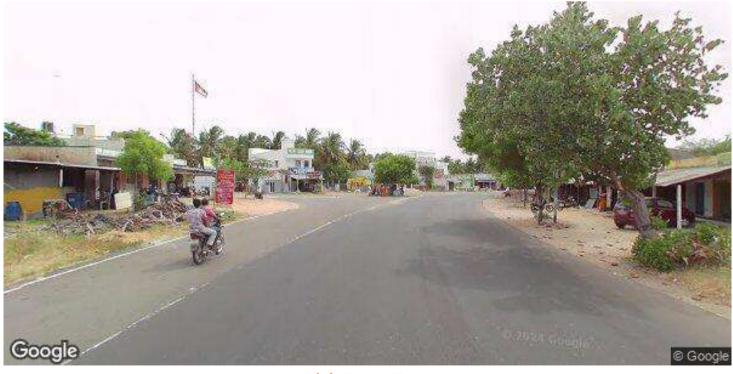
Risk Type: Turn Risk Level: High

Speed Limit: 15 KM/Hr Coordinates: 10.87174, 77.64440

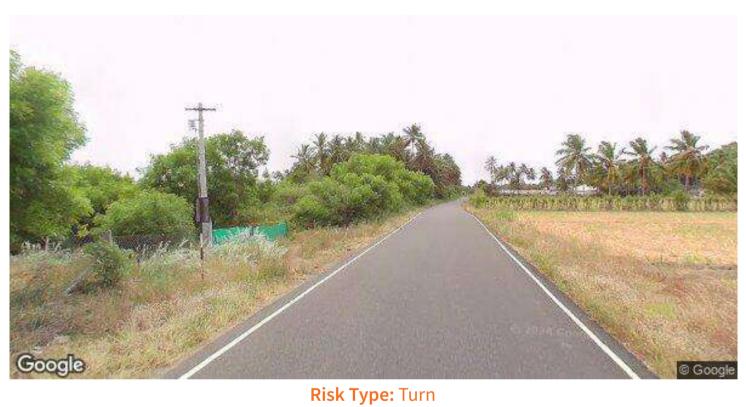
Risk Type: Turn
Risk Level: Medium
Speed Limit: 30 KM/Hr
Coordinates: 10.86372, 77.63528

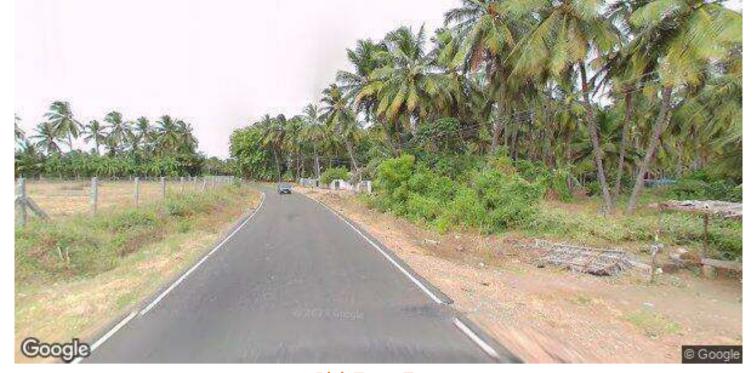
Risk Type: Turn
Risk Level: Medium
Speed Limit: 30 KM/Hr
Coordinates: 10.86166, 77.63330

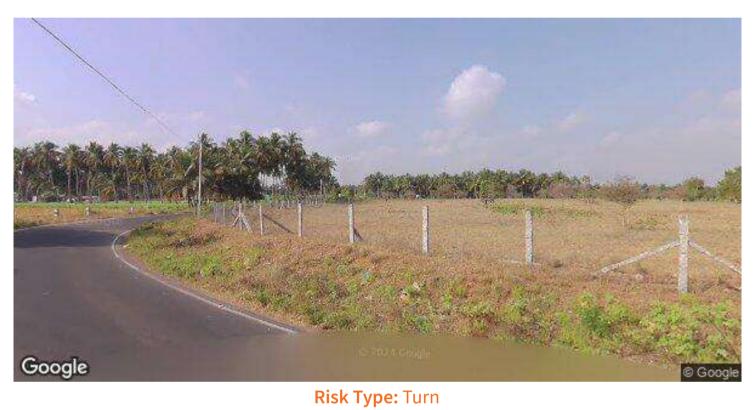
Risk Level: High
Speed Limit: 15 KM/Hr
Coordinates: 10.85787, 77.63357

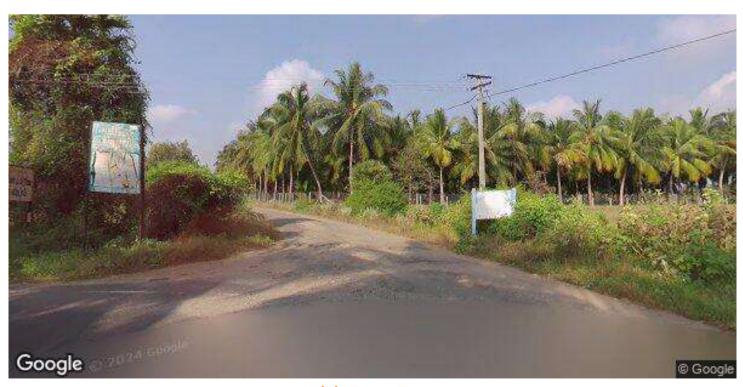
Risk Type: Turn Risk Level: High

Speed Limit: 15 KM/Hr Coordinates: 10.85690, 77.63240

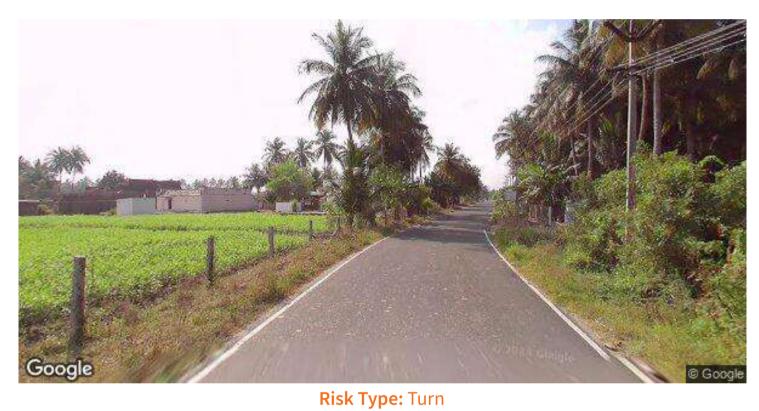
Risk Level: Medium
Speed Limit: 30 KM/Hr
Coordinates: 10.85261, 77.63402

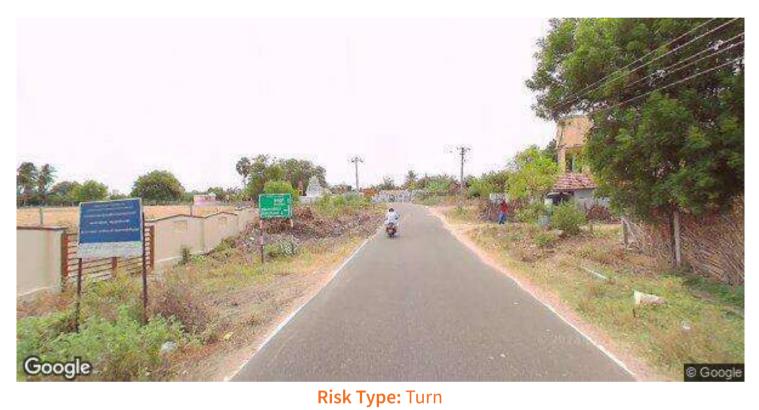
Risk Level: Medium
Speed Limit: 30 KM/Hr
Coordinates: 10.84078, 77.63352

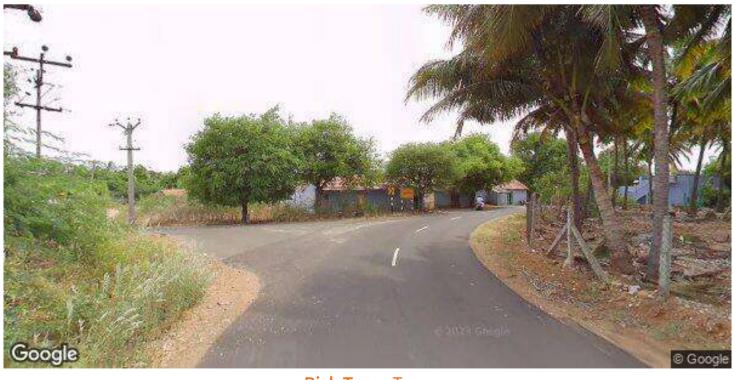
Risk Type: Turn Risk Level: High

Speed Limit: 15 KM/Hr Coordinates: 10.83987, 77.62957

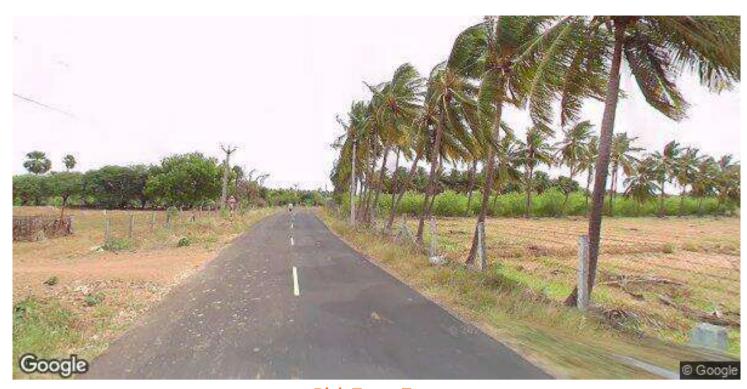
Risk Type: Turn
Risk Level: Medium
Speed Limit: 30 KM/Hr
Coordinates: 10.83842, 77.62941

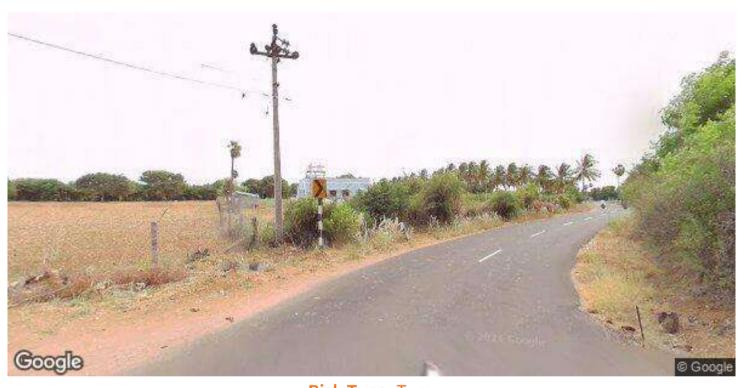
Risk Type: Turn
Risk Level: High
Speed Limit: 15 KM/Hr
Coordinates: 10.83784, 77.62873

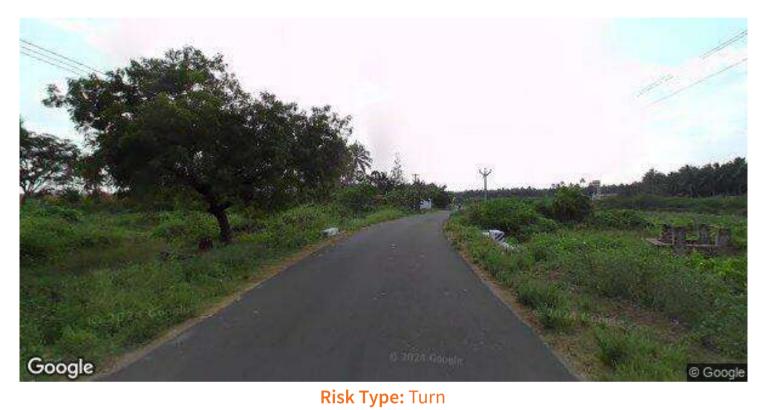
Risk Level: Medium
Speed Limit: 30 KM/Hr
Coordinates: 10.78968, 77.61905

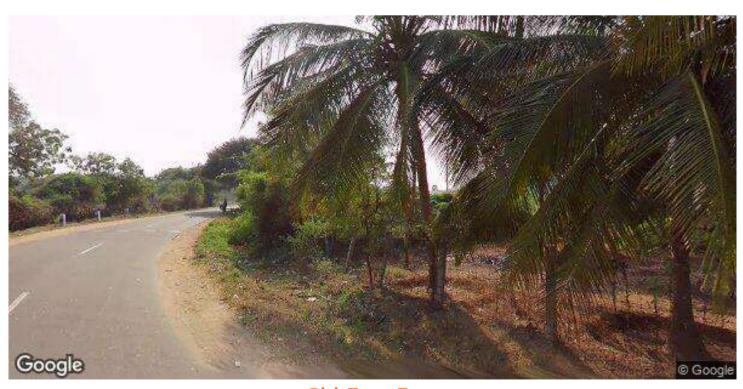
Risk Type: Turn
Risk Level: Medium

Speed Limit: 30 KM/Hr Coordinates: 10.78308, 77.61275

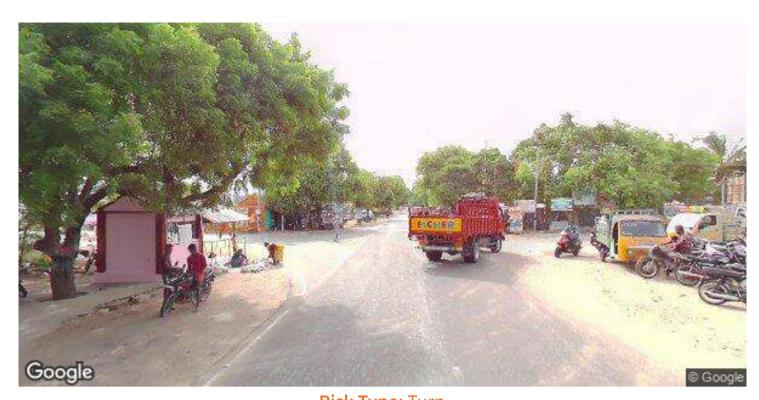
Risk Type: Turn
Risk Level: High
Speed Limit: 15 KM/Hr
Coordinates: 10.76663, 77.60179

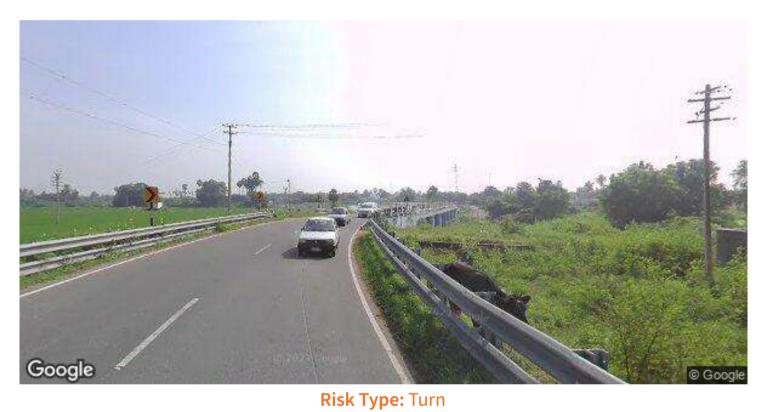
Risk Level: Medium
Speed Limit: 30 KM/Hr
Coordinates: 10.76745, 77.59629

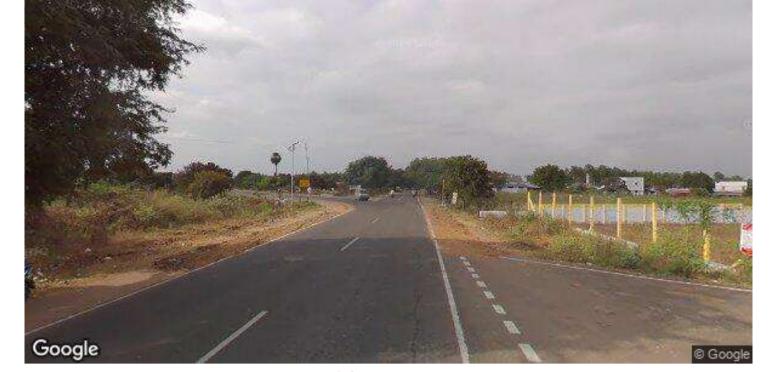
Risk Type: Turn
Risk Level: Medium
Speed Limit: 30 KM/Hr
Coordinates: 10.74757, 77.54899
