JOURNEY RISK MANAGEMENT (JRM) STUDY

IOCL Coimbatore Terminal to Coco Karatholuvu Sri Kalaivani Agen

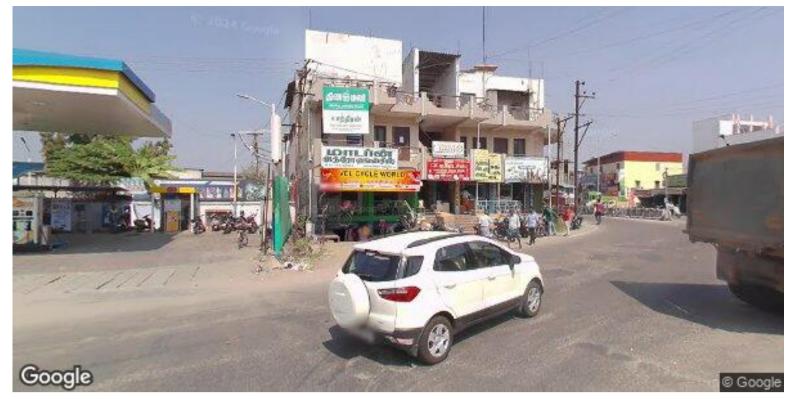
Coordinates: 10.58771, 77.24710

Risk Type: Roundabout
Risk Level: High
Speed Limit: 15 KM/Hr

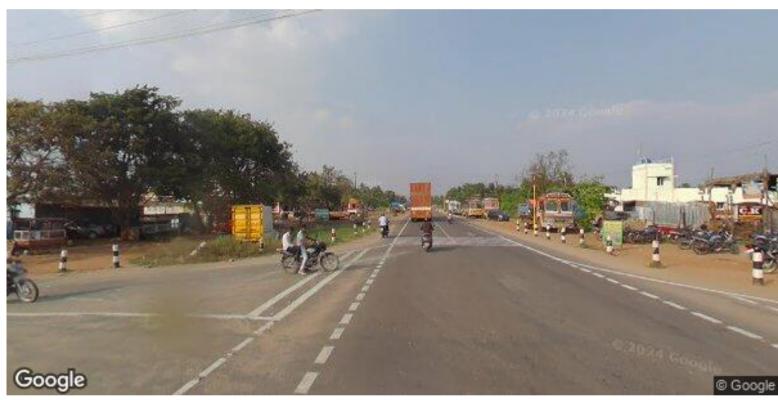
Coordinates: 11.03211, 77.07640

Risk Type: Blind Spot
Risk Level: Blind Spot
Speed Limit: 10 KM/Hr

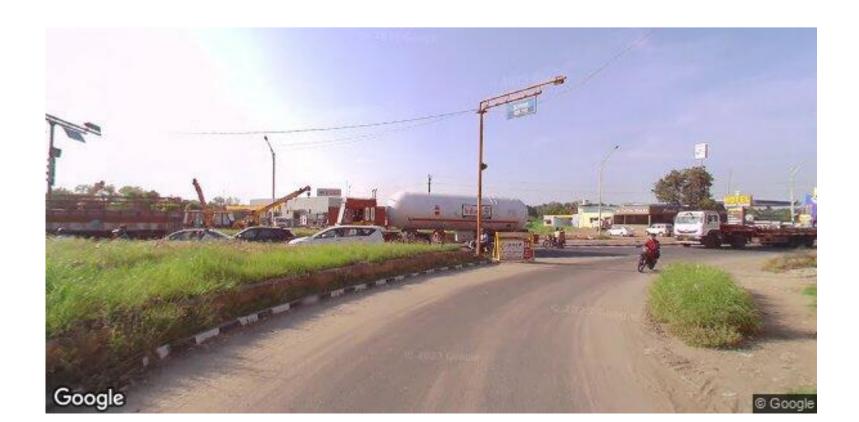
Coordinates: 11.00778, 77.07085

Risk Type: Blind Spot Risk Level: Blind Spot Speed Limit: 10 KM/Hr

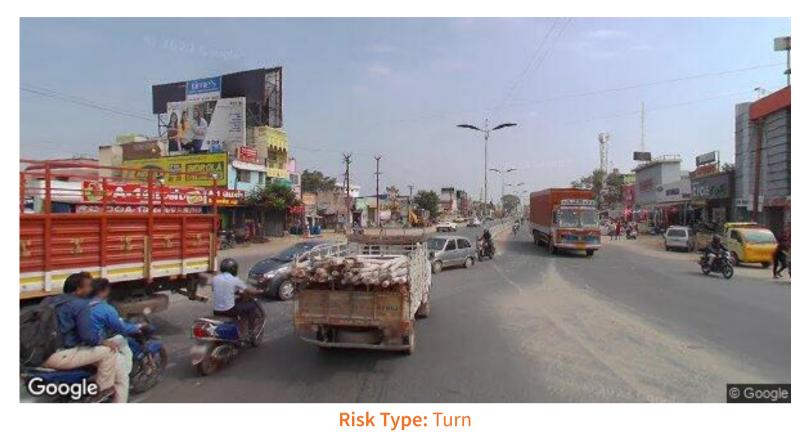
Risk Type. Turn
Risk Level: Medium
Speed Limit: 30 KM/Hr
Coordinates: 11.02774, 77.12761

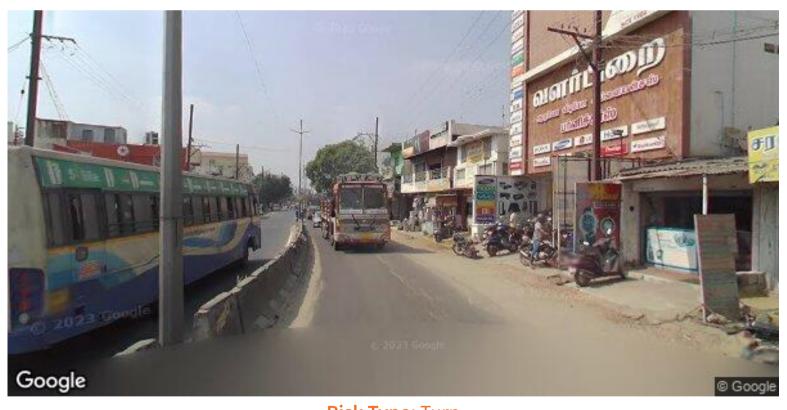
Risk Type: Turn
Risk Level: Medium
Speed Limit: 30 KM/Hr
Coordinates: 10.99570, 77.28153

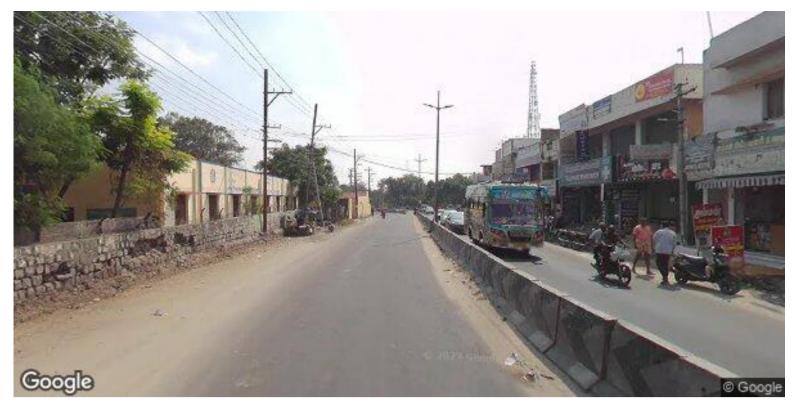
Risk Type: Turn
Risk Level: Medium
Speed Limit: 30 KM/Hr
Coordinates: 10.99535, 77.28179

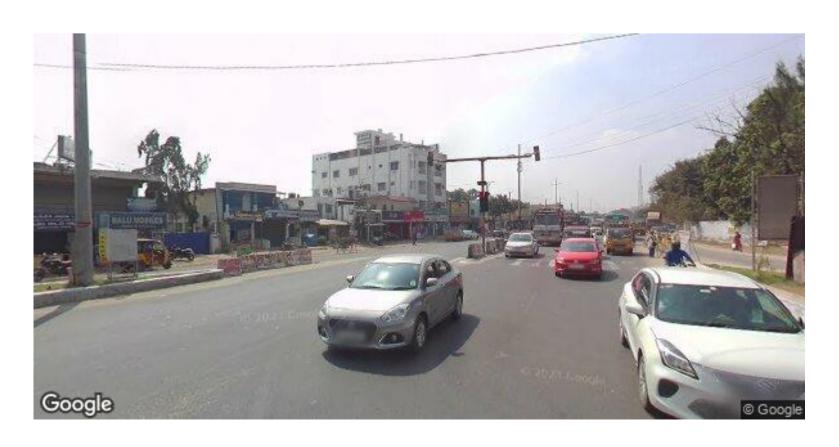
Coordinates: 10.99400, 77.28557

Risk Type: Turn
Risk Level: High
Speed Limit: 15 KM/Hr

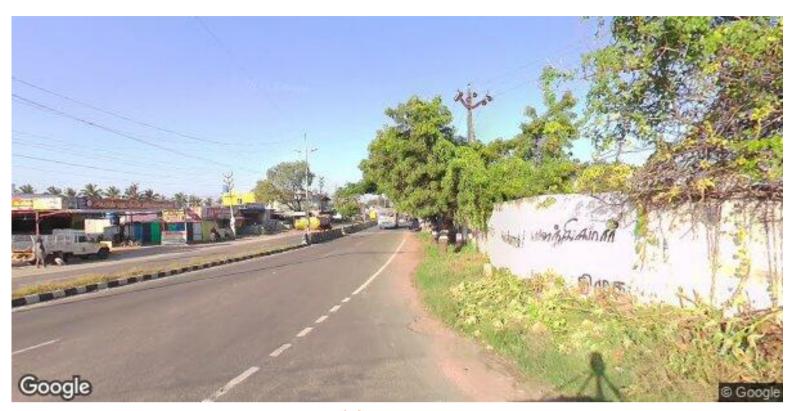
Risk Type: Turn
Risk Level: Medium
Speed Limit: 30 KM/Hr
Coordinates: 10.98116, 77.27933

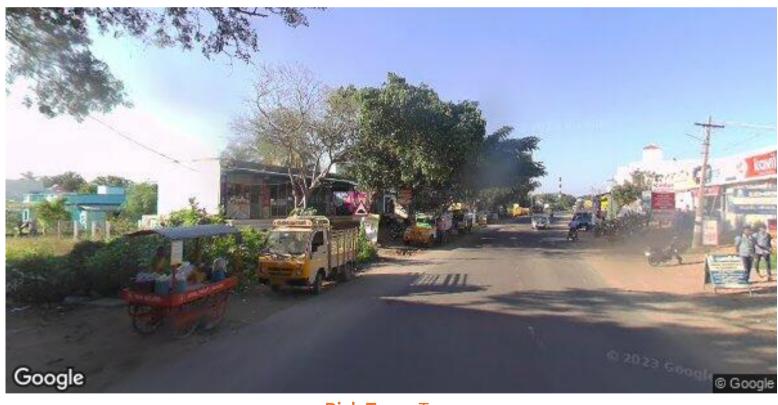
Risk Type: Turn
Risk Level: Medium
Speed Limit: 30 KM/Hr
Coordinates: 10.91559, 77.26611

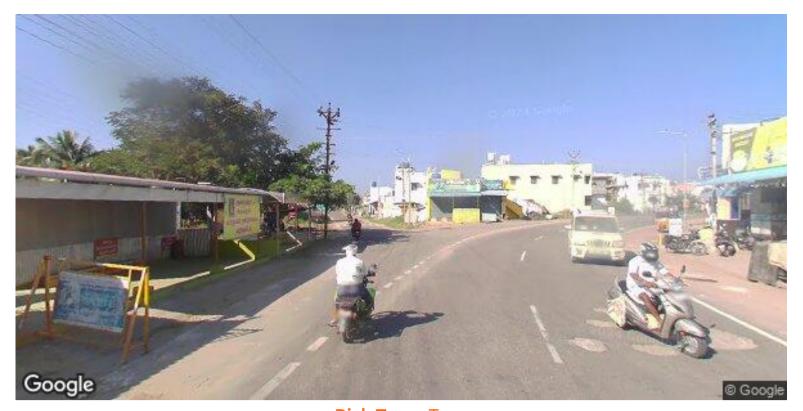
Risk Type: Turn
Risk Level: Medium
Speed Limit: 30 KM/Hr
Coordinates: 10.59541, 77.24546

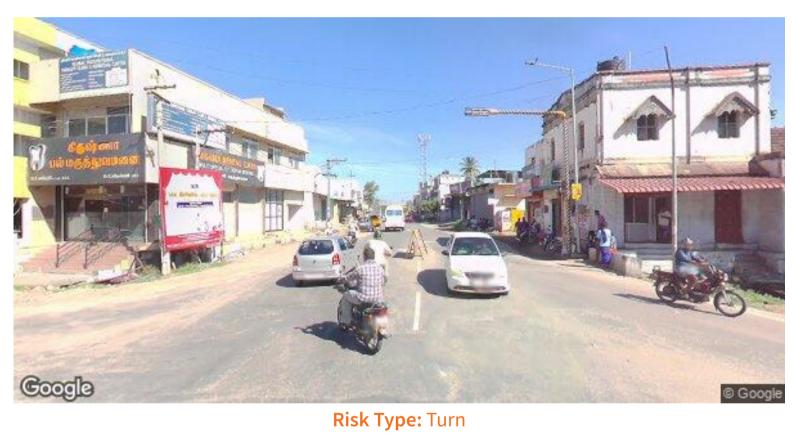
Risk Level: High
Speed Limit: 15 KM/Hr
Coordinates: 10.58828, 77.24496

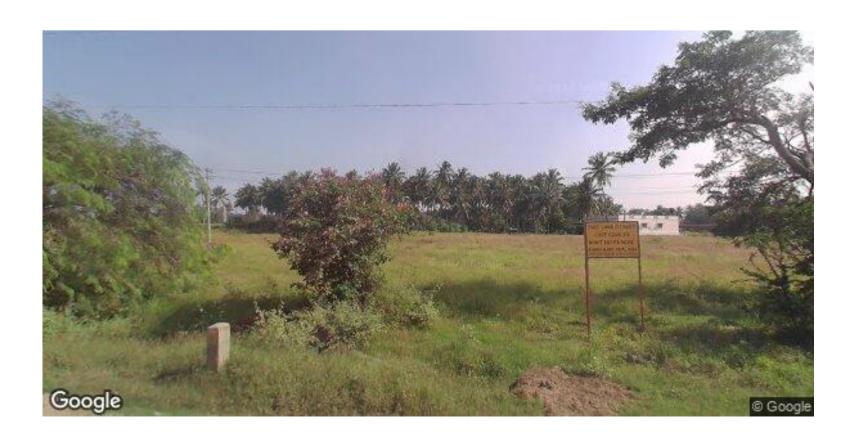
Coordinates: 10.60509, 77.27160

Risk Type: Turn
Risk Level: Medium
Speed Limit: 30 KM/Hr

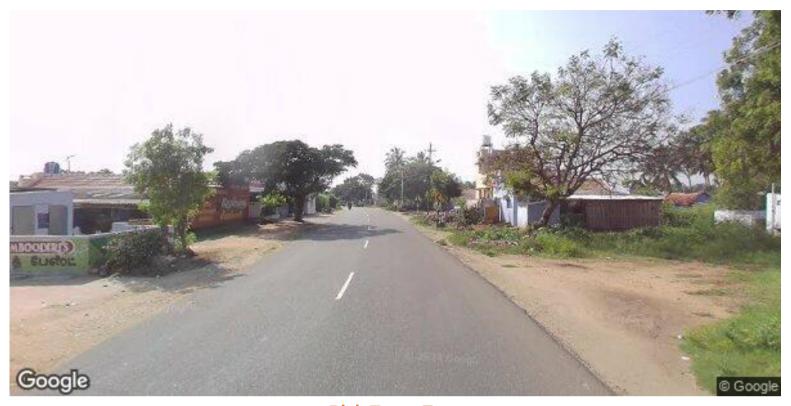
Risk Type: Turn
Risk Level: Medium
Speed Limit: 30 KM/Hr
Coordinates: 10.62280, 77.30143

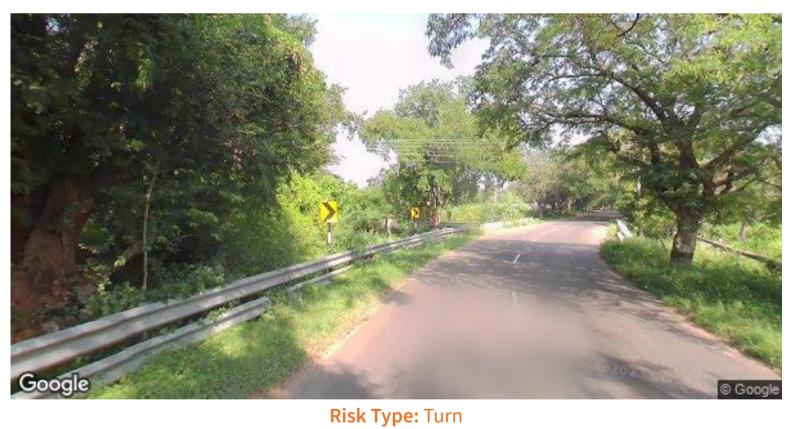
Risk Level: Medium
Speed Limit: 30 KM/Hr
Coordinates: 10.63102, 77.34372

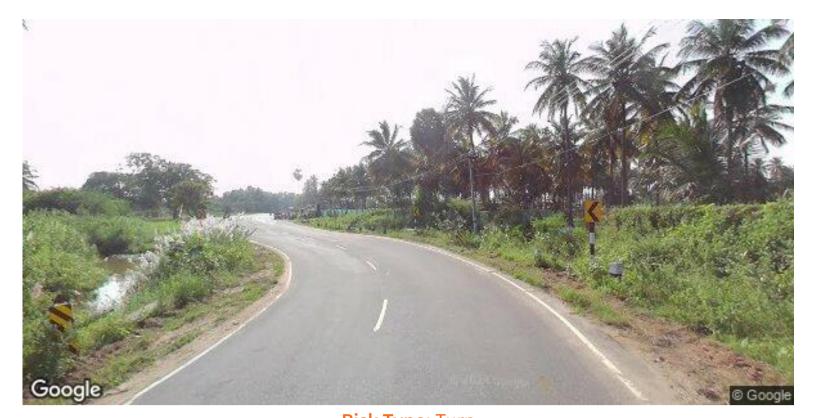
Coordinates: 10.62887, 77.38647

Risk Type: Turn
Risk Level: Medium
Speed Limit: 30 KM/Hr
