JOURNEY RISK MANAGEMENT (JRM) STUDY

Salem Terminal TO VELAVAN FUELS

Route Safety Analysis: Sangagiri to Kurunji Nagar, Tamil Nadu

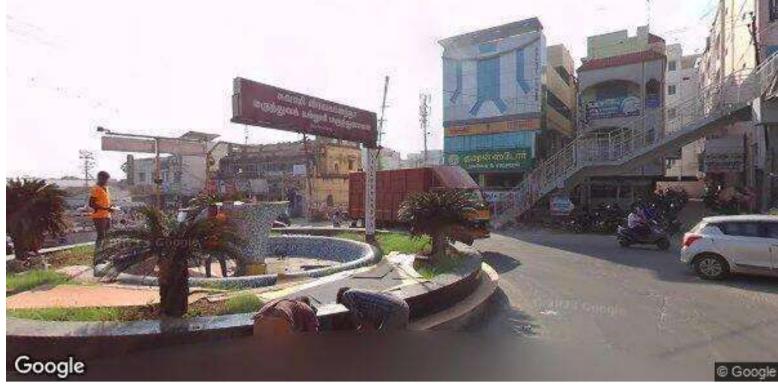
Risk Type: Roundabout
Risk Level: High
Speed Limit: 15 KM/Hr
Coordinates: 11.38395, 77.89480

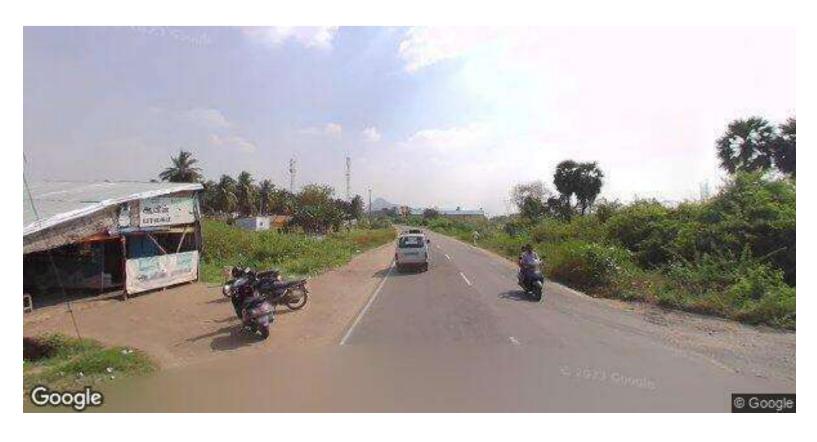
Coordinates: 11.44022, 77.87546

Risk Type: Turn
Risk Level: High
Speed Limit: 15 KM/Hr

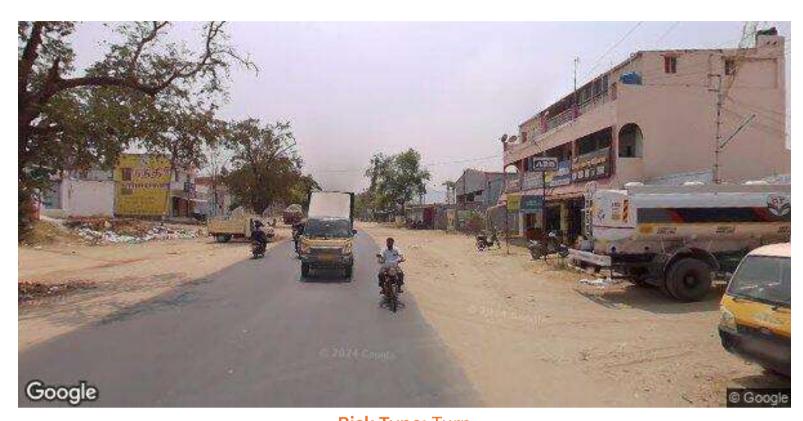
Risk Type: Turn
Risk Level: Medium
Speed Limit: 30 KM/Hr
Coordinates: 11.39976, 77.88382

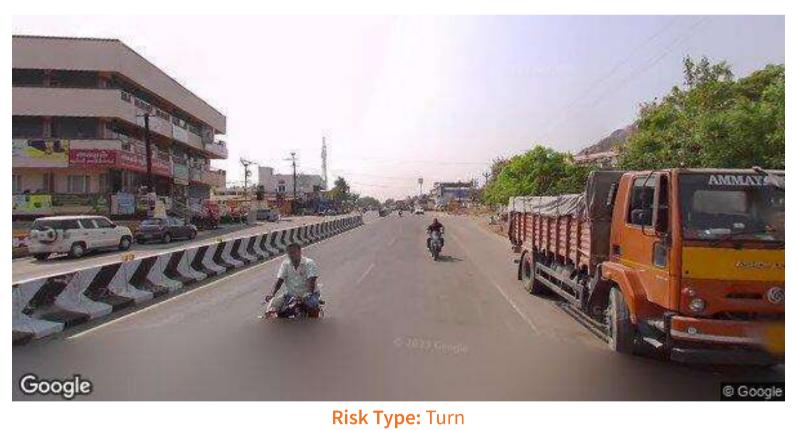
Coordinates: 11.39690, 77.88852

Risk Type: Turn
Risk Level: Medium
Speed Limit: 30 KM/Hr

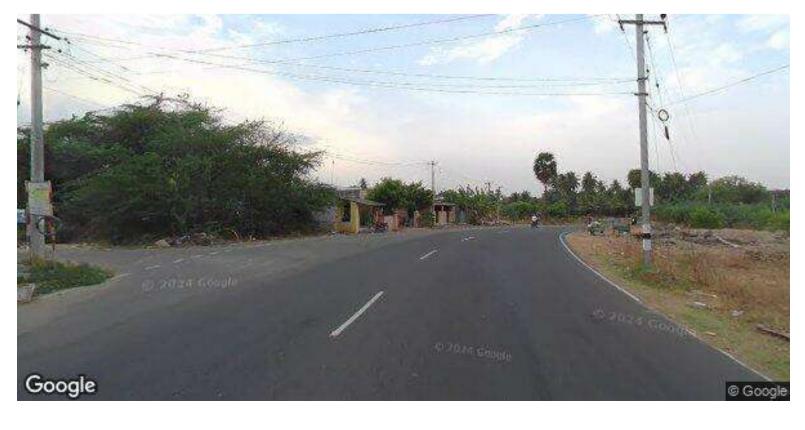
Coordinates: 11.33854, 77.86216

Risk Type: Turn
Risk Level: High
Speed Limit: 15 KM/Hr

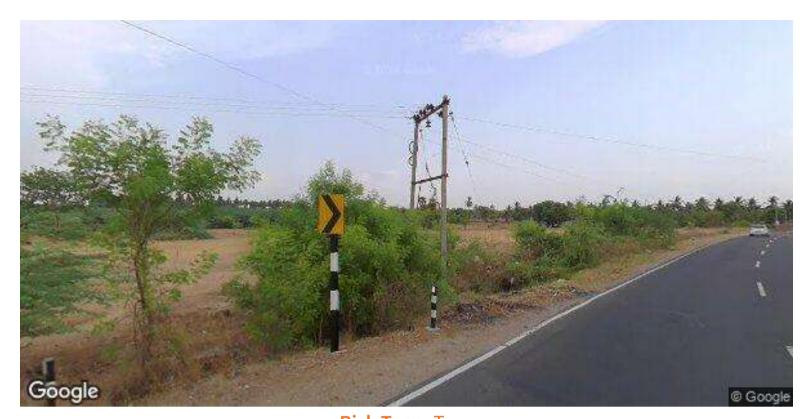
Risk Type: Turn
Risk Level: Medium
Speed Limit: 30 KM/Hr
Coordinates: 11.33778, 77.86236

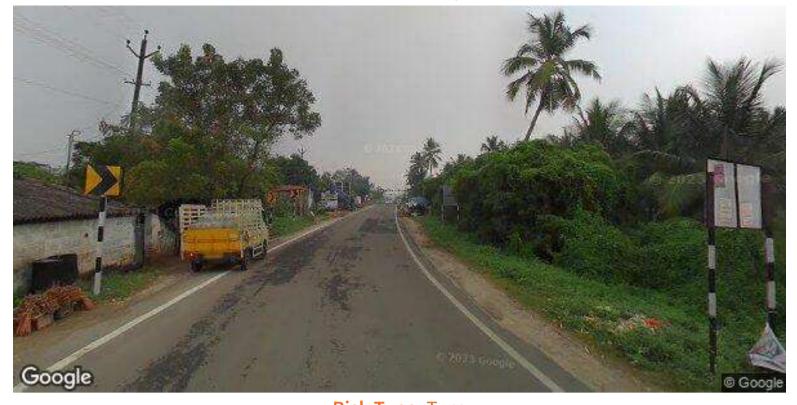
Risk Type: Turn
Risk Level: Medium
Speed Limit: 30 KM/Hr
Coordinates: 11.30973, 77.76712

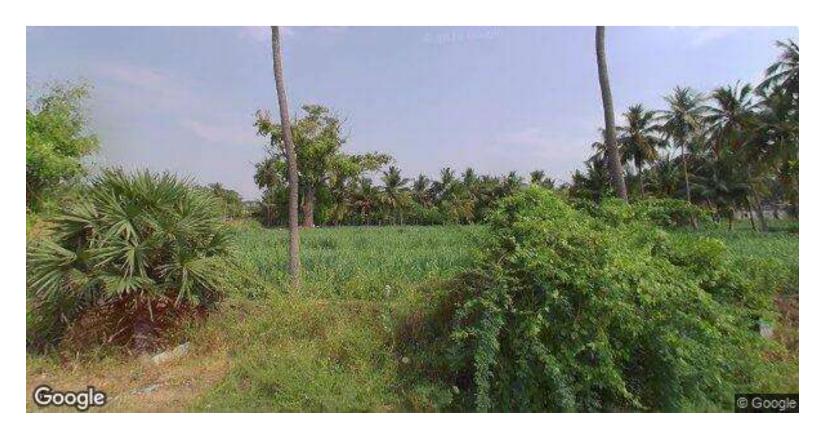
Coordinates: 11.29125, 77.74646

Risk Type: Turn
Risk Level: High
Speed Limit: 15 KM/Hr

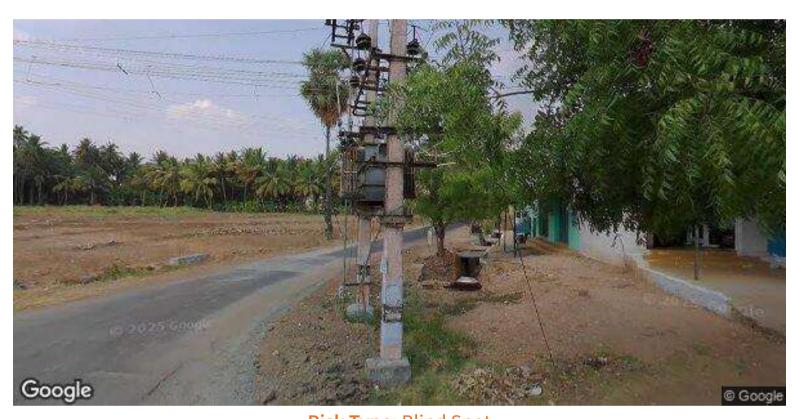
Risk Type: Blind Spot
Risk Level: Blind Spot
Speed Limit: 10 KM/Hr
Coordinates: 11.27330, 77.72715

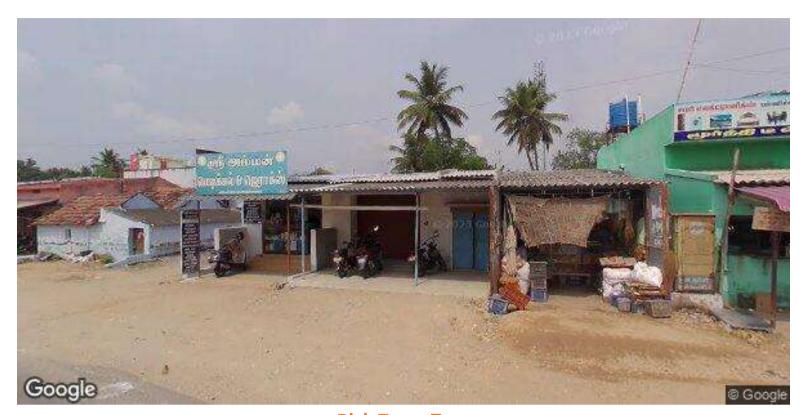
Risk Type: Turn
Risk Level: Medium
Speed Limit: 30 KM/Hr
Coordinates: 11.20776, 77.70916

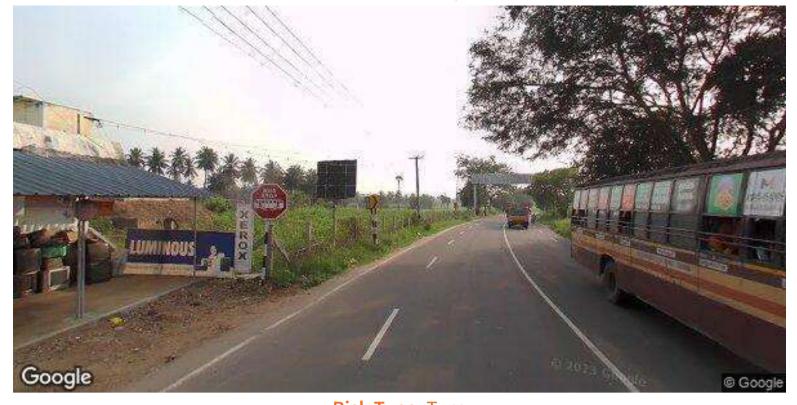
Risk Type: Turn
Risk Level: Medium
Speed Limit: 30 KM/Hr
Coordinates: 11.12102, 77.67919

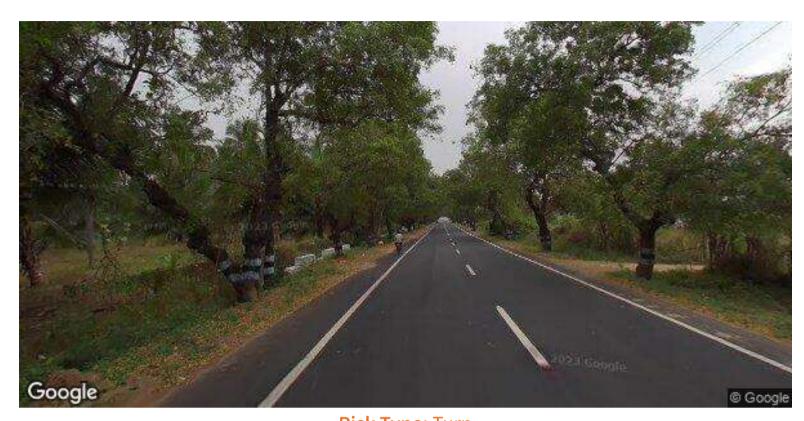
Risk Type: Turn
Risk Level: Medium
Speed Limit: 30 KM/Hr
Coordinates: 11.10436, 77.67044

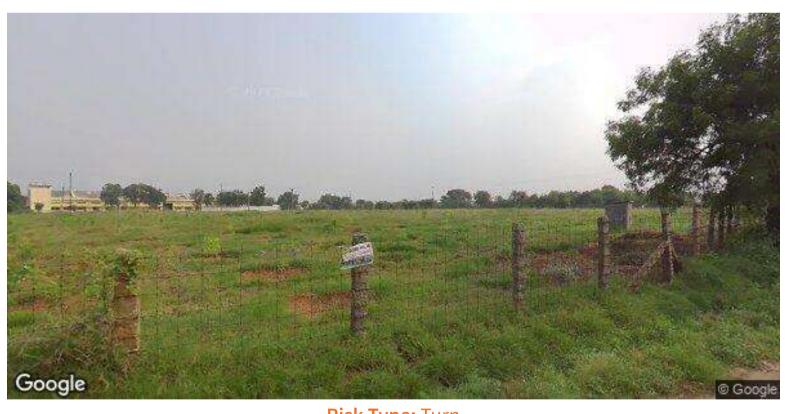
Coordinates: 11.09491, 77.66603

Risk Type: Turn
Risk Level: Medium
Speed Limit: 30 KM/Hr

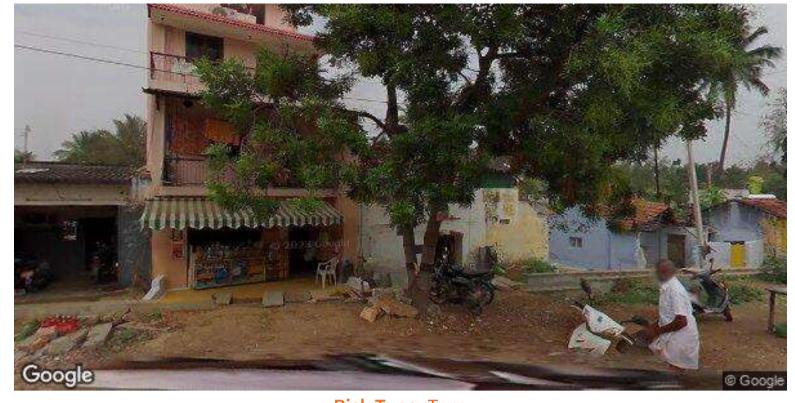
Risk Type: Turn
Risk Level: Medium
Speed Limit: 30 KM/Hr
Coordinates: 11.08696, 77.66407

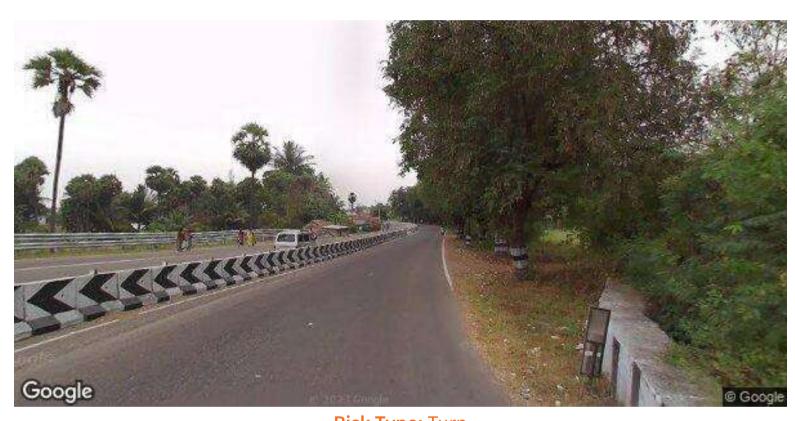
Risk Type: Turn
Risk Level: Medium
Speed Limit: 30 KM/Hr
Coordinates: 11.08296, 77.65857

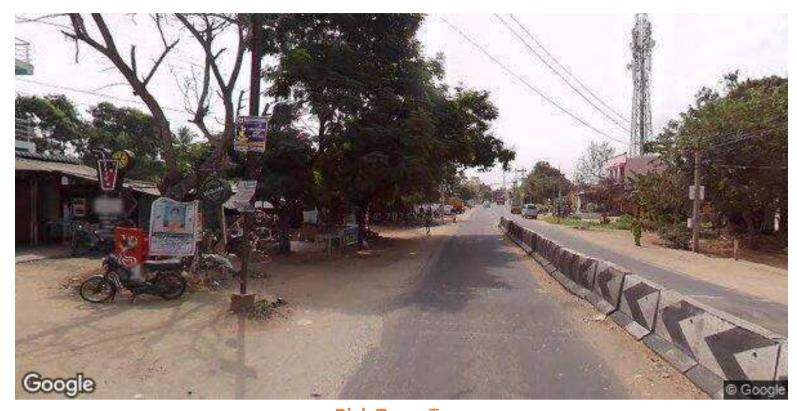
Coordinates: 11.00826, 77.56962

Risk Type: Turn
Risk Level: High
Speed Limit: 15 KM/Hr

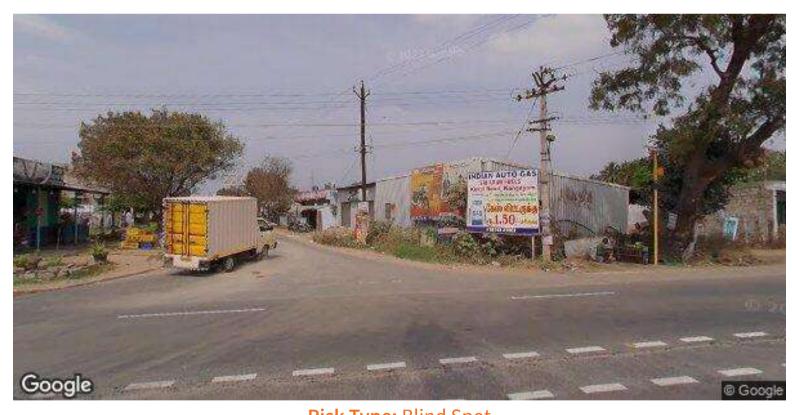
Coordinates: 11.00058, 77.56882

Risk Type: Blind Spot Risk Level: Blind Spot Speed Limit: 10 KM/Hr

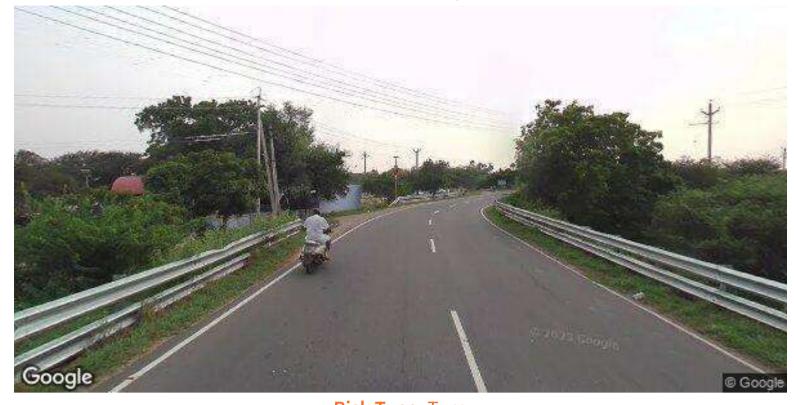
Risk Type: Turn
Risk Level: High
Speed Limit: 15 KM/Hr
Coordinates: 10.94722, 77.54709

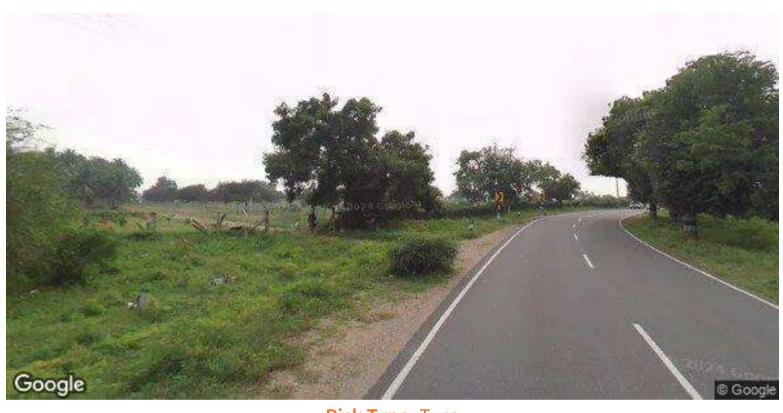
Risk Type: Turn
Risk Level: Medium
Speed Limit: 30 KM/Hr
Coordinates: 10.93895, 77.53976

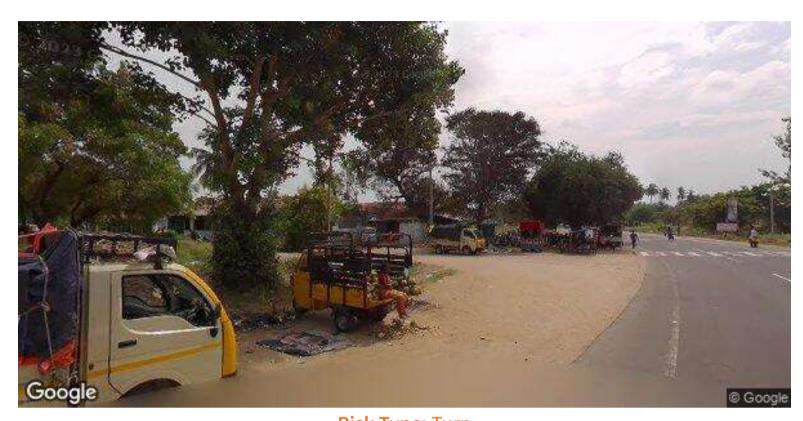
Risk Type: Turn
Risk Level: Medium
Speed Limit: 30 KM/Hr
Coordinates: 10.89213, 77.52646

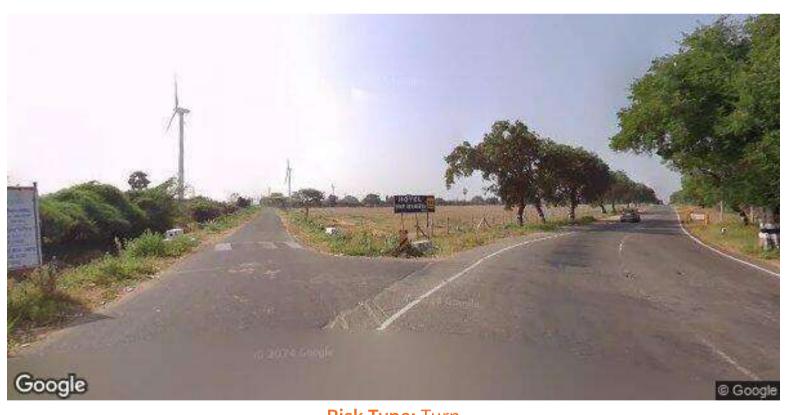
Coordinates: 10.83409, 77.52932

Risk Type: Turn
Risk Level: Medium
Speed Limit: 30 KM/Hr

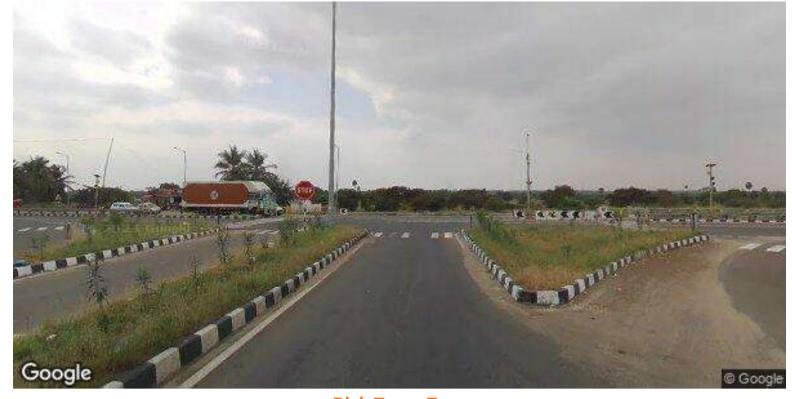
Risk Type: Turn
Risk Level: Medium
Speed Limit: 30 KM/Hr
Coordinates: 10.77642, 77.50712

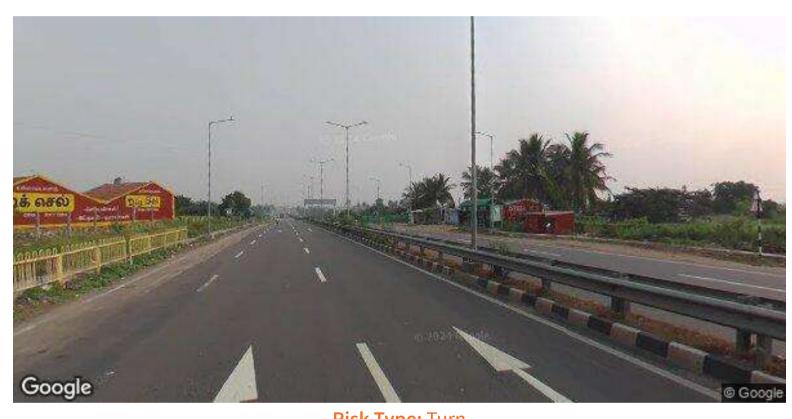
Risk Type: Turn
Risk Level: Medium
Speed Limit: 30 KM/Hr
Coordinates: 10.77580, 77.50724

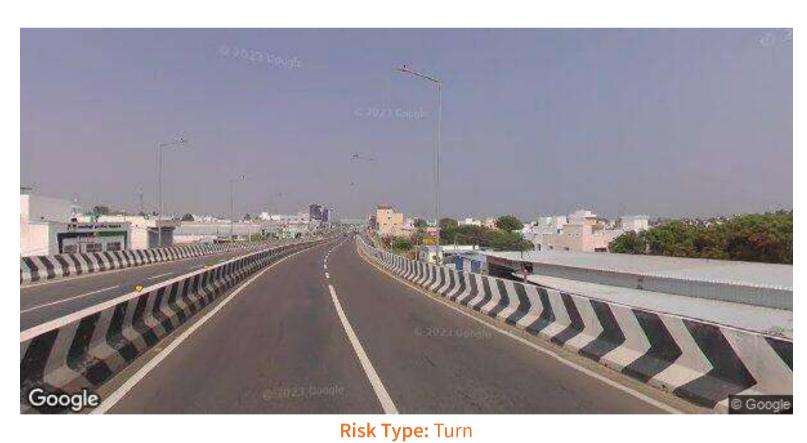
Coordinates: 10.73670, 77.51731

Risk Type. Turn
Risk Level: Medium
Speed Limit: 30 KM/Hr

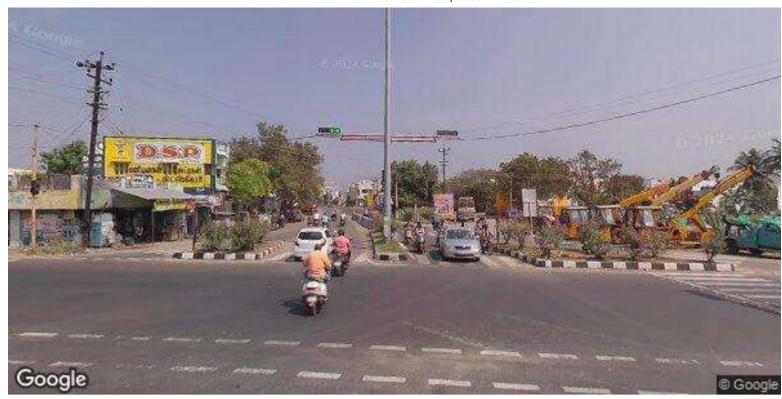
Coordinates: 10.72415, 77.52567

Risk Type: Blind Spot
Risk Level: Blind Spot
Speed Limit: 10 KM/Hr
