JOURNEY RISK MANAGEMENT (JRM) STUDY

Salem Terminal TO VINNAYAGA AGENCY

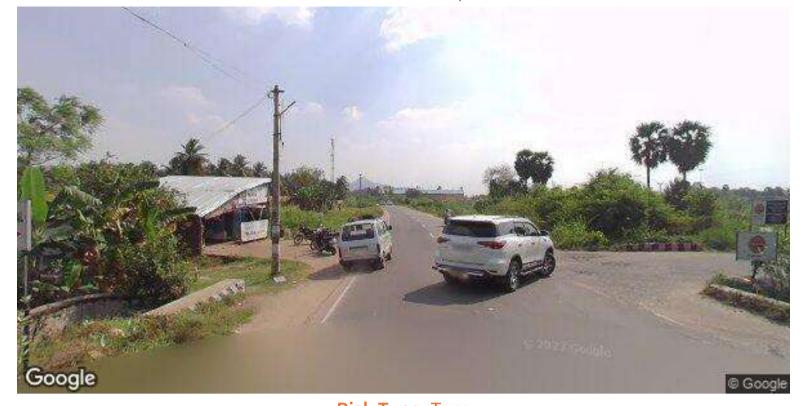
Risk Type: Turn
Risk Level: High
Speed Limit: 15 KM/Hr
Coordinates: 11.44029, 77.87544

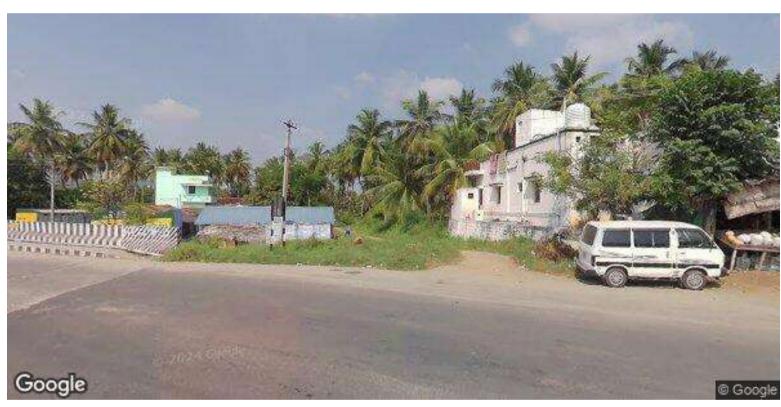
Risk Type: Turn
Risk Level: High
Speed Limit: 15 KM/Hr
Coordinates: 11.44898, 77.87410

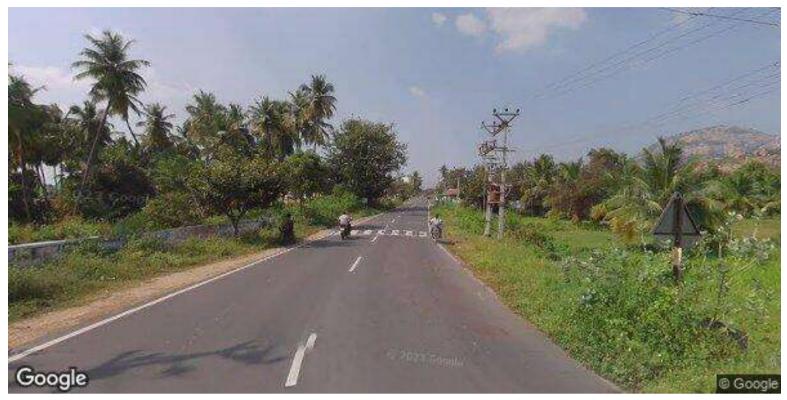
Coordinates: 11.45352, 77.85698

Risk Type: Turn
Risk Level: High
Speed Limit: 15 KM/Hr

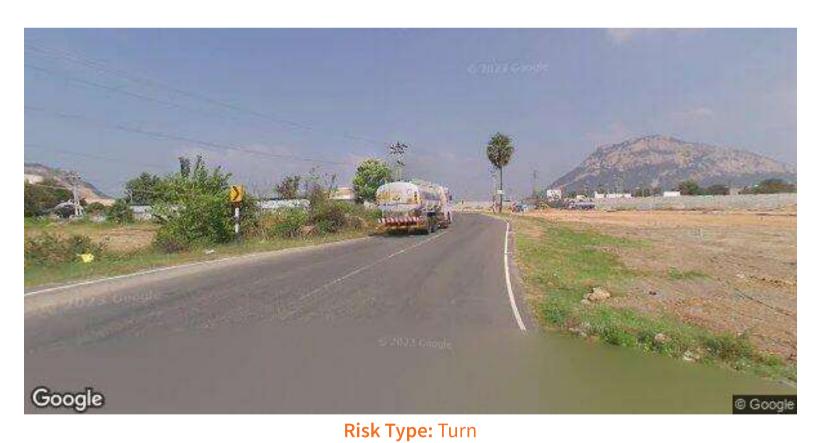
Coordinates: 11.45847, 77.85140

Risk Type: Turn
Risk Level: Medium
Speed Limit: 30 KM/Hr

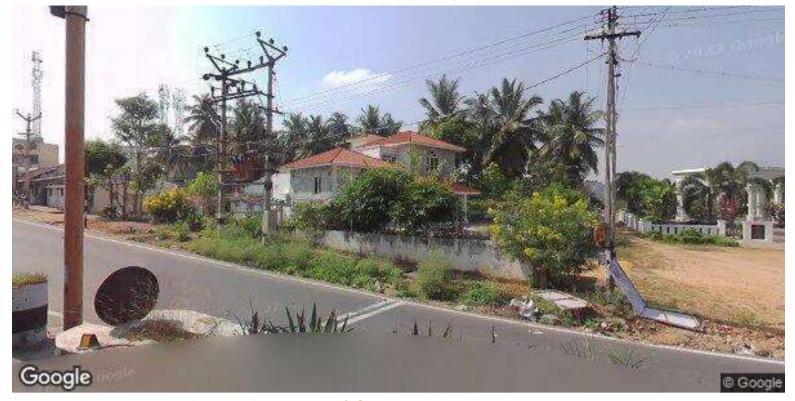
Risk Type: Turn
Risk Level: Medium
Speed Limit: 30 KM/Hr
Coordinates: 11.46303, 77.84945

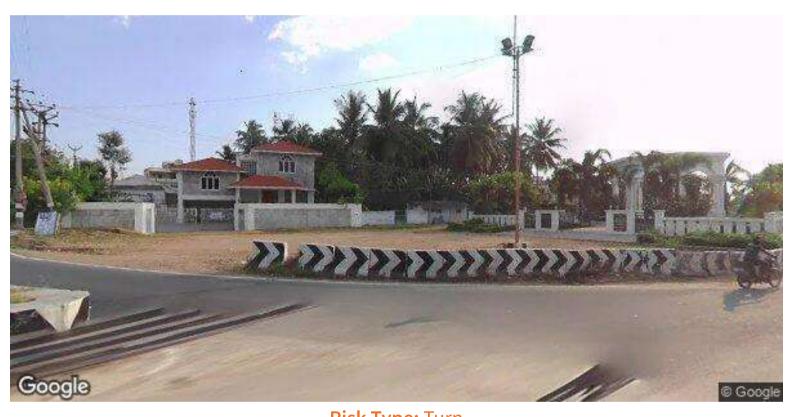
Risk Type: Turn
Risk Level: Medium
Speed Limit: 30 KM/Hr
Coordinates: 11.46314, 77.84928

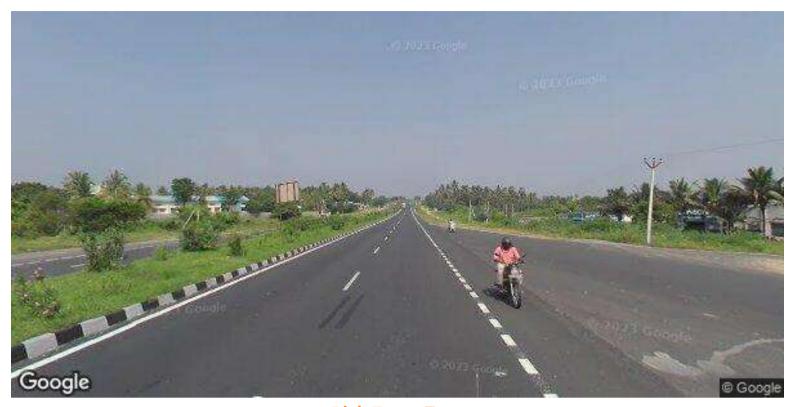
Coordinates: 11.40046, 77.65371

Risk Type: Turn
Risk Level: High
Speed Limit: 15 KM/Hr

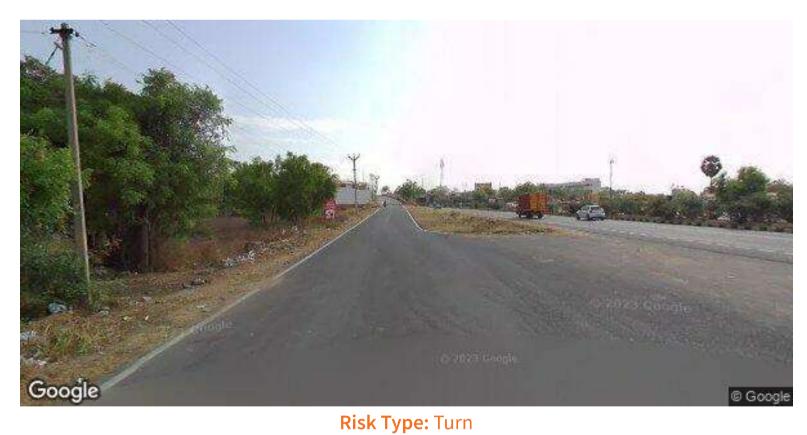
Coordinates: 11.40035, 77.65383

Risk Level: High
Speed Limit: 15 KM/Hr

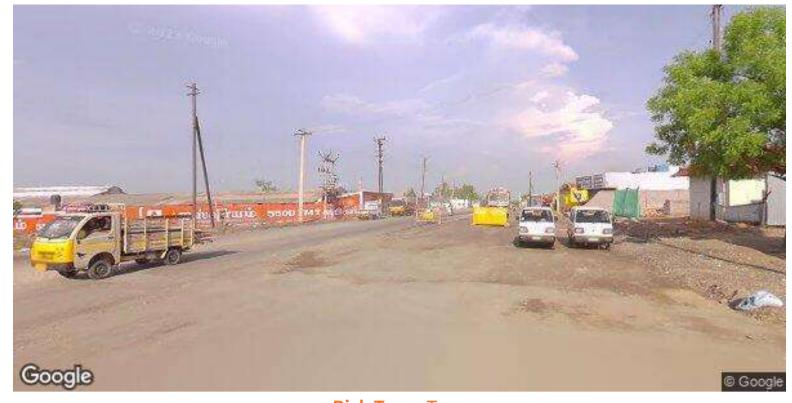
Risk Type: Turn
Risk Level: High
Speed Limit: 15 KM/Hr
Coordinates: 11.39829, 77.65233

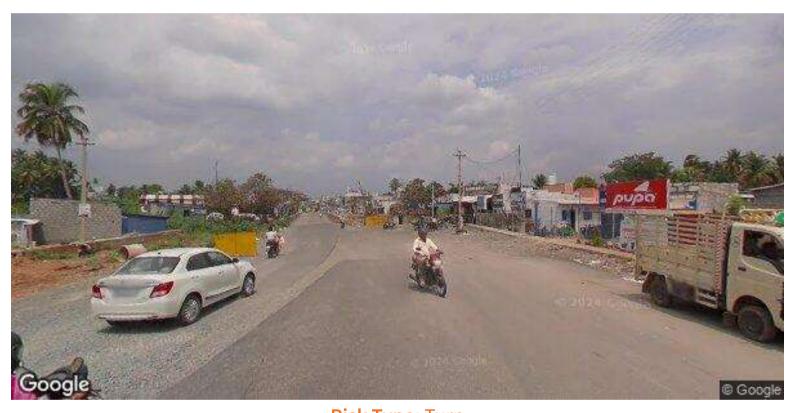
Risk Type: Turn
Risk Level: Medium
Speed Limit: 30 KM/Hr
Coordinates: 11.42079, 77.56127

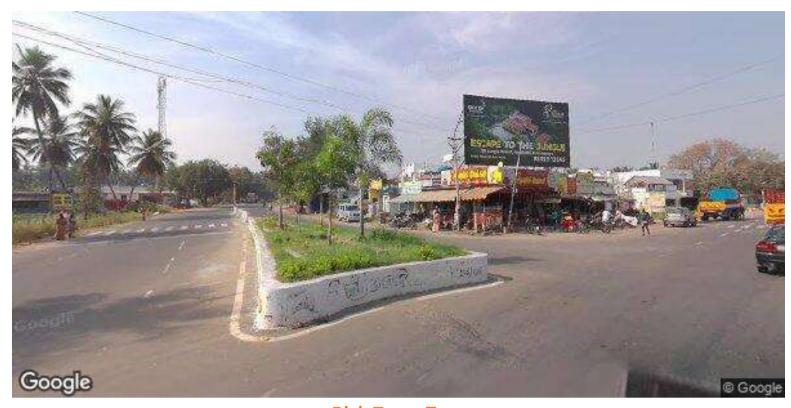
Coordinates: 11.45745, 77.36605

Risk Type: Turn
Risk Level: High
Speed Limit: 15 KM/Hr

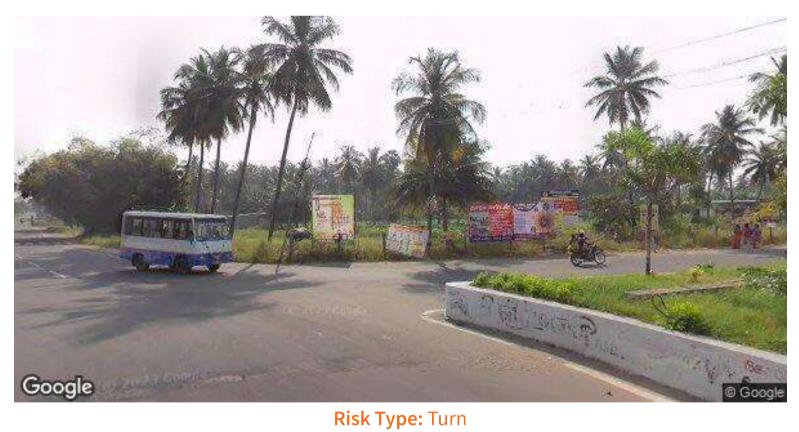
Coordinates: 11.45745, 77.36598

Risk Level: High
Speed Limit: 15 KM/Hr

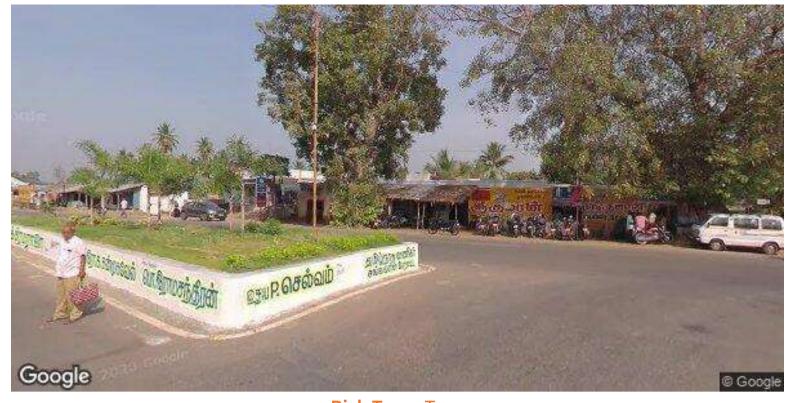
Risk Type: Turn
Risk Level: Medium
Speed Limit: 30 KM/Hr
Coordinates: 11.45747, 77.36596

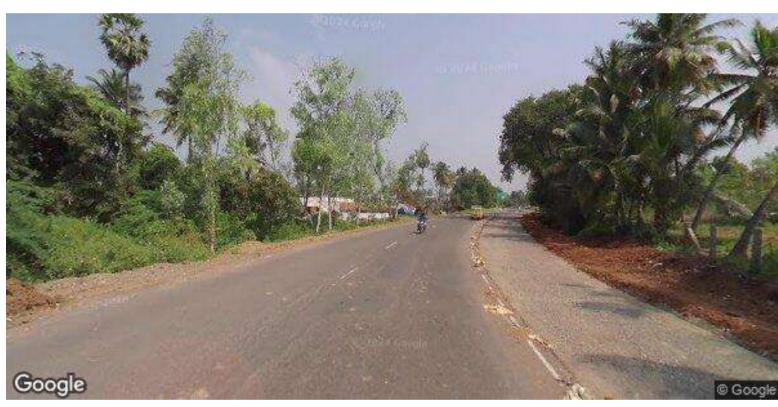
Risk Type: Turn
Risk Level: Medium
Speed Limit: 30 KM/Hr
Coordinates: 11.45763, 77.36309

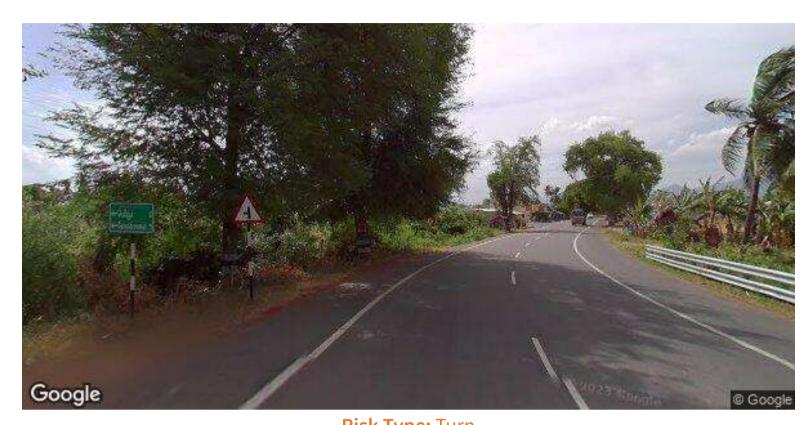
Coordinates: 11.45536, 77.25423

Risk Type: Turn
Risk Level: Medium
Speed Limit: 30 KM/Hr
