# JOURNEY RISK MANAGEMENT (JRM) STUDY

## **IOCL Coimbatore Terminal to TNSTC CTC Palani**

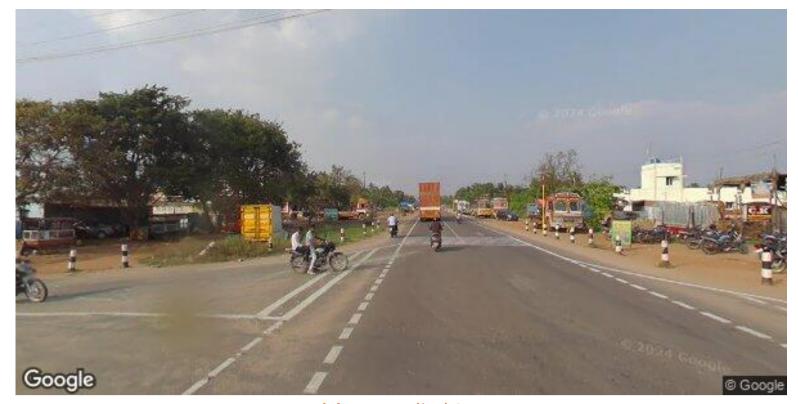
**Coordinates:** 11.03211, 77.07640

Risk Type: Blind Spot Risk Level: Blind Spot Speed Limit: 10 KM/Hr

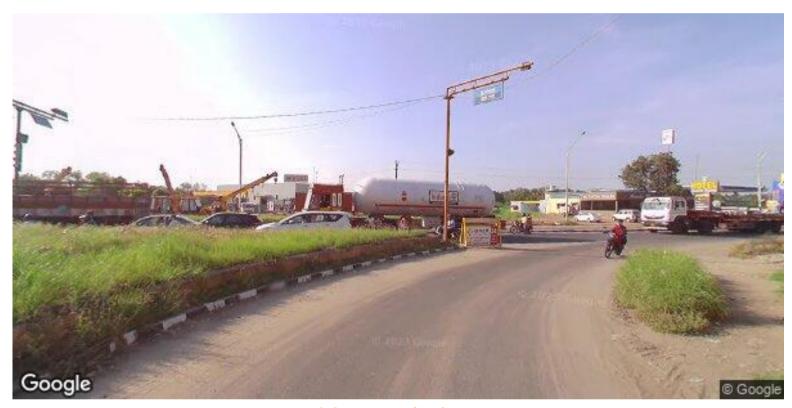
Risk Type: Blind Spot
Risk Level: Blind Spot
Speed Limit: 10 KM/Hr
Coordinates: 11.00778, 77.07085

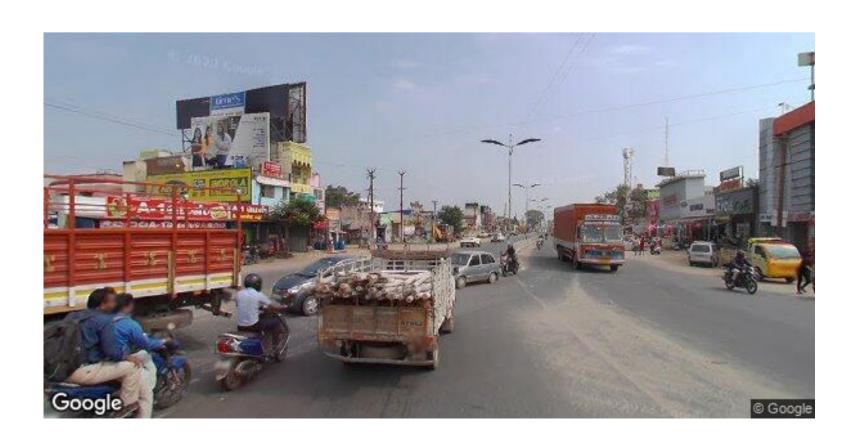
**Coordinates:** 11.02774, 77.12761

Risk Type: Turn
Risk Level: Medium
Speed Limit: 30 KM/Hr

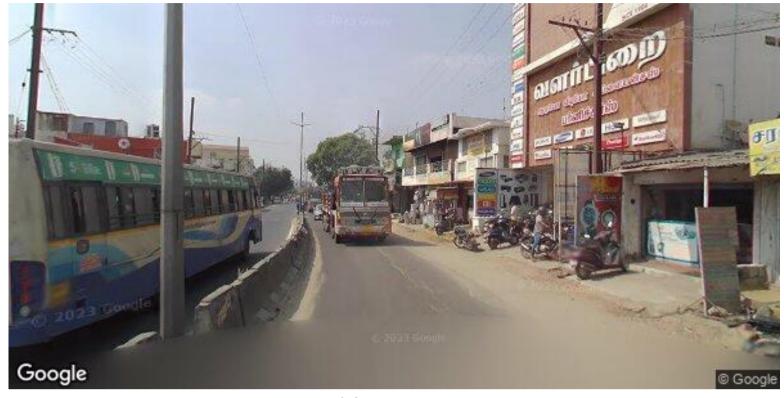
Risk Type: Turn
Risk Level: Medium
Speed Limit: 30 KM/Hr
Coordinates: 10.99570, 77.28153

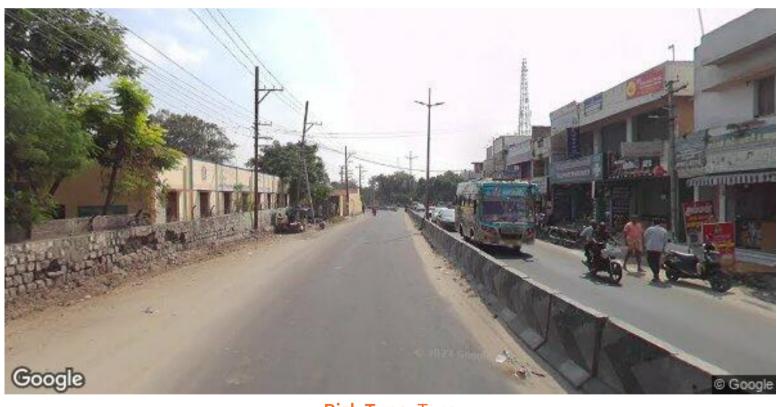
Risk Type: Turn
Risk Level: Medium
Speed Limit: 30 KM/Hr
Coordinates: 10.99535, 77.28179

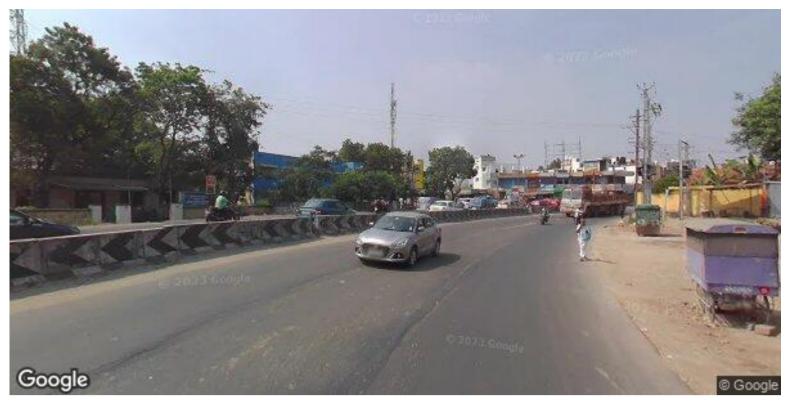
Risk Type: Turn
Risk Level: High
Speed Limit: 15 KM/Hr
Coordinates: 10.99416, 77.28200

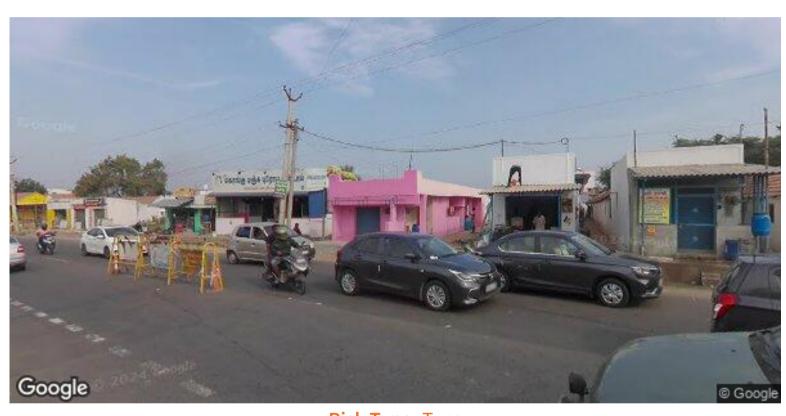
Risk Type: Turn
Risk Level: Medium
Speed Limit: 30 KM/Hr
Coordinates: 10.99304, 77.29585

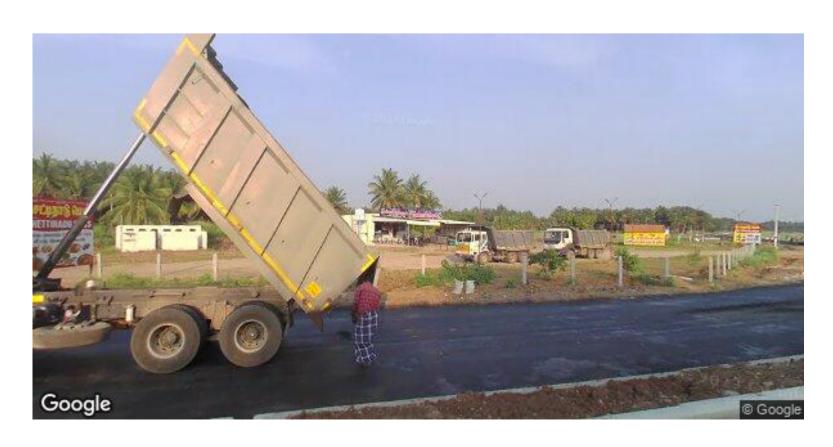
**Coordinates:** 10.88226, 77.36219

Risk Type: Turn
Risk Level: Medium
Speed Limit: 30 KM/Hr

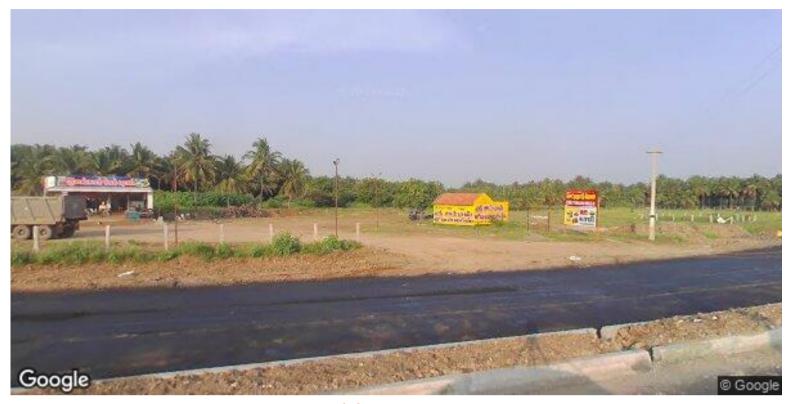
Risk Type: Turn
Risk Level: Medium
Speed Limit: 30 KM/Hr
Coordinates: 10.88198, 77.36259

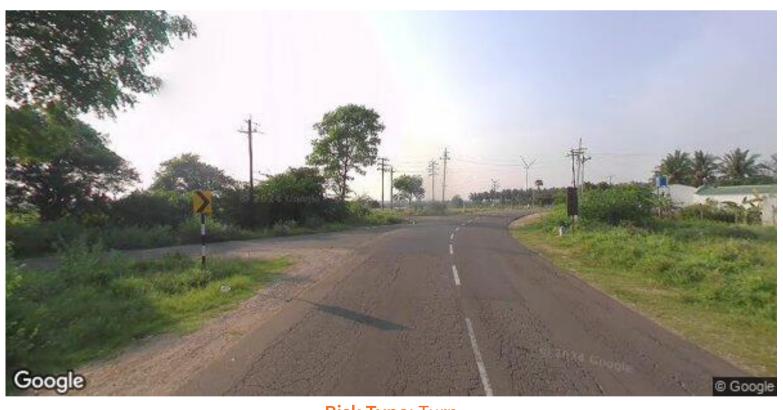
Risk Type: Turn
Risk Level: Medium
Speed Limit: 30 KM/Hr
Coordinates: 10.83247, 77.46080

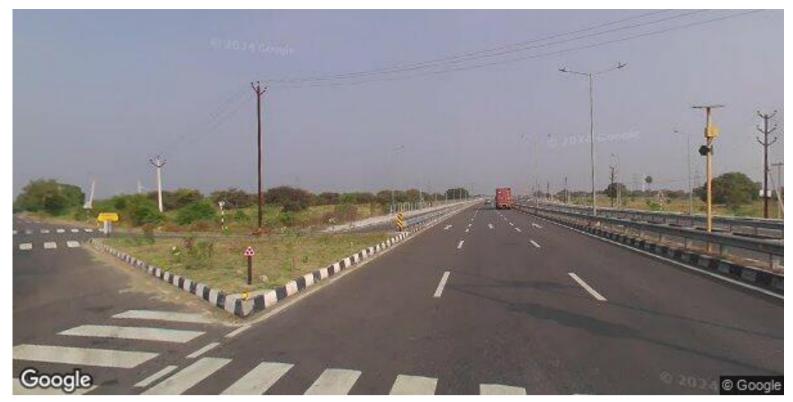
Risk Type: Turn
Risk Level: Medium
Speed Limit: 30 KM/Hr
Coordinates: 10.82855, 77.47237

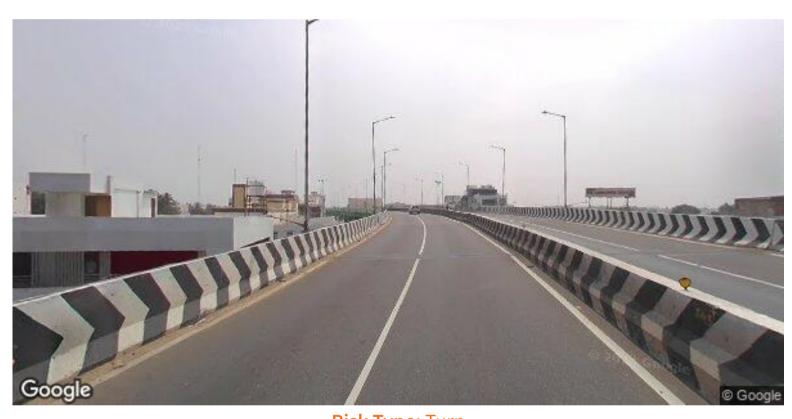
Risk Type: Turn
Risk Level: Medium
Speed Limit: 30 KM/Hr
Coordinates: 10.73654, 77.51731

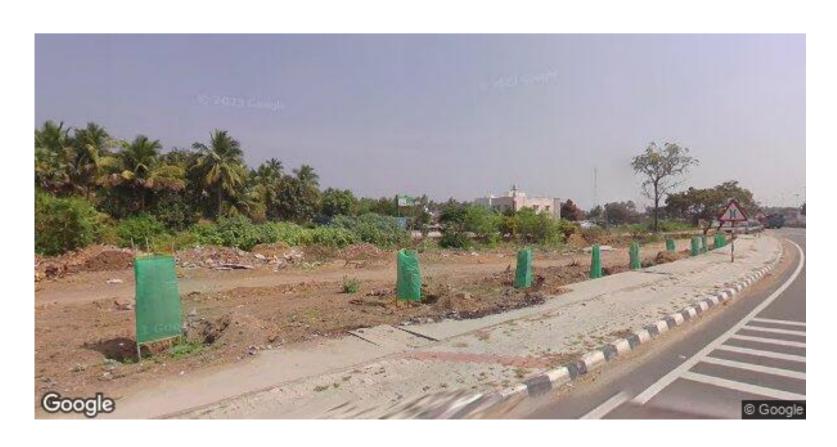
**Coordinates:** 10.71676, 77.53770

Risk Type: Turn
Risk Level: Medium
Speed Limit: 30 KM/Hr

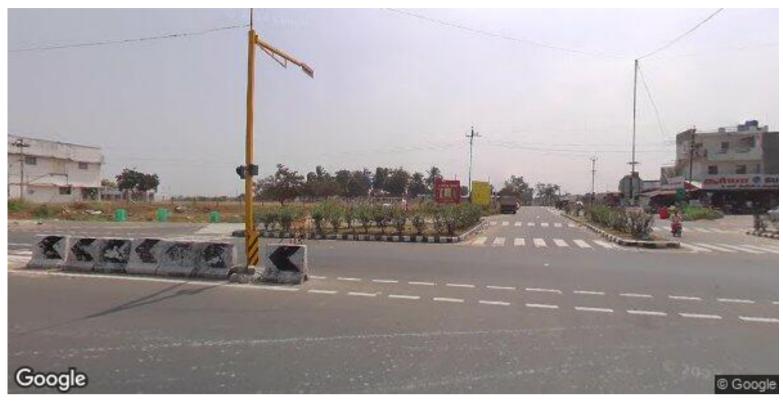
**Coordinates:** 10.71814, 77.54657

Risk Type: Blind Spot Risk Level: Blind Spot Speed Limit: 10 KM/Hr

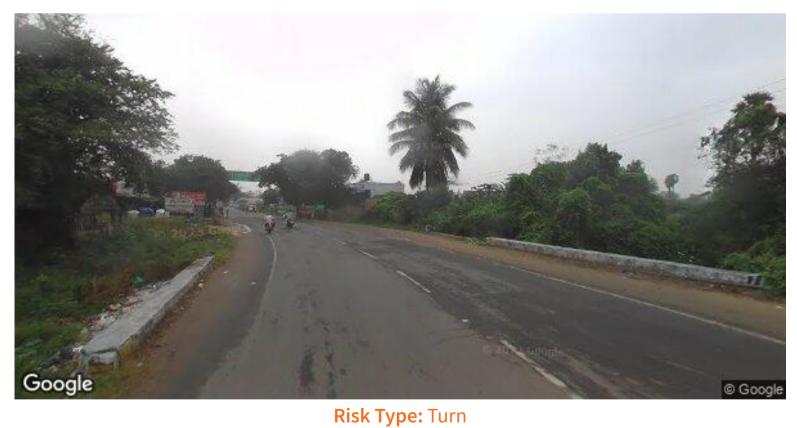
**Coordinates:** 10.49666, 77.53204

Risk Type: Turn
Risk Level: Medium
Speed Limit: 30 KM/Hr

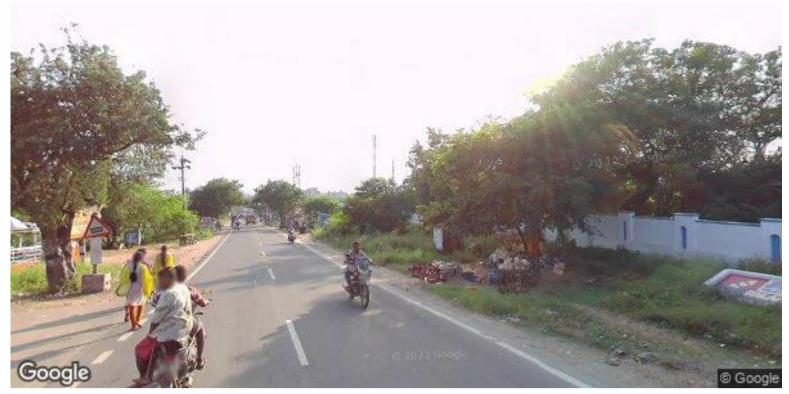
Risk Type: Turn
Risk Level: High
Speed Limit: 15 KM/Hr
Coordinates: 10.46253, 77.51898

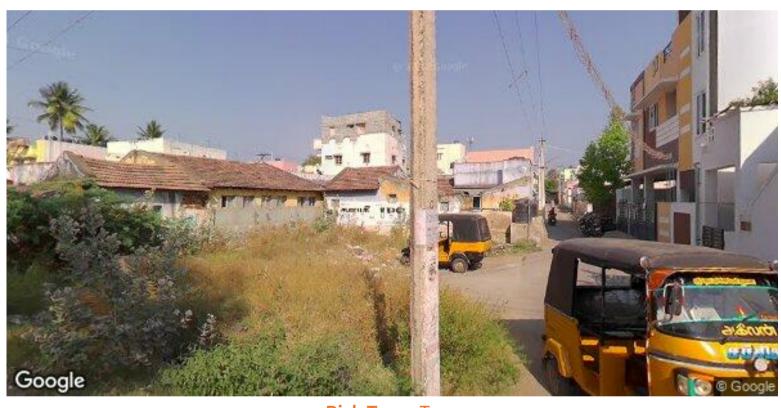
Risk Type: Turn
Risk Level: High
Speed Limit: 15 KM/Hr
Coordinates: 10.45536, 77.52484

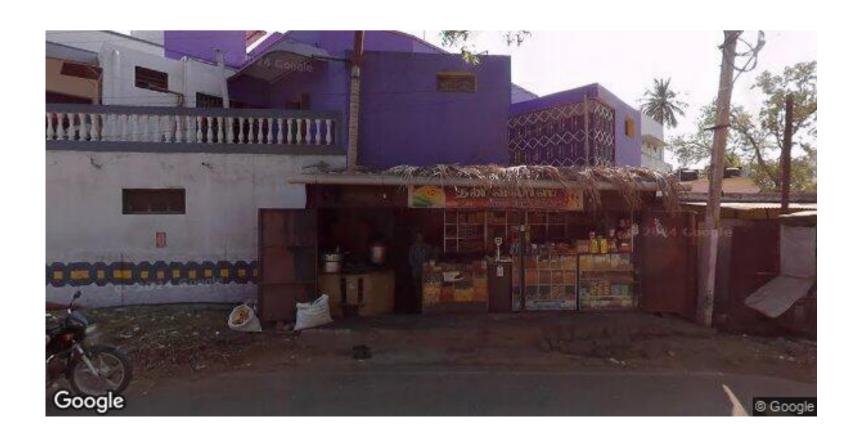
**Coordinates:** 10.45337, 77.52314

Risk Type: Blind Spot Risk Level: Blind Spot Speed Limit: 10 KM/Hr

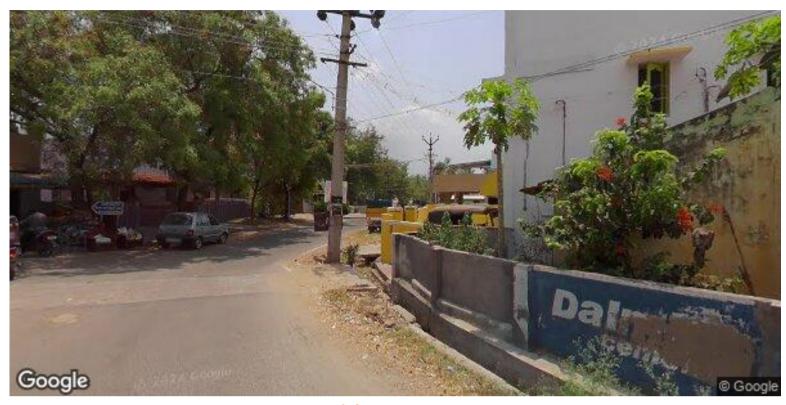
**Coordinates:** 10.45267, 77.52375

Risk Type: Turn
Risk Level: Medium
Speed Limit: 30 KM/Hr

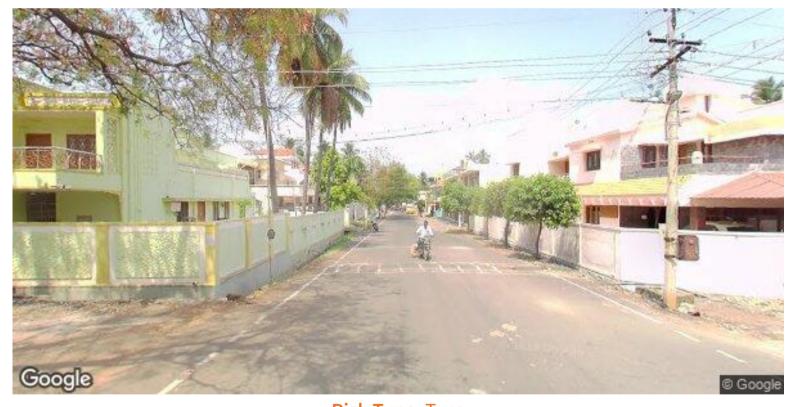
**Coordinates:** 10.45064, 77.52392

Risk Type: Turn
Risk Level: High
Speed Limit: 15 KM/Hr

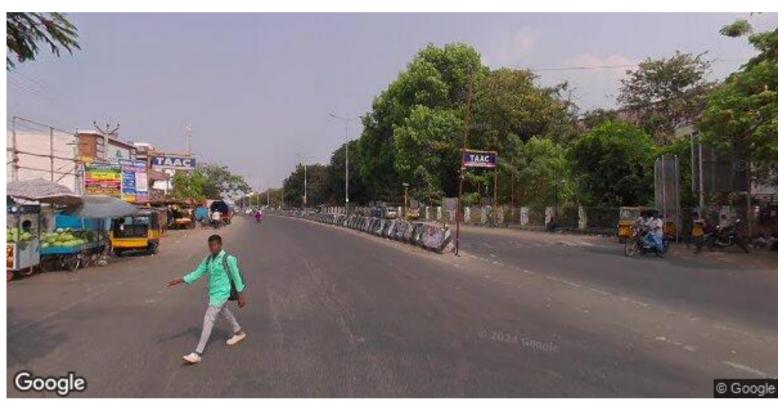
**Coordinates:** 10.44811, 77.52649

Risk Type: Turn
Risk Level: High
Speed Limit: 15 KM/Hr
