JOURNEY RISK MANAGEMENT (JRM) STUDY

Salem Terminal to SRI THANGAMMAN TRADERS

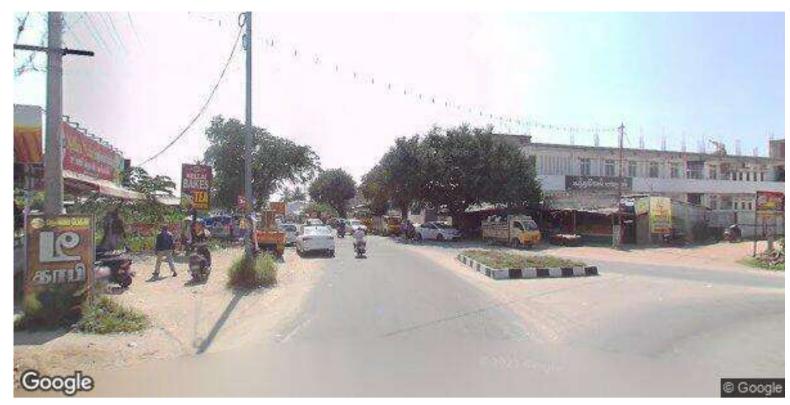
Coordinates: 11.17250, 77.26863

Risk Type: Roundabout
Risk Level: High
Speed Limit: 15 KM/Hr

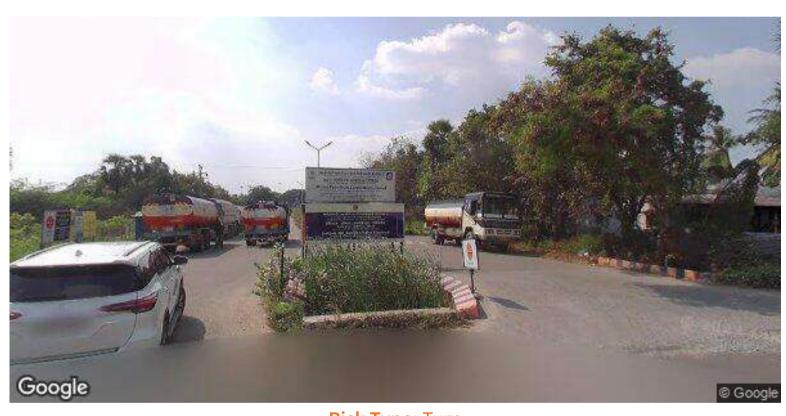
Coordinates: 11.44024, 77.87528

Risk Type: Turn
Risk Level: High
Speed Limit: 15 KM/Hr

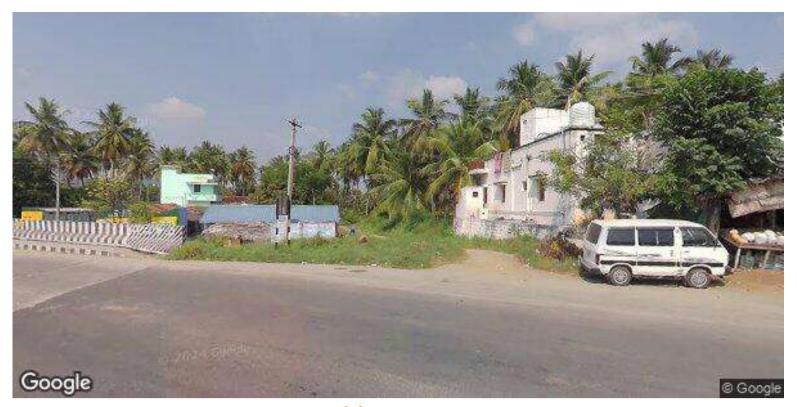
Risk Type: Turn
Risk Level: High
Speed Limit: 15 KM/Hr
Coordinates: 11.44898, 77.87410

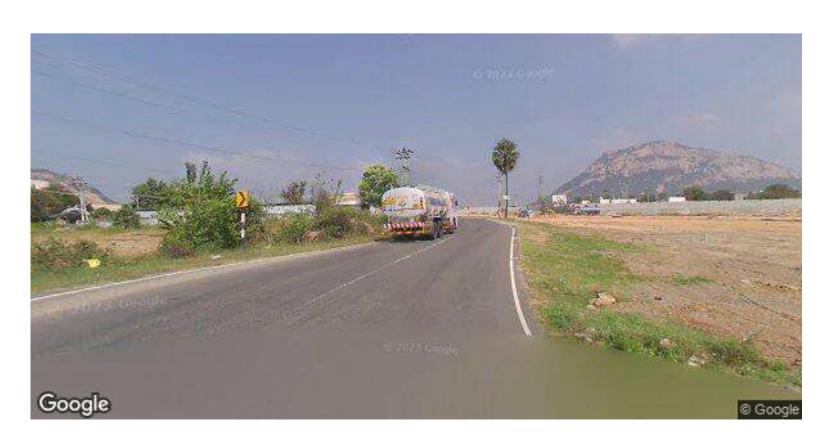
Coordinates: 11.45847, 77.85140

Risk Type: Turn
Risk Level: Medium
Speed Limit: 30 KM/Hr

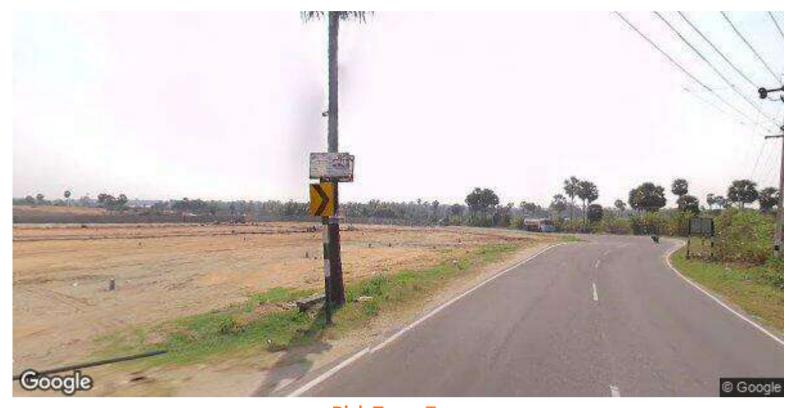
Coordinates: 11.45898, 77.85135

Risk Type: Turn
Risk Level: Medium
Speed Limit: 30 KM/Hr

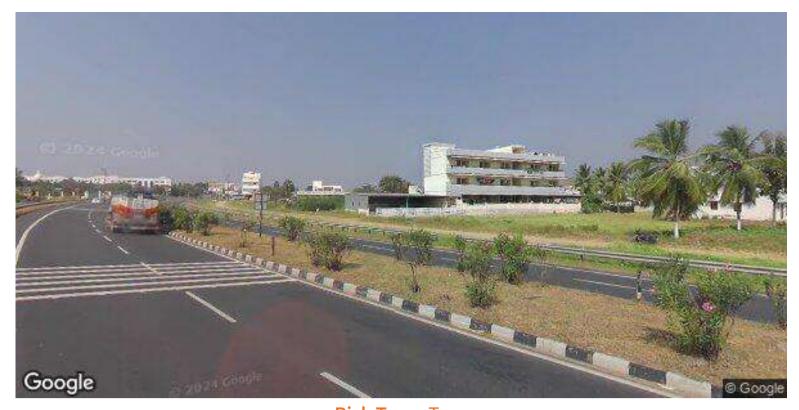
Risk Type: Turn
Risk Level: Medium
Speed Limit: 30 KM/Hr
Coordinates: 11.44965, 77.77565

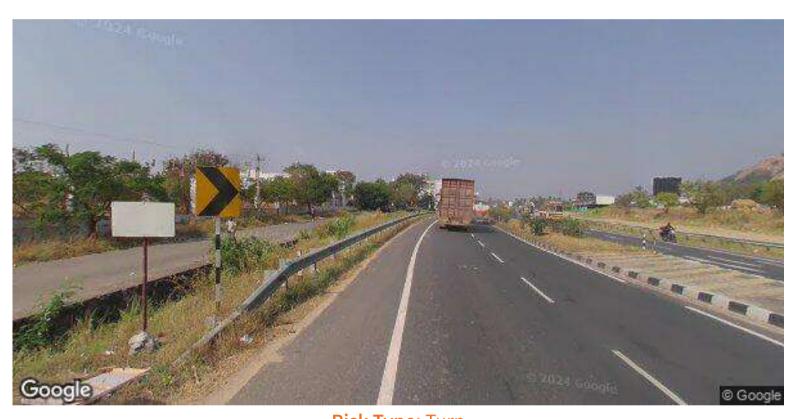
Risk Type: Turn
Risk Level: Medium
Speed Limit: 30 KM/Hr
Coordinates: 11.44953, 77.77344

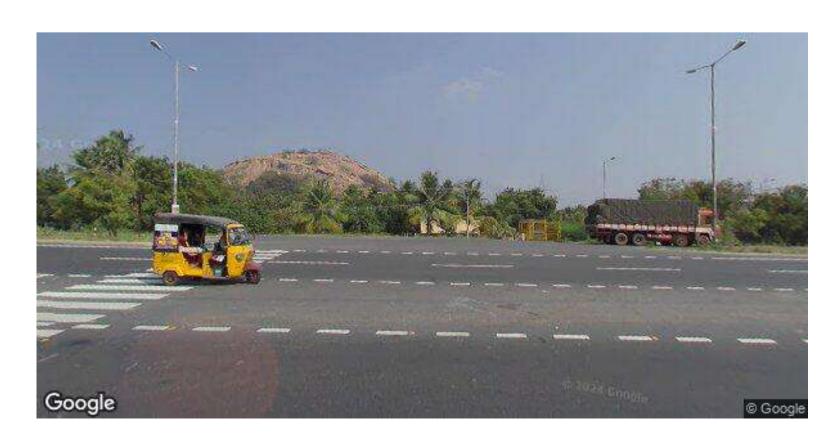
Coordinates: 11.45085, 77.77020

Risk Type: Turn
Risk Level: Medium
Speed Limit: 30 KM/Hr

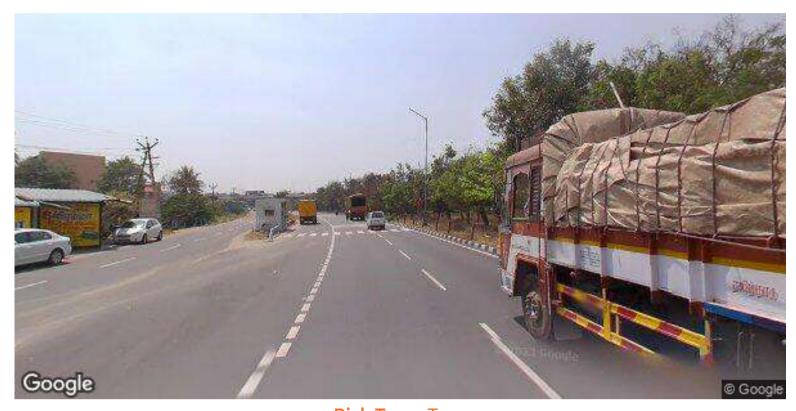
Coordinates: 11.43165, 77.67734

Risk Type: Turn
Risk Level: Medium
Speed Limit: 30 KM/Hr

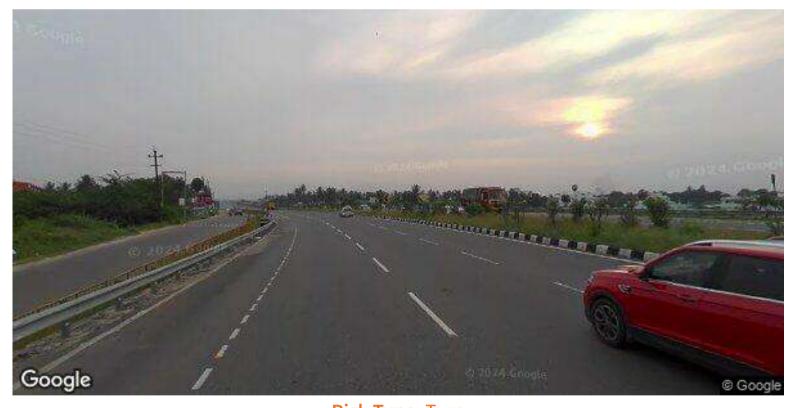
Coordinates: 11.18808, 77.28672

Risk Type: Turn
Risk Level: Medium
Speed Limit: 30 KM/Hr

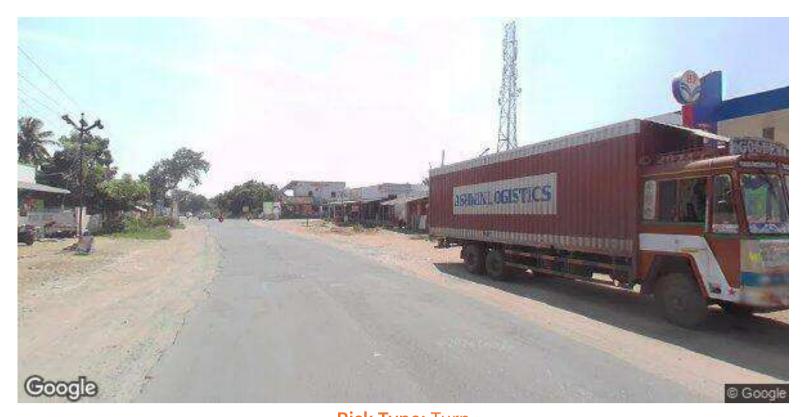
Risk Type: Turn
Risk Level: Medium
Speed Limit: 30 KM/Hr
Coordinates: 11.16848, 77.26757

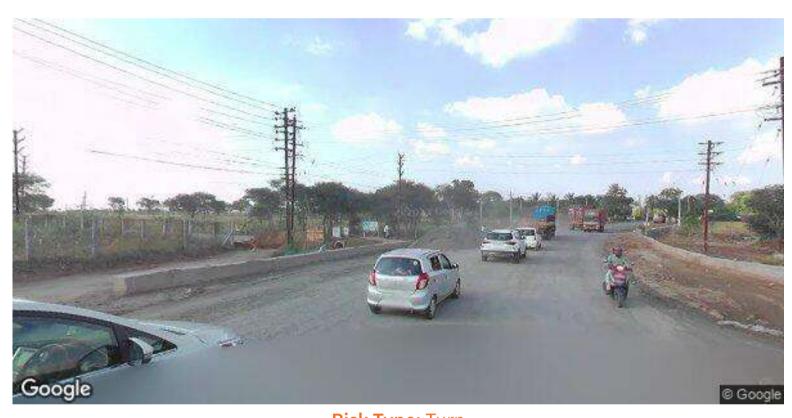
Risk Type: Turn
Risk Level: Medium
Speed Limit: 30 KM/Hr
Coordinates: 11.14580, 77.26363

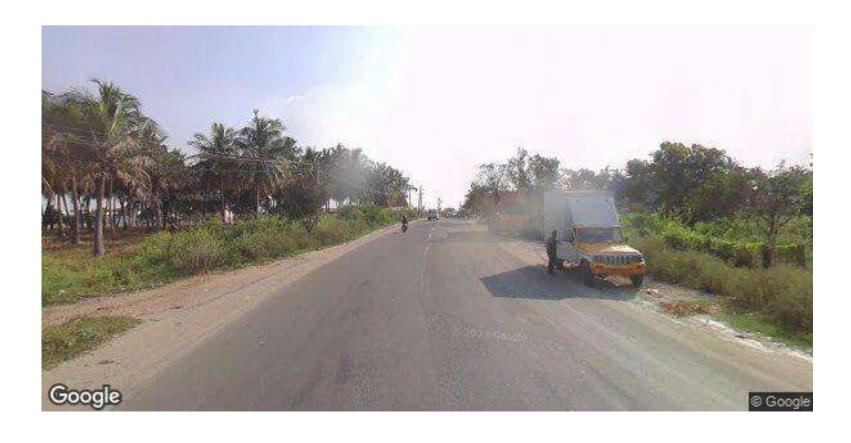
Coordinates: 11.10890, 77.27134

Risk Type: Turn
Risk Level: Medium
Speed Limit: 30 KM/Hr

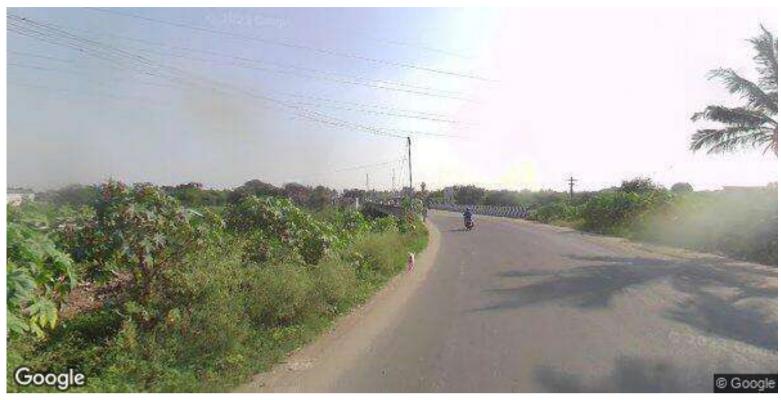
Coordinates: 11.10680, 77.27043

Risk Type: Turn
Risk Level: Medium
Speed Limit: 30 KM/Hr

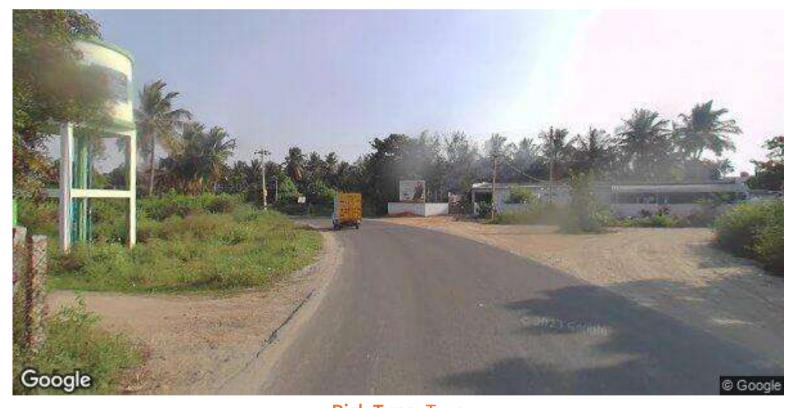
Coordinates: 11.06989, 77.26801

Risk Type: Turn
Risk Level: Medium
Speed Limit: 30 KM/Hr

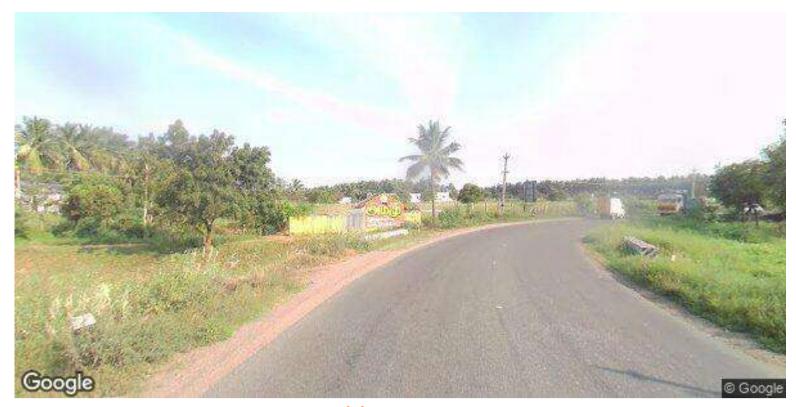
Risk Type: Turn
Risk Level: Medium
Speed Limit: 30 KM/Hr
Coordinates: 11.06826, 77.27076

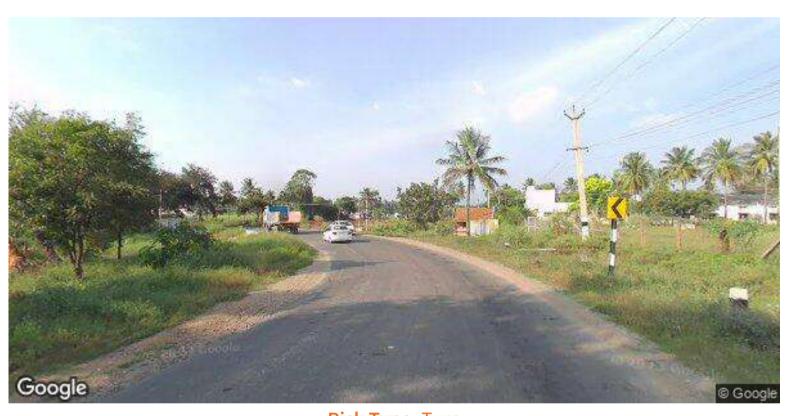
Risk Type: Turn
Risk Level: Medium
Speed Limit: 30 KM/Hr
Coordinates: 11.06781, 77.27098
