JOURNEY RISK MANAGEMENT (JRM) STUDY

Salem Terminal TO KAVIN AGENCIES

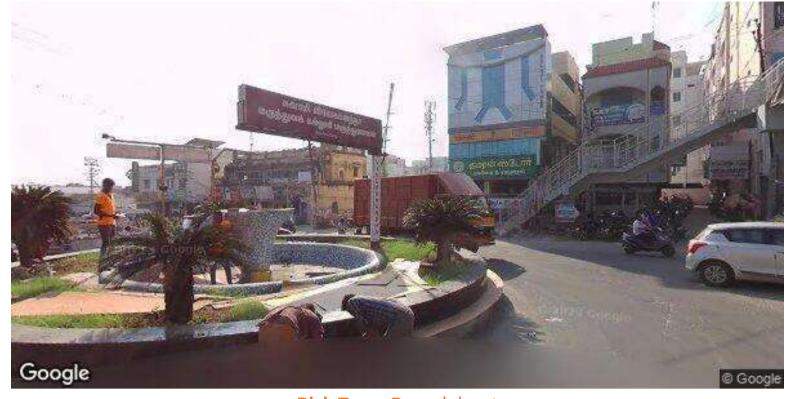
Risk Type: Roundabout
Risk Level: High
Speed Limit: 15 KM/Hr
Coordinates: 11.38395, 77.89480

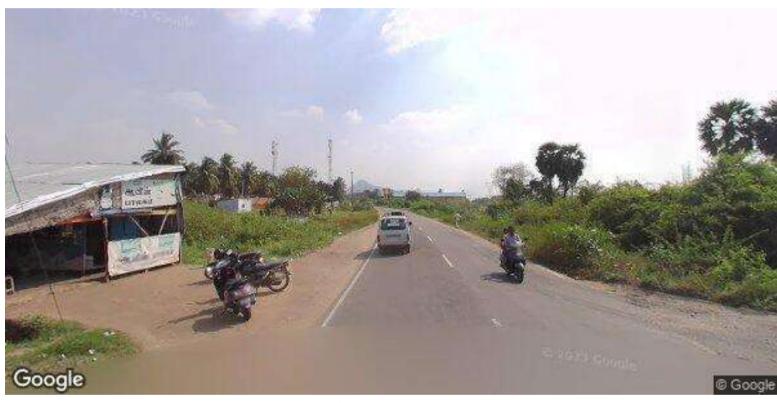
Risk Type: Turn
Risk Level: High
Speed Limit: 15 KM/Hr
Coordinates: 11.44022, 77.87546

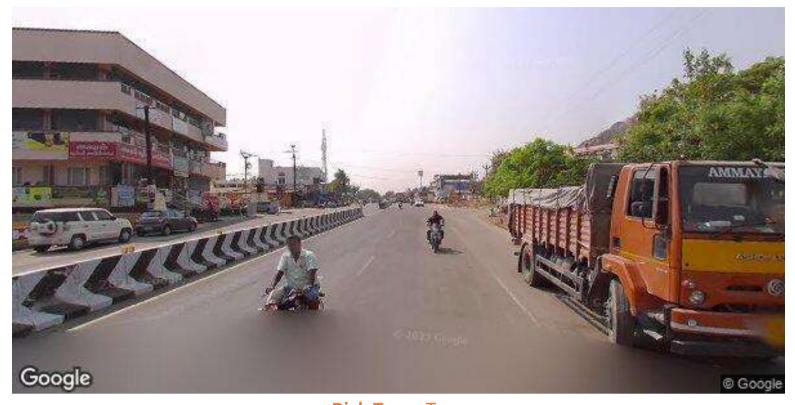
Risk Type: Turn
Risk Level: Medium
Speed Limit: 30 KM/Hr
Coordinates: 11.39690, 77.88852

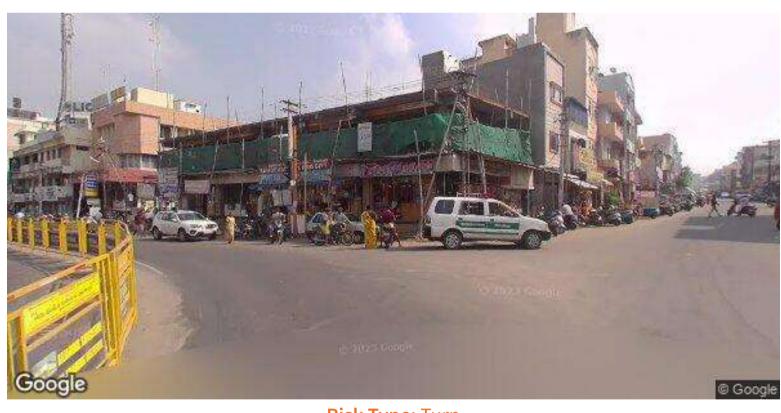
Coordinates: 11.37868, 77.89498

Risk Type: Turn
Risk Level: High
Speed Limit: 15 KM/Hr

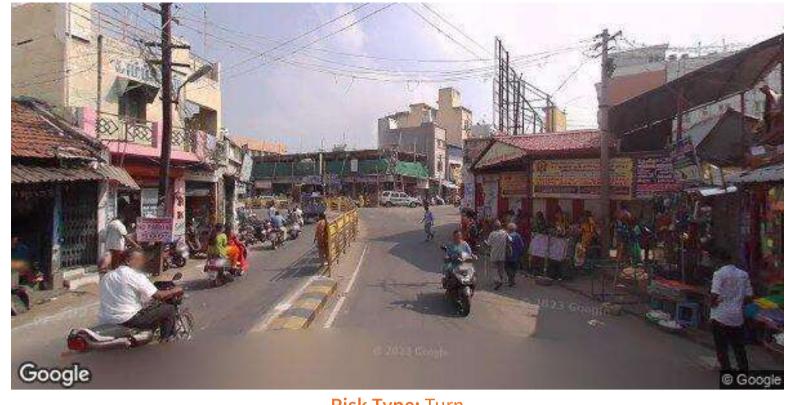
Risk Type: Turn
Risk Level: Medium
Speed Limit: 30 KM/Hr
Coordinates: 11.37857, 77.89473

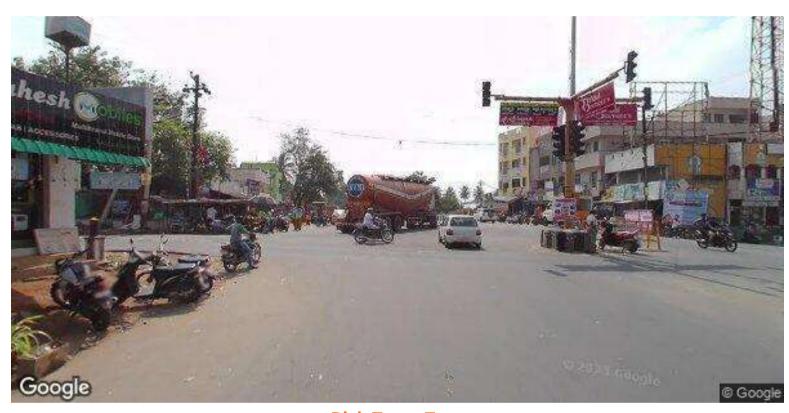
Risk Type: Turn
Risk Level: High
Speed Limit: 15 KM/Hr
Coordinates: 11.36616, 77.88885

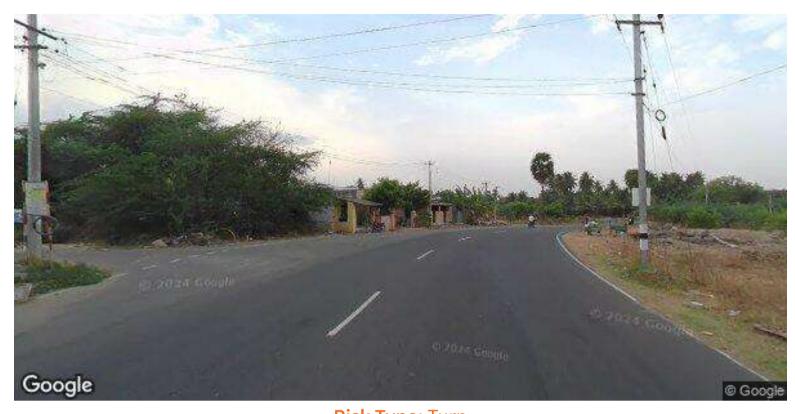
Risk Type: Turn
Risk Level: Medium
Speed Limit: 30 KM/Hr
Coordinates: 11.33854, 77.86216

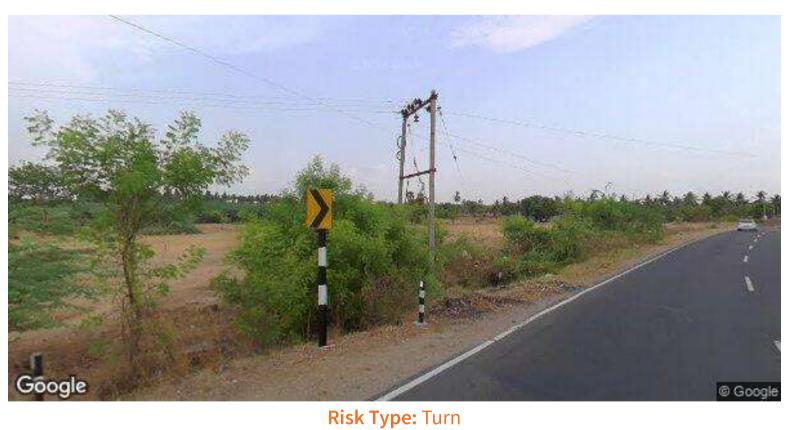
Coordinates: 11.33778, 77.86236

Risk Type: Turn
Risk Level: Medium
Speed Limit: 30 KM/Hr

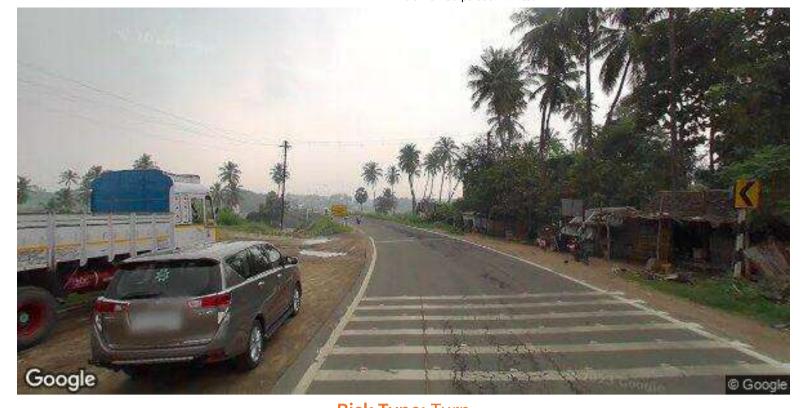
Risk Type: Turn
Risk Level: Medium
Speed Limit: 30 KM/Hr
Coordinates: 11.30952, 77.77587

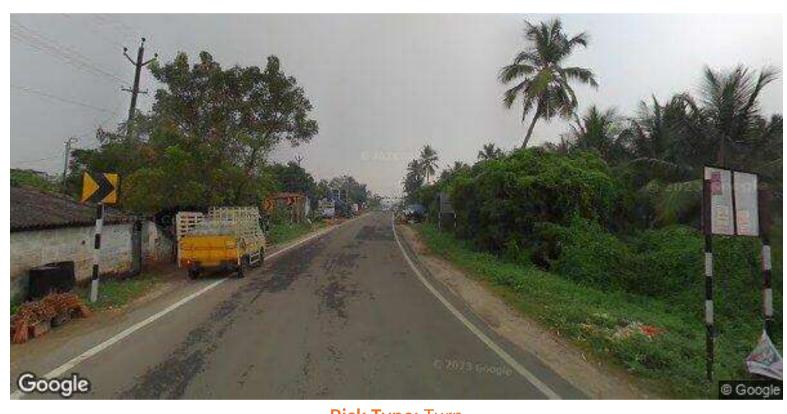
Risk Type: Turn
Risk Level: Medium
Speed Limit: 30 KM/Hr
Coordinates: 11.30973, 77.76712

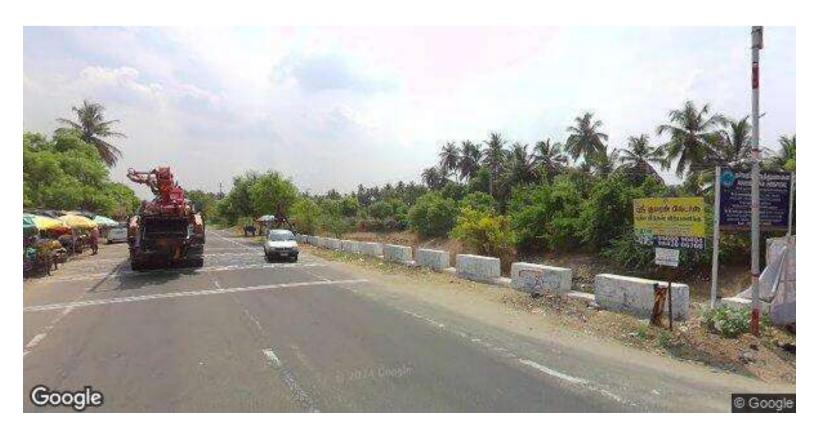
Coordinates: 11.29490, 77.74685

Risk Type: Turn
Risk Level: High
Speed Limit: 15 KM/Hr

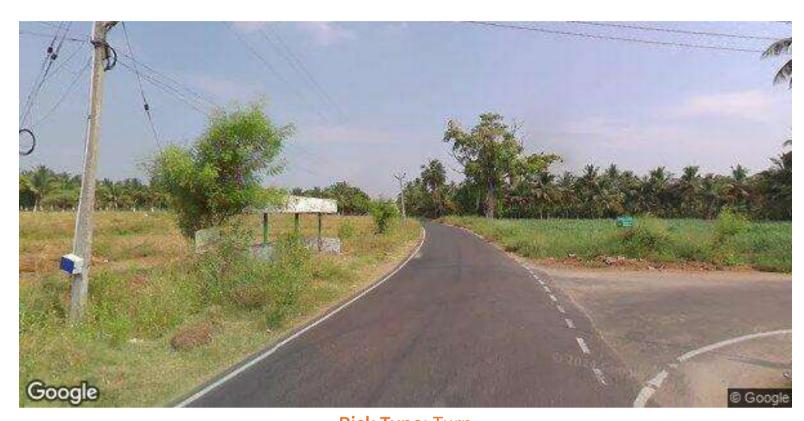
Risk Type: Turn
Risk Level: High
Speed Limit: 15 KM/Hr
Coordinates: 11.29141, 77.74662

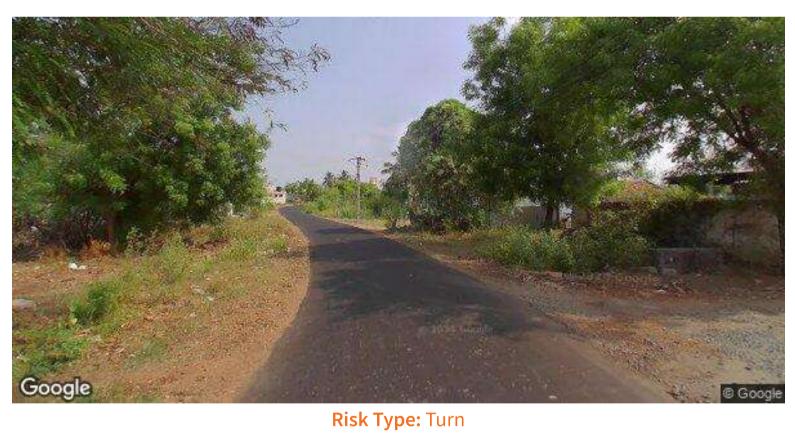
Risk Level: Medium
Speed Limit: 30 KM/Hr
Coordinates: 11.28844, 77.74319

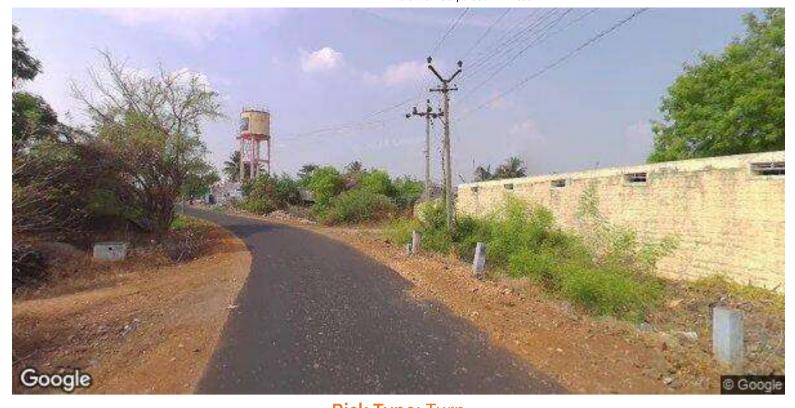
Risk Type: Turn
Risk Level: Medium
Speed Limit: 30 KM/Hr
Coordinates: 11.28573, 77.74281

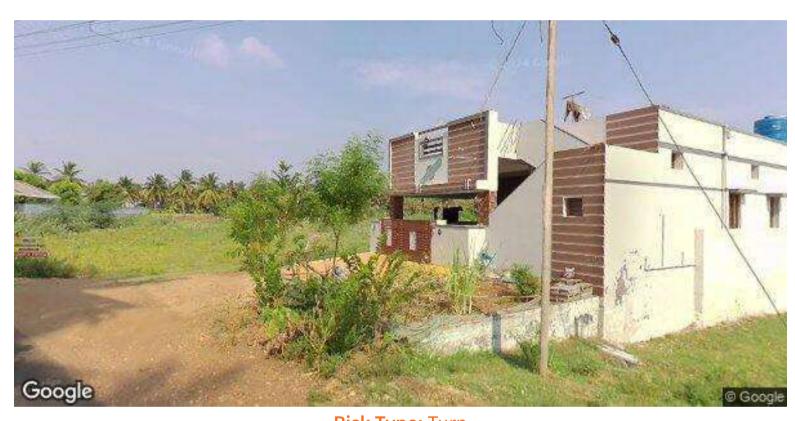
Risk Type: Turn
Risk Level: High
Speed Limit: 15 KM/Hr
Coordinates: 11.27319, 77.72981

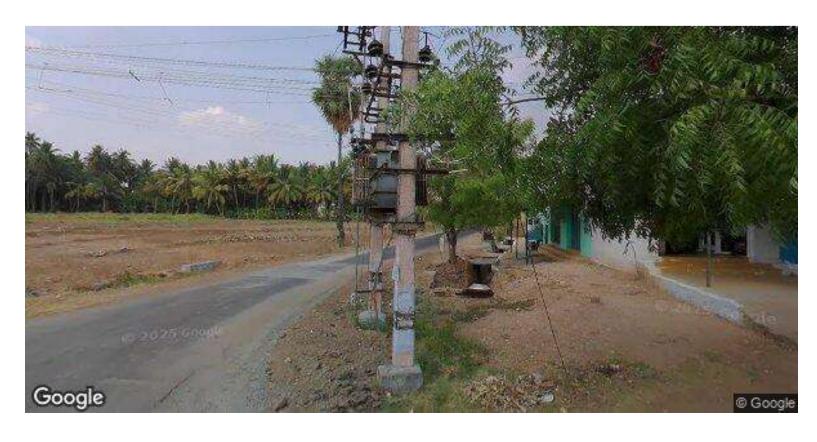
Coordinates: 11.27330, 77.72715

Risk Type: Blind Spot Risk Level: Blind Spot Speed Limit: 10 KM/Hr

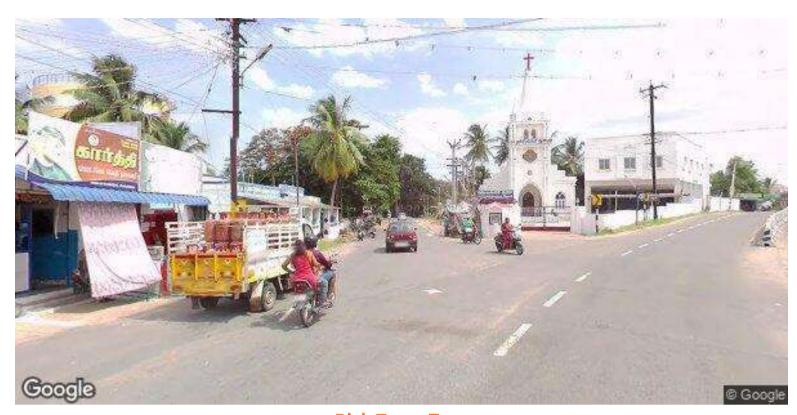
Risk Type: Turn
Risk Level: Medium
Speed Limit: 30 KM/Hr
Coordinates: 11.23054, 77.71796

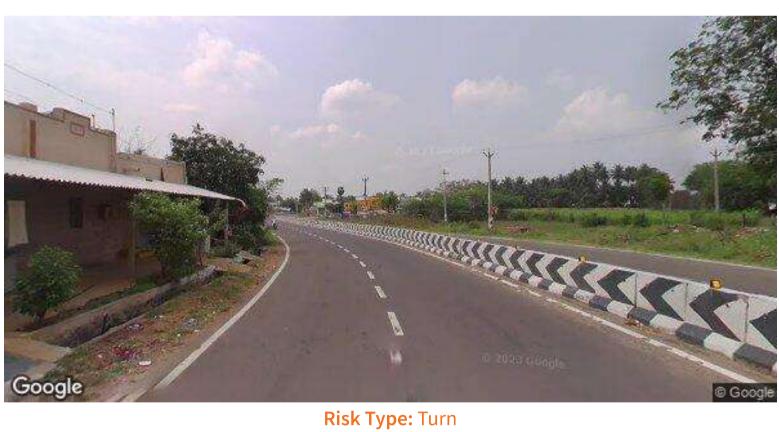
Coordinates: 11.22387, 77.71385

Risk Type: Turn
Risk Level: Medium
Speed Limit: 30 KM/Hr

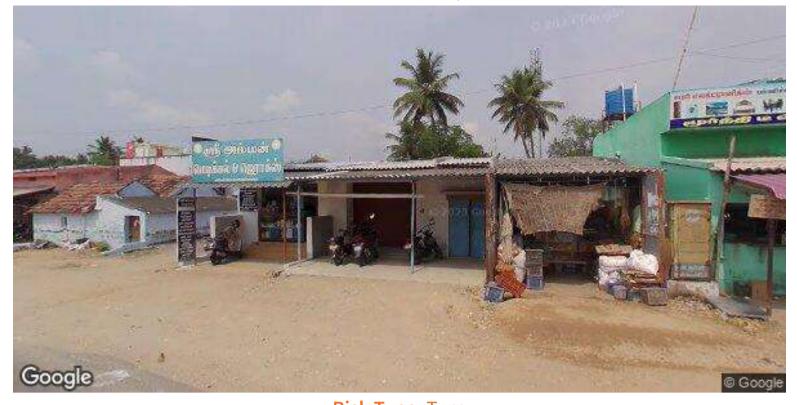
Risk Type: Turn
Risk Level: Medium
Speed Limit: 30 KM/Hr
Coordinates: 11.20776, 77.70916

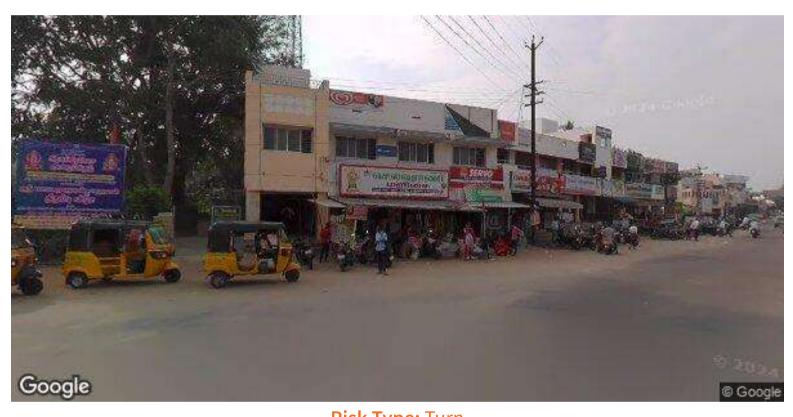
Risk Type: Turn
Risk Level: Medium
Speed Limit: 30 KM/Hr
Coordinates: 11.15942, 77.70068

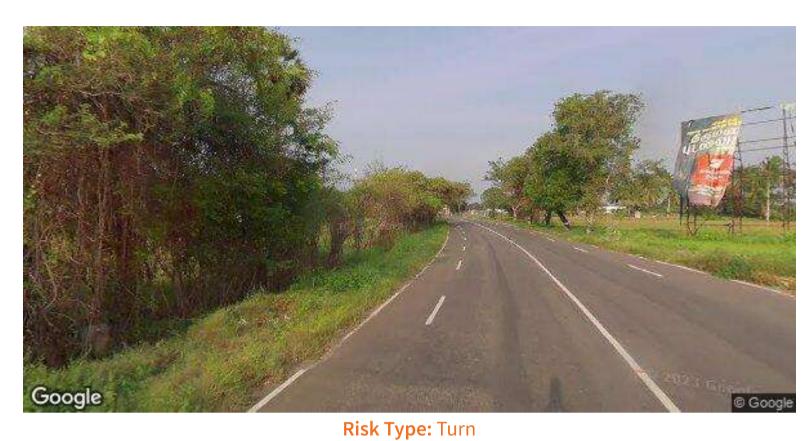
Risk Level: Medium
Speed Limit: 30 KM/Hr
Coordinates: 11.11932, 77.67786

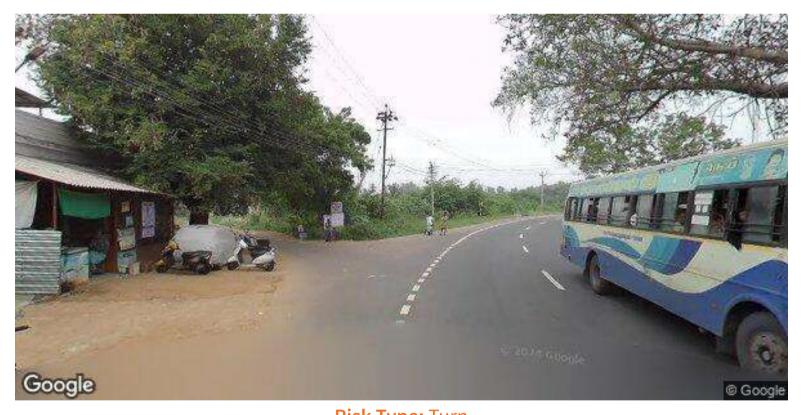
Coordinates: 11.11710, 77.67175

Risk Type: Turn
Risk Level: Medium
Speed Limit: 30 KM/Hr

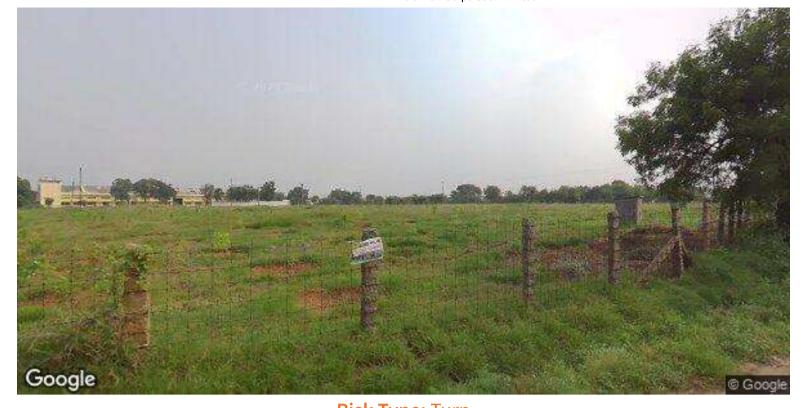
Risk Type: Turn
Risk Level: Medium
Speed Limit: 30 KM/Hr
Coordinates: 11.09491, 77.66603

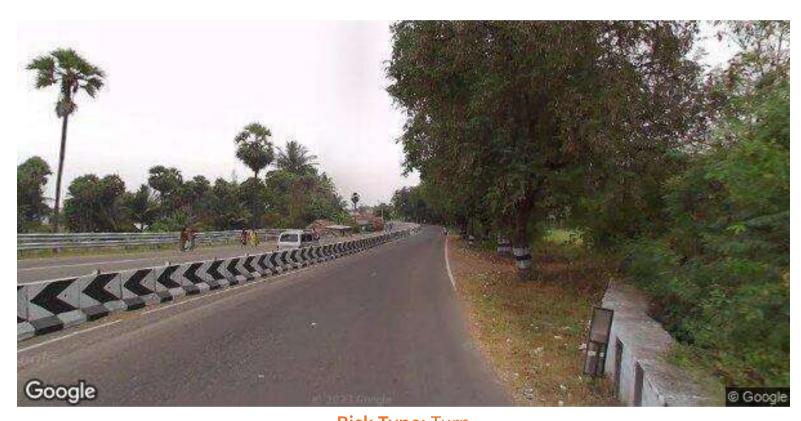
Risk Type: Turn
Risk Level: Medium
Speed Limit: 30 KM/Hr
Coordinates: 11.08296, 77.65857

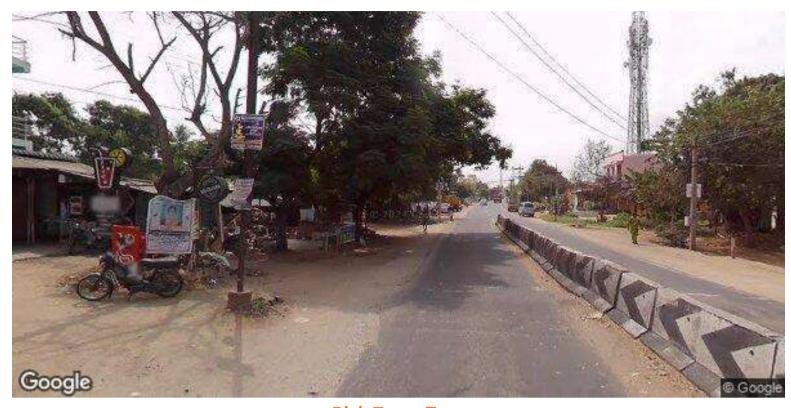
Coordinates: 11.00826, 77.56962

Risk Type: Turn
Risk Level: High
Speed Limit: 15 KM/Hr

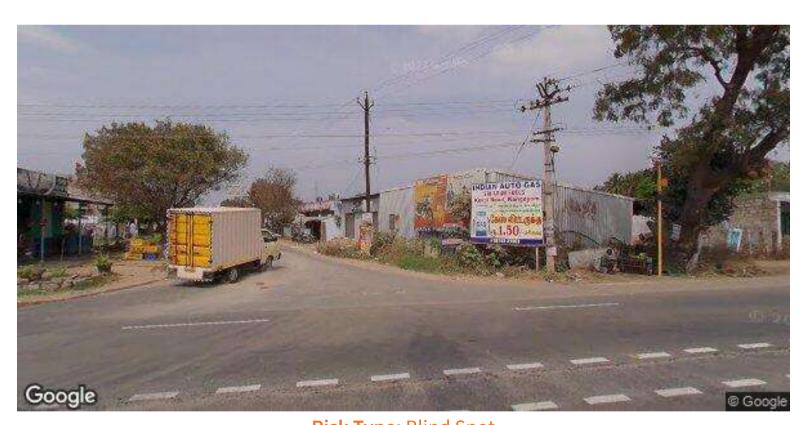
Coordinates: 11.00058, 77.56882

Risk Type: Blind Spot
Risk Level: Blind Spot
Speed Limit: 10 KM/Hr

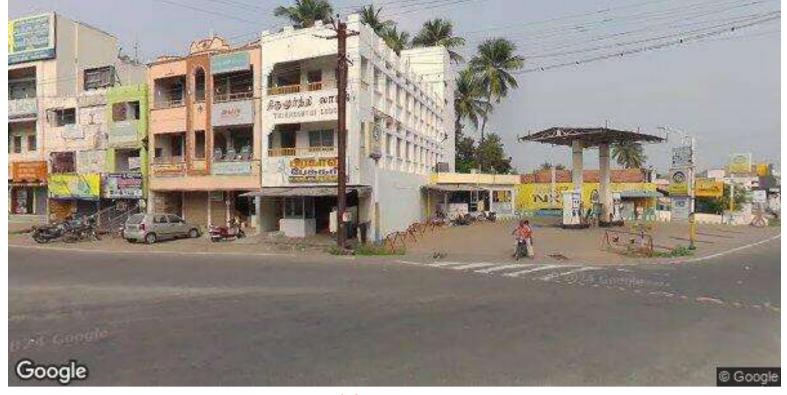
Risk Type: Turn
Risk Level: High
Speed Limit: 15 KM/Hr
Coordinates: 11.00172, 77.56268

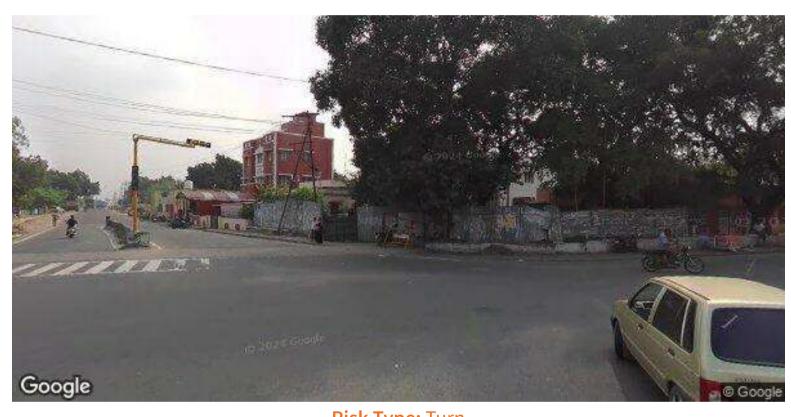
Risk Type: Turn
Risk Level: Medium
Speed Limit: 30 KM/Hr
Coordinates: 11.00170, 77.56267

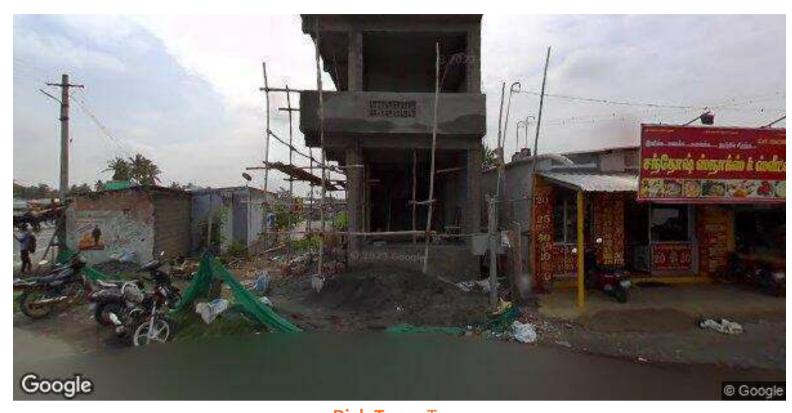
Coordinates: 10.97018, 77.42713

Risk Type: Turn
Risk Level: High
Speed Limit: 15 KM/Hr

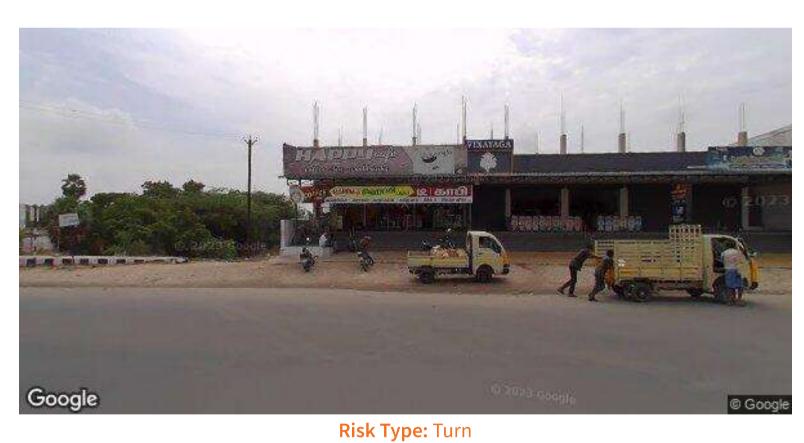
Coordinates: 10.96805, 77.42718

Risk Level: High
Speed Limit: 15 KM/Hr

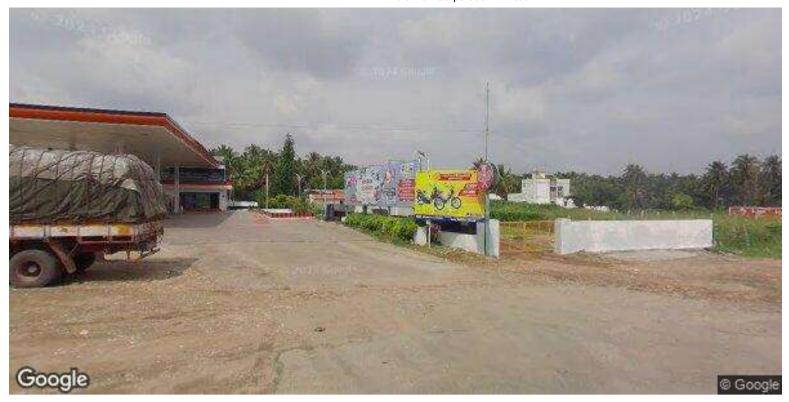
Coordinates: 10.97046, 77.38433

Risk Type: Turn
Risk Level: High
Speed Limit: 15 KM/Hr
