JOURNEY RISK MANAGEMENT (JRM) STUDY

Salem Terminal TO R S PETROLEUM

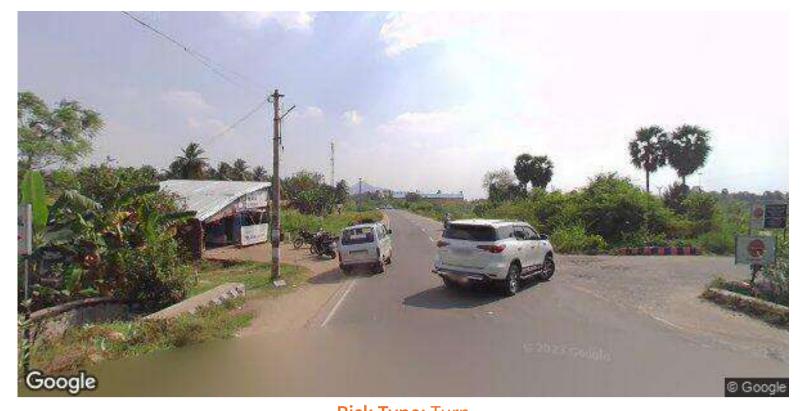
Risk Type: Turn
Speed Limit: 15 KM/Hr
Distance from Start: 0.32 km
Coordinates: 11.44029, 77.87544

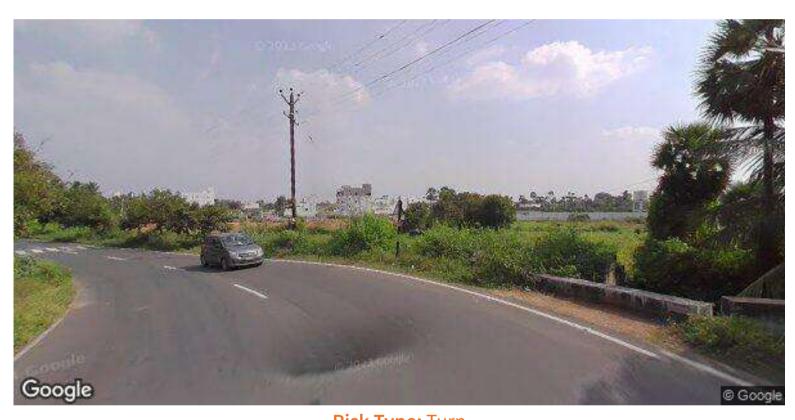
Risk Type: Turn
Speed Limit: 15 KM/Hr
Distance from Start: 3.35 km
Coordinates: 11.45350, 77.85700

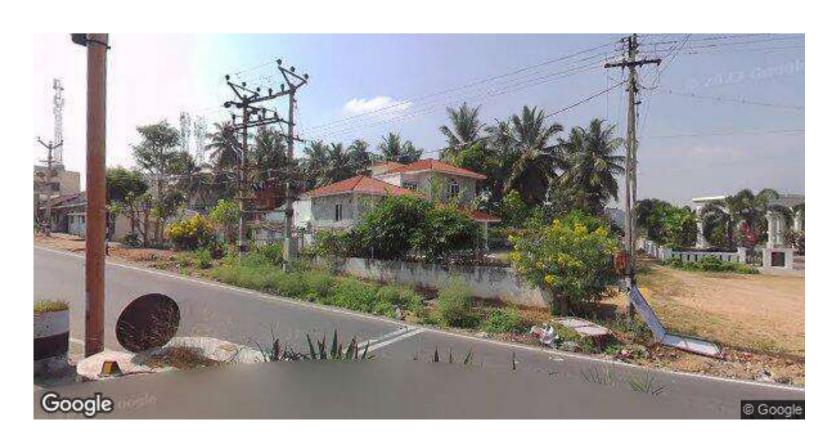
Risk Type: Turn
Speed Limit: 15 KM/Hr
Distance from Start: 4.74 km

Coordinates: 11.46303, 77.84945

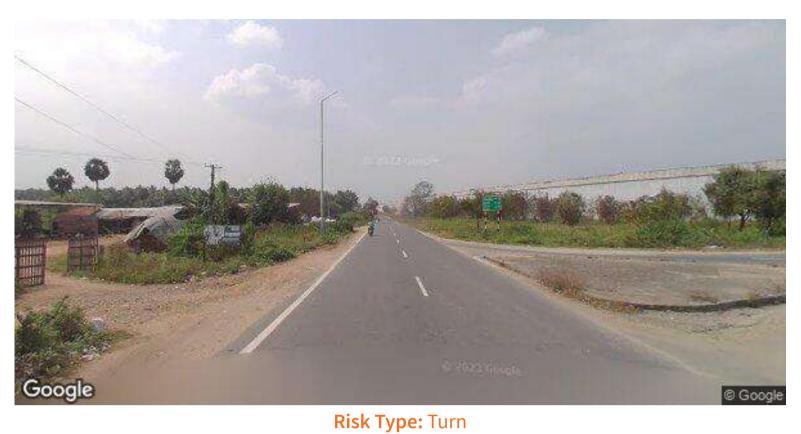
Speed Limit: 15 KM/Hr
Distance from Start: 8.39 km
Coordinates: 11.45542, 77.81725

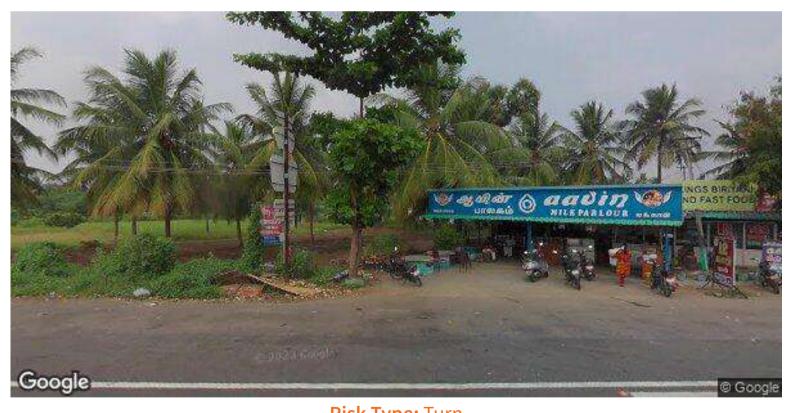
Risk Type: Turn
Speed Limit: 15 KM/Hr
Distance from Start: 8.53 km
Coordinates: 11.45631, 77.81668

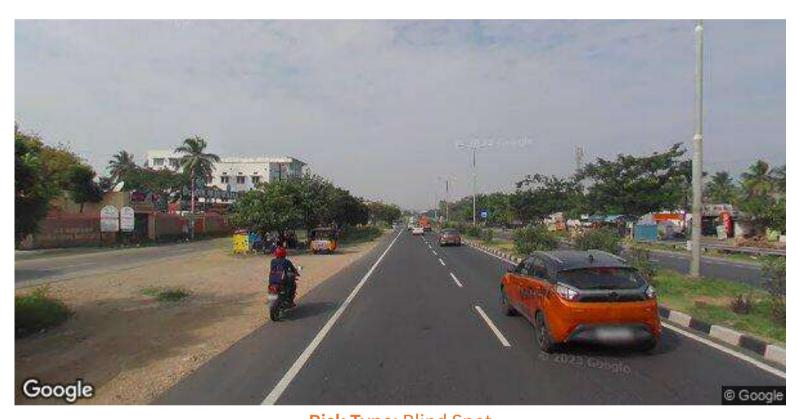
Risk Type: Blind Spot
Speed Limit: 10 KM/Hr
Distance from Start: 18.69 km
Coordinates: 11.44530, 77.72783

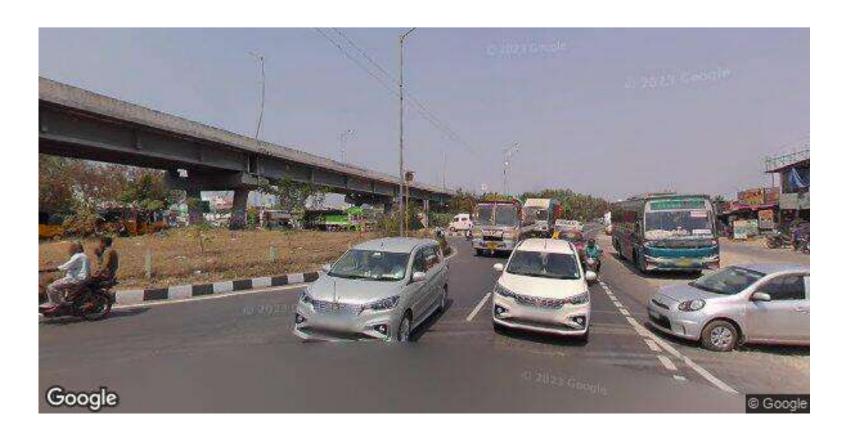
Risk Type: Turn
Speed Limit: 15 KM/Hr
Distance from Start: 24.91 km

Coordinates: 11.43001, 77.67575

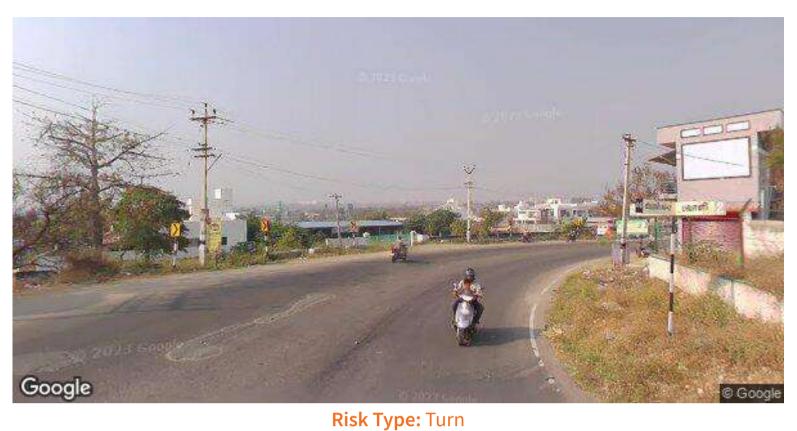
Speed Limit: 15 KM/Hr
Distance from Start: 25.62 km
Coordinates: 11.43278, 77.67024

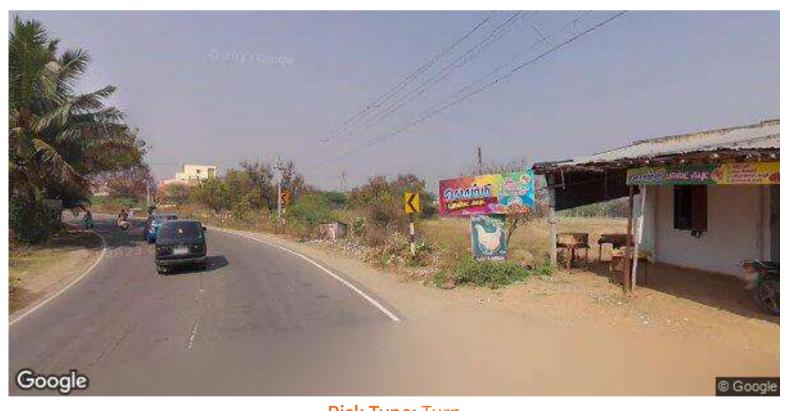
Risk Type: Turn
Speed Limit: 15 KM/Hr
Distance from Start: 26.01 km
Coordinates: 11.43346, 77.66700

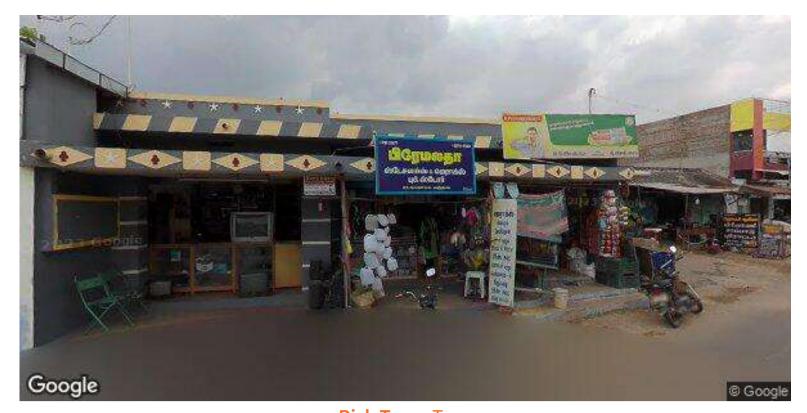
Risk Type: Turn
Speed Limit: 15 KM/Hr
Distance from Start: 38.20 km
Coordinates: 11.42640, 77.55909
