# JOURNEY RISK MANAGEMENT (JRM) STUDY

# **IOCL Coimbatore Terminal to A N G Agency**

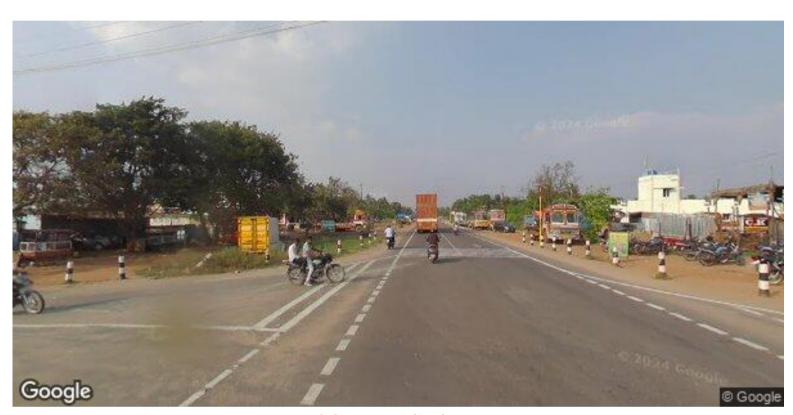
**Coordinates:** 11.03211, 77.07640

Risk Type: Blind Spot Risk Level: Blind Spot Speed Limit: 10 KM/Hr

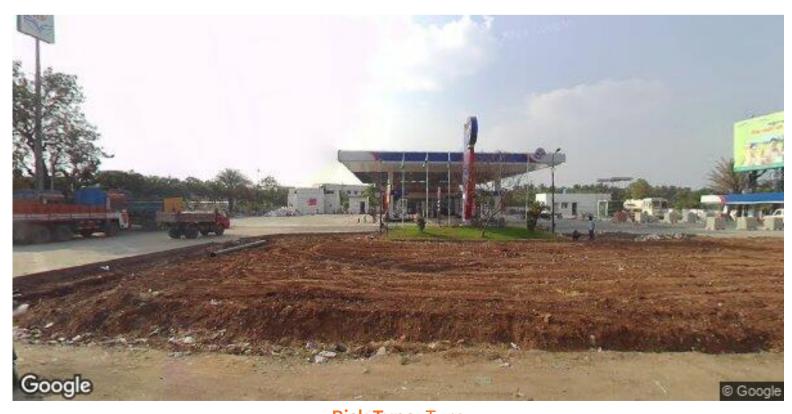
Risk Type: Turn
Risk Level: Medium

Speed Limit: 30 KM/Hr
Coordinates: 11.00873, 77.07114

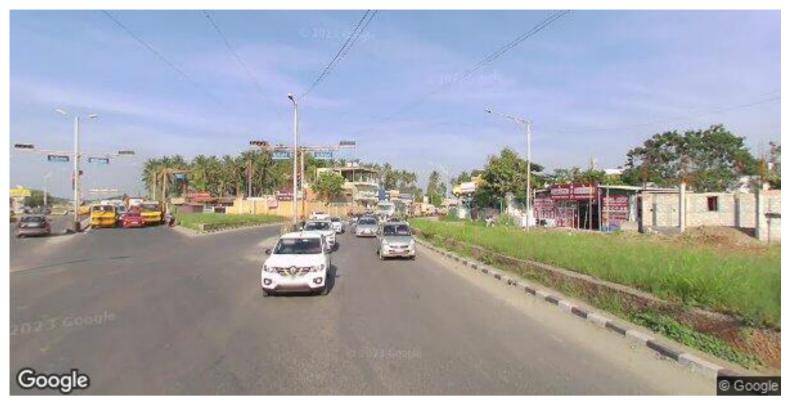
Risk Type: Turn
Risk Level: Medium
Speed Limit: 30 KM/Hr
Coordinates: 11.00737, 77.07049

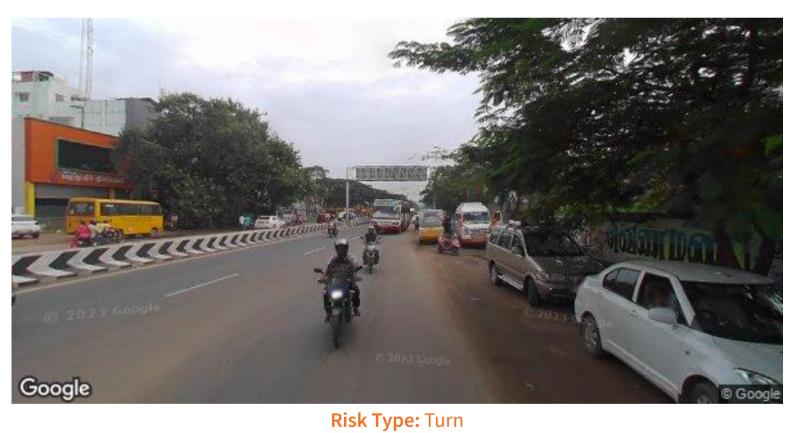
**Coordinates:** 10.99678, 77.00653

Risk Type: Turn
Risk Level: Medium
Speed Limit: 30 KM/Hr

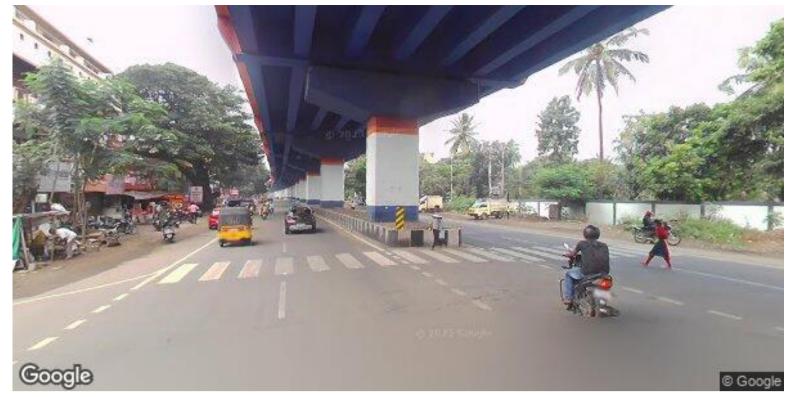
Risk Type: Blind Spot
Risk Level: Blind Spot
Speed Limit: 10 KM/Hr
Coordinates: 10.99700, 77.00222

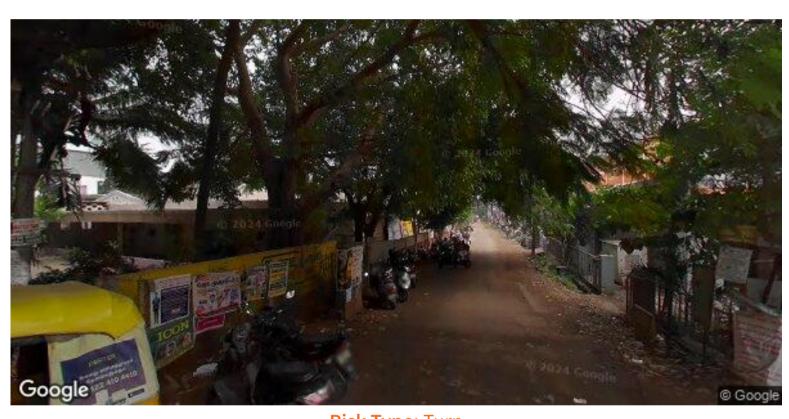
Risk Type: Turn
Risk Level: High
Speed Limit: 15 KM/Hr
Coordinates: 10.99689, 77.00222

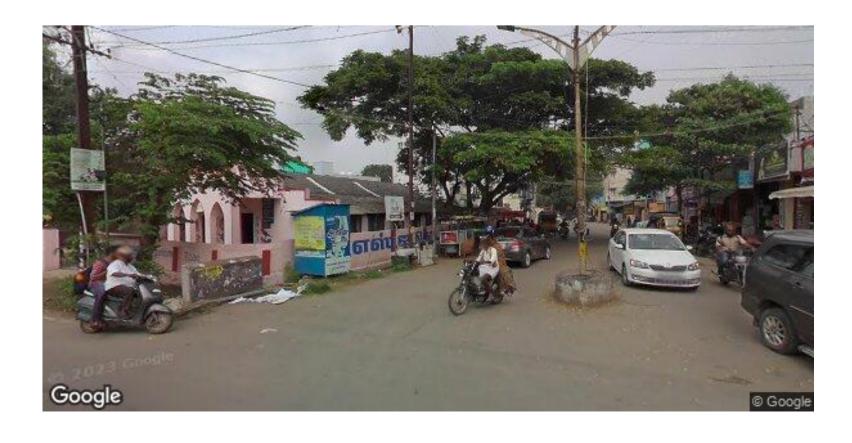
**Coordinates:** 10.99315, 76.99745

Risk Type: Blind Spot Risk Level: Blind Spot Speed Limit: 10 KM/Hr

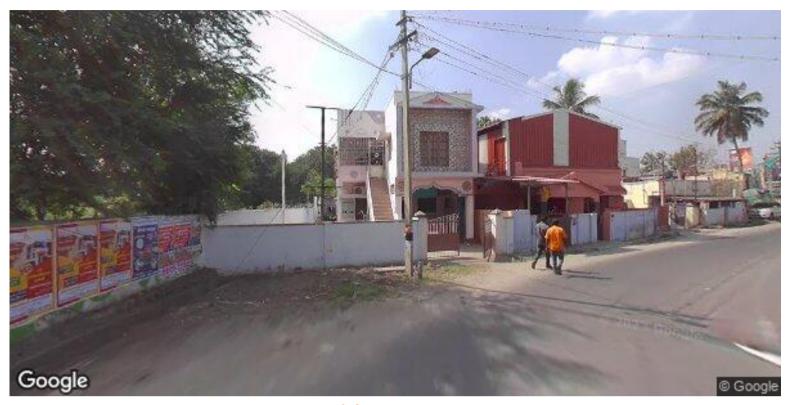
**Coordinates:** 10.96577, 76.98909

Risk Type: Turn
Risk Level: Medium
Speed Limit: 30 KM/Hr

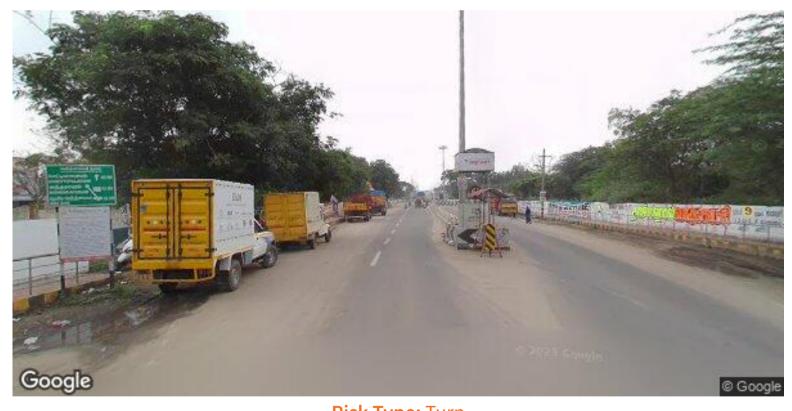
Risk Type: Turn
Risk Level: Medium
Speed Limit: 30 KM/Hr
Coordinates: 10.96179, 76.98659

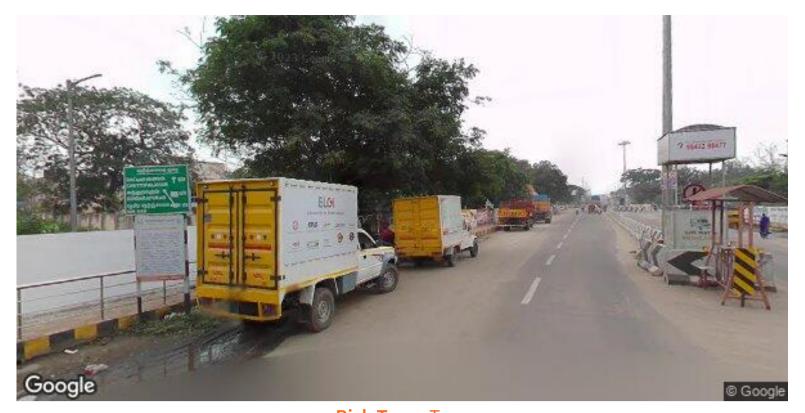
Risk Type: Turn
Risk Level: Medium
Speed Limit: 30 KM/Hr
Coordinates: 10.96173, 76.98661

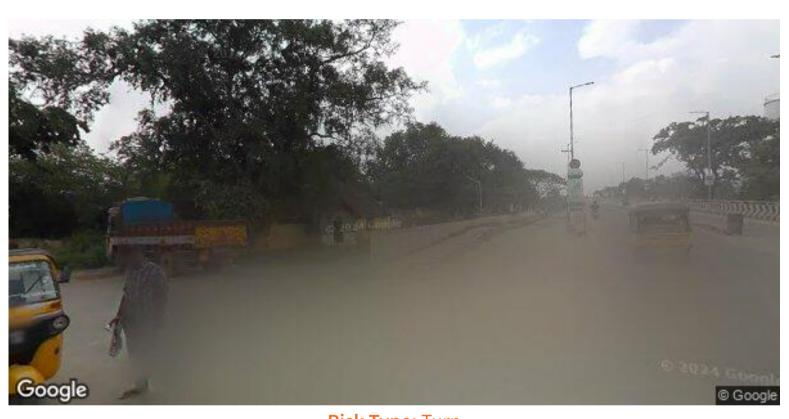
Risk Type: Turn
Risk Level: Medium
Speed Limit: 30 KM/Hr
Coordinates: 10.96088, 76.98632

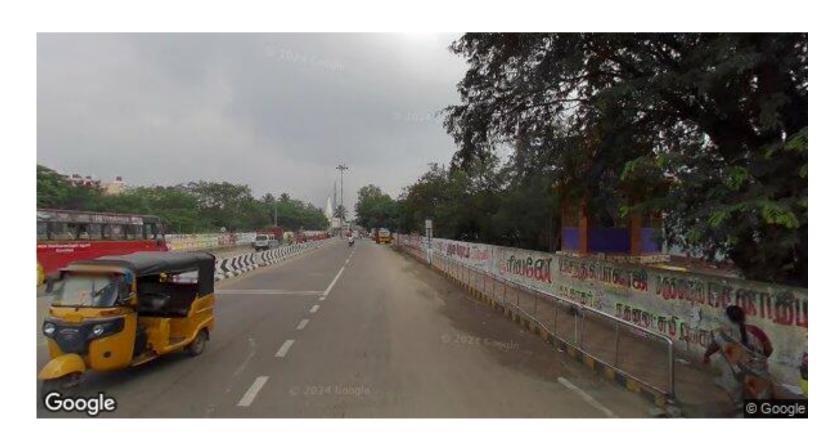
**Coordinates:** 10.96086, 76.98632

Risk Type: Turn
Risk Level: Medium
Speed Limit: 30 KM/Hr

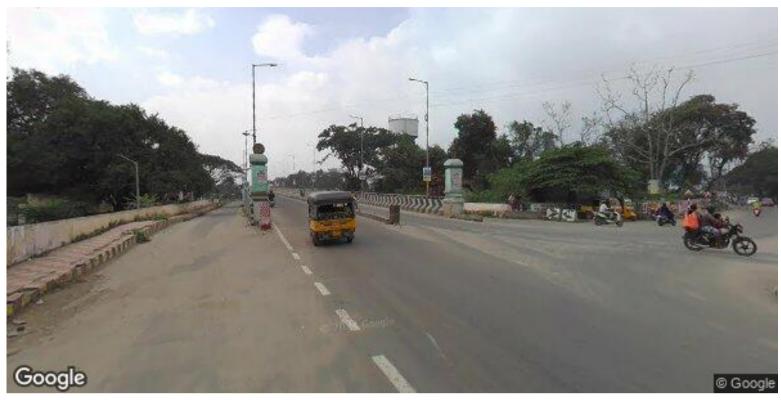
**Coordinates:** 10.96082, 76.98629

Risk Type: Turn
Risk Level: Medium
Speed Limit: 30 KM/Hr

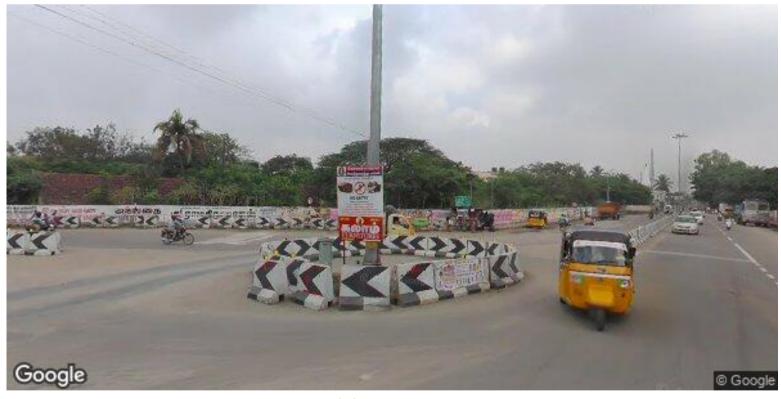
**Coordinates:** 10.96081, 76.98626

Risk Type: Turn
Risk Level: Medium
Speed Limit: 30 KM/Hr

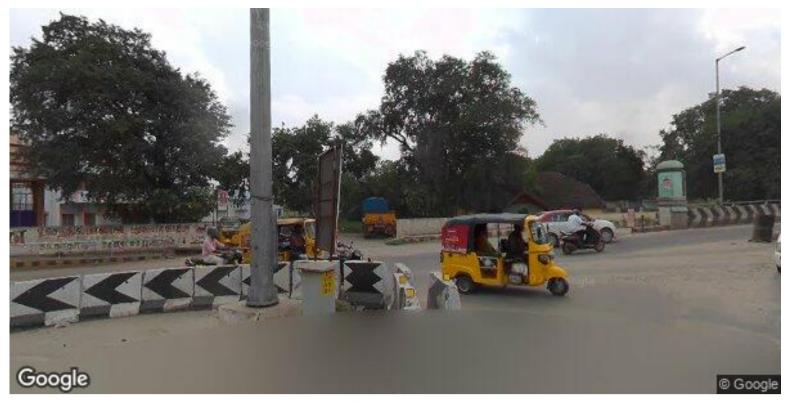
**Coordinates:** 10.96083, 76.98620

Risk Type: Turn
Risk Level: Medium
Speed Limit: 30 KM/Hr

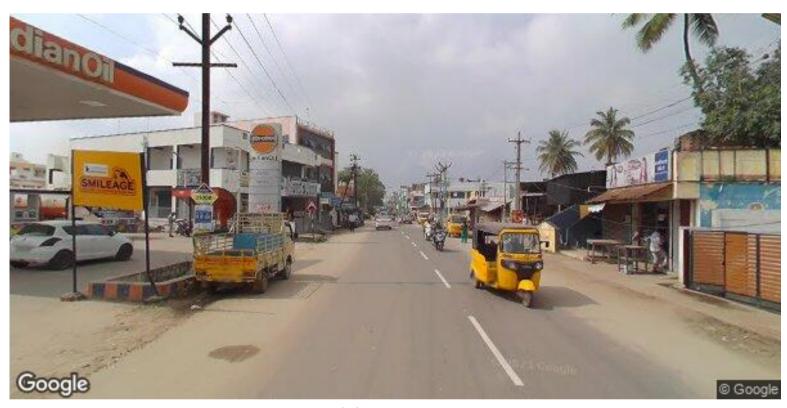
**Coordinates:** 10.95824, 76.97793

Risk Type: Turn
Risk Level: High
Speed Limit: 15 KM/Hr
