JOURNEY RISK MANAGEMENT (JRM) STUDY

IOCL Coimbatore Terminal to G S Agency

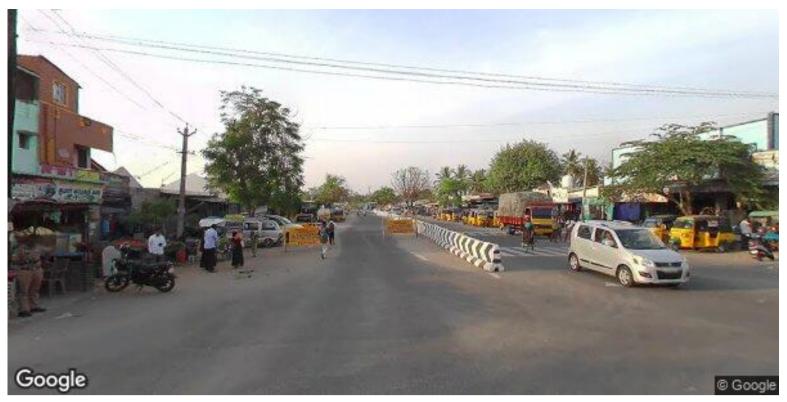
Risk Type: Roundabout
Risk Level: High
Speed Limit: 15 KM/Hr
Coordinates: 11.10246, 77.27138

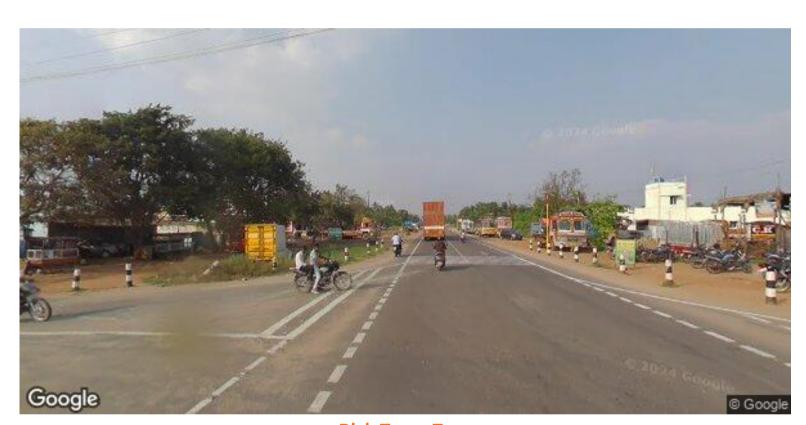
Risk Type: Turn
Risk Level: High
Speed Limit: 15 KM/Hr
Coordinates: 11.03211, 77.07640

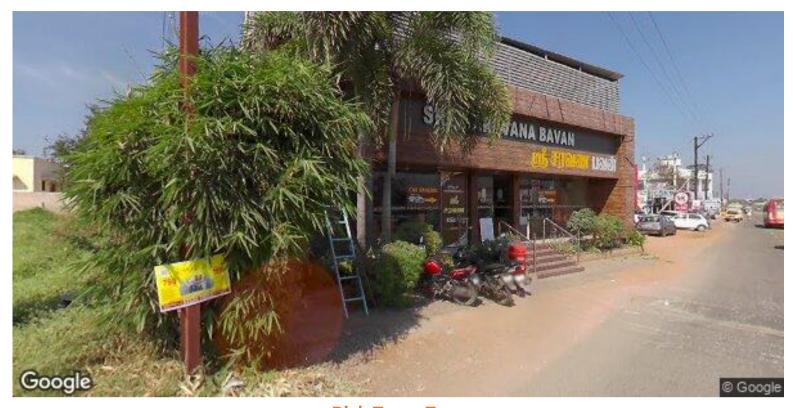
Risk Type: Turn
Risk Level: Medium
Speed Limit: 30 KM/Hr
Coordinates: 11.10527, 77.17318

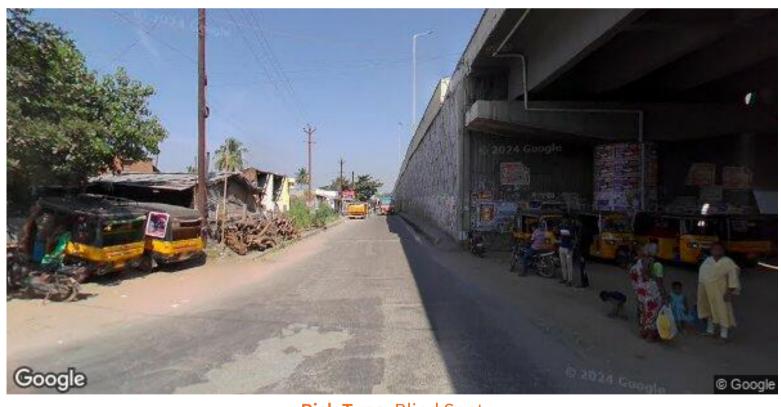
Risk Type: Blind Spot
Risk Level: Blind Spot
Speed Limit: 10 KM/Hr
Coordinates: 11.10783, 77.17709

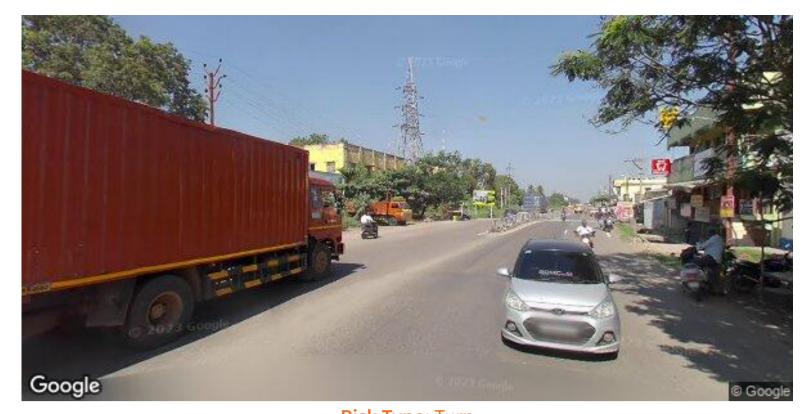
Risk Type: Turn
Risk Level: Medium
Speed Limit: 30 KM/Hr
Coordinates: 11.08752, 77.18466

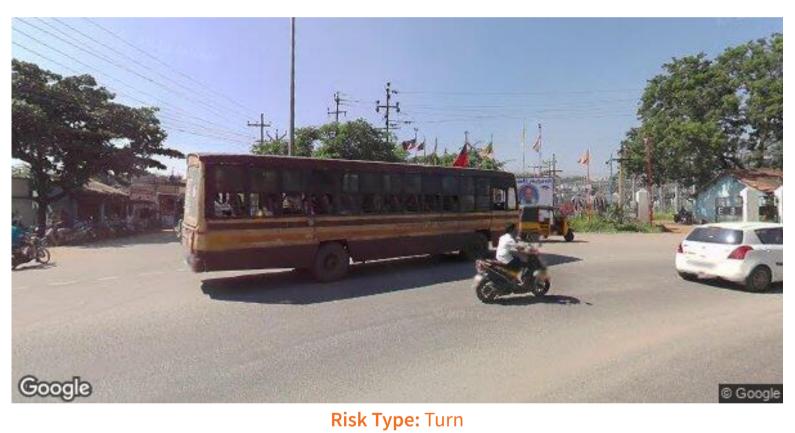
Risk Level: High
Speed Limit: 15 KM/Hr
Coordinates: 11.08745, 77.18473

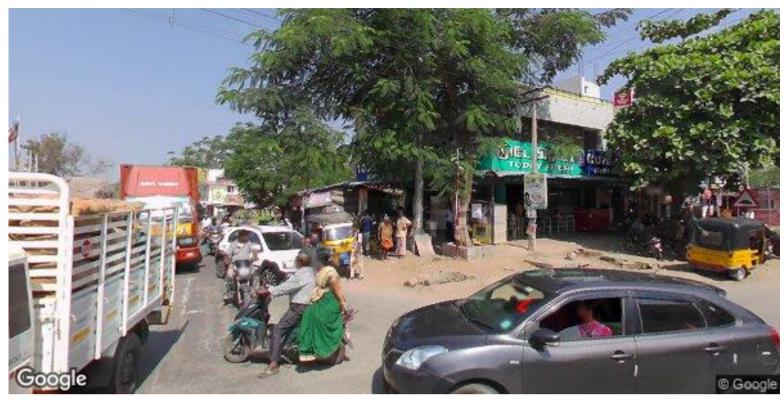
Risk Type: Blind Spot
Risk Level: Blind Spot
Speed Limit: 10 KM/Hr
Coordinates: 11.07394, 77.19267

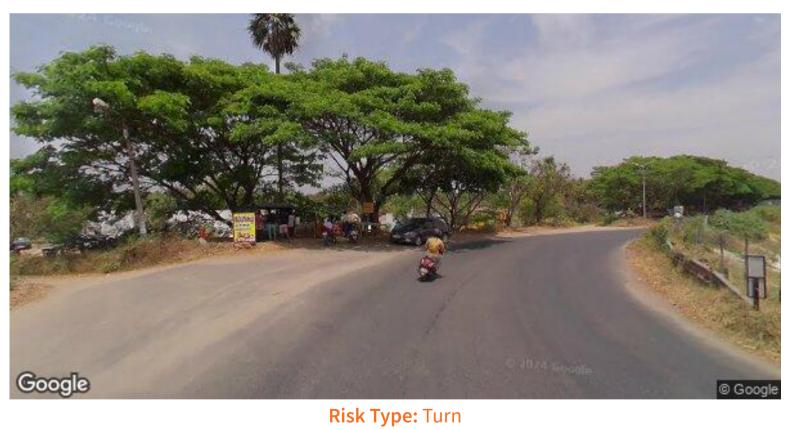
Risk Type. Turn
Risk Level: Medium
Speed Limit: 30 KM/Hr
Coordinates: 11.07557, 77.19746

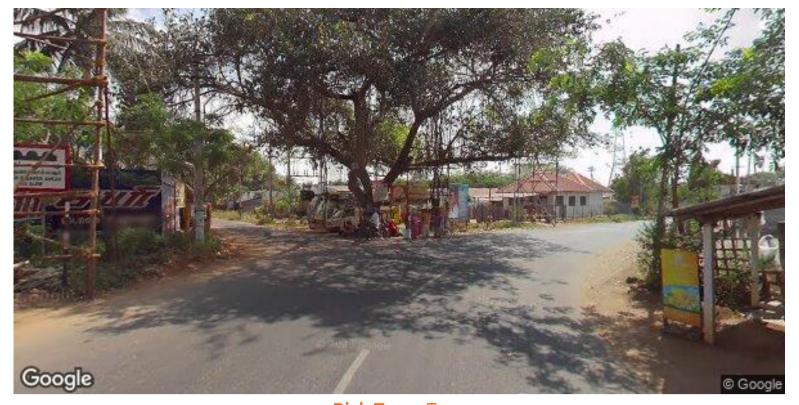
Risk Type: Turn
Risk Level: Medium
Speed Limit: 30 KM/Hr
Coordinates: 11.09065, 77.22676

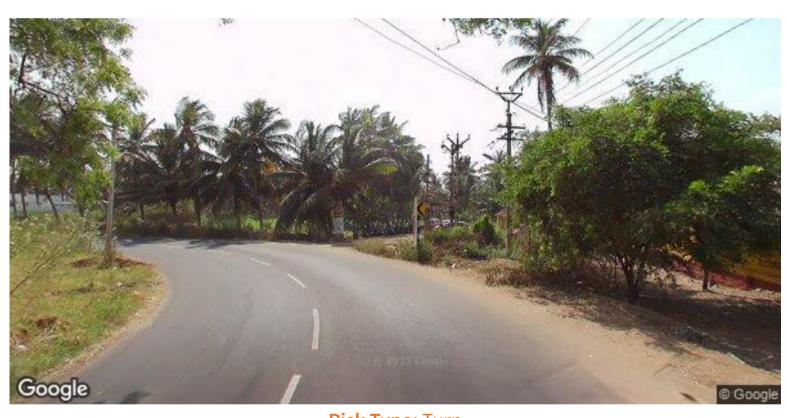
Risk Type: Turn
Risk Level: Medium
Speed Limit: 30 KM/Hr
Coordinates: 11.09259, 77.22725

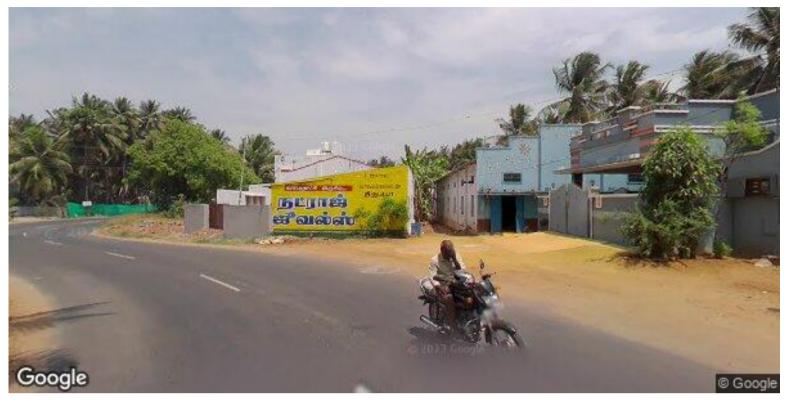
Risk Type: Turn
Risk Level: Medium
Speed Limit: 30 KM/Hr
Coordinates: 11.09574, 77.23660

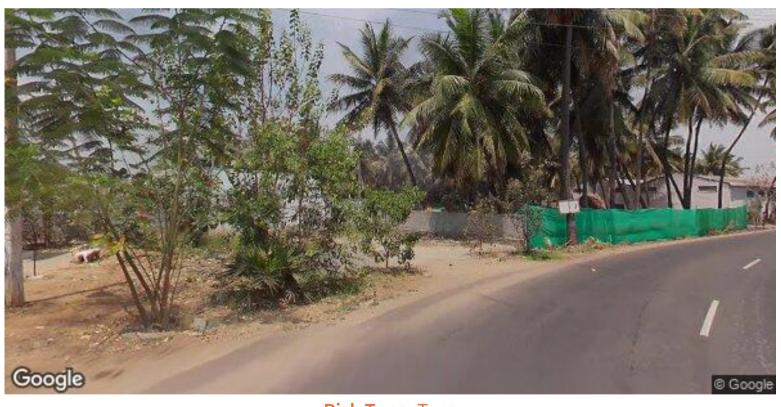
Risk Type: Turn
Risk Level: Medium
Speed Limit: 30 KM/Hr
Coordinates: 11.09611, 77.23678

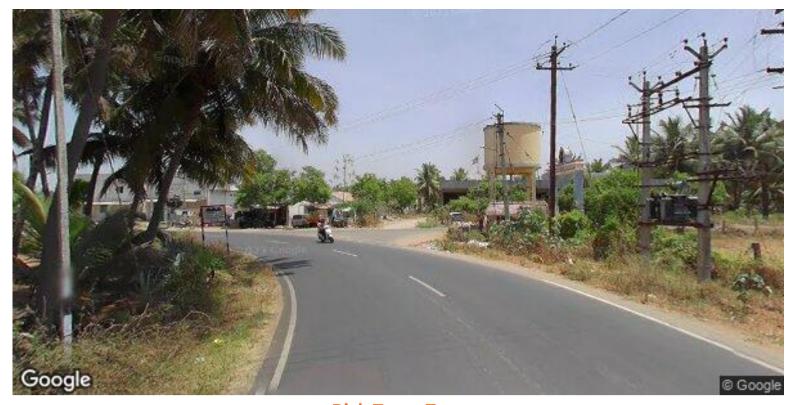
Risk Type: Turn
Risk Level: Medium
Speed Limit: 30 KM/Hr
Coordinates: 11.09686, 77.24282

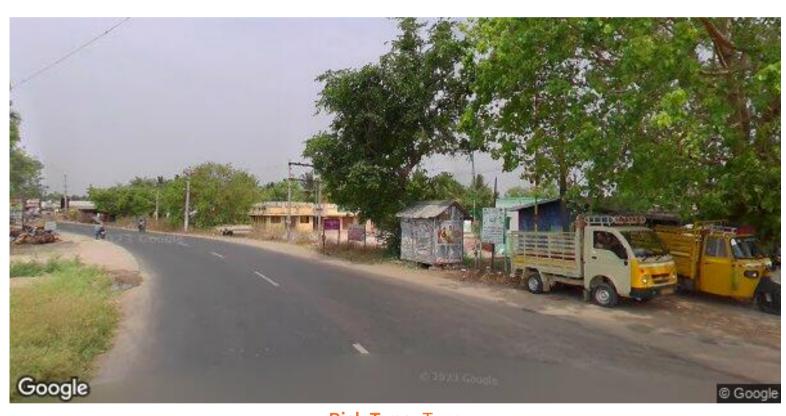
Risk Type: Turn
Risk Level: Medium
Speed Limit: 30 KM/Hr
Coordinates: 11.10142, 77.24908

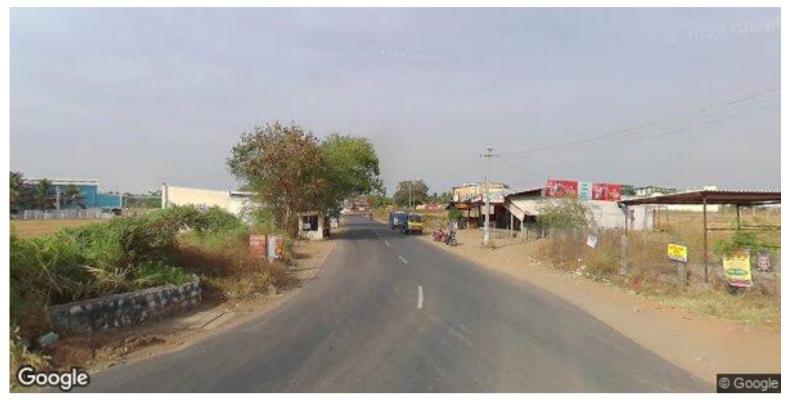
Risk Type: Turn
Risk Level: Medium
Speed Limit: 30 KM/Hr
Coordinates: 11.10084, 77.26441

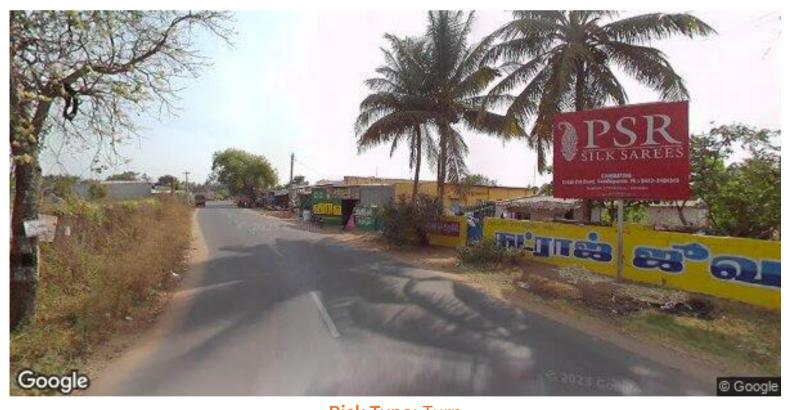
Risk Type: Turn
Risk Level: Medium
Speed Limit: 30 KM/Hr
Coordinates: 11.10182, 77.26510
