JOURNEY RISK MANAGEMENT (JRM) STUDY

Salem Terminal TO RL AGENCY

Route Safety Analysis Report: CVQF+23W, Sangagiri to JMWJ+6P8, Guruvareddiyur

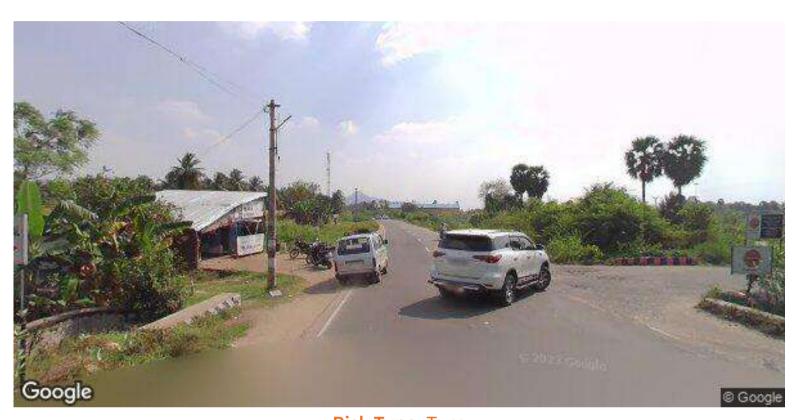
Risk Type: Turn
Risk Level: High
Speed Limit: 15 KM/Hr
Coordinates: 11.44029, 77.87544

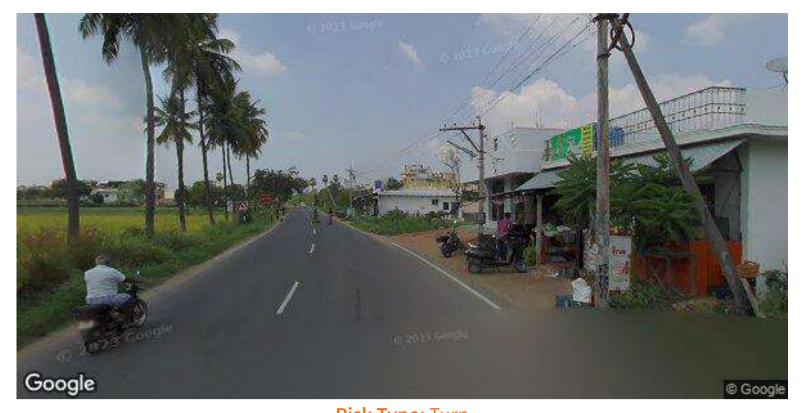
Risk Type: Turn
Risk Level: Medium
Speed Limit: 30 KM/Hr
Coordinates: 11.45127, 77.86734

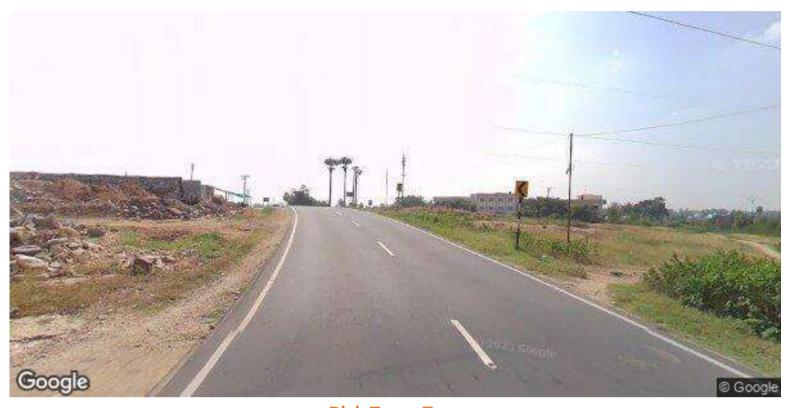
Coordinates: 11.46046, 77.85037

Risk Type: Turn
Risk Level: Medium
Speed Limit: 30 KM/Hr

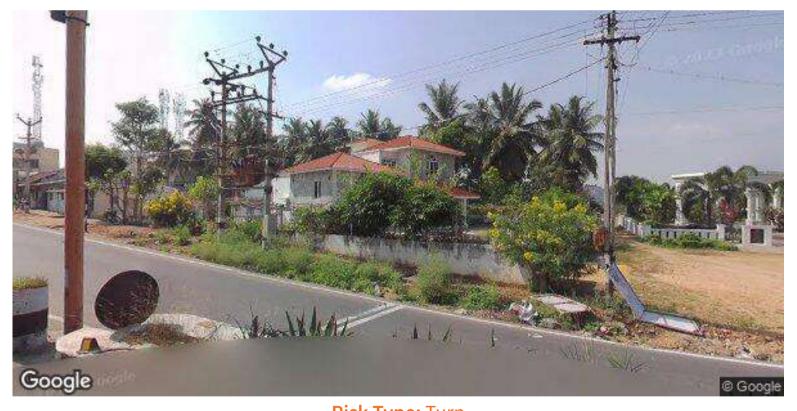
Coordinates: 11.46303, 77.84945

Risk Type: Turn
Risk Level: Medium
Speed Limit: 30 KM/Hr

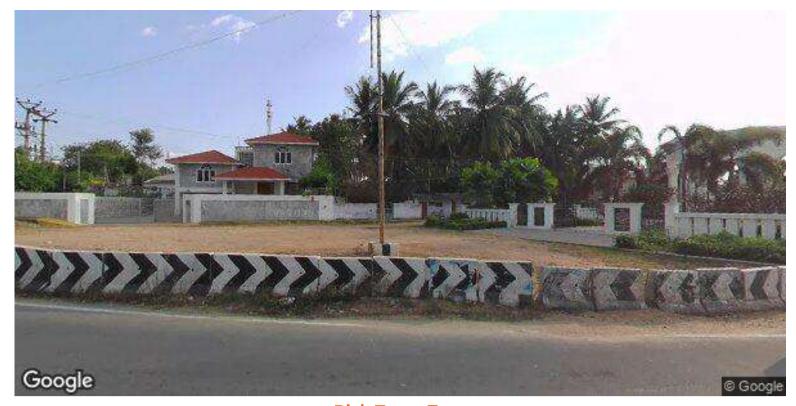
Risk Type: Turn
Risk Level: Medium
Speed Limit: 30 KM/Hr
Coordinates: 11.46316, 77.84921

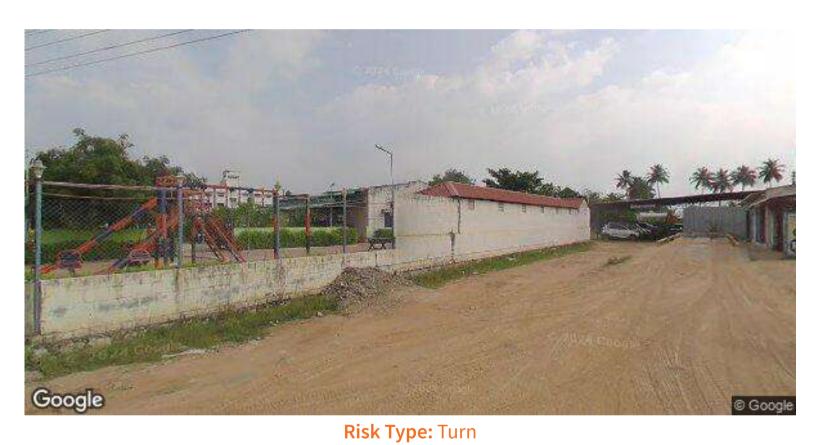
Risk Level: High
Speed Limit: 15 KM/Hr
Coordinates: 11.44377, 77.71562

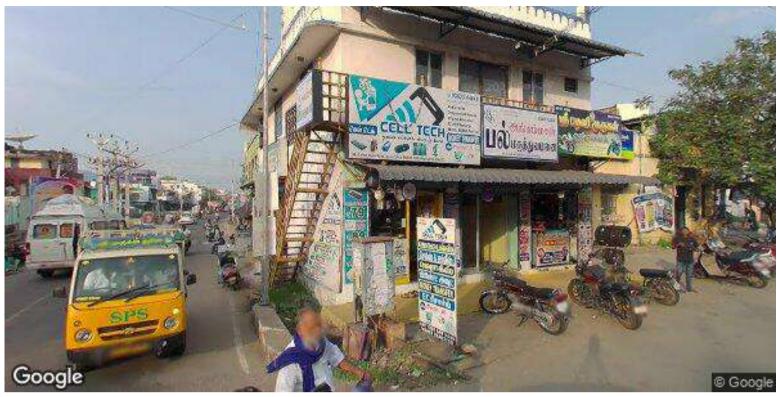
Coordinates: 11.44111, 77.69331

Risk Type: Turn
Risk Level: High
Speed Limit: 15 KM/Hr

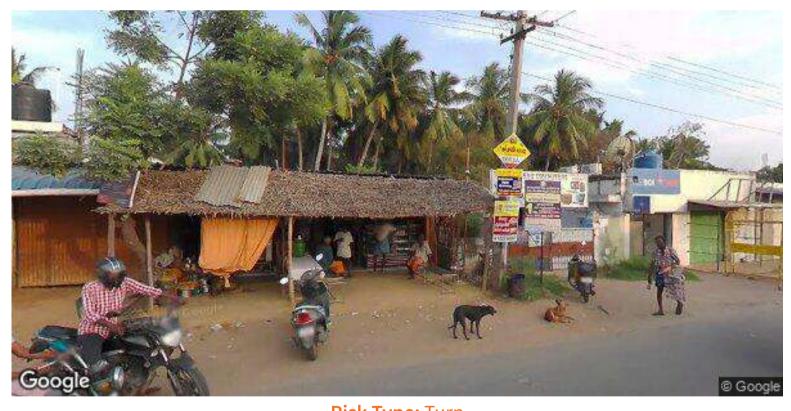
Coordinates: 11.44985, 77.69520

Risk Type: Turn
Risk Level: High
Speed Limit: 15 KM/Hr

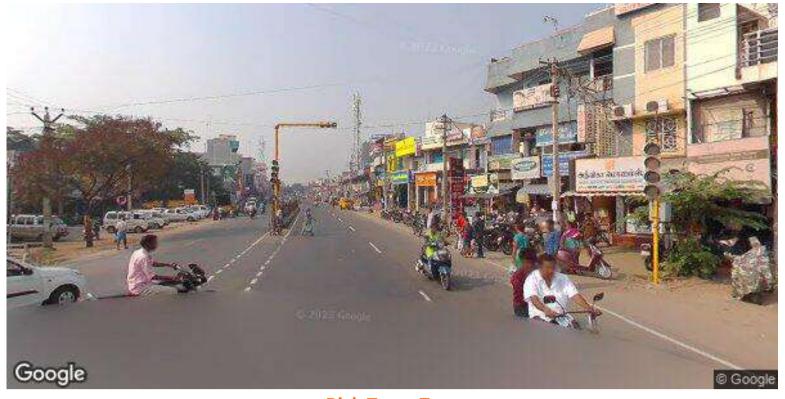
Risk Type: Turn
Risk Level: High
Speed Limit: 15 KM/Hr
Coordinates: 11.45331, 77.68803

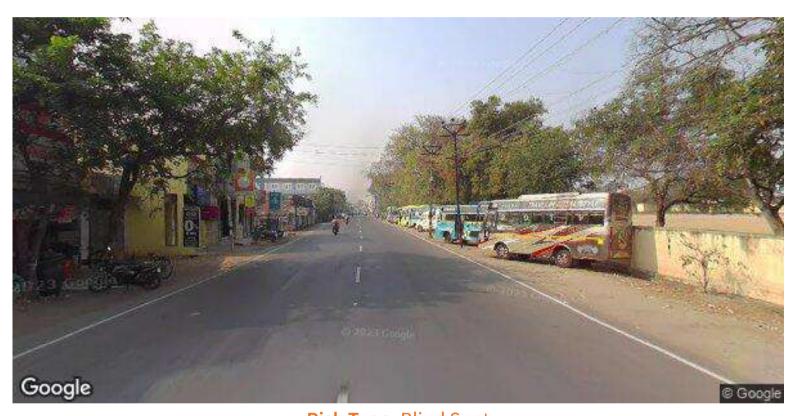
Risk Type: Blind Spot
Risk Level: Blind Spot
Speed Limit: 10 KM/Hr
Coordinates: 11.44979, 77.68549

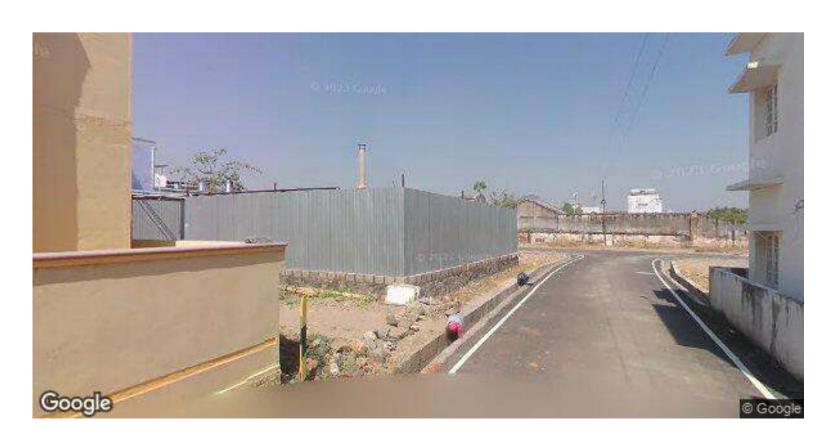
Coordinates: 11.44948, 77.68645

Risk Type: Turn
Risk Level: High
Speed Limit: 15 KM/Hr

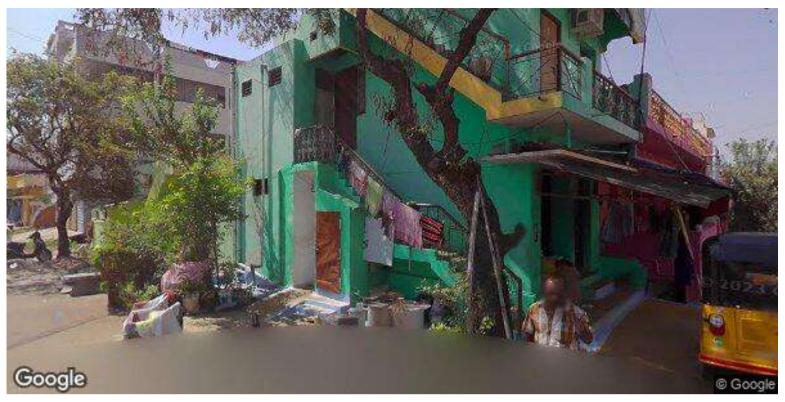
Coordinates: 11.44801, 77.68596

Risk Type: Turn
Risk Level: High
Speed Limit: 15 KM/Hr

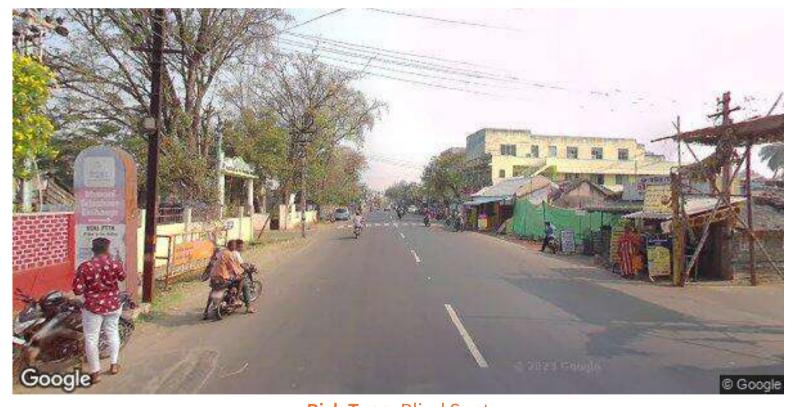
Coordinates: 11.44842, 77.68473

Risk Type: Blind Spot
Risk Level: Blind Spot
Speed Limit: 10 KM/Hr

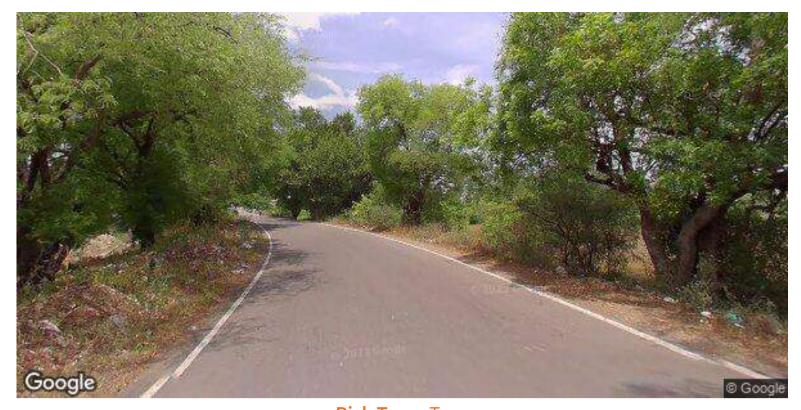
Risk Type: Turn
Risk Level: Medium
Speed Limit: 30 KM/Hr
Coordinates: 11.55440, 77.71815

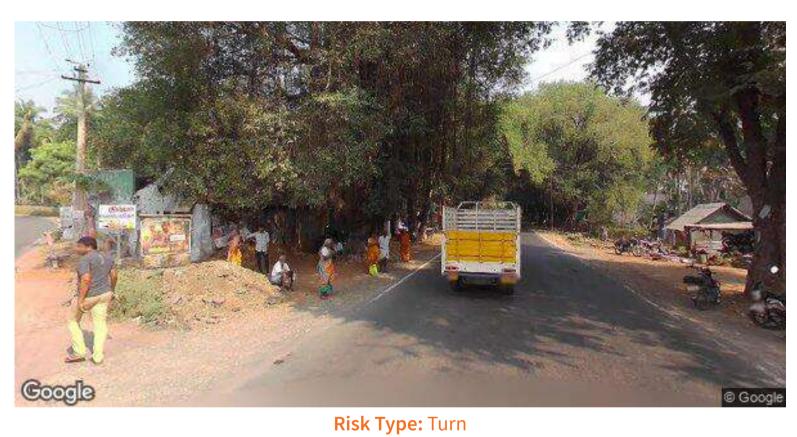
Coordinates: 11.59946, 77.73130

Risk Type: Turn

Risk Level: High

Speed Limit: 15 KM/Hr

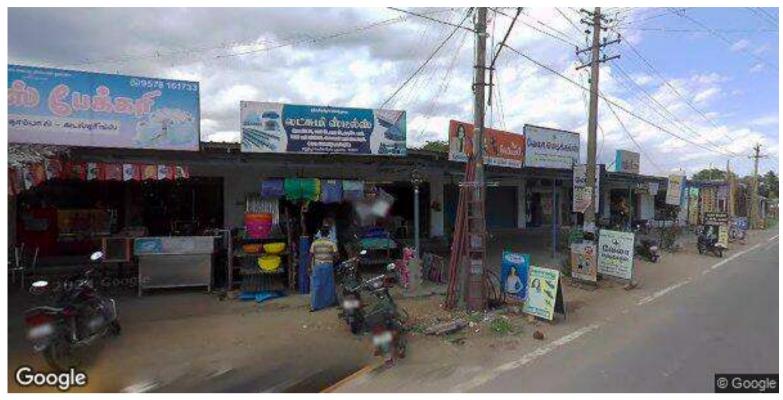
Coordinates: 11.61026, 77.71748

Risk Type: Blind Spot Risk Level: Blind Spot Speed Limit: 10 KM/Hr

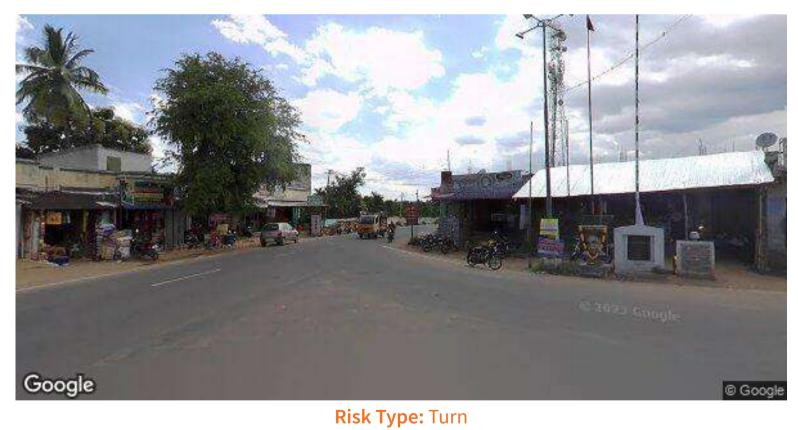
Coordinates: 11.60985, 77.71617

Risk Level: High

Speed Limit: 15 KM/Hr

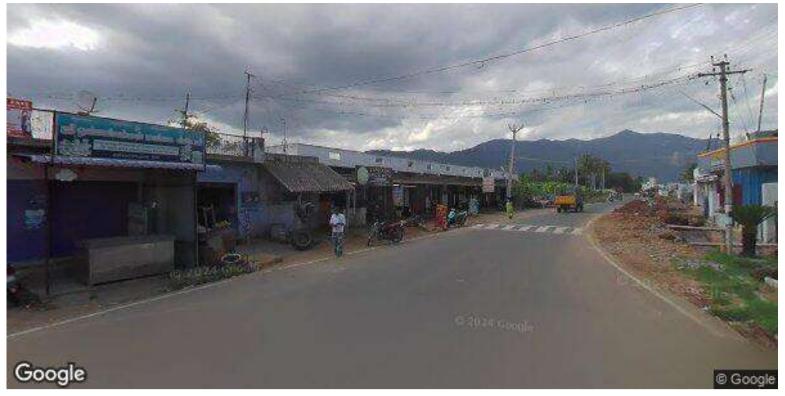
Risk Type: Turn
Risk Level: High
Speed Limit: 15 KM/Hr
Coordinates: 11.60999, 77.71606

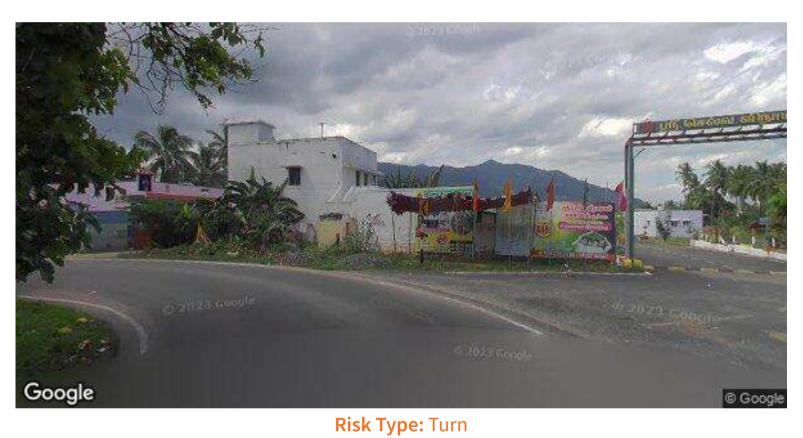
Risk Level: High
Speed Limit: 15 KM/Hr
Coordinates: 11.61277, 77.71687

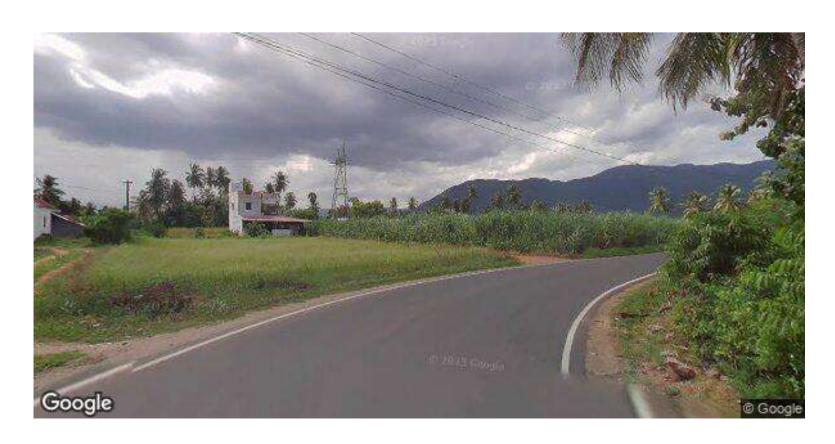
Coordinates: 11.61330, 77.71567

Risk Type: Turn
Risk Level: High
Speed Limit: 15 KM/Hr

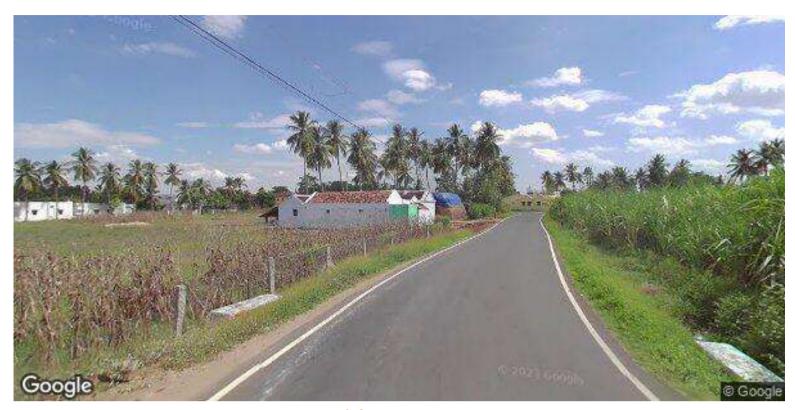
Coordinates: 11.61424, 77.71584

Risk Type: Turn
Risk Level: High
Speed Limit: 15 KM/Hr

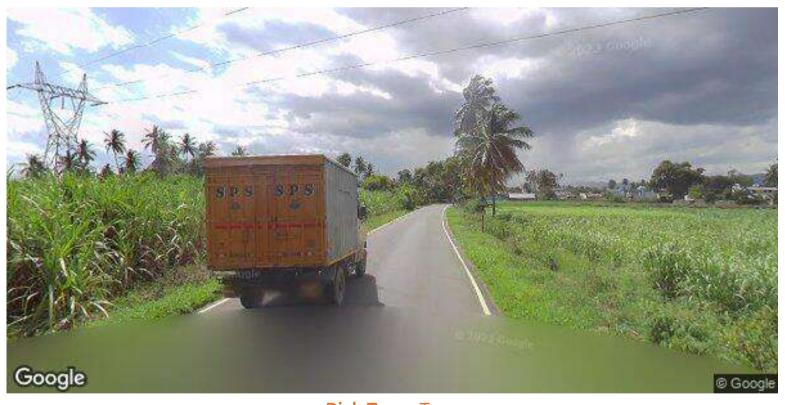
Risk Type: Turn
Risk Level: Medium
Speed Limit: 30 KM/Hr
Coordinates: 11.61439, 77.71570

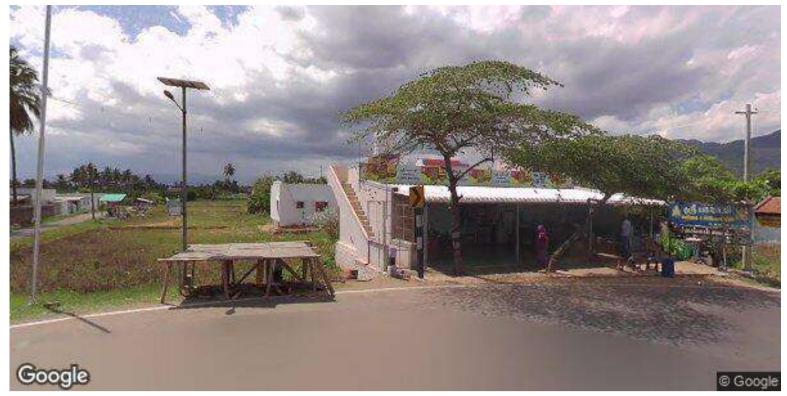
Coordinates: 11.61537, 77.71369

Risk Type: Turn
Risk Level: High
Speed Limit: 15 KM/Hr

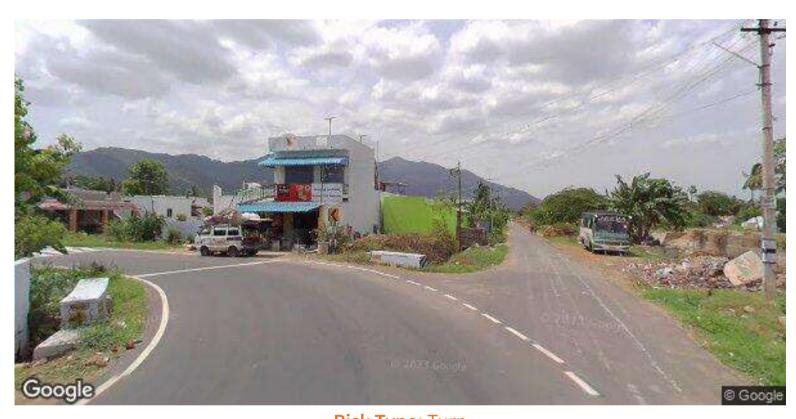
Risk Type: Turn
Risk Level: Medium
Speed Limit: 30 KM/Hr
Coordinates: 11.61584, 77.71389

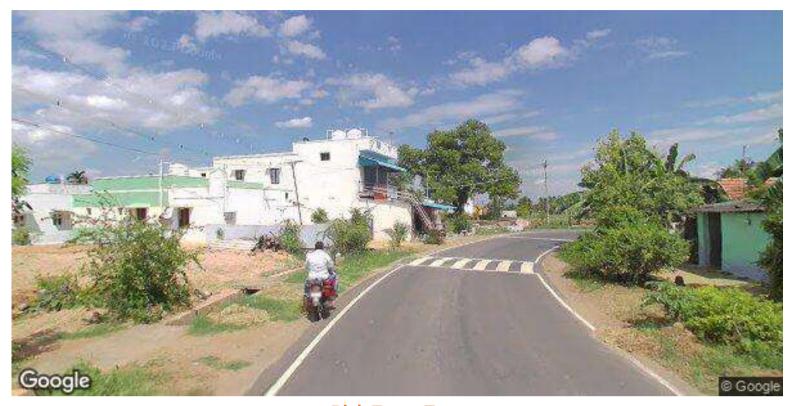
Risk Type: Turn
Risk Level: Medium
Speed Limit: 30 KM/Hr
Coordinates: 11.61608, 77.71371

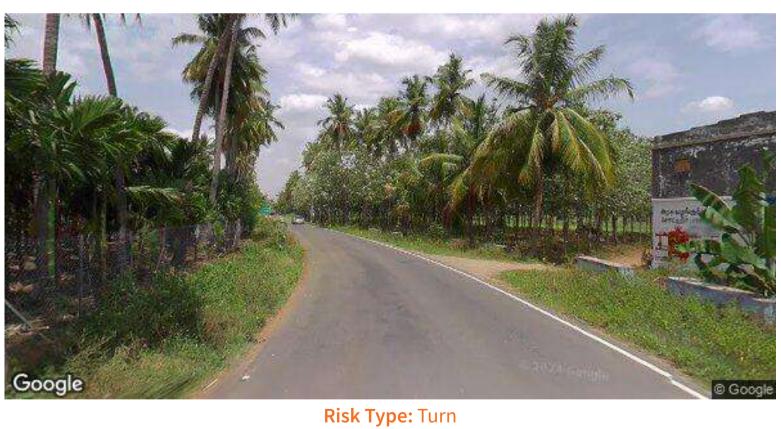
Risk Type. Turn
Risk Level: Medium
Speed Limit: 30 KM/Hr
Coordinates: 11.61792, 77.71017

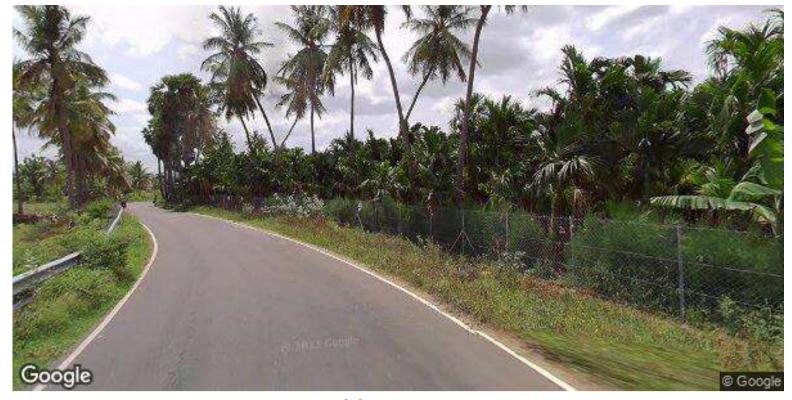
Risk Type: Turn
Risk Level: Medium
Speed Limit: 30 KM/Hr
Coordinates: 11.61875, 77.70972

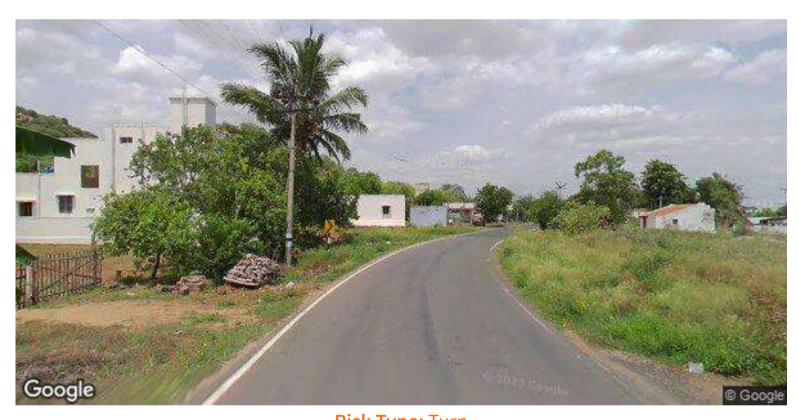
Risk Type: Turn
Risk Level: Medium
Speed Limit: 30 KM/Hr
Coordinates: 11.63368, 77.69795

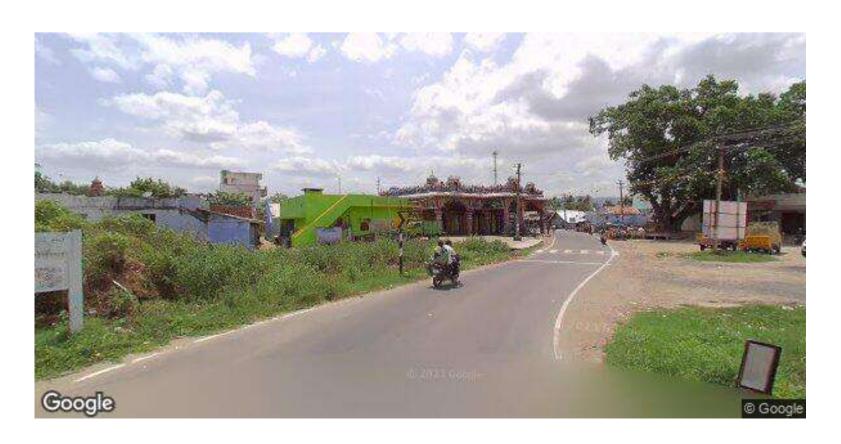
Coordinates: 11.63946, 77.68505

Risk Type: Turn
Risk Level: High
Speed Limit: 15 KM/Hr

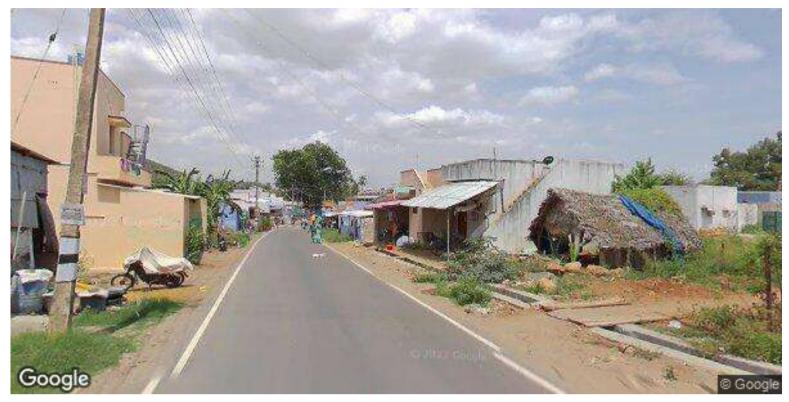
Coordinates: 11.64030, 77.68399

Risk Type: Turn
Risk Level: Medium
Speed Limit: 30 KM/Hr

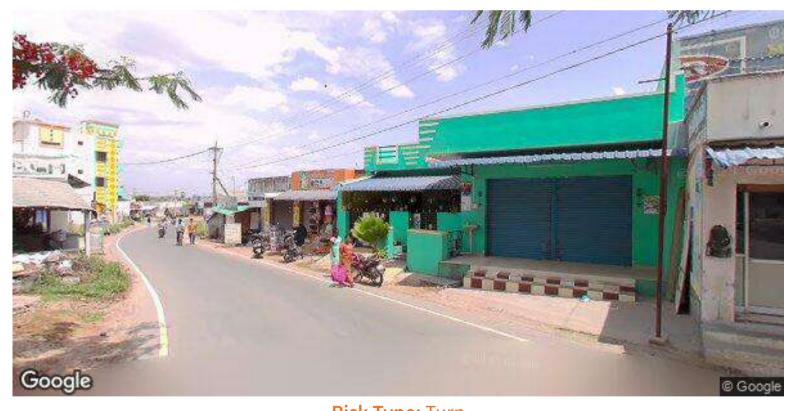
Coordinates: 11.64093, 77.68331

Risk Type: Turn
Risk Level: Medium
Speed Limit: 30 KM/Hr
