JOURNEY RISK MANAGEMENT (JRM) STUDY

Salem Terminal to ALAGUMALAI MUTHUKUMARAN FUELS

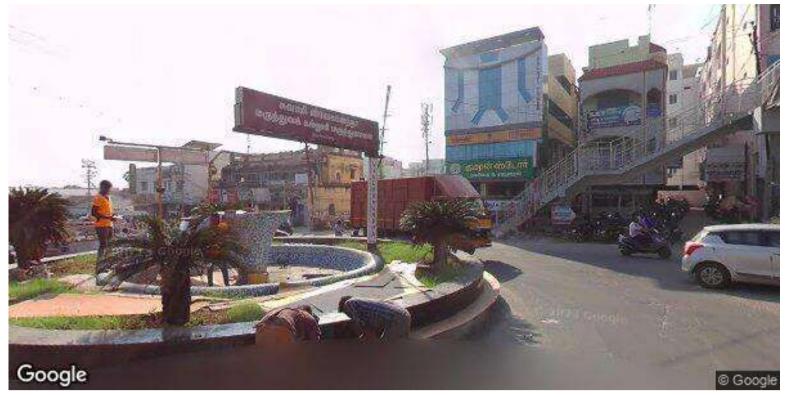
Risk Type: Roundabout
Risk Level: High
Speed Limit: 15 KM/Hr
Coordinates: 11.38395, 77.89480

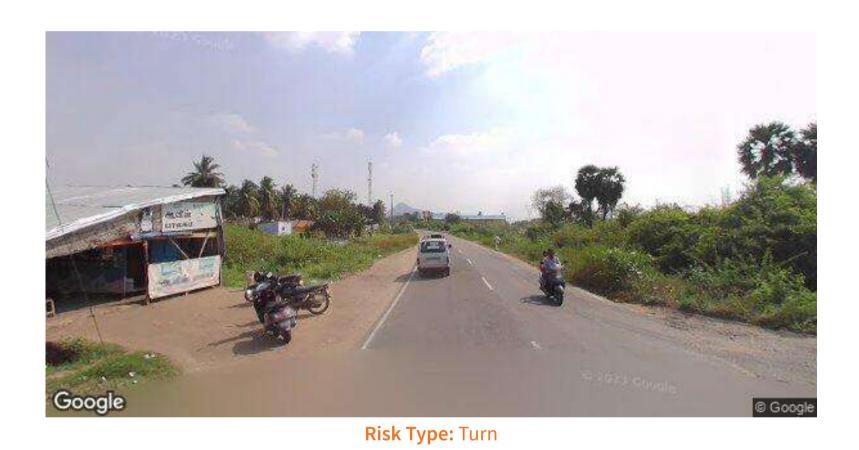
Speed Limit: 15 KM/Hr Coordinates: 11.44022, 77.87546

Risk Level: High

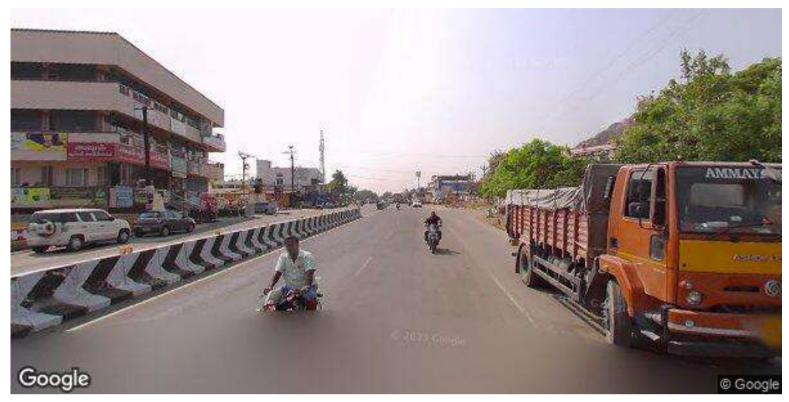
Coordinates: 11.39690, 77.88852

Risk Type: Turn
Risk Level: Medium
Speed Limit: 30 KM/Hr

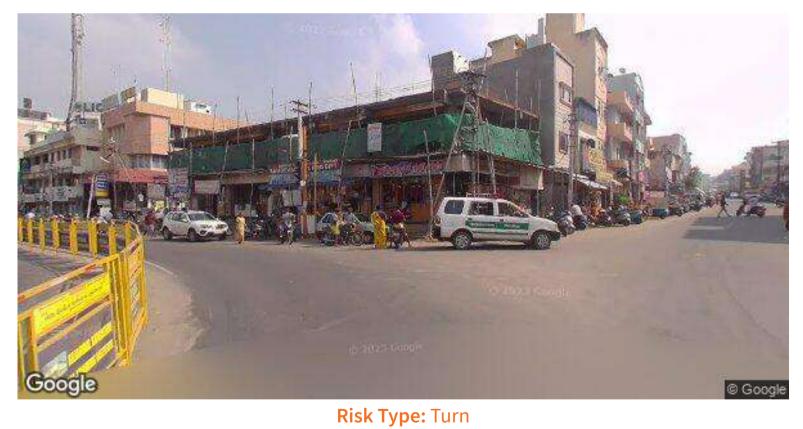
Coordinates: 11.37868, 77.89498

Risk Type: Turn
Risk Level: High
Speed Limit: 15 KM/Hr

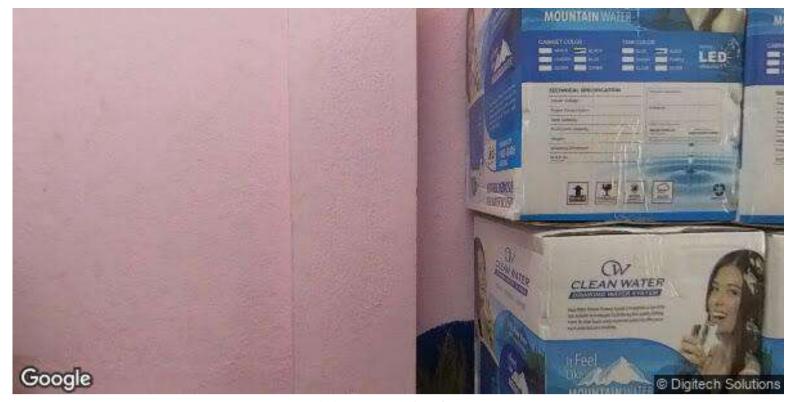
Coordinates: 11.37862, 77.89530

Risk Type: Blind Spot Risk Level: Blind Spot Speed Limit: 10 KM/Hr

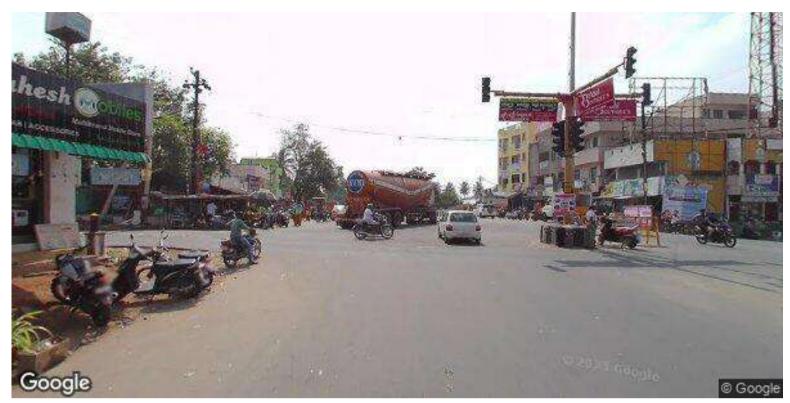
Coordinates: 11.36616, 77.88885

Risk Type: Turn
Risk Level: High
Speed Limit: 15 KM/Hr

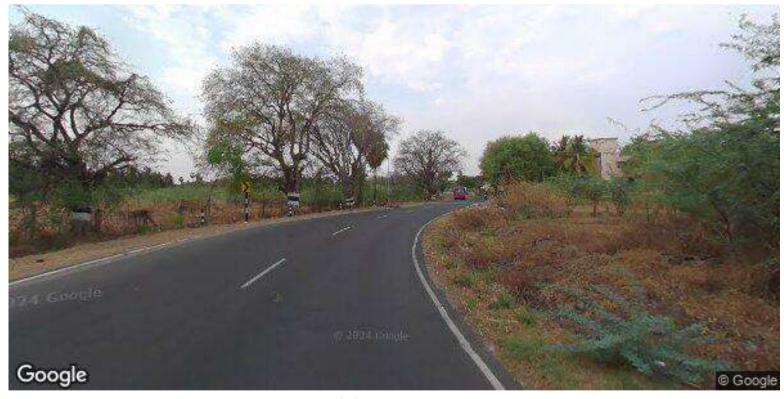
Coordinates: 11.34067, 77.86347

Risk Type: Turn
Risk Level: Medium
Speed Limit: 30 KM/Hr

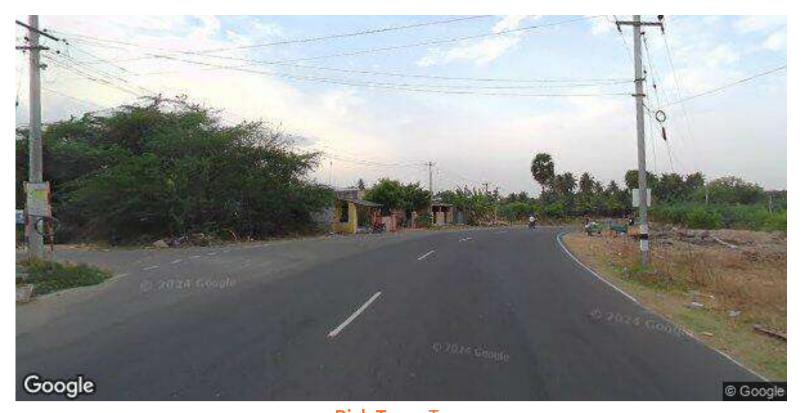
Risk Type: Turn
Risk Level: Medium
Speed Limit: 30 KM/Hr
Coordinates: 11.33854, 77.86216

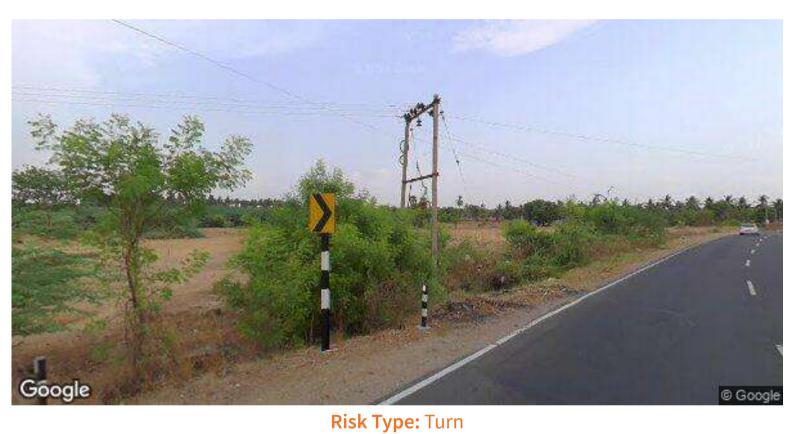
Risk Level: Medium
Speed Limit: 30 KM/Hr
Coordinates: 11.33778, 77.86236

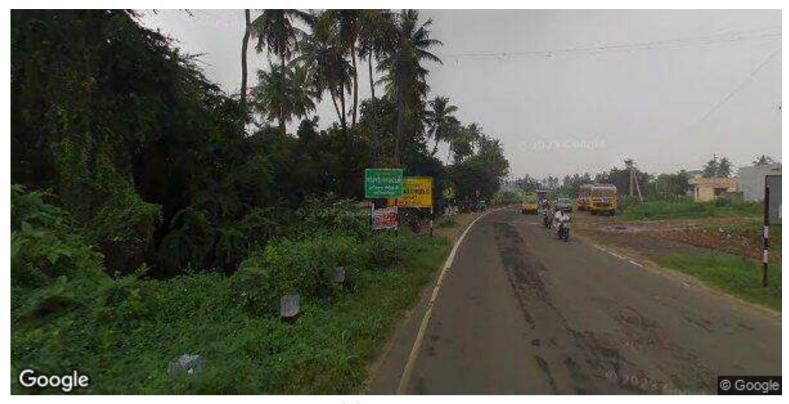
Risk Type: Turn
Risk Level: Medium
Speed Limit: 30 KM/Hr
Coordinates: 11.30955, 77.77637

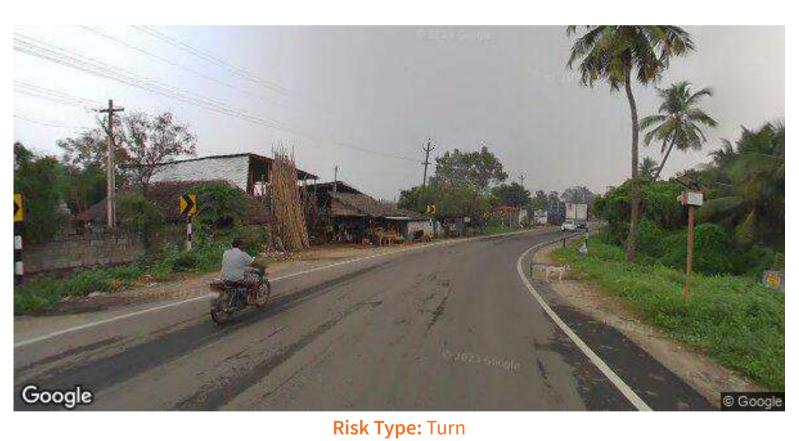
Risk Type. Turn
Risk Level: Medium
Speed Limit: 30 KM/Hr
Coordinates: 11.30963, 77.76695

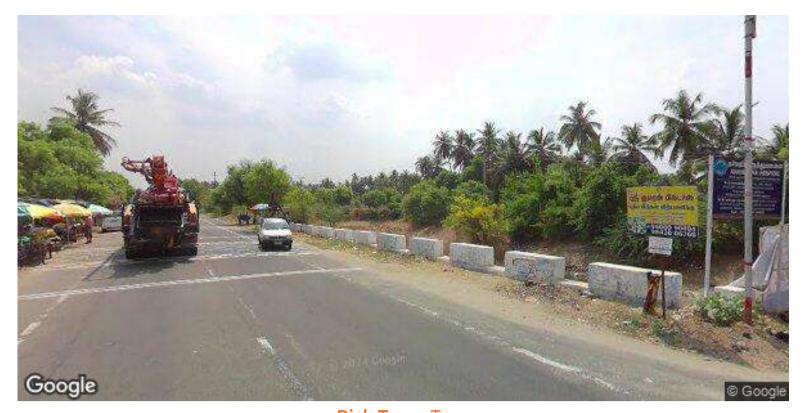
Risk Type: Turn
Risk Level: High
Speed Limit: 15 KM/Hr
Coordinates: 11.29490, 77.74685

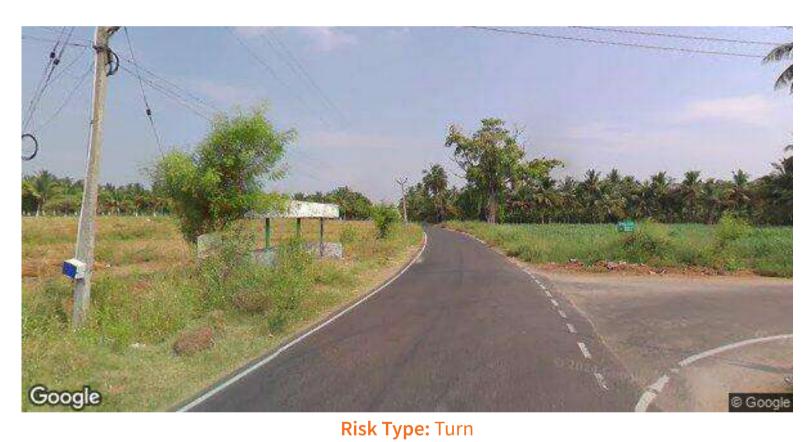
Risk Level: High
Speed Limit: 15 KM/Hr
Coordinates: 11.29141, 77.74662

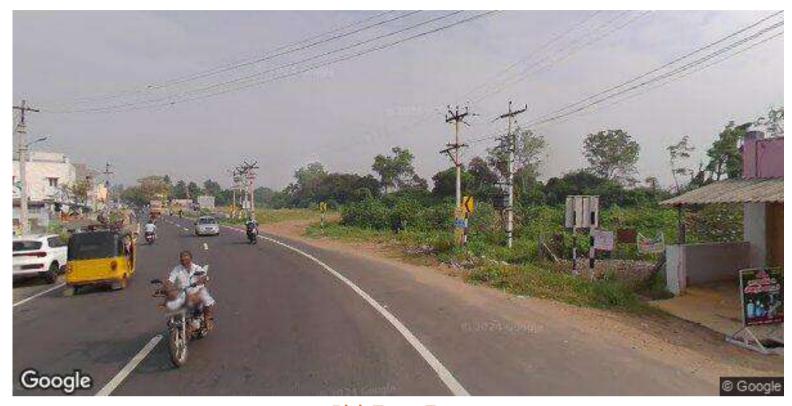
Risk Type: Turn
Risk Level: Medium
Speed Limit: 30 KM/Hr
Coordinates: 11.16078, 77.70122

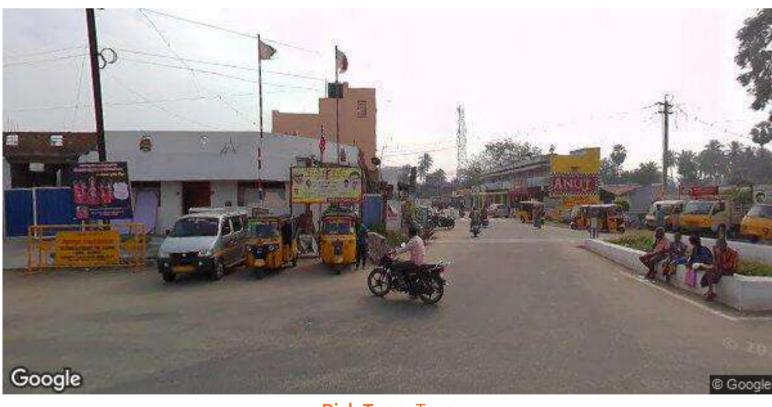
Risk Type: Turn
Risk Level: Medium
Speed Limit: 30 KM/Hr
Coordinates: 11.15953, 77.70067

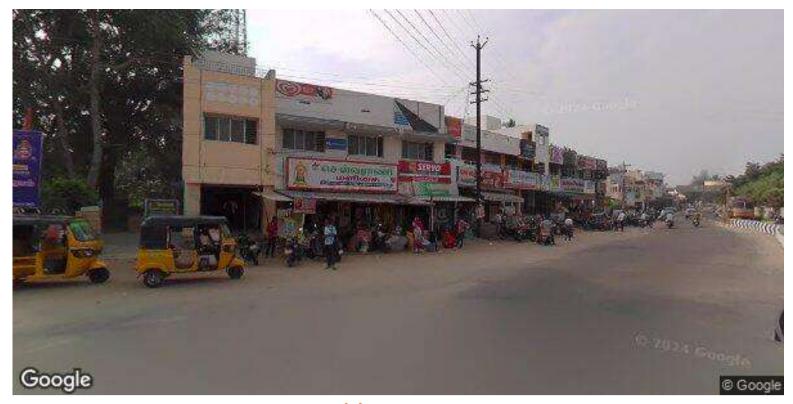
Risk Type: Turn
Risk Level: High
Speed Limit: 15 KM/Hr
Coordinates: 11.15944, 77.70068

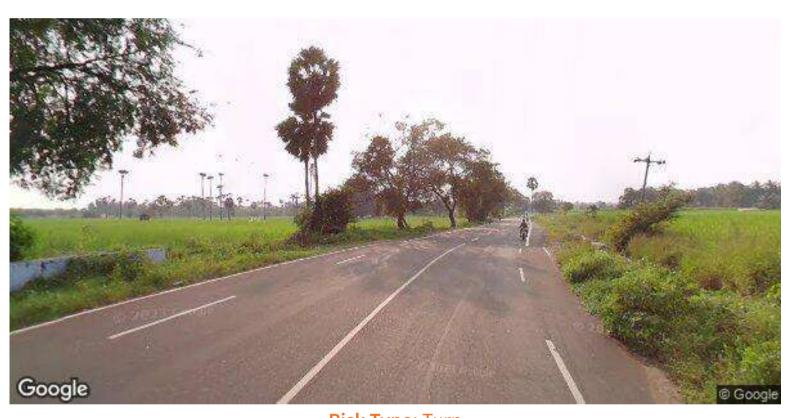
Risk Type: Turn
Risk Level: Medium
Speed Limit: 30 KM/Hr
Coordinates: 11.11918, 77.67766

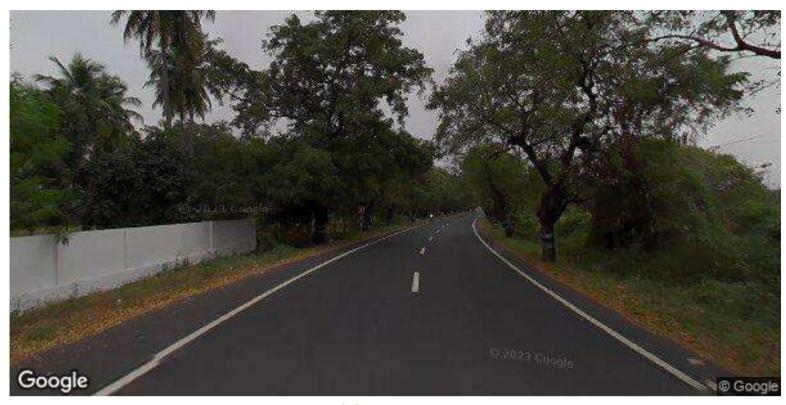
Coordinates: 11.10481, 77.67060

Risk Type: Turn
Risk Level: Medium
Speed Limit: 30 KM/Hr

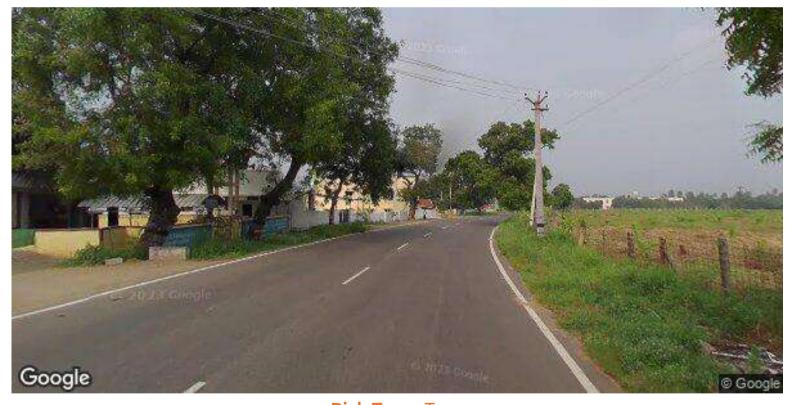
Risk Type: Turn
Risk Level: Medium
Speed Limit: 30 KM/Hr
Coordinates: 11.09509, 77.66612

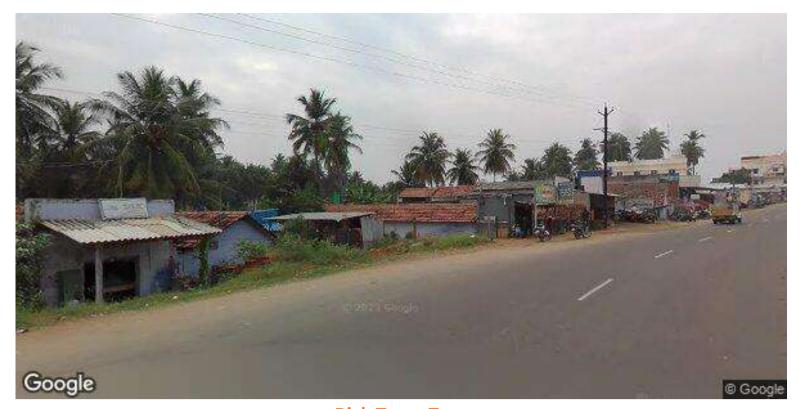
Risk Type: Turn
Risk Level: Medium
Speed Limit: 30 KM/Hr
Coordinates: 11.08730, 77.66436

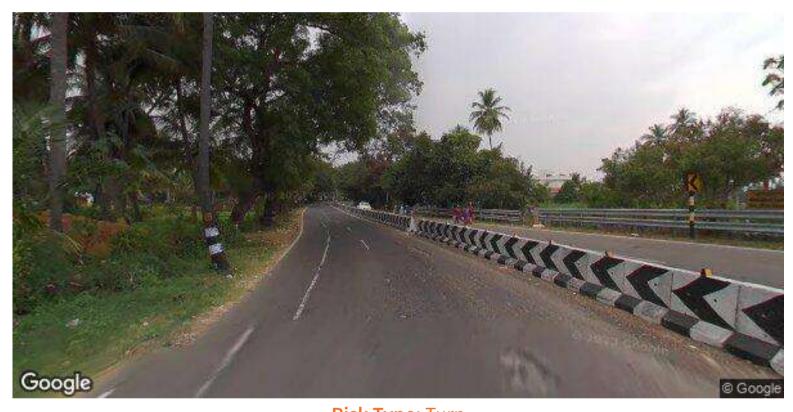
Risk Type: Turn
Risk Level: Medium
Speed Limit: 30 KM/Hr
Coordinates: 11.08282, 77.65837

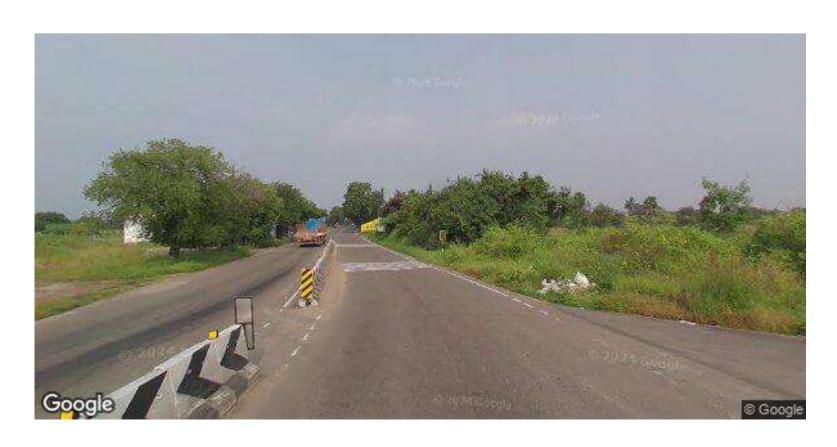
Coordinates: 11.06189, 77.63943

Risk Type: Turn
Risk Level: High
Speed Limit: 15 KM/Hr

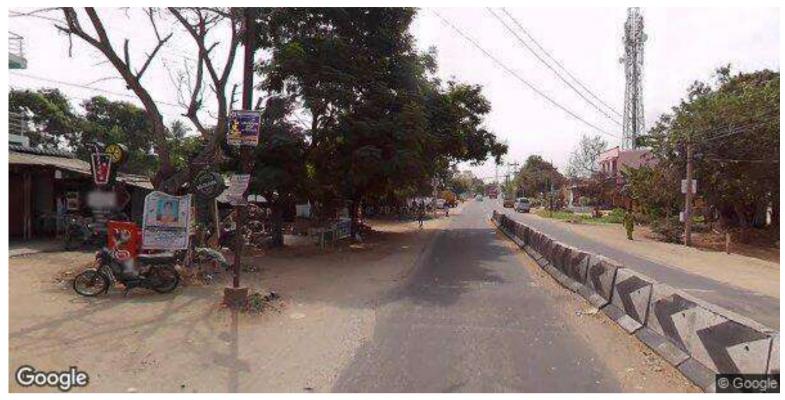
Coordinates: 11.00826, 77.56962

Risk Type: Turn
Risk Level: High
Speed Limit: 15 KM/Hr

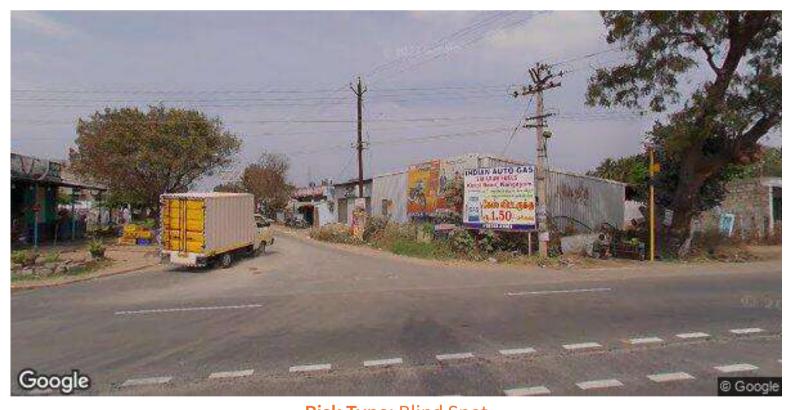
Coordinates: 11.00058, 77.56882

Risk Type: Blind Spot
Risk Level: Blind Spot
Speed Limit: 10 KM/Hr

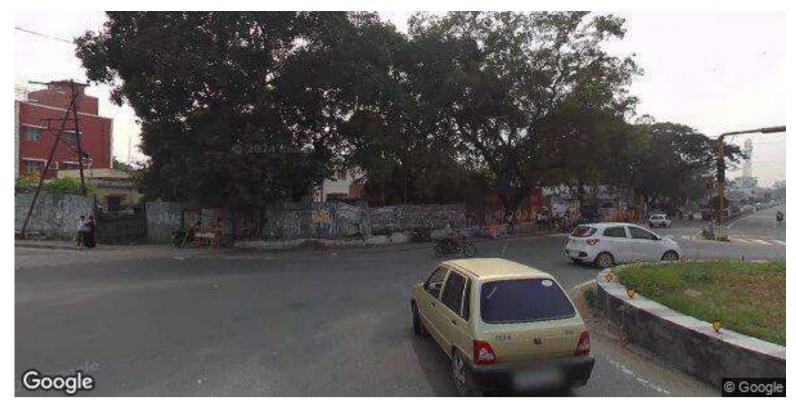
Risk Type: Turn
Risk Level: High
Speed Limit: 15 KM/Hr
Coordinates: 11.00171, 77.56267

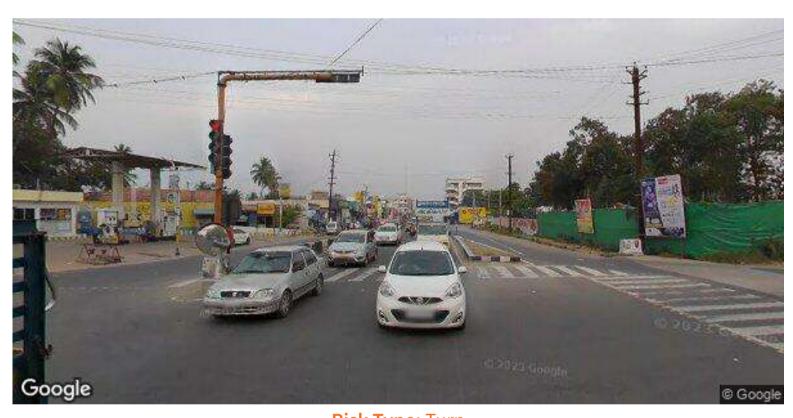
Risk Type: Turn
Risk Level: Medium
Speed Limit: 30 KM/Hr
Coordinates: 11.00168, 77.56265

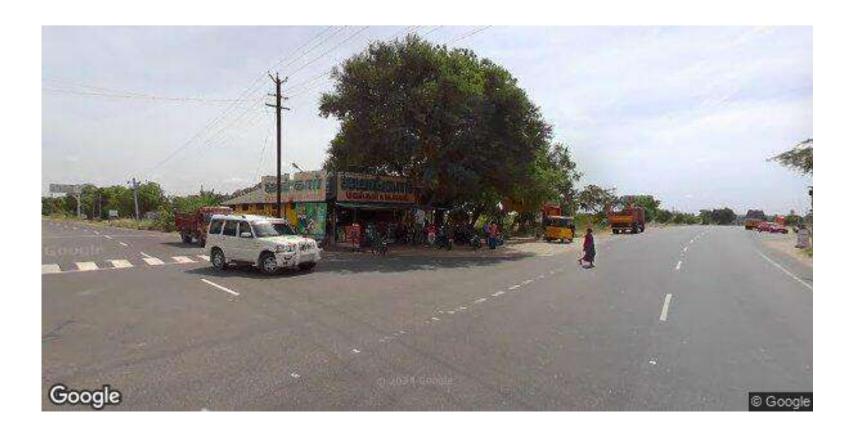
Coordinates: 10.97407, 77.44310

Risk Type: Blind Spot Risk Level: Blind Spot Speed Limit: 10 KM/Hr

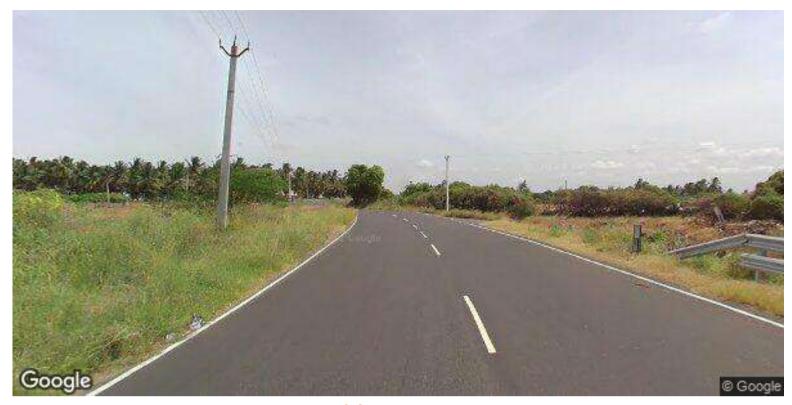
Coordinates: 10.99839, 77.43708

Risk Type: Turn
Risk Level: High
Speed Limit: 15 KM/Hr
