JOURNEY RISK MANAGEMENT (JRM) STUDY

Salem Terminal TO PGS PETROL BUNK

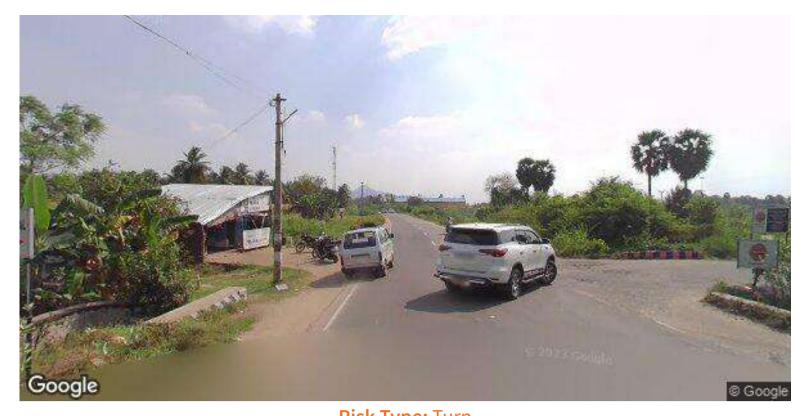
Risk Type: Turn
Speed Limit: 15 KM/Hr
Distance from Start: 0.29 km
Coordinates: 11.44029, 77.87544

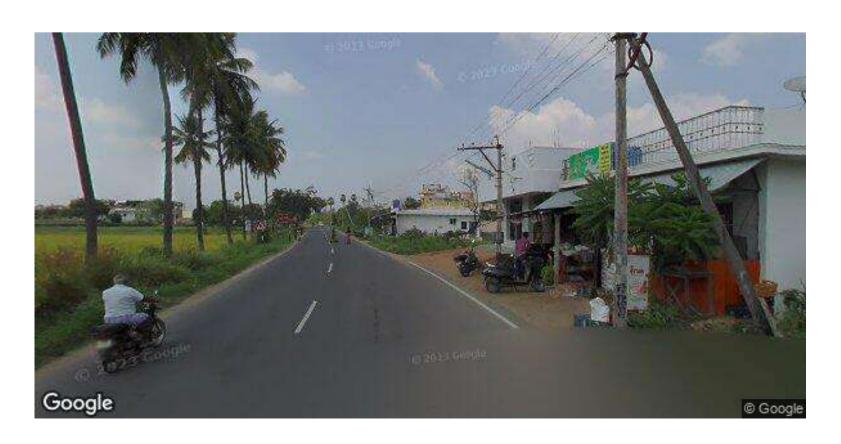
Risk Type: Turn
Speed Limit: 15 KM/Hr
Distance from Start: 2.15 km

Coordinates: 11.45127, 77.86734

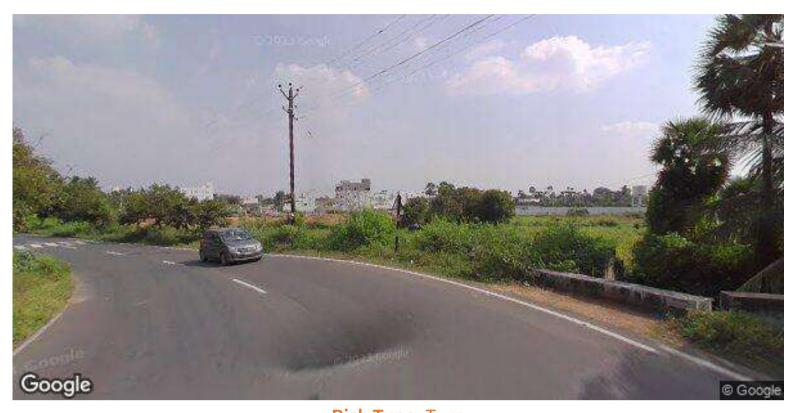
Risk Type: Turn
Speed Limit: 15 KM/Hr
Distance from Start: 3.29 km
Coordinates: 11.45350, 77.85700

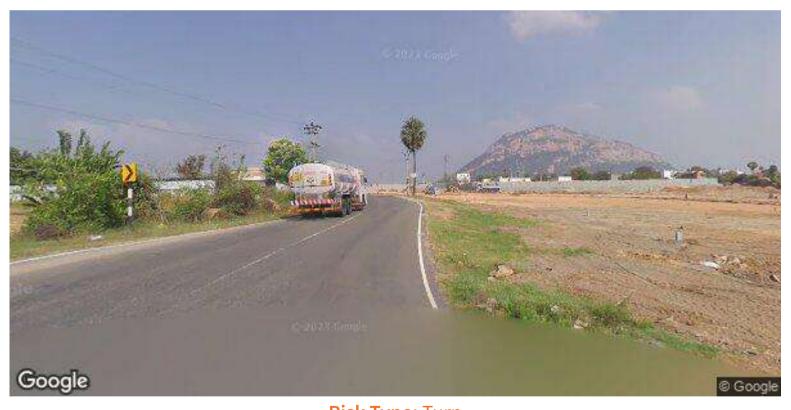
Risk Type: Turn
Speed Limit: 15 KM/Hr
Distance from Start: 4.11 km
Coordinates: 11.45845, 77.85141

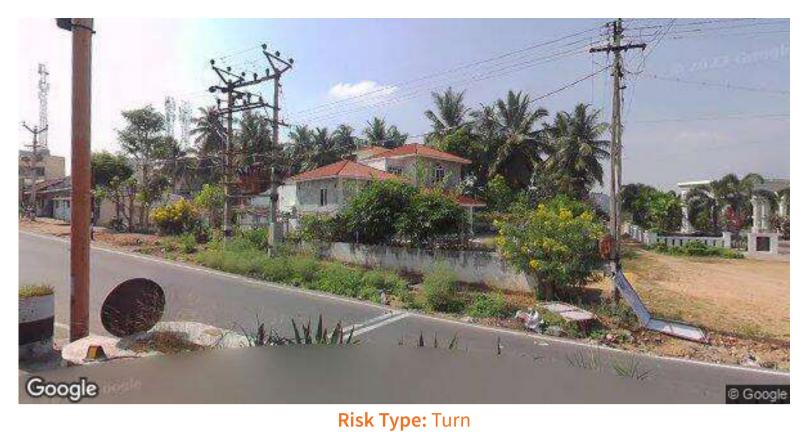
Speed Limit: 15 KM/Hr
Distance from Start: 4.65 km
Coordinates: 11.46303, 77.84945

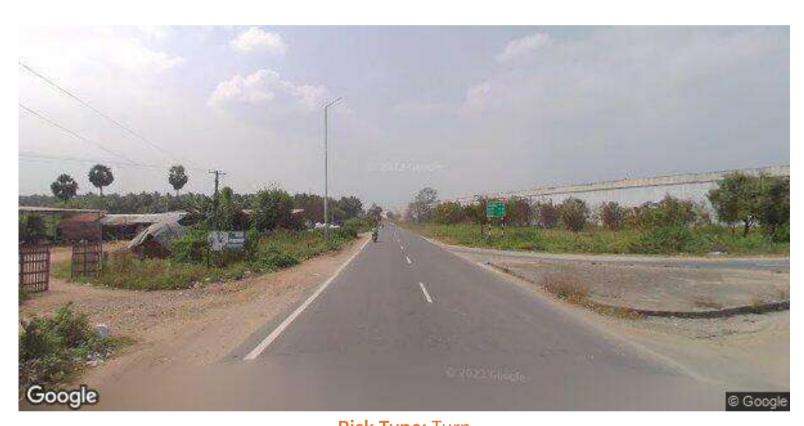
Risk Type: Turn
Speed Limit: 15 KM/Hr
Distance from Start: 8.37 km
Coordinates: 11.45542, 77.81725

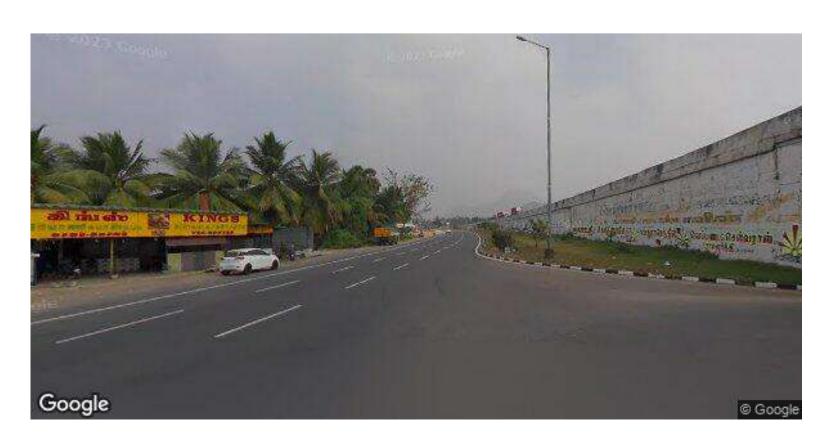
Risk Type: Blind Spot Speed Limit: 10 KM/Hr Distance from Start: 8.50 km

Coordinates: 11.45634, 77.81673

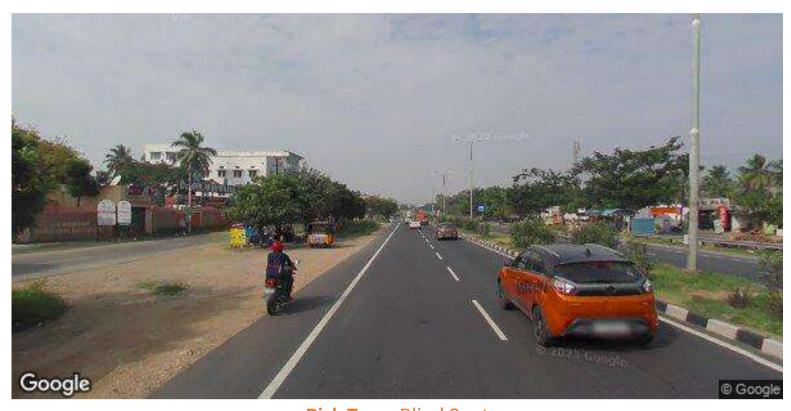
Risk Type: Blind Spot
Speed Limit: 10 KM/Hr
Distance from Start: 18.65 km
Coordinates: 11.44530, 77.72783

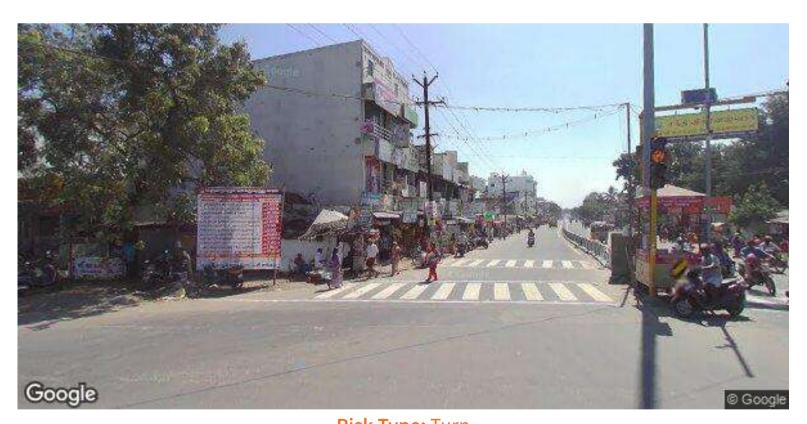
Risk Type: Turn
Speed Limit: 15 KM/Hr
Distance from Start: 74.23 km
Coordinates: 11.20728, 77.35914

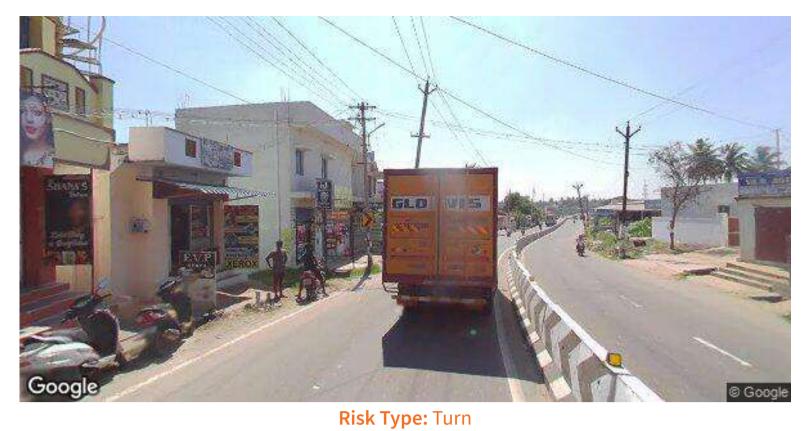
Speed Limit: 15 KM/Hr
Distance from Start: 74.85 km
Coordinates: 11.20246, 77.35895

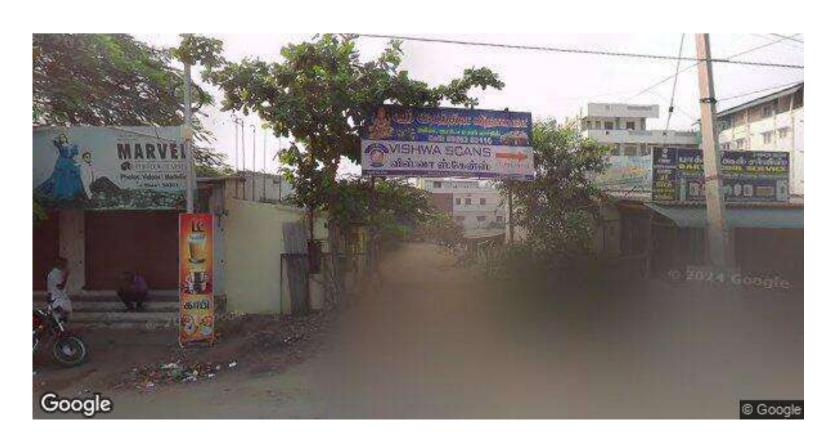
Risk Type: Turn
Speed Limit: 15 KM/Hr
Distance from Start: 83.24 km

Coordinates: 11.13131, 77.34033

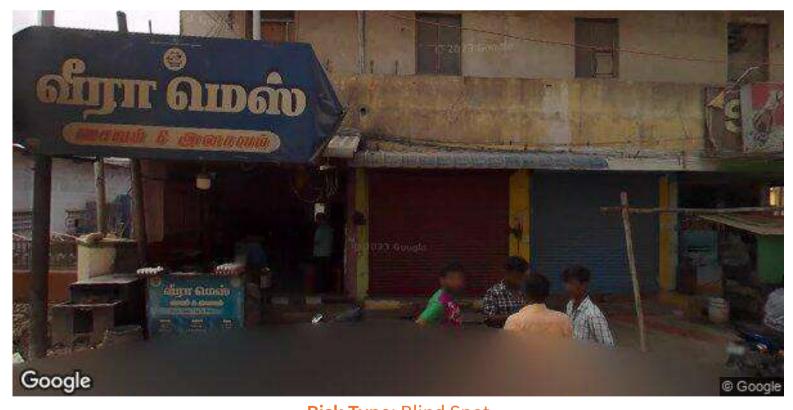
Risk Type: Blind Spot
Speed Limit: 10 KM/Hr
Distance from Start: 84.21 km
Coordinates: 11.12918, 77.33333

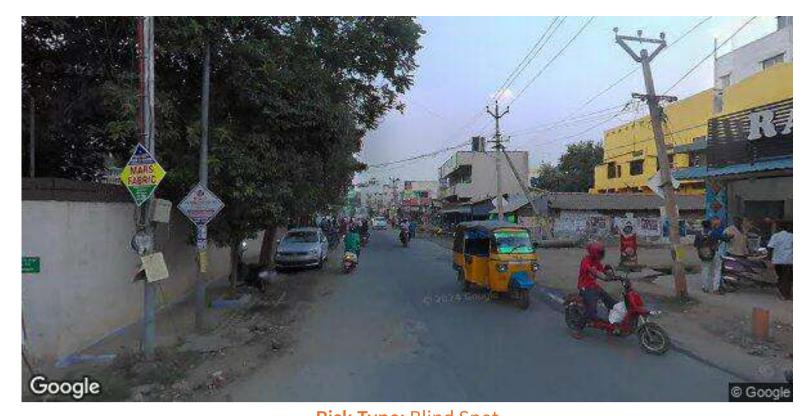
Risk Type: Blind Spot
Speed Limit: 10 KM/Hr
Distance from Start: 84.78 km
Coordinates: 11.13433, 77.33289
