# JOURNEY RISK MANAGEMENT (JRM) STUDY

### **IOCL Coimbatore Terminal to Sri Skanda Agencies**

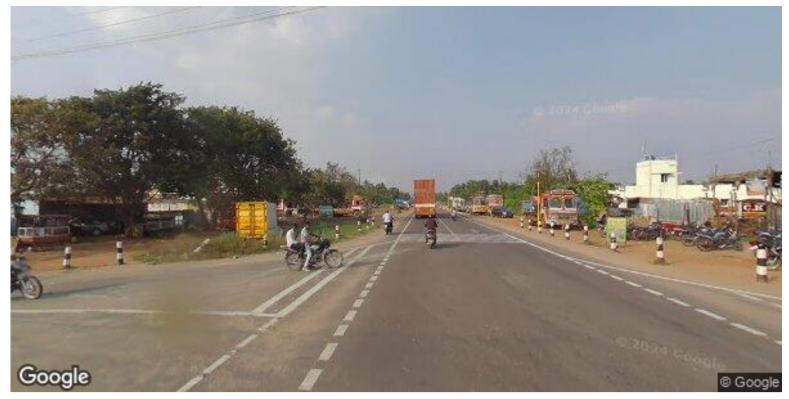
**Coordinates:** 11.03211, 77.07640

Risk Type: Turn
Risk Level: High
Speed Limit: 15 KM/Hr

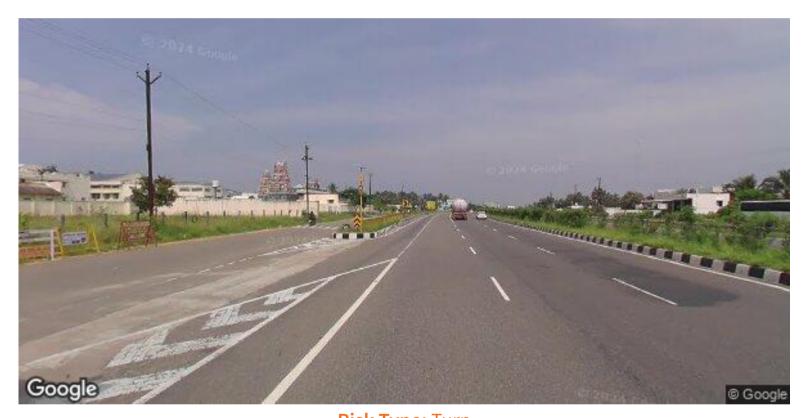
Risk Type: Turn
Risk Level: Medium
Speed Limit: 30 KM/Hr
Coordinates: 11.14084, 77.20403

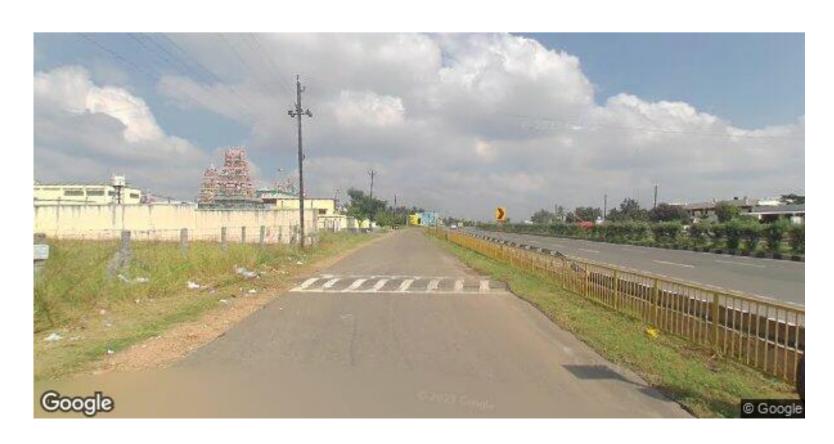
**Coordinates:** 11.14110, 77.20394

Risk Type: Turn
Risk Level: Medium
Speed Limit: 30 KM/Hr

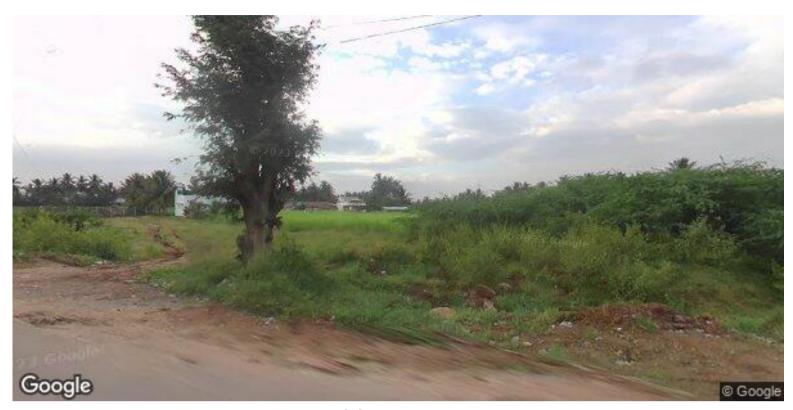
Coordinates: 11.15497, 77.21322

Risk Type: Turn
Risk Level: High
Speed Limit: 15 KM/Hr

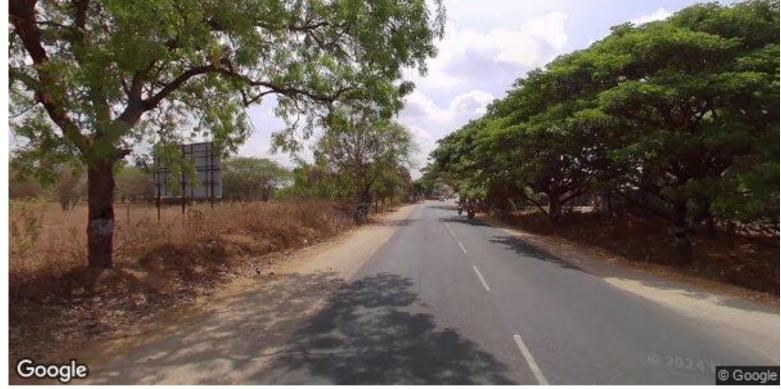
Risk Type: Turn
Risk Level: High
Speed Limit: 15 KM/Hr
Coordinates: 11.20298, 77.22563

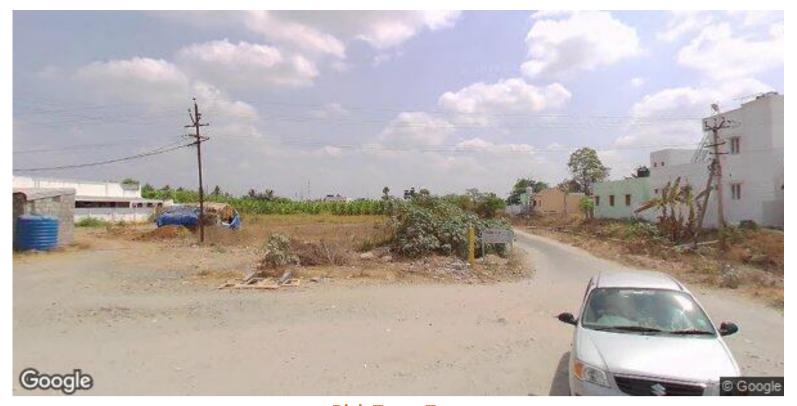
Risk Type: Turn
Risk Level: High
Speed Limit: 15 KM/Hr
Coordinates: 11.20290, 77.22764

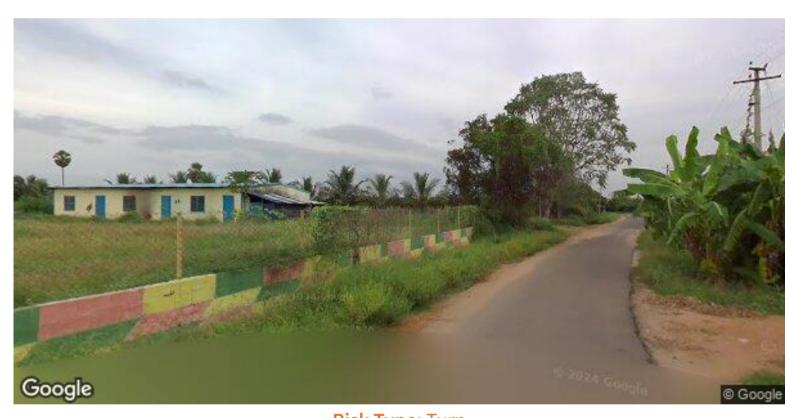
Risk Type: Turn
Risk Level: Medium
Speed Limit: 30 KM/Hr
Coordinates: 11.23543, 77.23700

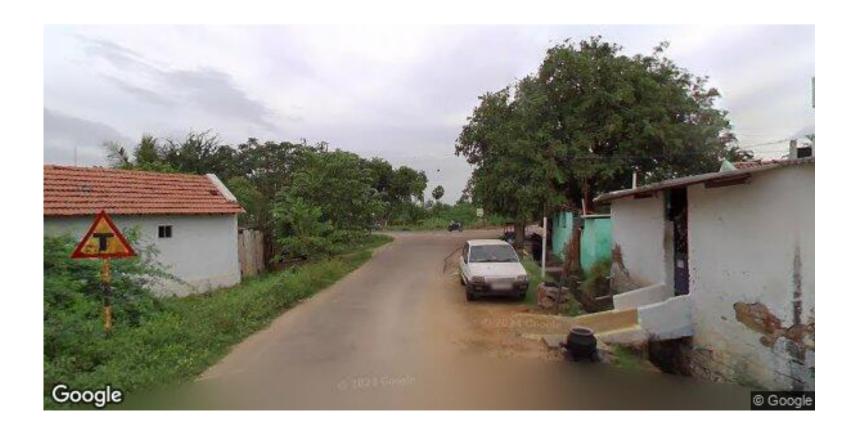
**Coordinates:** 11.23929, 77.23789

Risk Type: Turn
Risk Level: Medium
Speed Limit: 30 KM/Hr

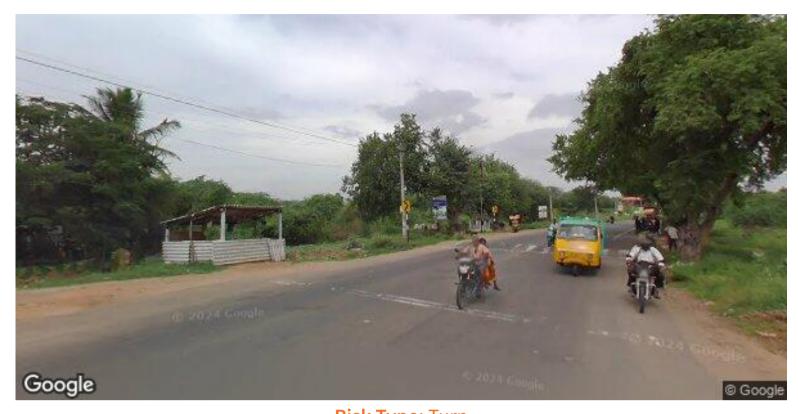
**Coordinates:** 11.23953, 77.23817

Risk Type: Turn
Risk Level: High
Speed Limit: 15 KM/Hr

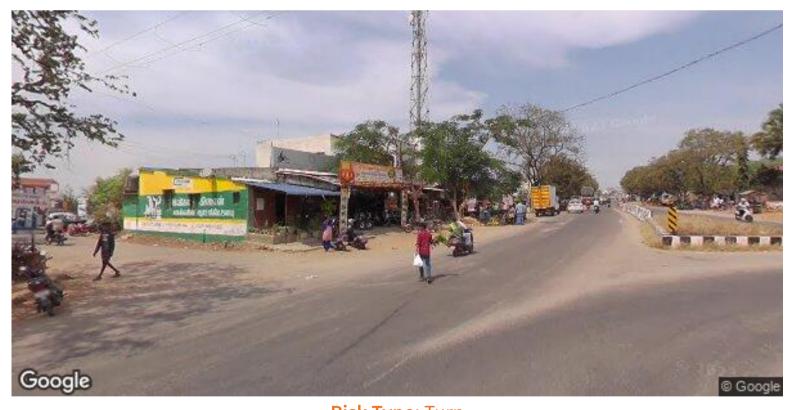
**Coordinates:** 11.24260, 77.23782

Risk Type: Turn
Risk Level: Medium
Speed Limit: 30 KM/Hr

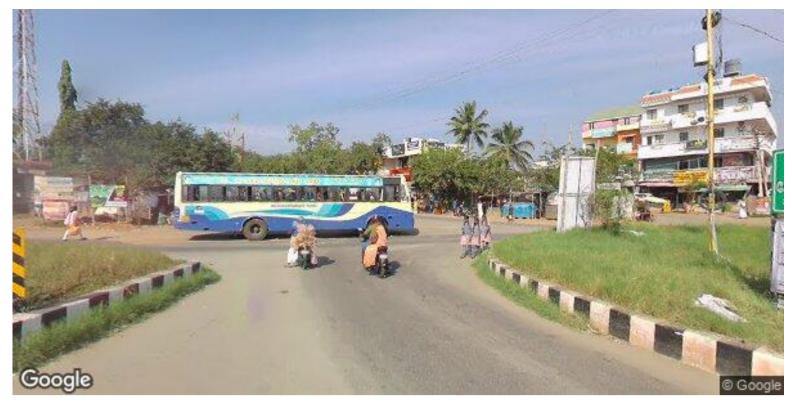
Risk Type: Turn
Risk Level: High
Speed Limit: 15 KM/Hr
Coordinates: 11.24271, 77.23777

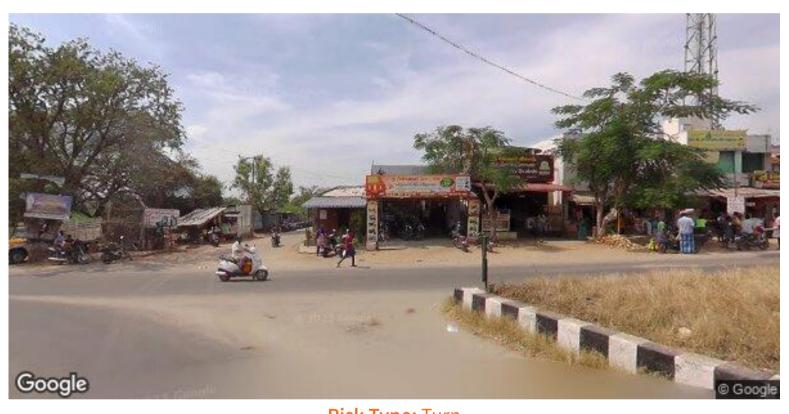
Risk Type: Turn
Risk Level: Medium
Speed Limit: 30 KM/Hr
Coordinates: 11.24280, 77.23782

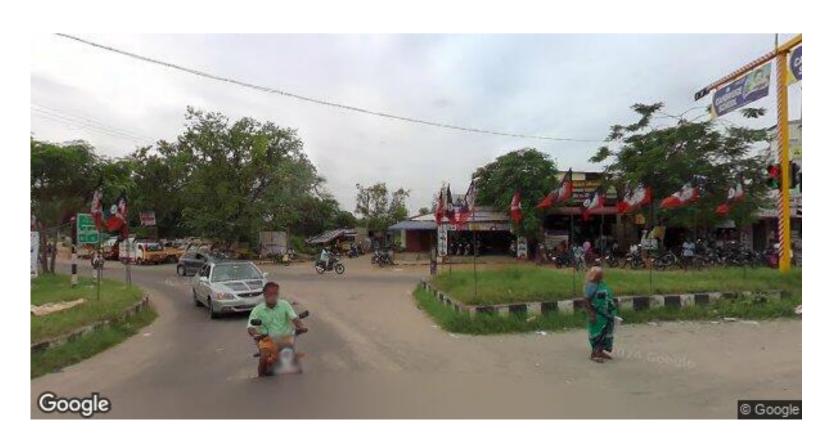
**Coordinates:** 11.24281, 77.23785

Risk Type: Turn
Risk Level: High
Speed Limit: 15 KM/Hr

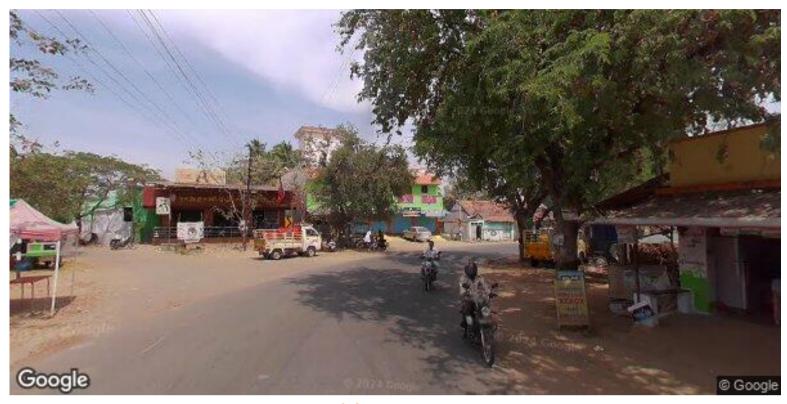
Risk Type: Turn
Risk Level: Medium
Speed Limit: 30 KM/Hr
Coordinates: 11.24910, 77.23723

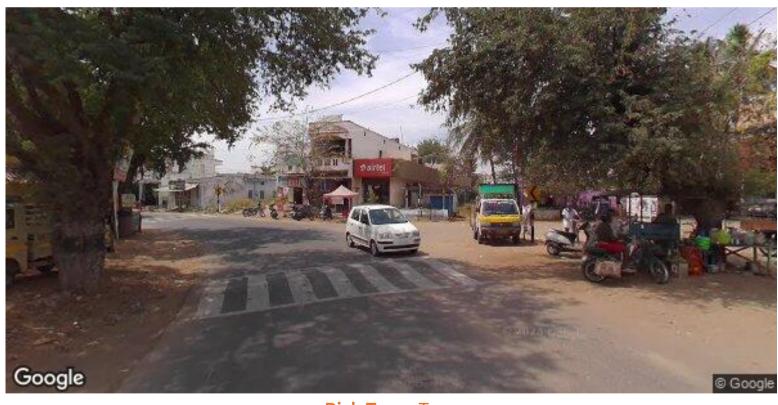
Risk Type: Turn
Risk Level: Medium
Speed Limit: 30 KM/Hr
Coordinates: 11.24927, 77.23739

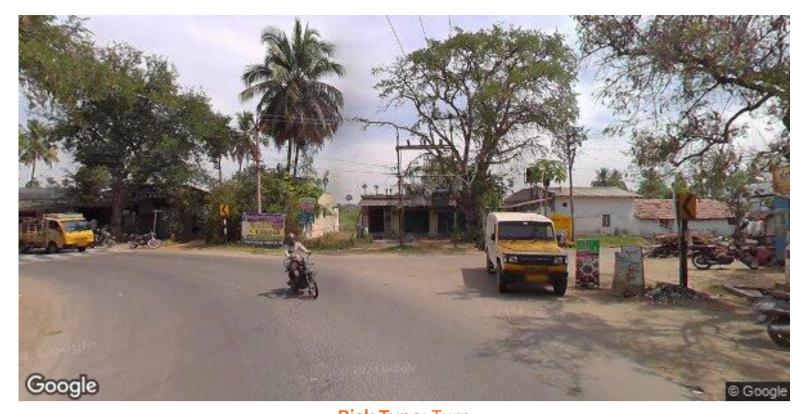
Risk Type: Turn
Risk Level: Medium
Speed Limit: 30 KM/Hr
Coordinates: 11.24940, 77.23788

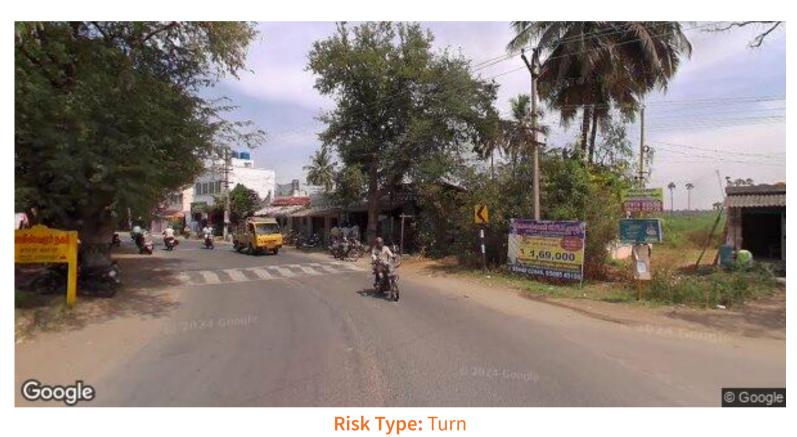
Risk Type: Turn
Risk Level: High
Speed Limit: 15 KM/Hr
Coordinates: 11.24949, 77.23797

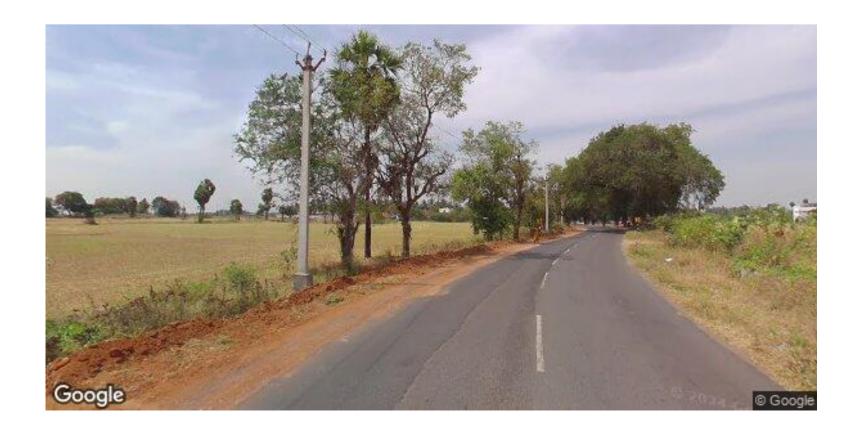
**Coordinates:** 11.25949, 77.24611

Risk Type: Turn
Risk Level: Medium
Speed Limit: 30 KM/Hr

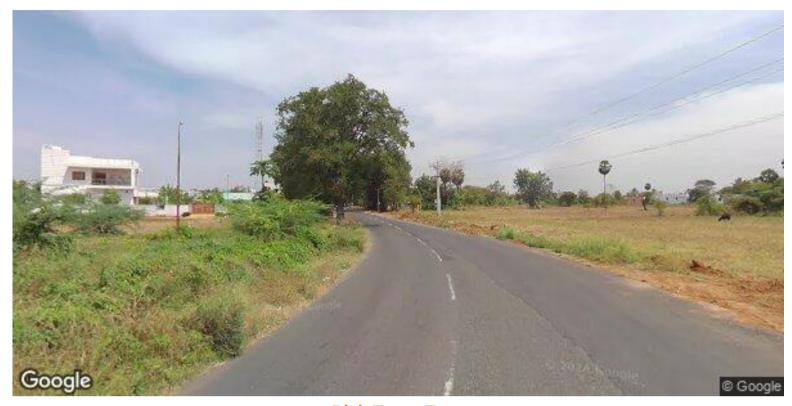
**Coordinates:** 11.25963, 77.24639

Risk Type: Turn
Risk Level: Medium
Speed Limit: 30 KM/Hr
