JOURNEY RISK MANAGEMENT (JRM) STUDY

IOCL Coimbatore Terminal to Velmurugan Service Station

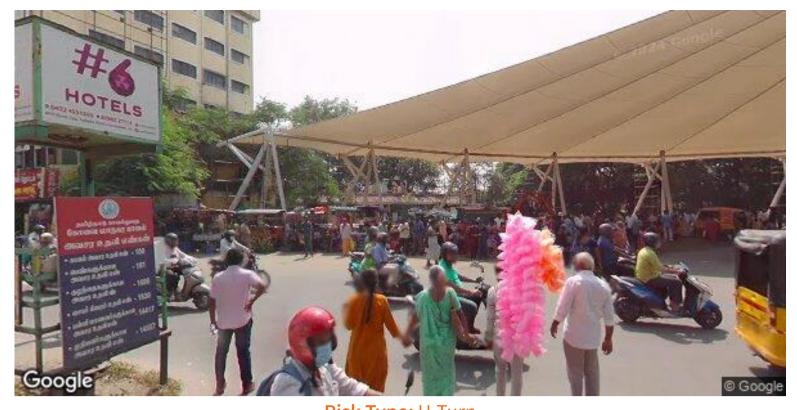
Coordinates: 10.9947329, 76.9695579

Risk Type: U-Turn
Risk Level: High
Speed Limit: 10 KM/Hr

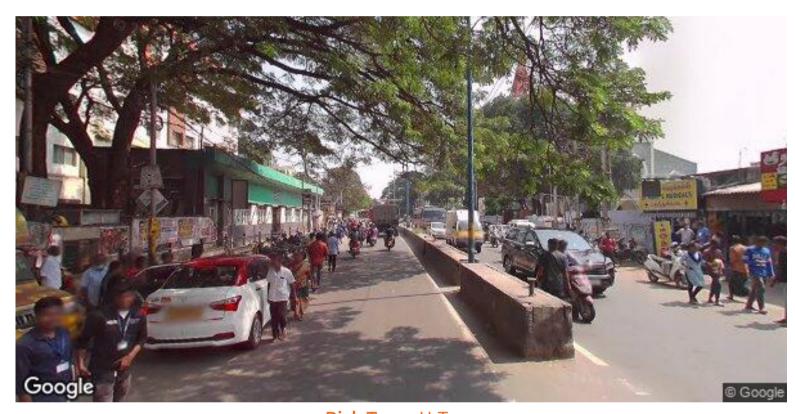
Coordinates: 10.9948308, 76.97018039999999

Risk Type: U-Turn
Risk Level: High
Speed Limit: 10 KM/Hr

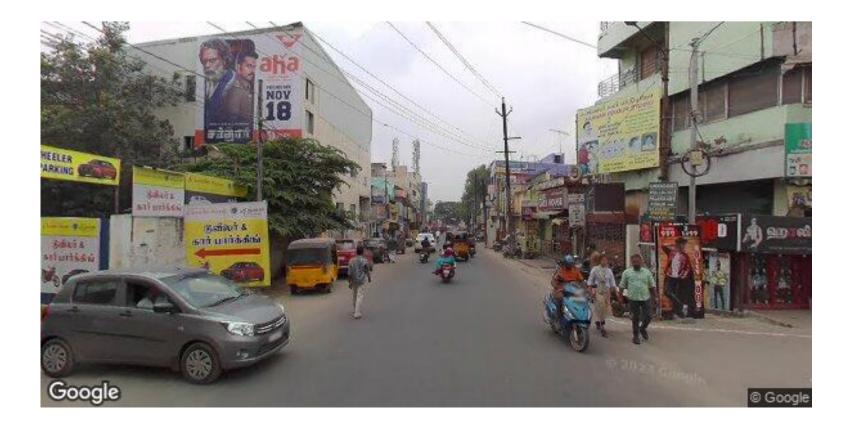
Coordinates: 10.9924704, 76.9606424

Risk Type: U-Turn
Risk Level: High
Speed Limit: 10 KM/Hr

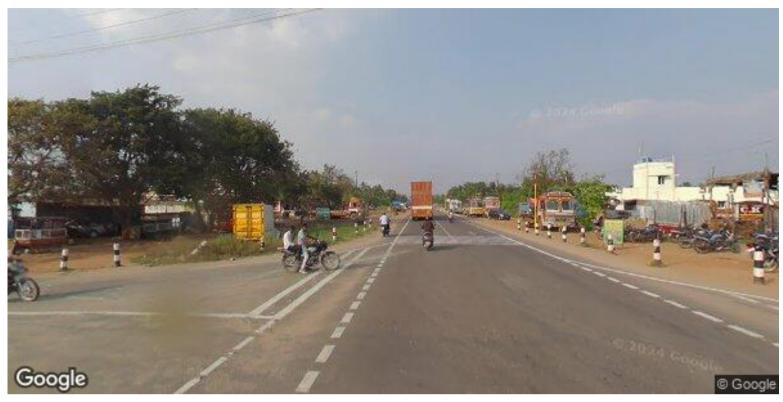
Coordinates: 11.03211, 77.07640

Risk Type: Blind Spot Risk Level: Blind Spot Speed Limit: 10 KM/Hr

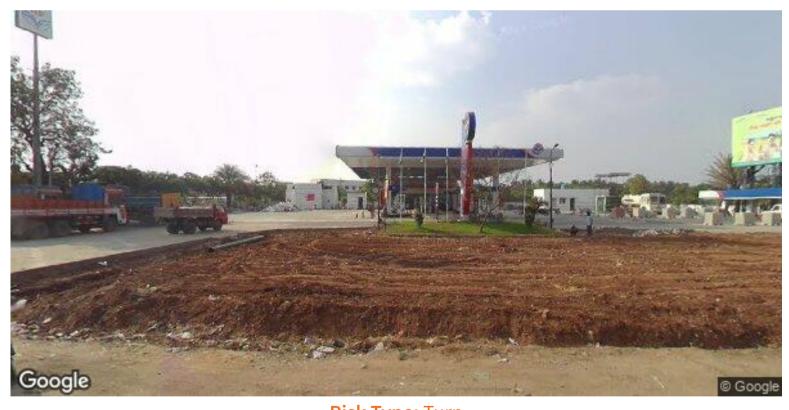
Risk Type: Turn
Risk Level: Medium
Speed Limit: 30 KM/Hr
Coordinates: 11.00873, 77.07114

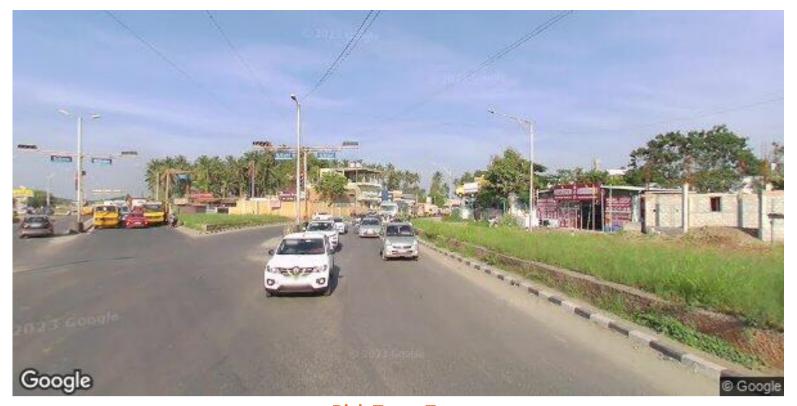
Coordinates: 11.00737, 77.07049

Risk Type: Turn
Risk Level: Medium
Speed Limit: 30 KM/Hr

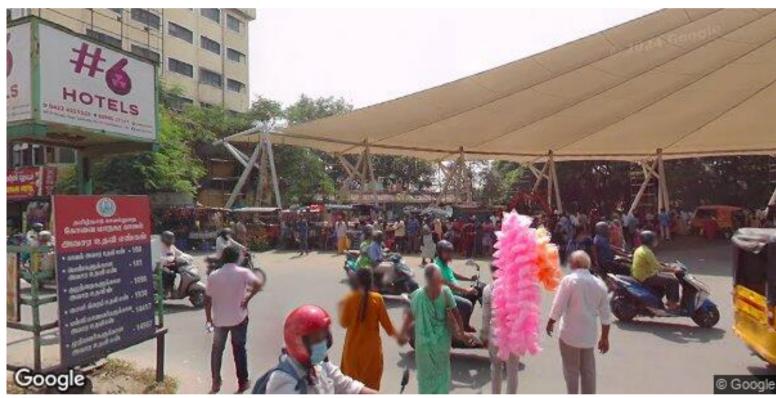
Coordinates: 10.99473, 76.96956

Risk Type: Turn
Risk Level: High
Speed Limit: 15 KM/Hr

Risk Type: Blind Spot
Risk Level: Blind Spot
Speed Limit: 10 KM/Hr

Coordinates: 10.99481, 76.96955

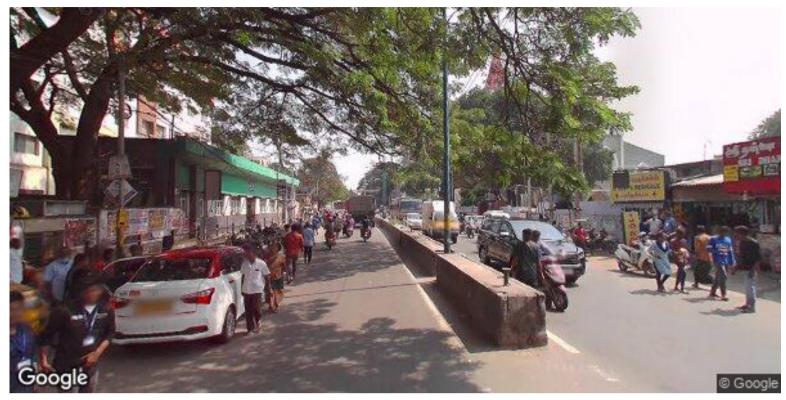
Coordinates: 10.99483, 76.97018

Risk Type: Turn
Risk Level: High
Speed Limit: 15 KM/Hr

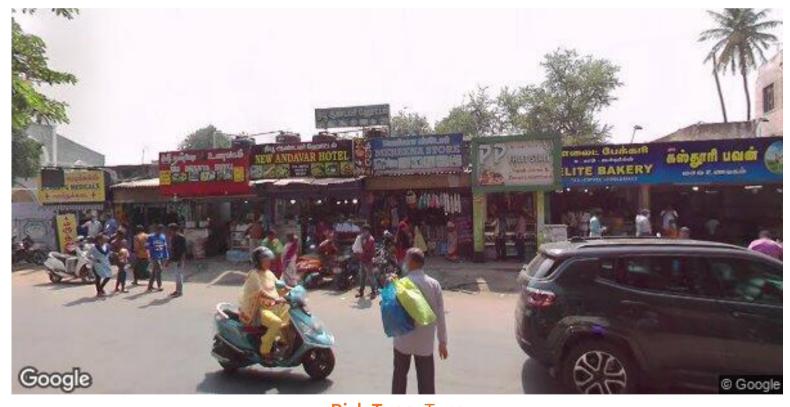
Coordinates: 10.99477, 76.97018

Risk Type: Turn
Risk Level: High
Speed Limit: 15 KM/Hr

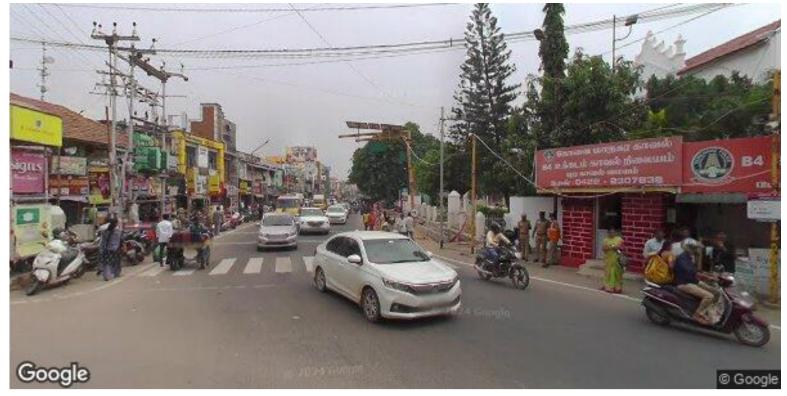
Coordinates: 10.99353, 76.96082

Risk Type: Turn
Risk Level: High
Speed Limit: 15 KM/Hr

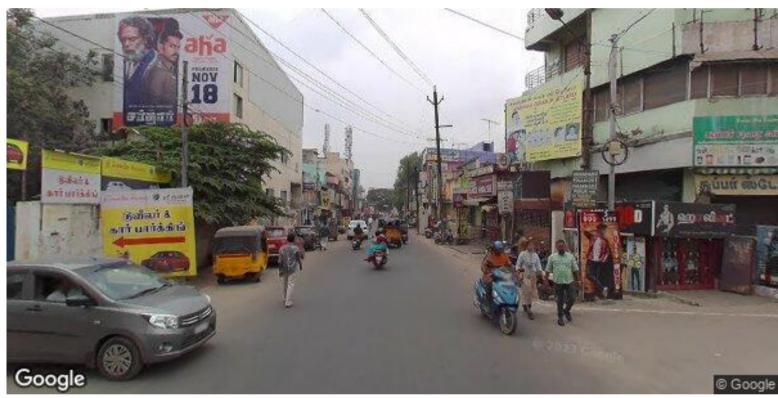
Coordinates: 10.99247, 76.96064

Risk Type: Turn
Risk Level: High
Speed Limit: 15 KM/Hr

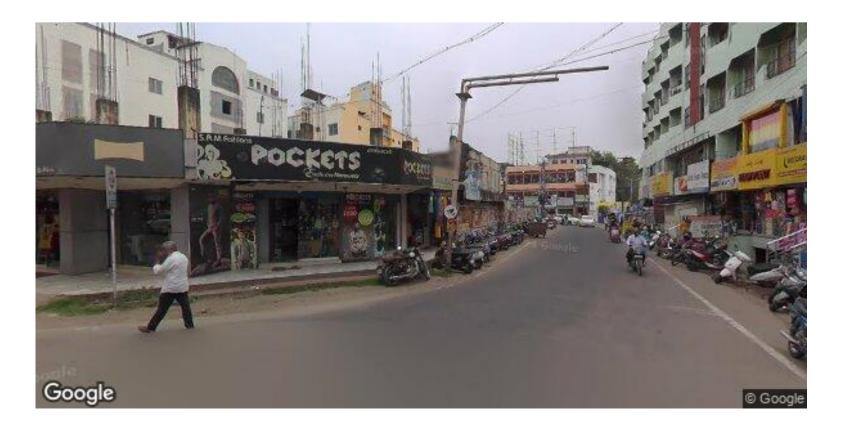
Coordinates: 10.99240, 76.96003

Risk Type: Turn
Risk Level: High
Speed Limit: 15 KM/Hr

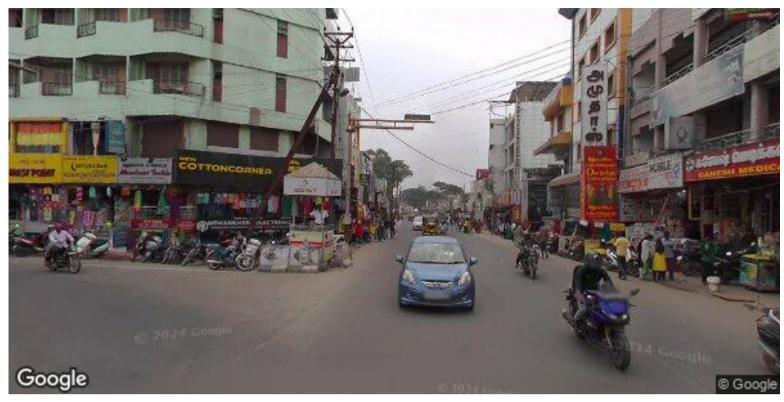
Coordinates: 10.99247, 76.96001

Risk Type: Turn
Risk Level: High
Speed Limit: 15 KM/Hr

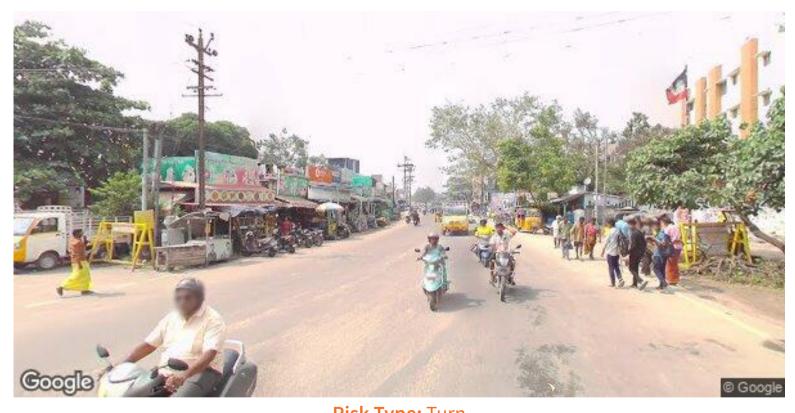
Coordinates: 10.99220, 76.95053

Risk Type: Turn
Risk Level: Medium
Speed Limit: 30 KM/Hr

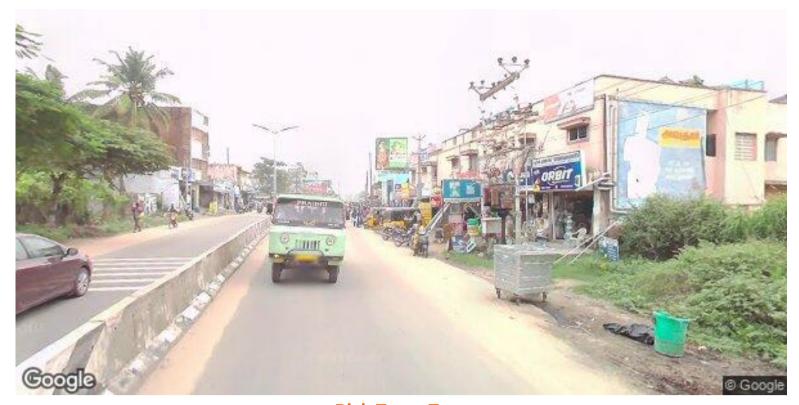
Risk Type: Turn
Risk Level: Medium
Speed Limit: 30 KM/Hr
Coordinates: 10.98396, 76.92463

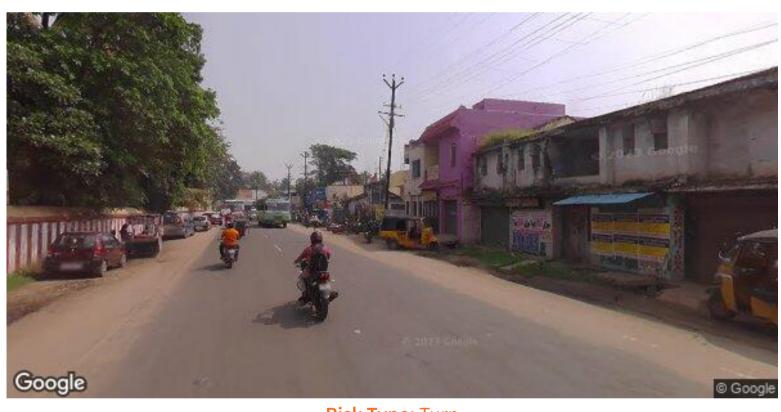
Risk Type: Turn
Risk Level: Medium
Speed Limit: 30 KM/Hr
Coordinates: 10.97533, 76.91472

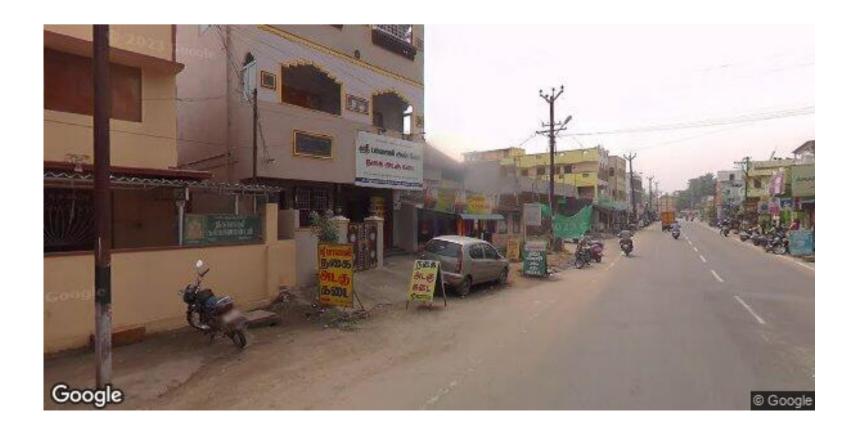
Coordinates: 10.97527, 76.91468

Risk Type: Turn
Risk Level: Medium
Speed Limit: 30 KM/Hr

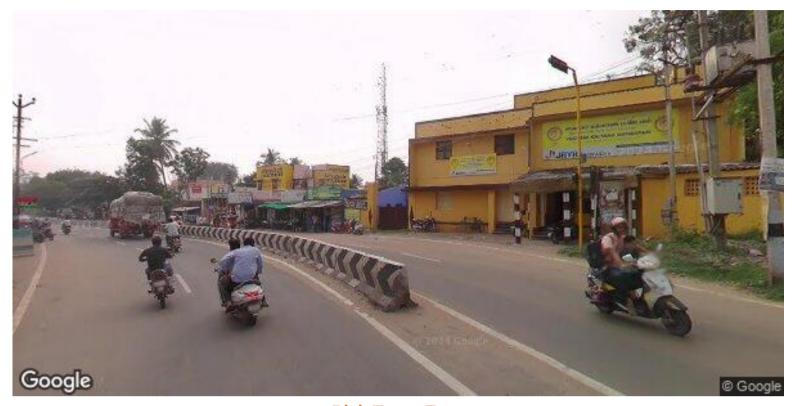
Coordinates: 10.97448, 76.91289

Risk Type: Turn
Risk Level: Medium
Speed Limit: 30 KM/Hr

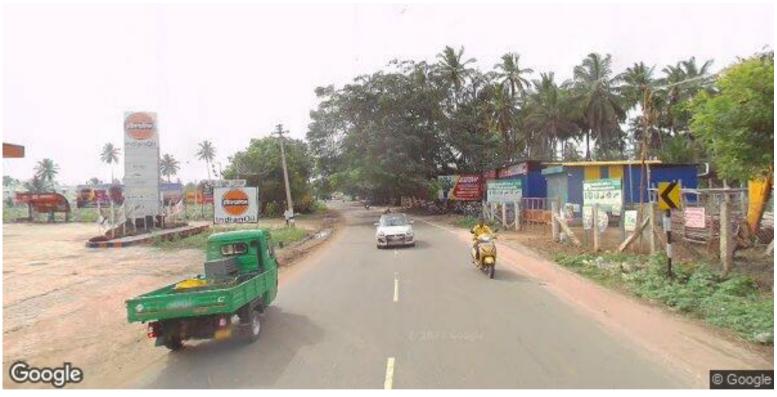
Risk Type: Turn
Risk Level: High
Speed Limit: 15 KM/Hr
Coordinates: 10.97444, 76.86585
