# JOURNEY RISK MANAGEMENT (JRM) STUDY

# Salem Terminal To SREE SAI PETROLEUM AGENCY

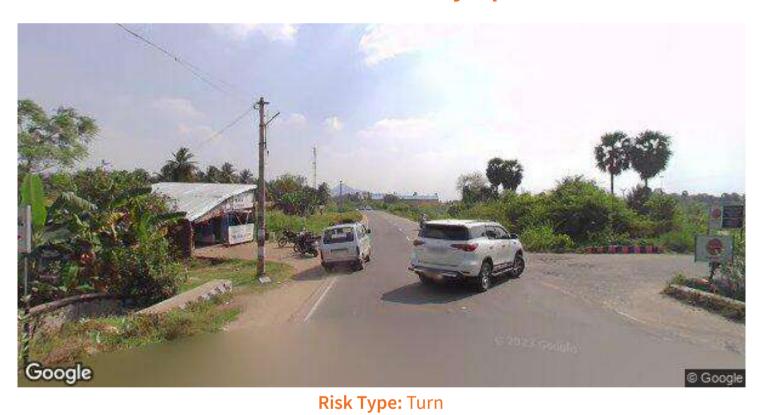
Risk Level: High
Speed Limit: 15 KM/Hr
Coordinates: 11.44029, 77.87544

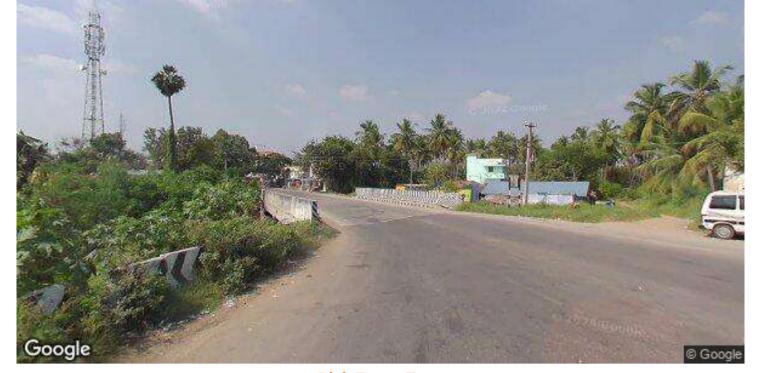
Risk Type: Turn
Risk Level: High
Speed Limit: 15 KM/Hr
Coordinates: 11.44893, 77.87413

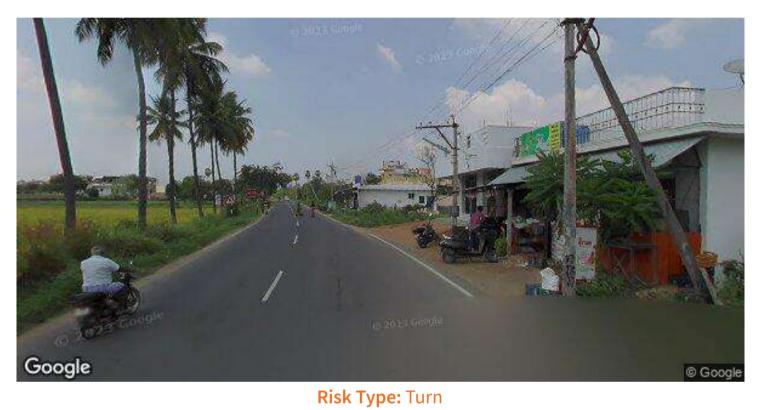
Risk Level: Medium
Speed Limit: 30 KM/Hr
Coordinates: 11.45127, 77.86734

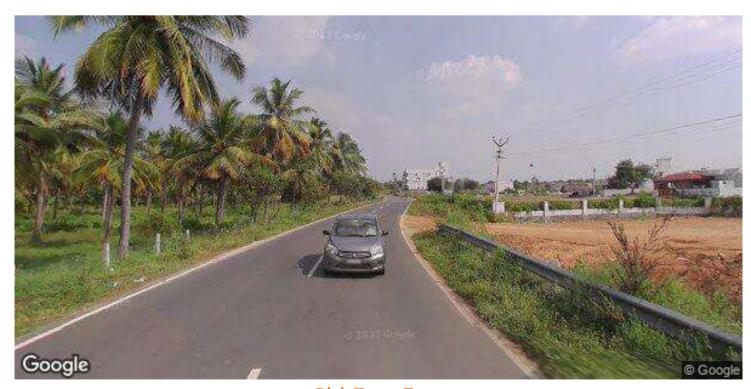
Risk Type: Turn
Risk Level: Medium

Speed Limit: 30 KM/Hr Coordinates: 11.45354, 77.85798

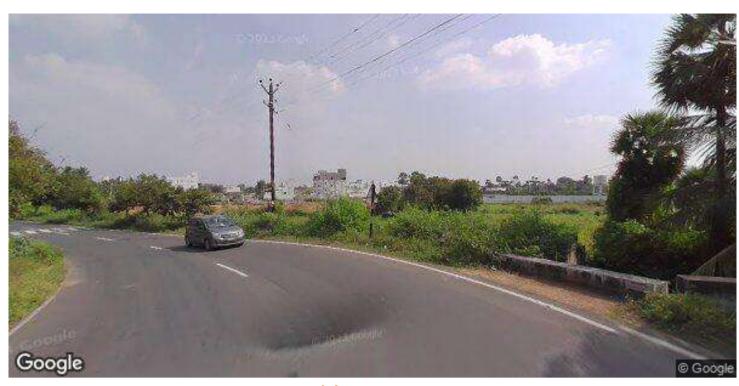
Risk Type: Turn
Risk Level: High
Speed Limit: 15 KM/Hr
Coordinates: 11.45350, 77.85700

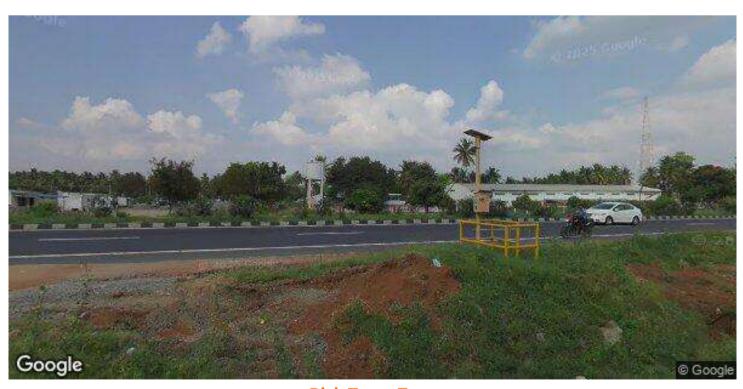
Risk Type: Turn
Risk Level: Medium

Speed Limit: 30 KM/Hr Coordinates: 11.29141, 77.58266

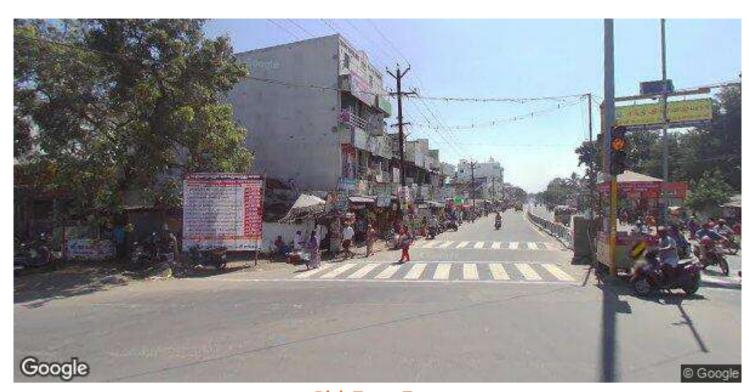
Risk Type: Turn
Risk Level: High
Speed Limit: 15 KM/Hr
Coordinates: 11.20728, 77.35914

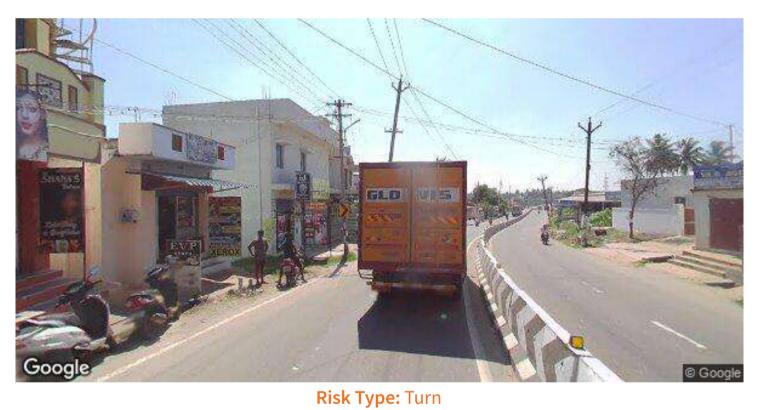
Risk Level: Medium
Speed Limit: 30 KM/Hr
Coordinates: 11.20246, 77.35895

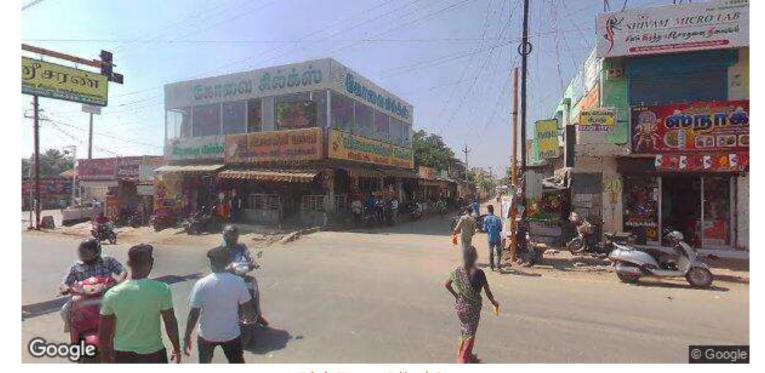
Risk Type: Blind Spot
Risk Level: Blind Spot
Speed Limit: 10 KM/Hr

**Coordinates:** 11.14829, 77.34631
