# JOURNEY RISK MANAGEMENT (JRM) STUDY

## **Salem Terminal to ABHI FUELS**

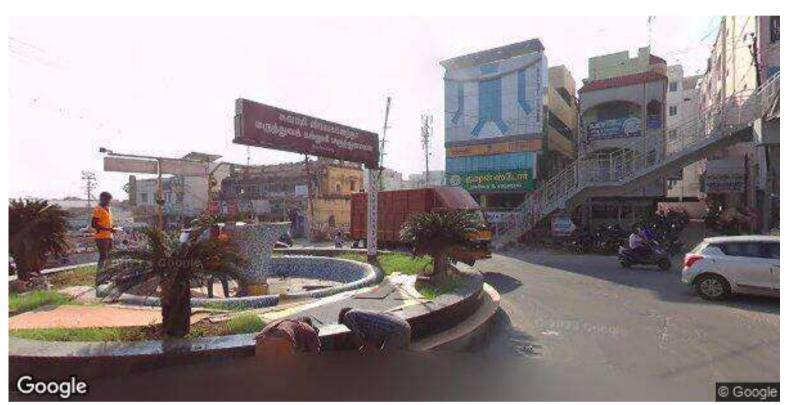
**Coordinates:** 11.38395, 77.89480

Risk Type: Roundabout
Risk Level: High
Speed Limit: 15 KM/Hr

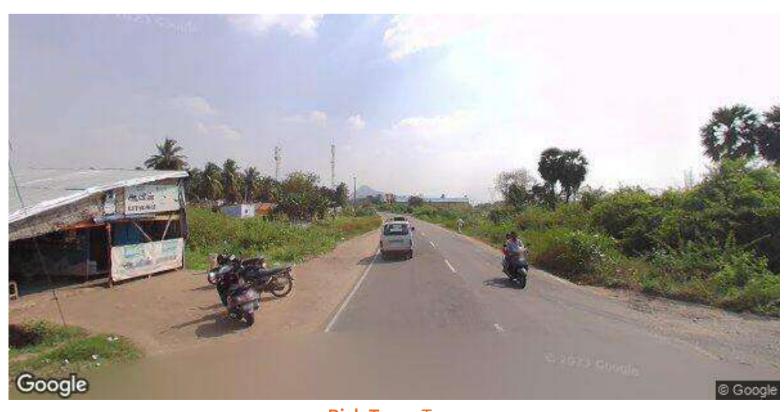
Risk Type: Turn
Risk Level: High

Speed Limit: 15 KM/Hr Coordinates: 11.44022, 77.87546

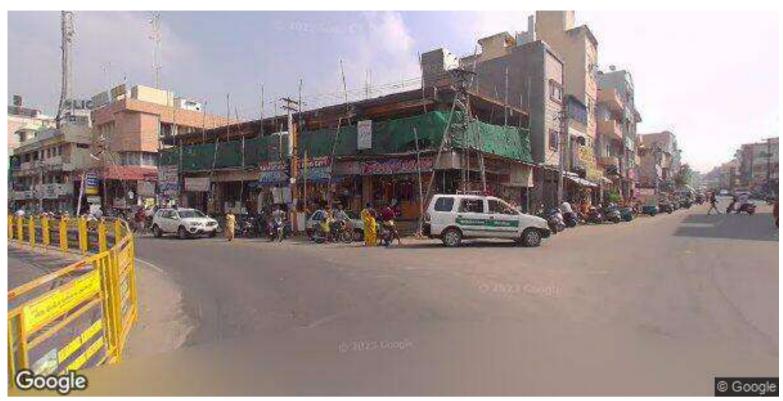
**Coordinates:** 11.37868, 77.89498

Risk Type: Turn
Risk Level: High
Speed Limit: 15 KM/Hr

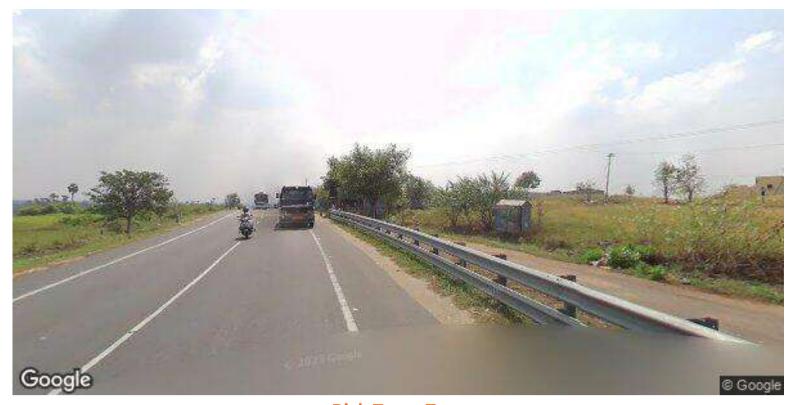
Risk Type: Turn
Risk Level: Medium
Speed Limit: 30 KM/Hr
Coordinates: 11.34135, 77.90145

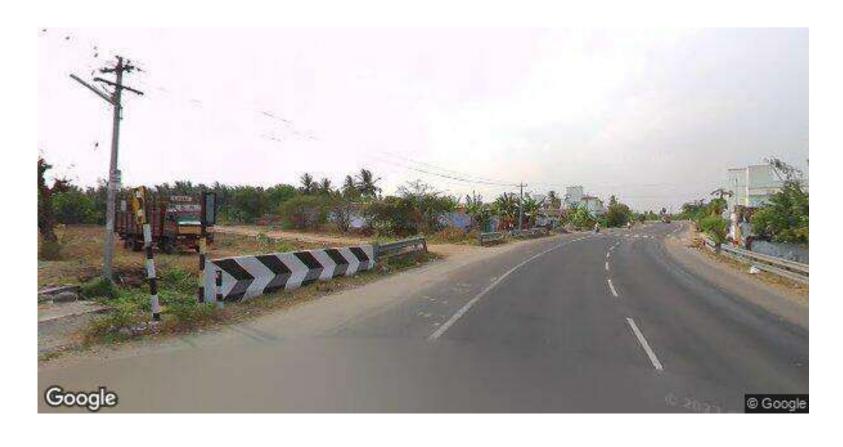
**Coordinates:** 11.16755, 78.01568

Risk Type: Turn
Risk Level: Medium
Speed Limit: 30 KM/Hr

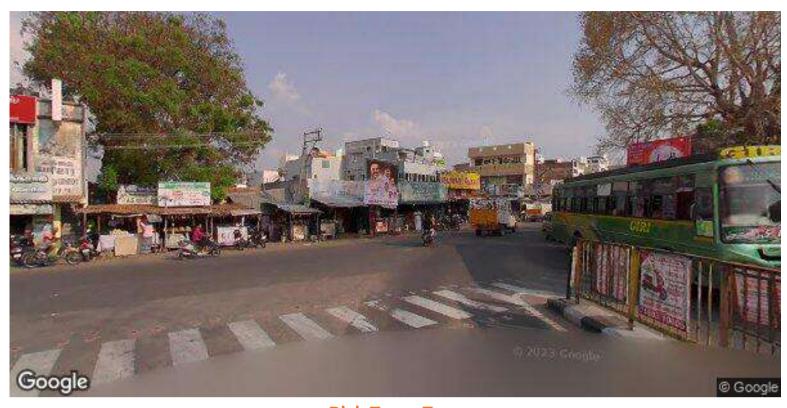
Risk Type: Turn
Risk Level: Medium
Speed Limit: 30 KM/Hr
Coordinates: 11.15579, 78.02169

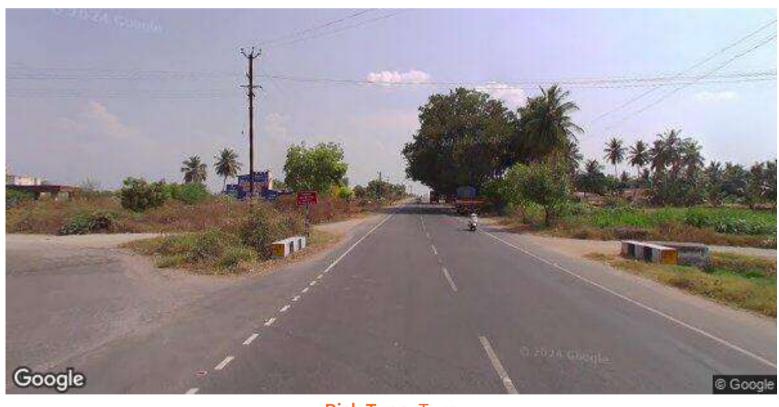
Risk Type: Turn
Risk Level: High
Speed Limit: 15 KM/Hr
Coordinates: 11.14545, 78.02208

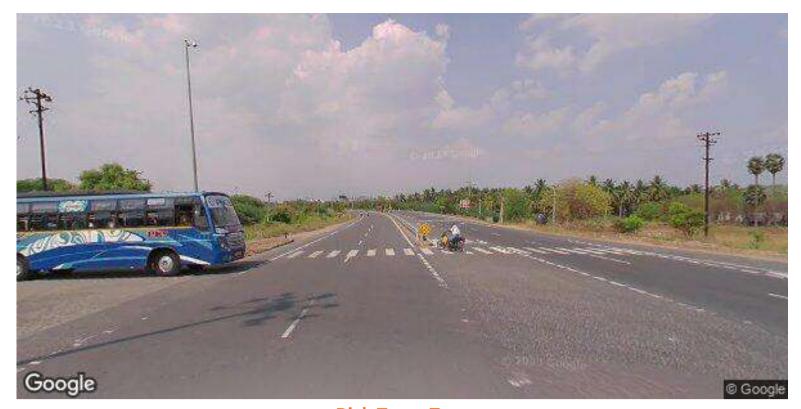
Risk Type: Turn
Risk Level: High
Speed Limit: 15 KM/Hr
Coordinates: 11.14485, 78.02282

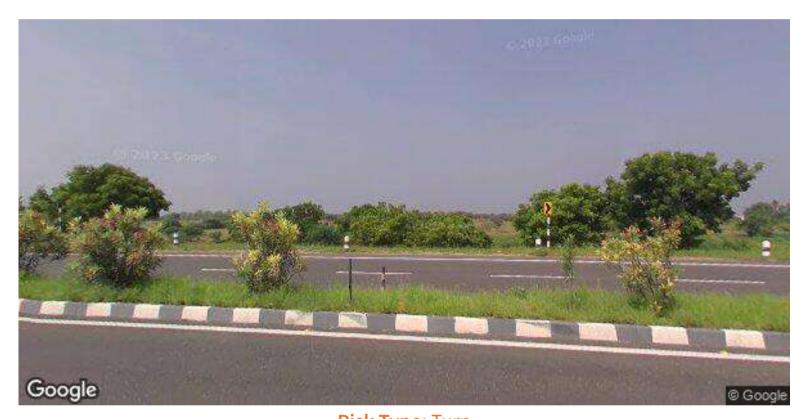
Risk Type: Turn
Risk Level: Medium
Speed Limit: 30 KM/Hr
Coordinates: 10.79871, 77.92719

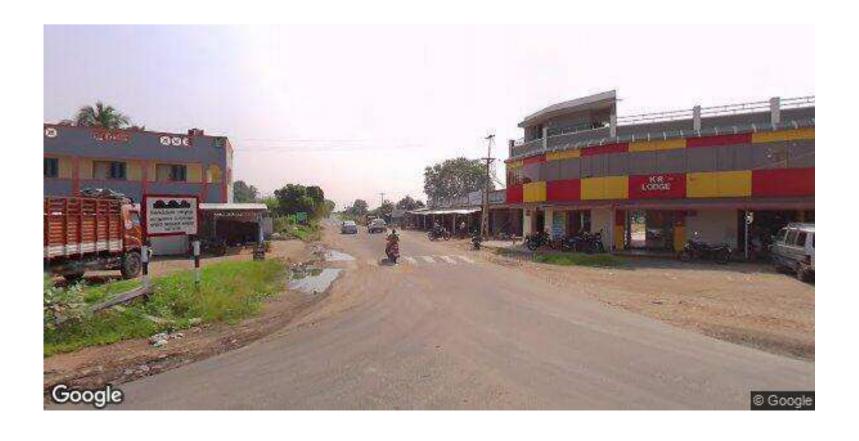
**Coordinates:** 10.77306, 77.91788

Risk Type: Blind Spot Risk Level: Blind Spot Speed Limit: 10 KM/Hr

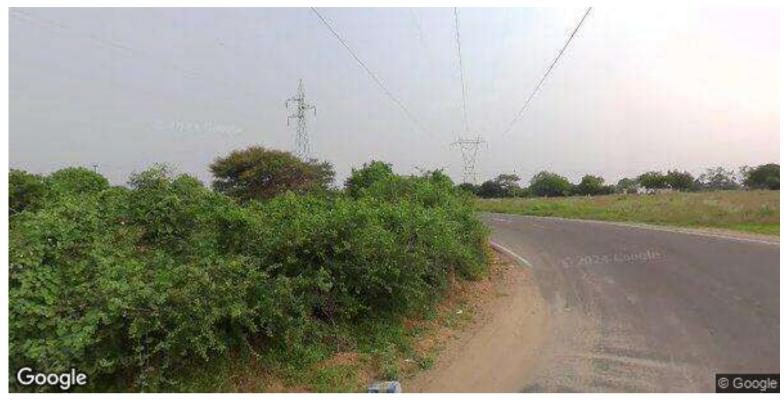
Risk Type: Turn
Risk Level: High
Speed Limit: 15 KM/Hr
Coordinates: 10.77230, 77.93223

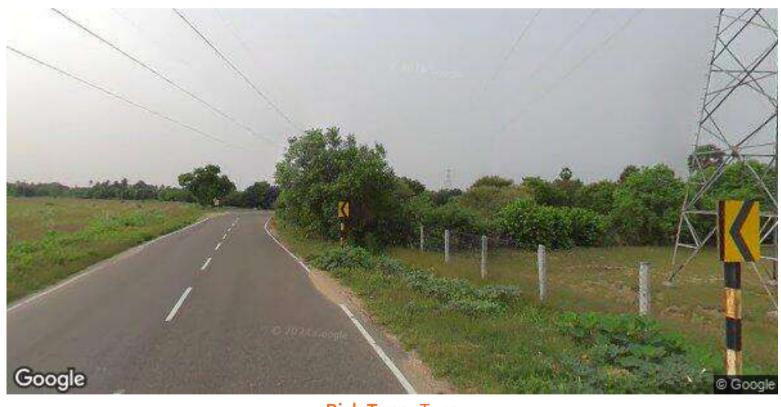
Risk Type: Turn
Risk Level: High
Speed Limit: 15 KM/Hr
Coordinates: 10.77294, 77.93238

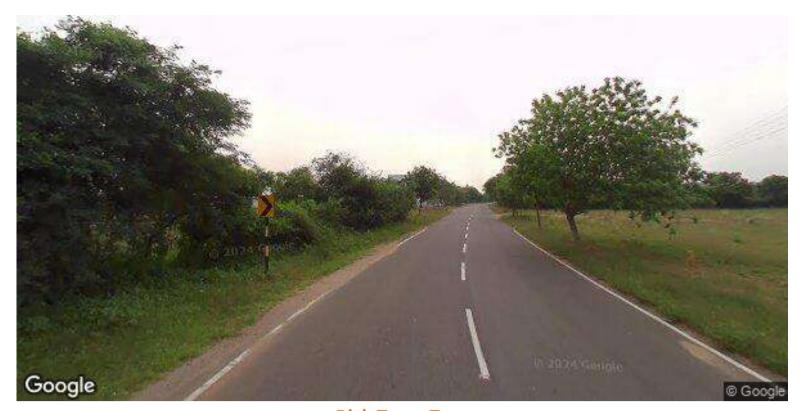
Risk Type: Turn
Risk Level: Medium
Speed Limit: 30 KM/Hr
Coordinates: 10.77303, 77.93269

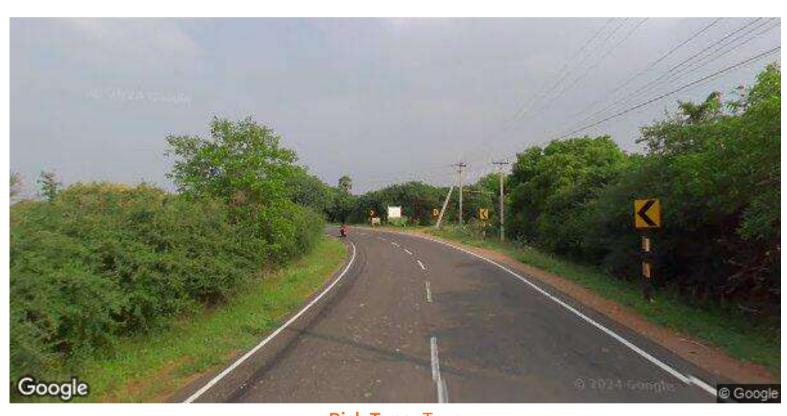
Risk Type: Turn
Risk Level: Medium
Speed Limit: 30 KM/Hr
Coordinates: 10.76865, 77.93912

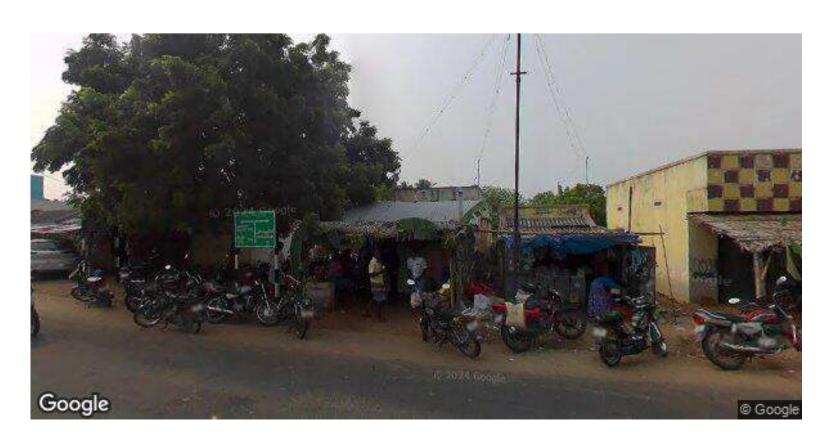
**Coordinates:** 10.76392, 77.96575

Risk Type: Turn
Risk Level: Medium
Speed Limit: 30 KM/Hr
