JOURNEY RISK MANAGEMENT (JRM) STUDY

Salem Terminal to SRI ROYAL PETROLEUM

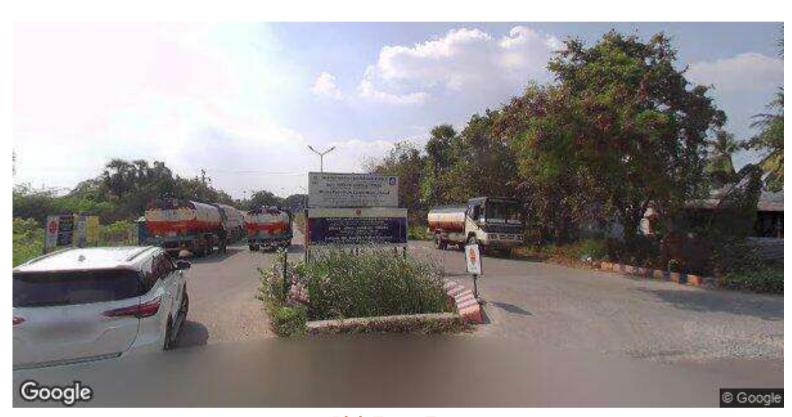
Risk Type: Turn
Risk Level: High
Speed Limit: 15 KM/Hr
Coordinates: 11.44024, 77.87528

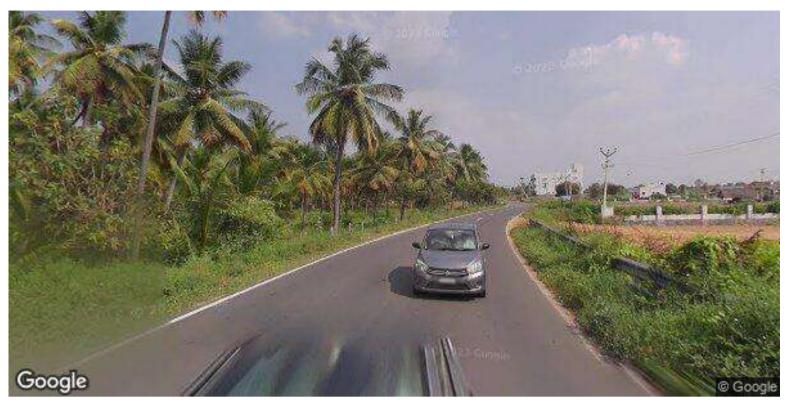
Risk Type: Turn
Risk Level: Medium
Speed Limit: 30 KM/Hr
Coordinates: 11.45357, 77.85789

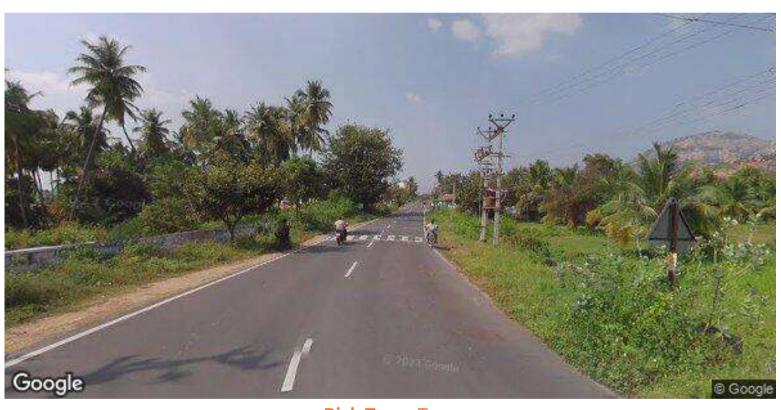
Risk Type: Turn
Risk Level: High
Speed Limit: 15 KM/Hr
Coordinates: 11.45352, 77.85698

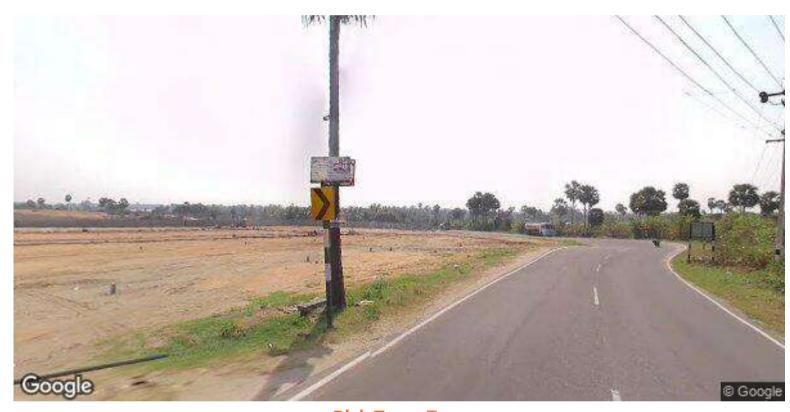
Risk Type: Turn
Risk Level: Medium
Speed Limit: 30 KM/Hr
Coordinates: 11.45898, 77.85135

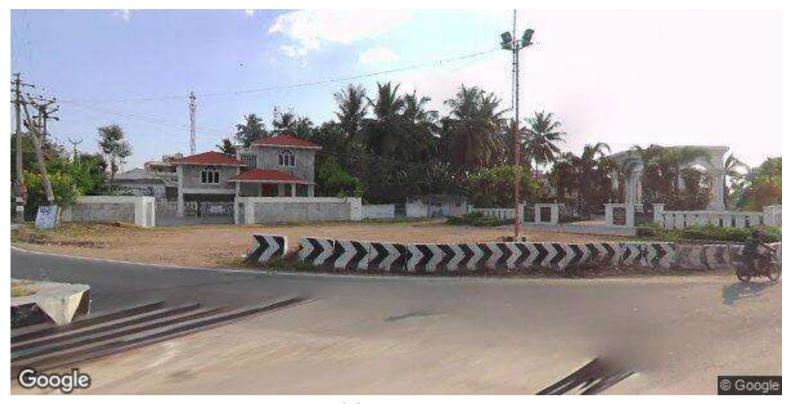
Coordinates: 11.46314, 77.84928

Risk Type: Turn
Risk Level: Medium
Speed Limit: 30 KM/Hr

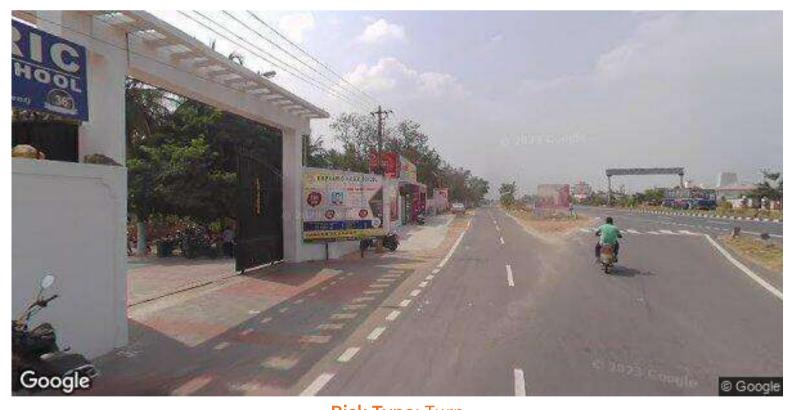
Coordinates: 11.45509, 77.81383

Risk Type: Turn
Risk Level: Medium
Speed Limit: 30 KM/Hr

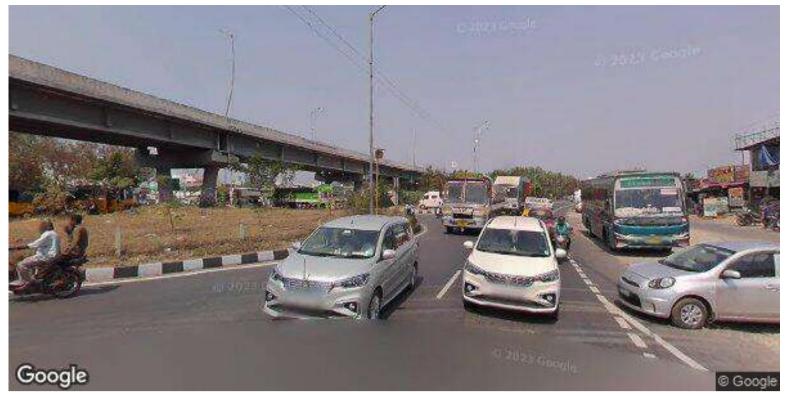
Coordinates: 11.43001, 77.67575

Risk Type: Turn
Risk Level: High
Speed Limit: 15 KM/Hr

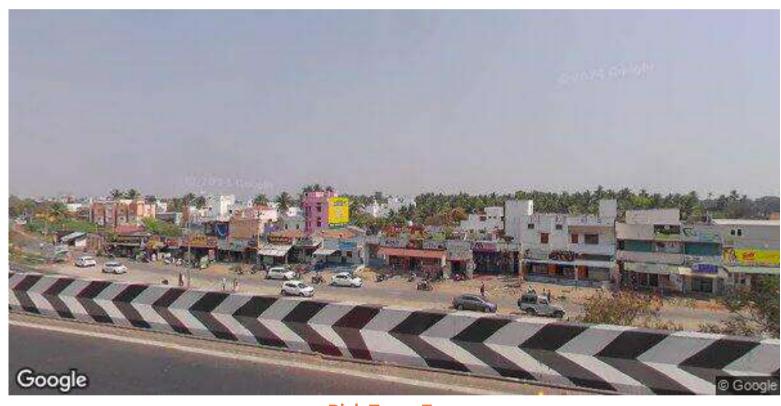
Risk Type: Turn
Risk Level: Medium
Speed Limit: 30 KM/Hr
Coordinates: 11.43003, 77.67551

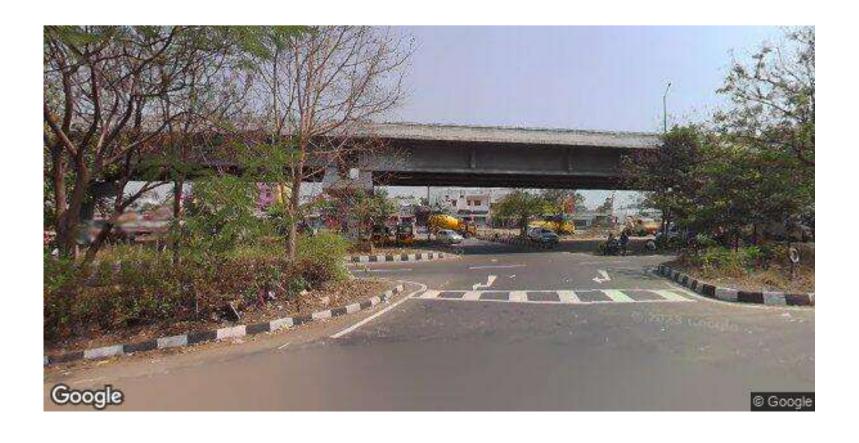
Coordinates: 11.43026, 77.67525

Risk Type: Turn
Risk Level: High
Speed Limit: 15 KM/Hr

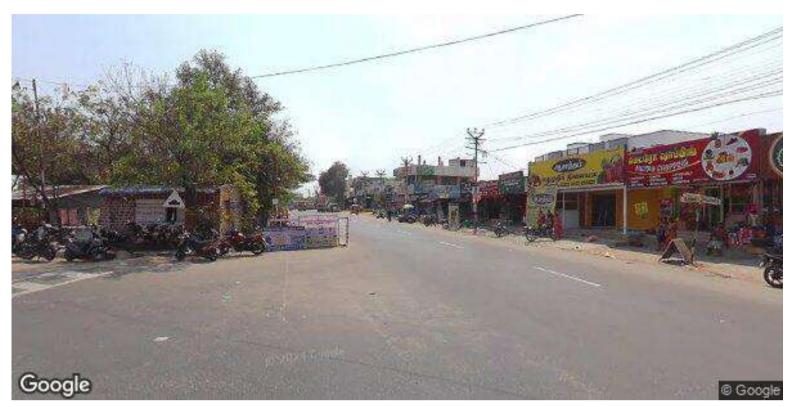
Coordinates: 11.43073, 77.67536

Risk Type: Blind Spot
Risk Level: Blind Spot
Speed Limit: 10 KM/Hr

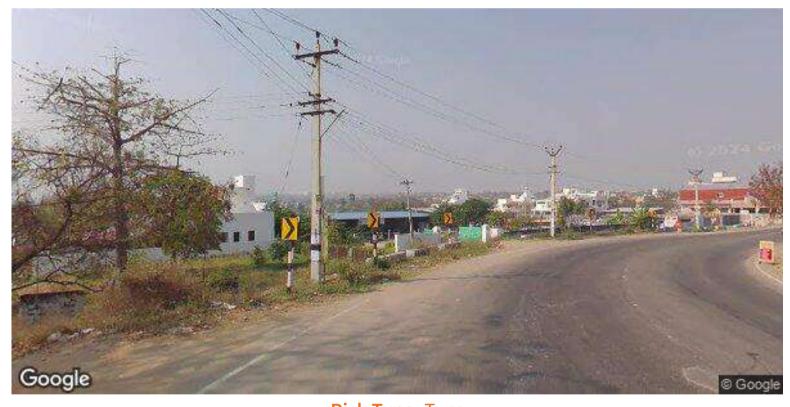
Risk Type: Turn
Risk Level: Medium
Speed Limit: 30 KM/Hr
Coordinates: 11.43273, 77.67018

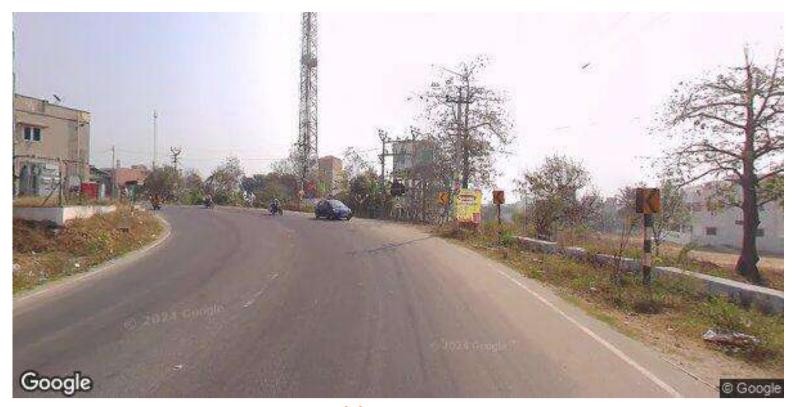
Risk Type: Turn
Risk Level: Medium
Speed Limit: 30 KM/Hr
Coordinates: 11.43268, 77.66999

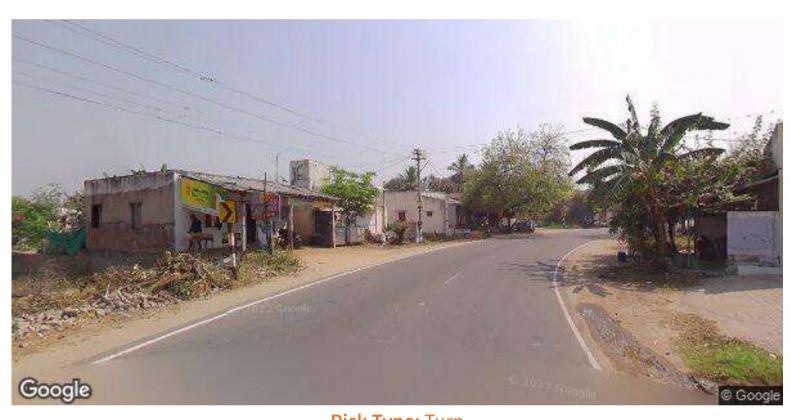
Risk Type: Turn
Risk Level: High
Speed Limit: 15 KM/Hr
Coordinates: 11.43342, 77.66685

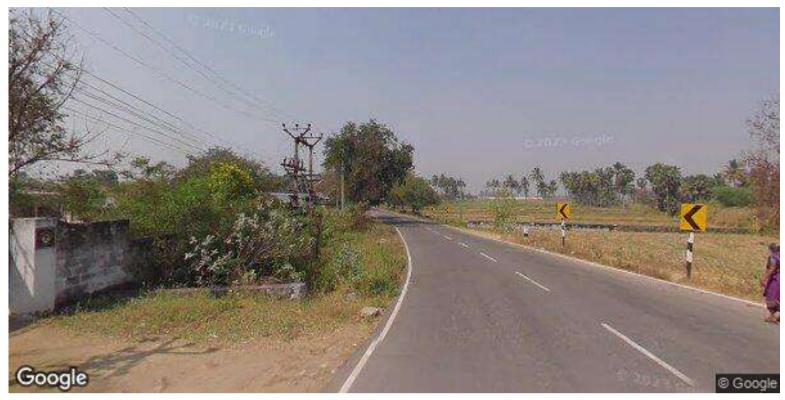
Risk Type: Turn
Risk Level: Medium
Speed Limit: 30 KM/Hr
Coordinates: 11.43222, 77.65329

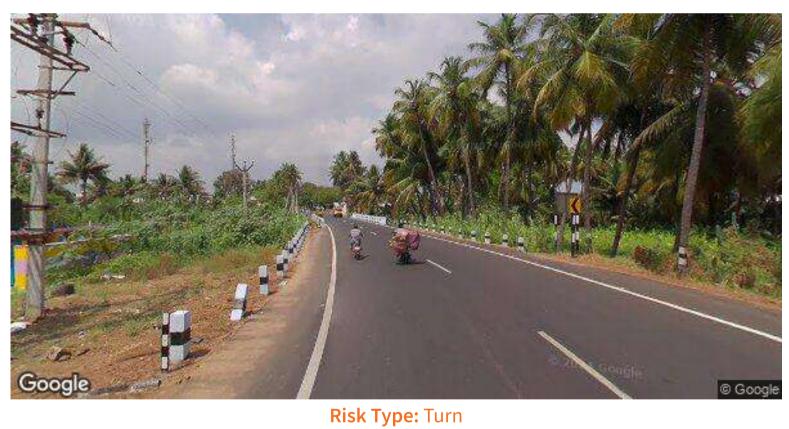
Risk Type. Turn
Risk Level: Medium
Speed Limit: 30 KM/Hr
Coordinates: 11.42904, 77.57122

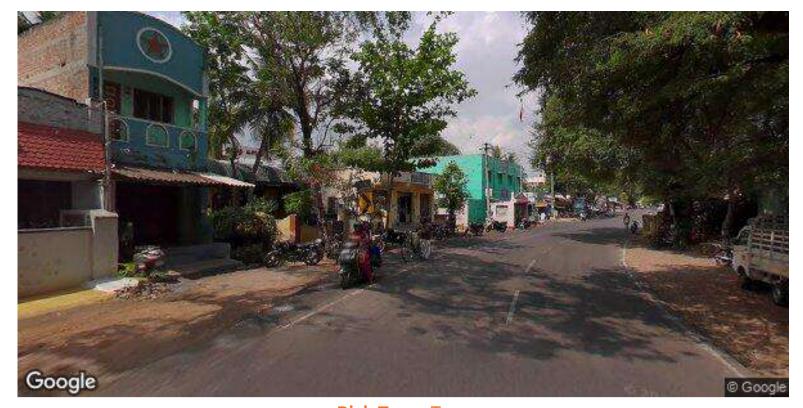
Risk Type: Turn
Risk Level: Medium
Speed Limit: 30 KM/Hr
Coordinates: 11.42838, 77.56943

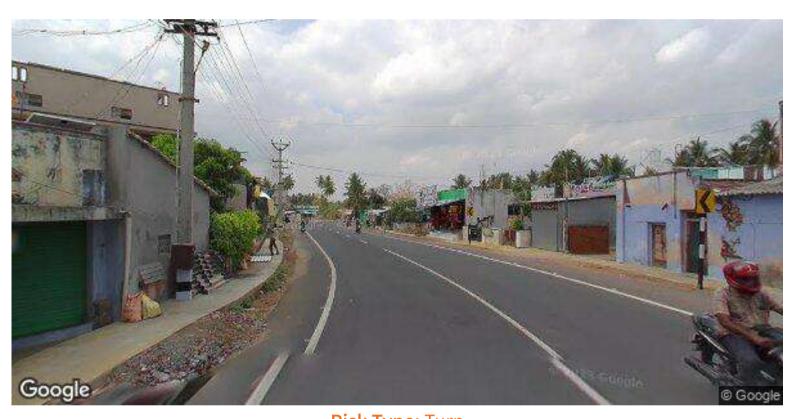
Risk Type: Turn
Risk Level: Medium
Speed Limit: 30 KM/Hr
Coordinates: 11.42828, 77.56554

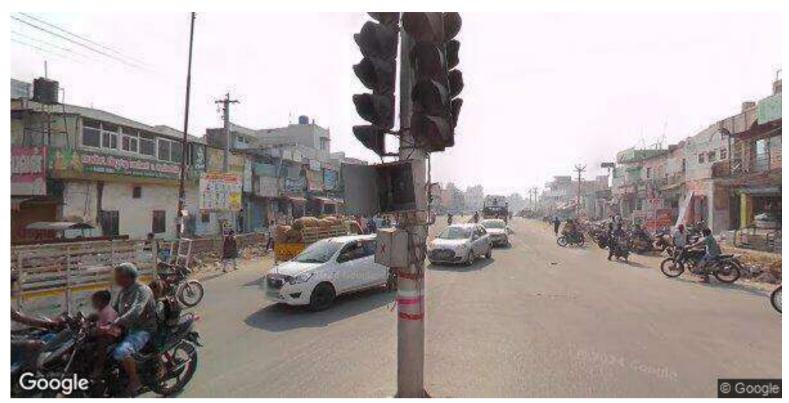
Coordinates: 11.42337, 77.55804

Risk Type: Turn
Risk Level: High
Speed Limit: 15 KM/Hr

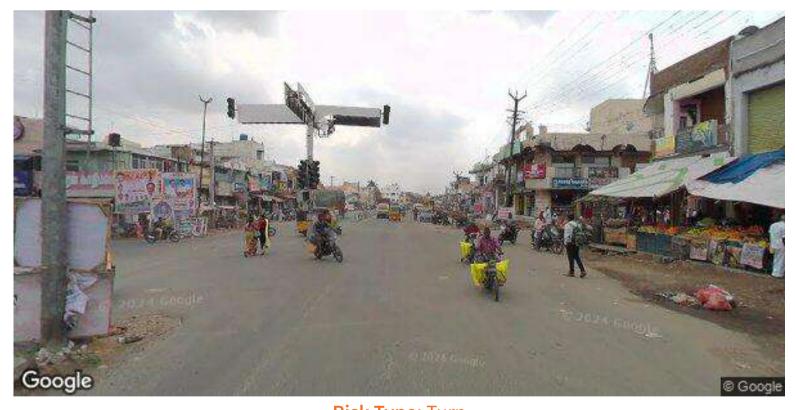
Risk Type: Turn
Risk Level: Medium
Speed Limit: 30 KM/Hr
Coordinates: 11.42335, 77.55788

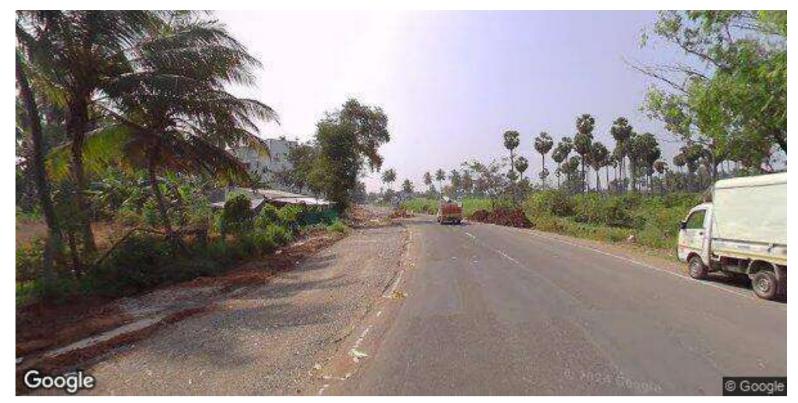
Risk Type: Turn
Risk Level: Medium
Speed Limit: 30 KM/Hr
Coordinates: 11.45761, 77.36302

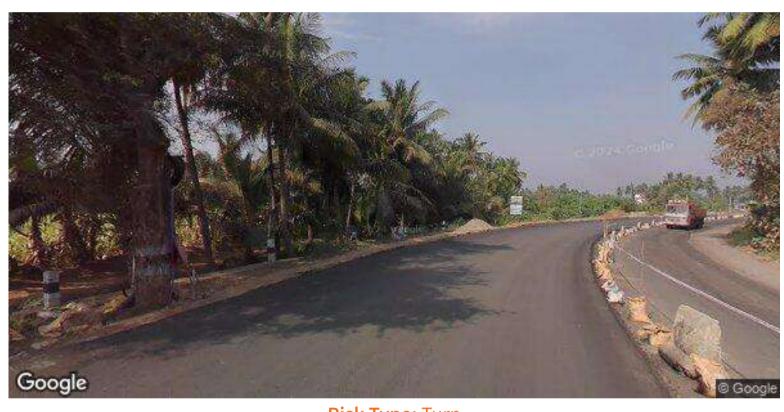
Risk Type: Turn
Risk Level: Medium
Speed Limit: 30 KM/Hr
Coordinates: 11.45634, 77.35808

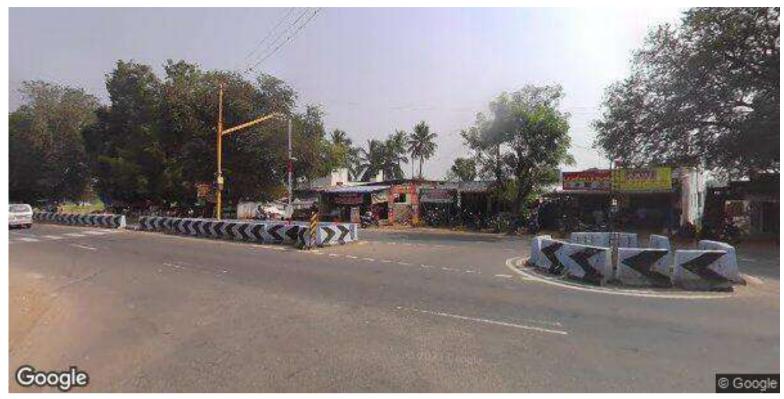
Coordinates: 11.45964, 77.30748

Risk Type: Turn
Risk Level: High
Speed Limit: 15 KM/Hr

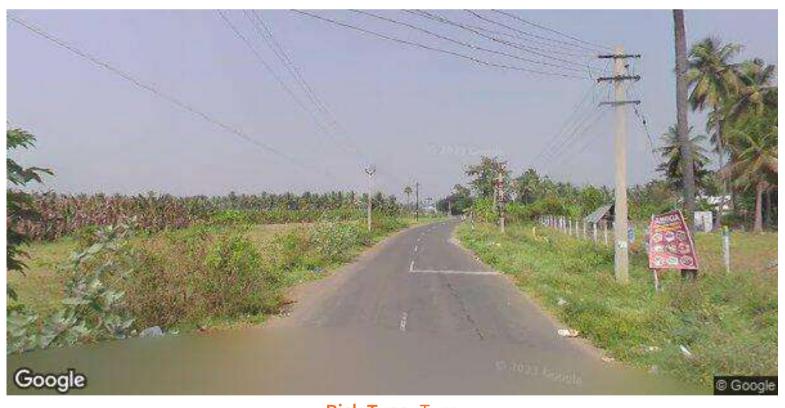
Coordinates: 11.46616, 77.30075

Risk Type: Turn
Risk Level: Medium
Speed Limit: 30 KM/Hr

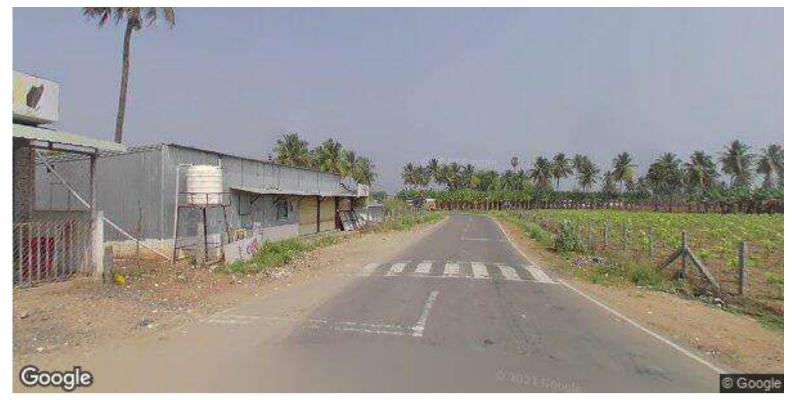
Risk Type: Turn
Risk Level: High
Speed Limit: 15 KM/Hr
Coordinates: 11.47157, 77.29804

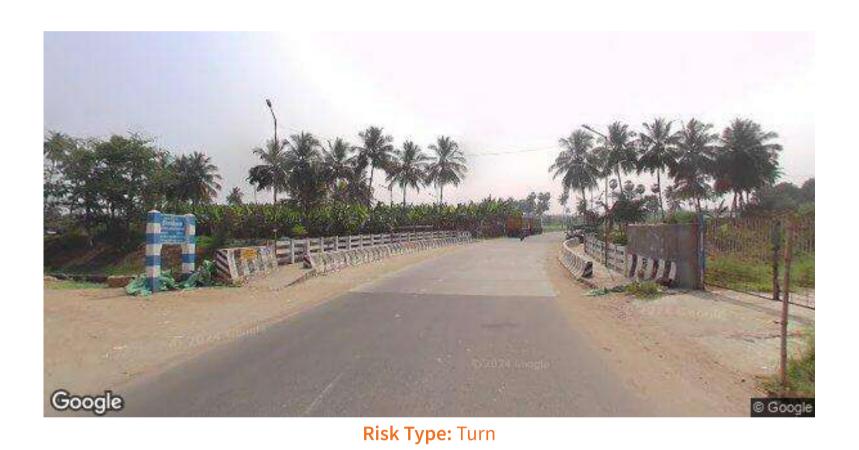
Speed Limit: 30 KM/Hr Coordinates: 11.47294, 77.29866

Risk Level: Medium

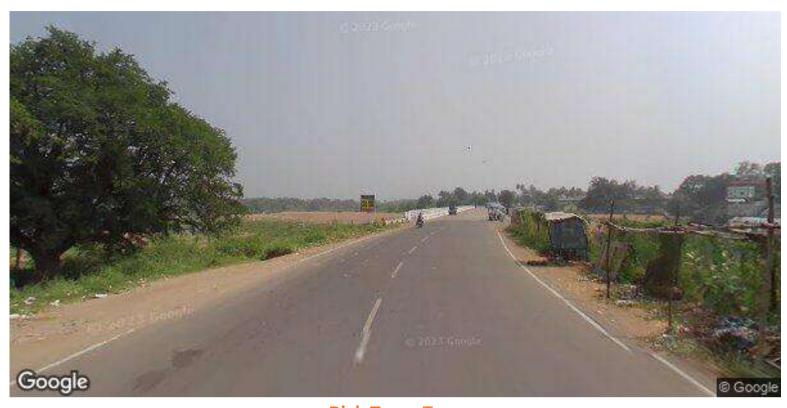
Coordinates: 11.47449, 77.29614

Risk Type: Turn
Risk Level: Medium
Speed Limit: 30 KM/Hr

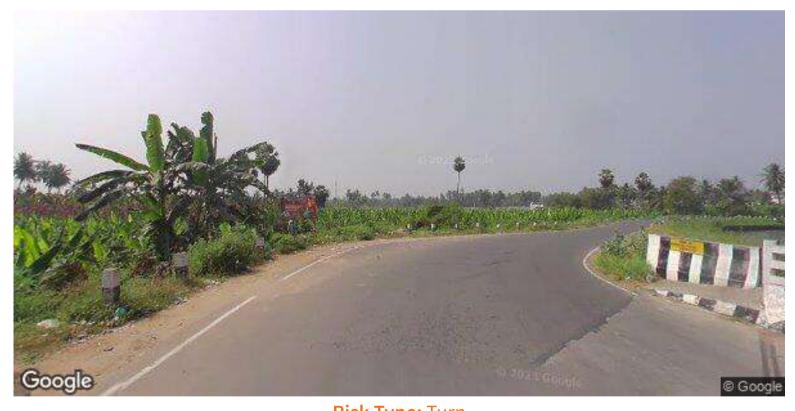
Coordinates: 11.47449, 77.29541

Risk Type: Turn
Risk Level: Medium
Speed Limit: 30 KM/Hr

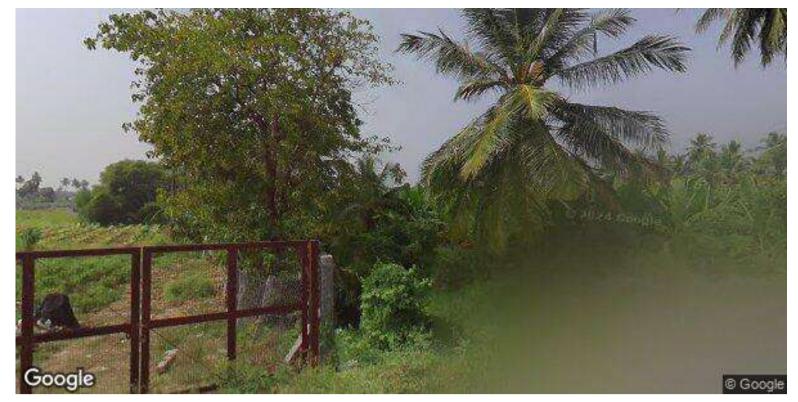
Risk Type: Turn
Risk Level: Medium
Speed Limit: 30 KM/Hr
Coordinates: 11.47525, 77.29446

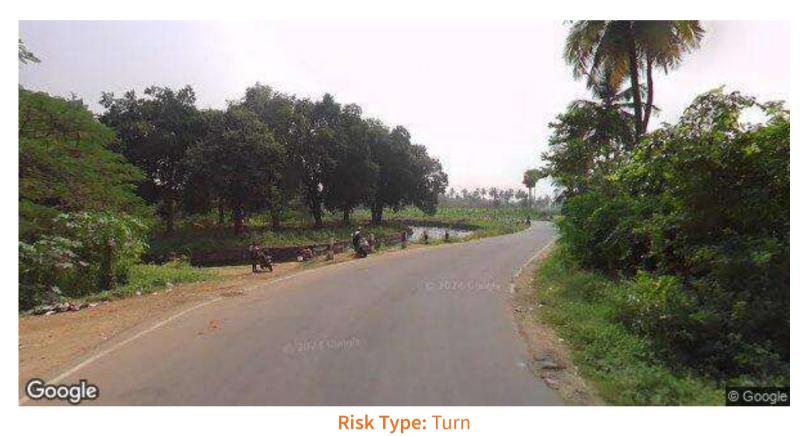
Coordinates: 11.47602, 77.29451

Risk Type: Turn

Risk Level: High

Speed Limit: 15 KM/Hr

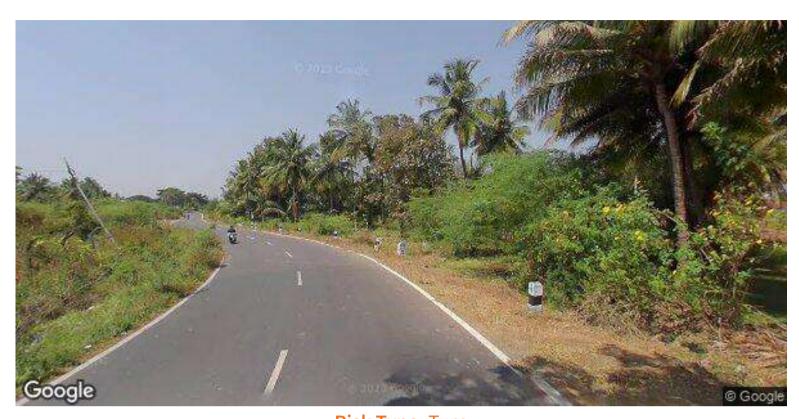
Risk Type: Turn
Risk Level: Medium
Speed Limit: 30 KM/Hr
Coordinates: 11.48272, 77.28581

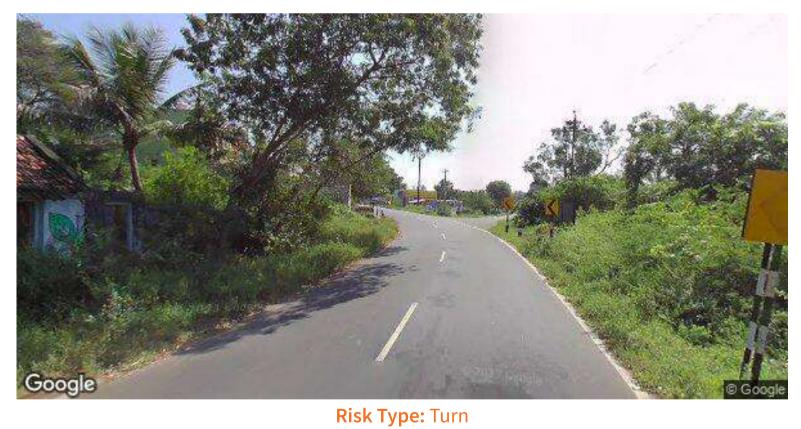
Risk Level: Medium
Speed Limit: 30 KM/Hr
Coordinates: 11.49558, 77.25638

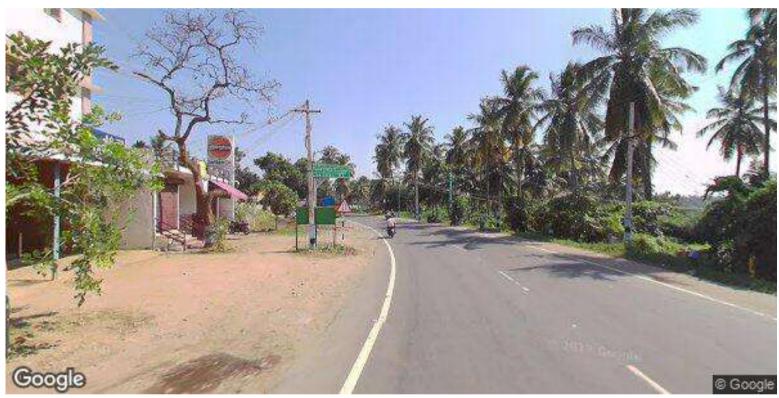
Risk Type: Turn
Risk Level: Medium
Speed Limit: 30 KM/Hr
Coordinates: 11.50939, 77.22974

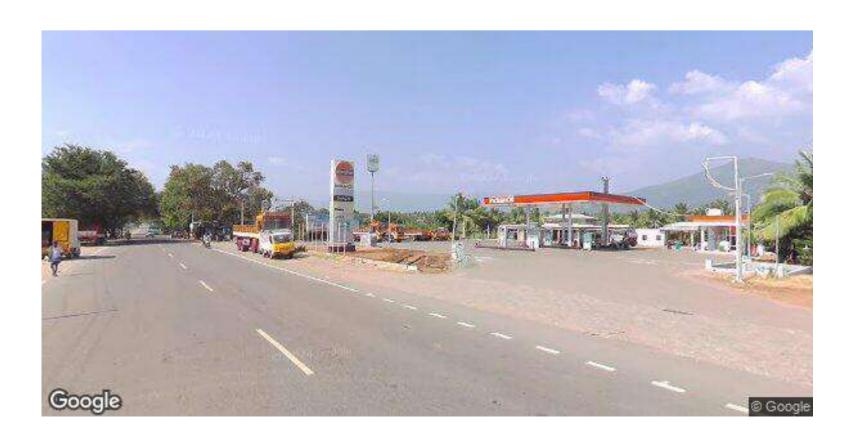
Coordinates: 11.51961, 77.21565

Risk Type: Turn
Risk Level: High
Speed Limit: 15 KM/Hr

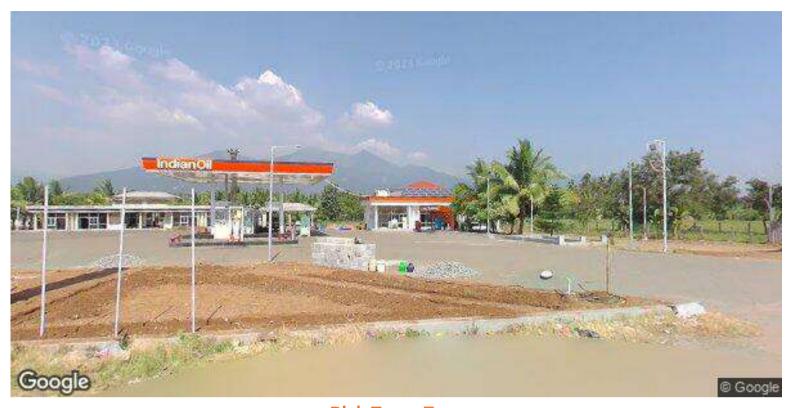
Coordinates: 11.51990, 77.21564

Risk Type: Turn
Risk Level: Medium
Speed Limit: 30 KM/Hr
