JOURNEY RISK MANAGEMENT (JRM) STUDY

Salem Terminal to AEGAN PETRO FILLS

Route Safety Analysis Report

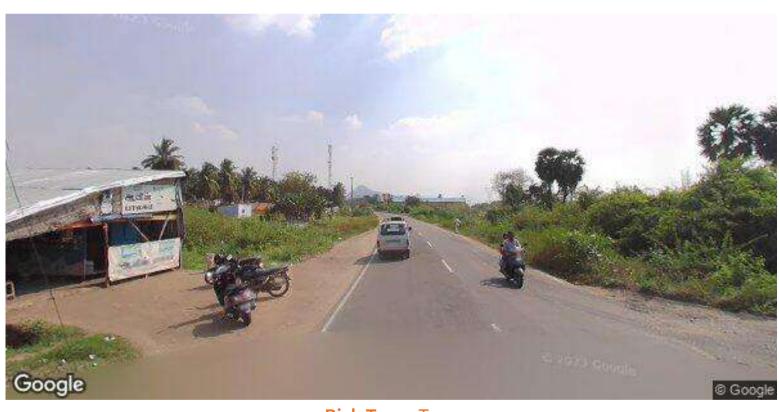
Risk Type: Turn
Risk Level: High
Speed Limit: 15 KM/Hr
Coordinates: 11.44022, 77.87546

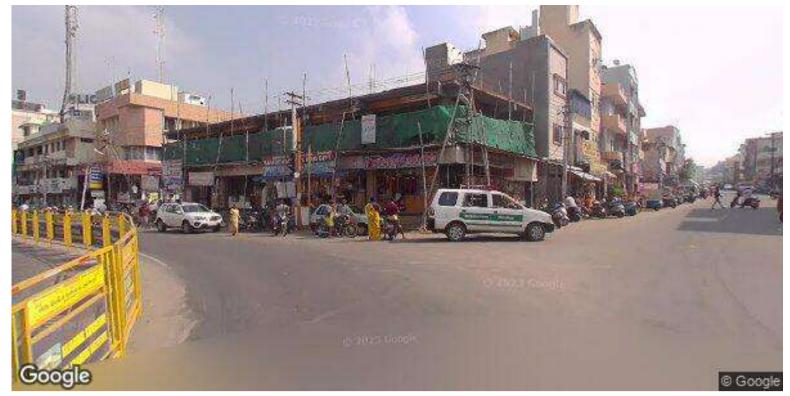
Risk Type: Turn
Risk Level: High
Speed Limit: 15 KM/Hr
Coordinates: 11.37868, 77.89498

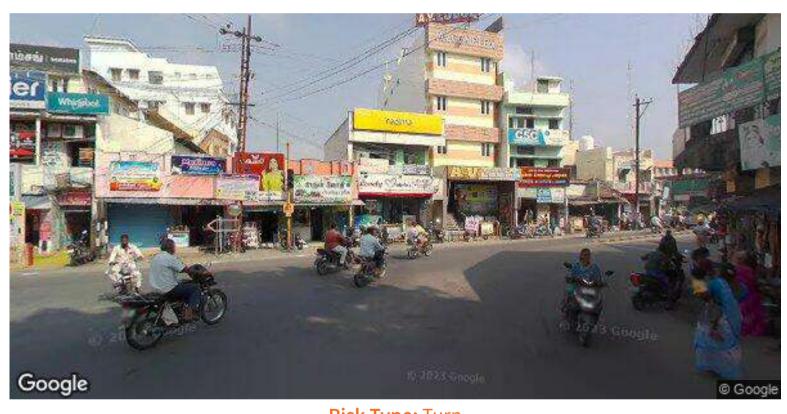
Risk Type: Turn
Risk Level: Medium
Speed Limit: 30 KM/Hr
Coordinates: 11.37842, 77.89452

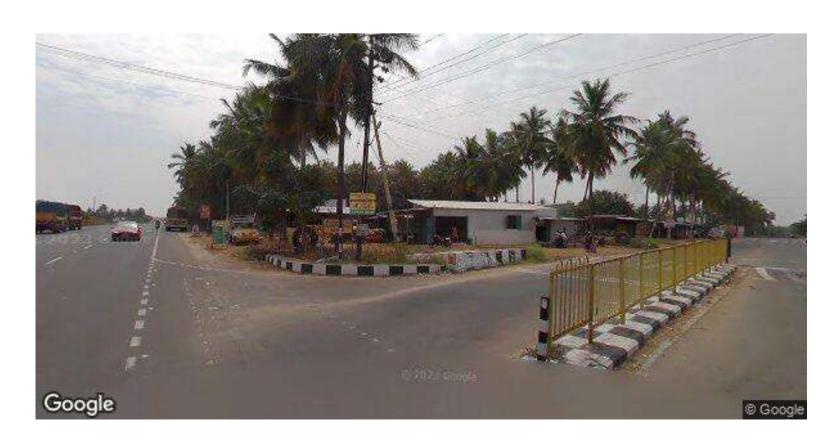
Risk Type: Turn
Risk Level: High
Speed Limit: 15 KM/Hr

Coordinates: 11.30859, 77.92918

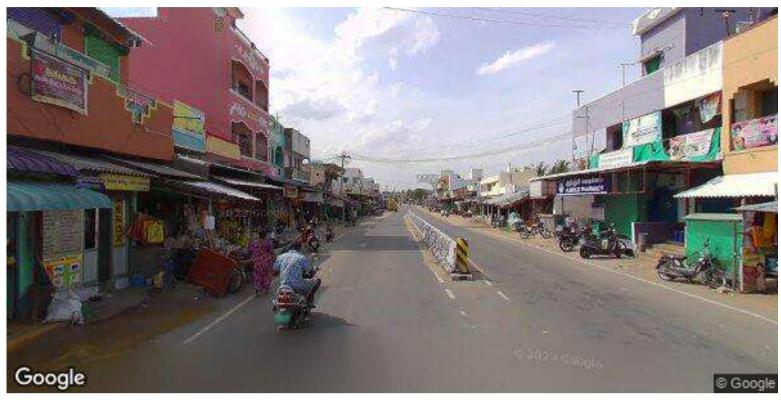
Risk Type: Turn
Risk Level: High
Speed Limit: 15 KM/Hr

Coordinates: 11.24000, 77.87363

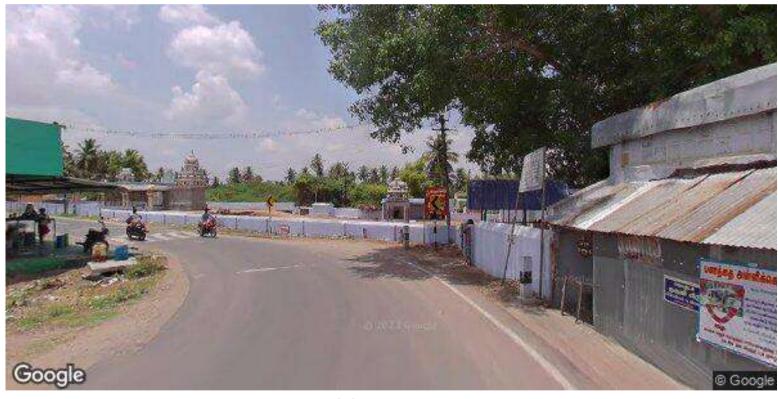
Risk Type: Turn
Risk Level: Medium
Speed Limit: 30 KM/Hr

Coordinates: 11.24053, 77.86902

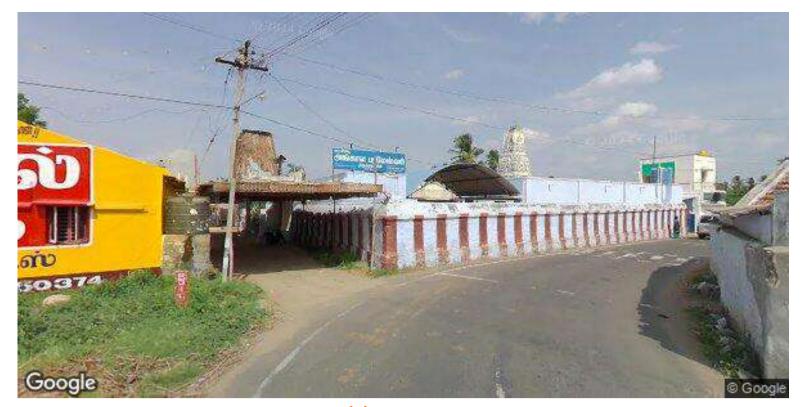
Risk Type: Turn
Risk Level: Medium
Speed Limit: 30 KM/Hr
Coordinates: 11.24115, 77.86891

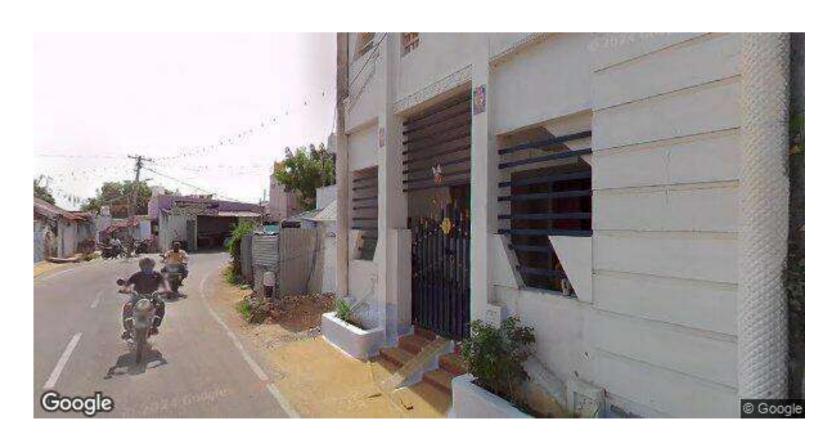
Risk Type: Turn
Risk Level: High
Speed Limit: 15 KM/Hr

Coordinates: 11.24159, 77.86874

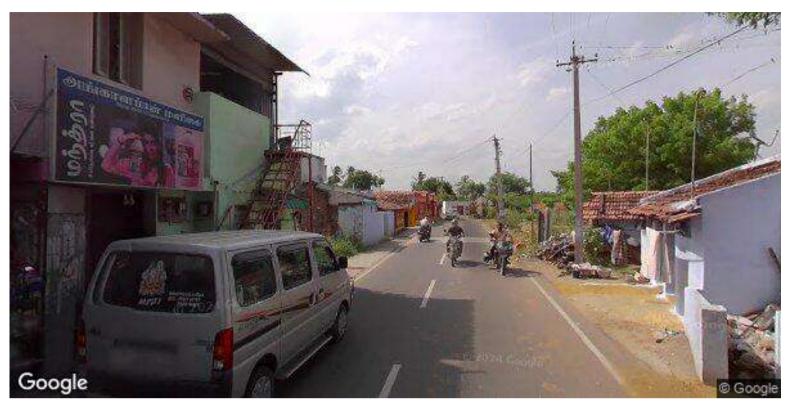
Risk Type: Turn
Risk Level: High
Speed Limit: 15 KM/Hr

Coordinates: 11.24170, 77.86842

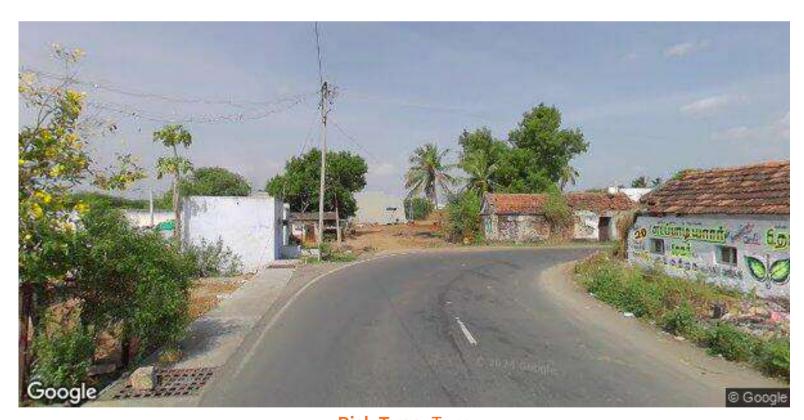
Risk Type: Turn
Risk Level: High
Speed Limit: 15 KM/Hr

Coordinates: 11.24248, 77.86829

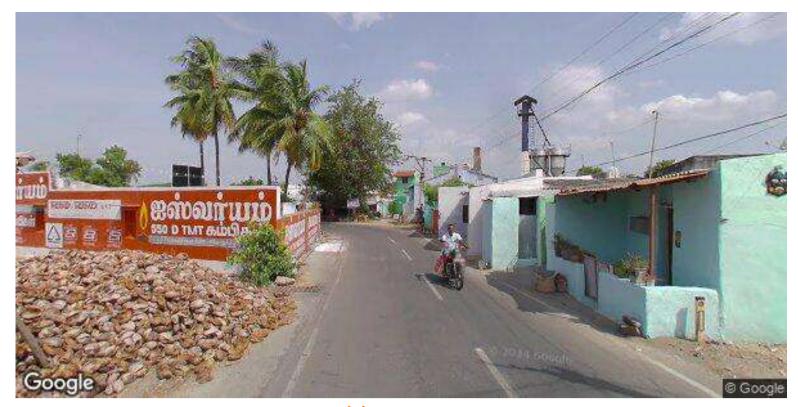
Risk Type: Turn
Risk Level: Medium
Speed Limit: 30 KM/Hr
Coordinates: 11.24257, 77.86776

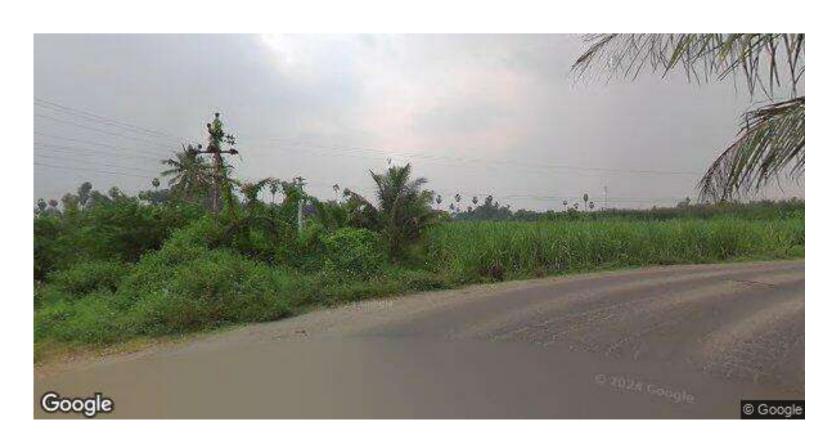
Risk Type: Turn
Risk Level: Medium
Speed Limit: 30 KM/Hr

Coordinates: 11.24101, 77.86034

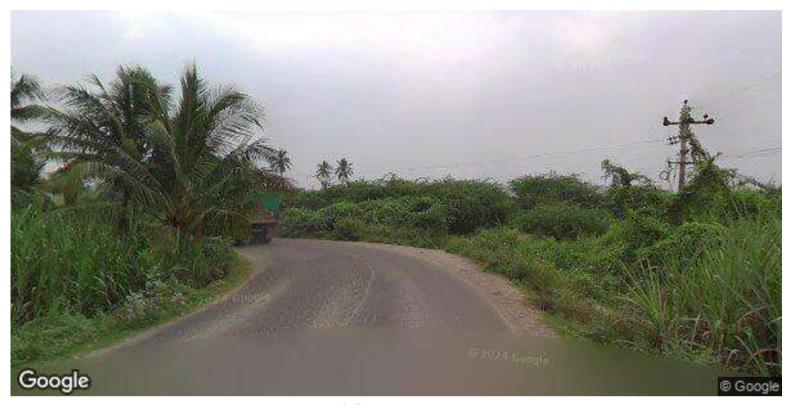
Risk Type: Turn
Risk Level: Medium
Speed Limit: 30 KM/Hr
Coordinates: 11.24103, 77.86020

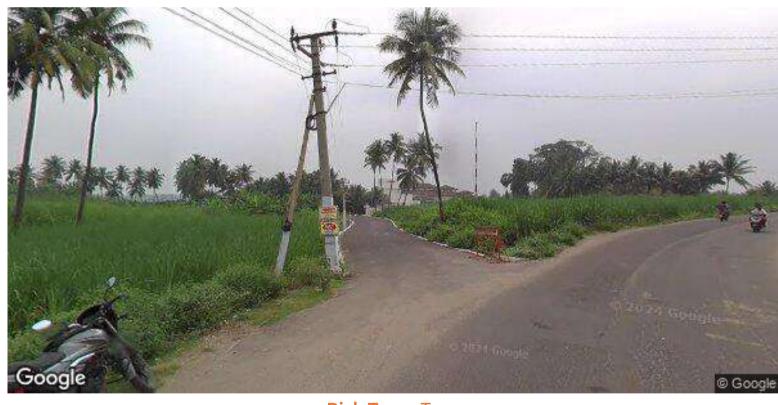
Risk Type: Turn
Risk Level: Medium
Speed Limit: 30 KM/Hr
Coordinates: 11.24197, 77.85905

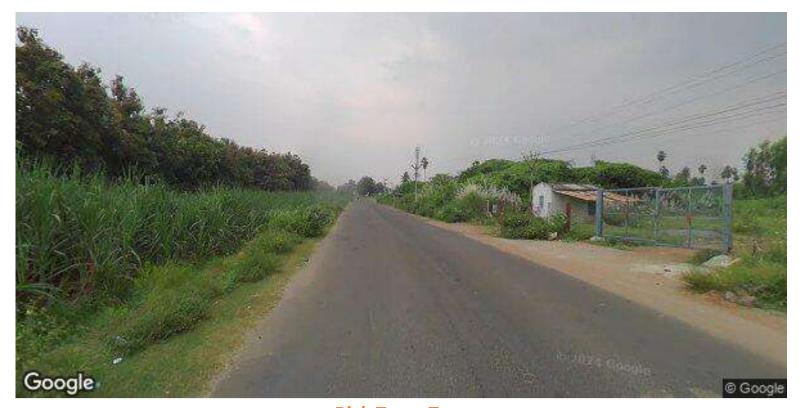
Risk Type: Turn
Risk Level: Medium
Speed Limit: 30 KM/Hr
Coordinates: 11.24196, 77.85856

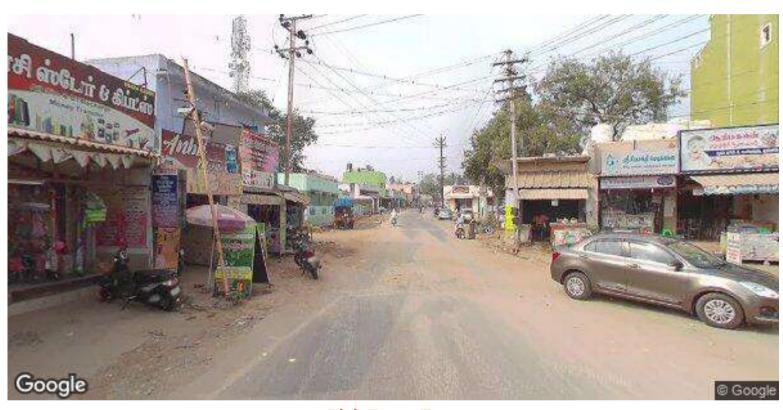
Risk Type: Turn
Risk Level: High
Speed Limit: 15 KM/Hr

Coordinates: 11.18856, 77.77110

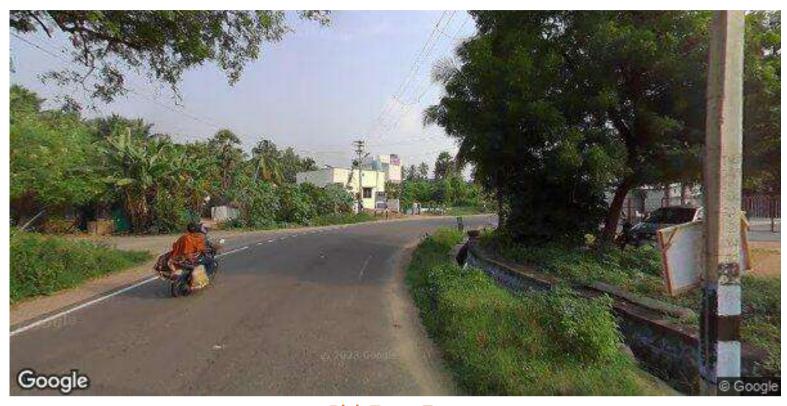
Risk Type: Turn
Risk Level: Medium
Speed Limit: 30 KM/Hr
Coordinates: 11.16377, 77.77421

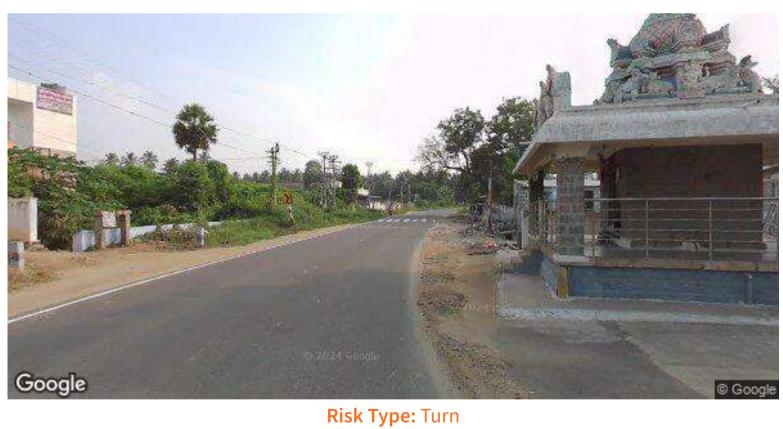
Risk Type. Turn
Risk Level: Medium
Speed Limit: 30 KM/Hr
Coordinates: 11.16354, 77.77435

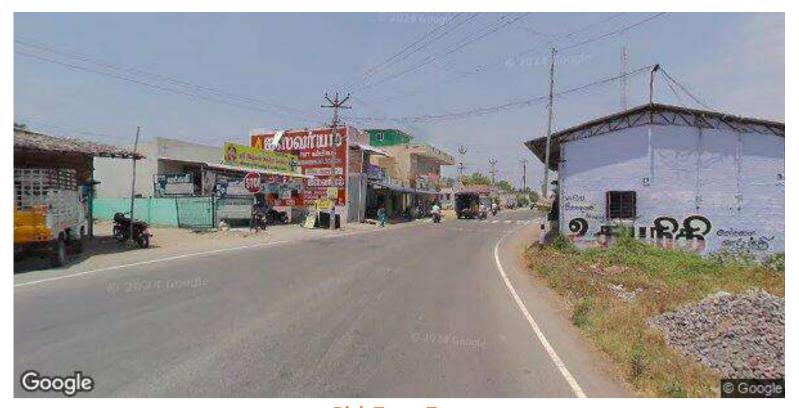
Risk Type: Turn
Risk Level: Medium
Speed Limit: 30 KM/Hr
Coordinates: 11.04718, 77.73742

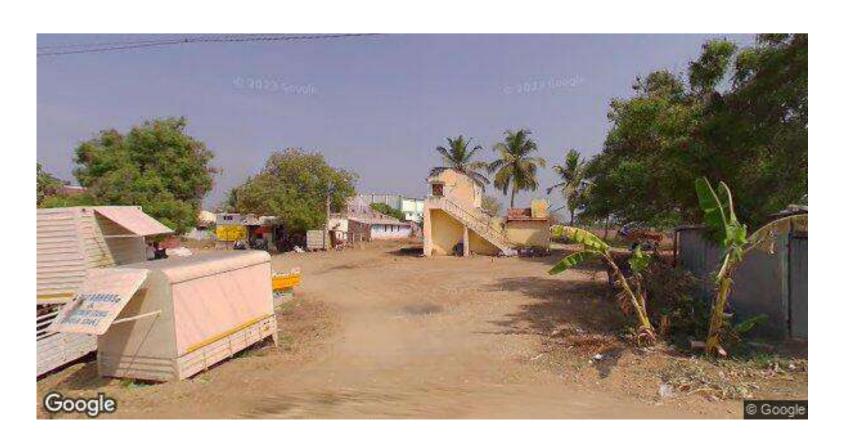
Risk Type: Blind Spot Risk Level: Blind Spot Speed Limit: 10 KM/Hr

Coordinates: 11.04848, 77.74469

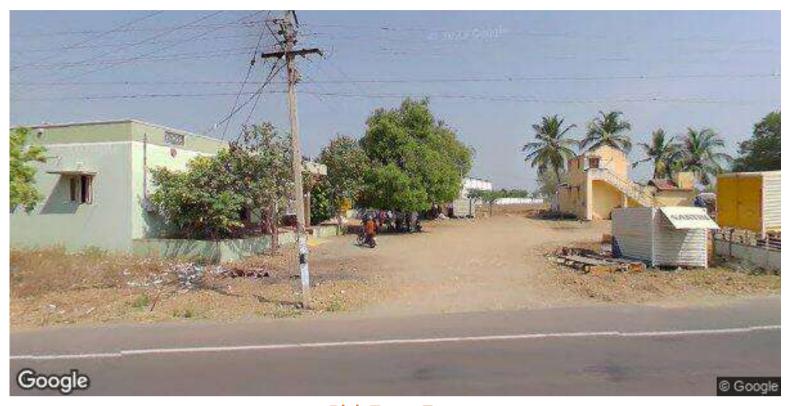
Risk Type: Turn
Risk Level: High
Speed Limit: 15 KM/Hr

Coordinates: 11.04838, 77.74455
