JOURNEY RISK MANAGEMENT (JRM) STUDY

IOCL Coimbatore Terminal to Annur Lorry Owners Association

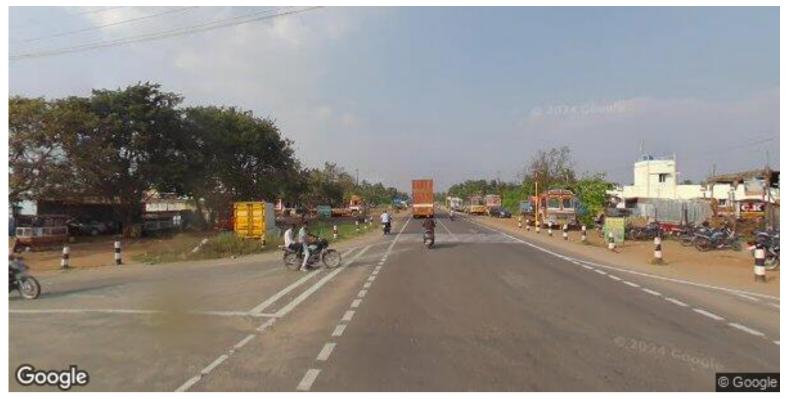
Coordinates: 11.03211, 77.07640

Risk Type: Turn
Risk Level: High
Speed Limit: 15 KM/Hr

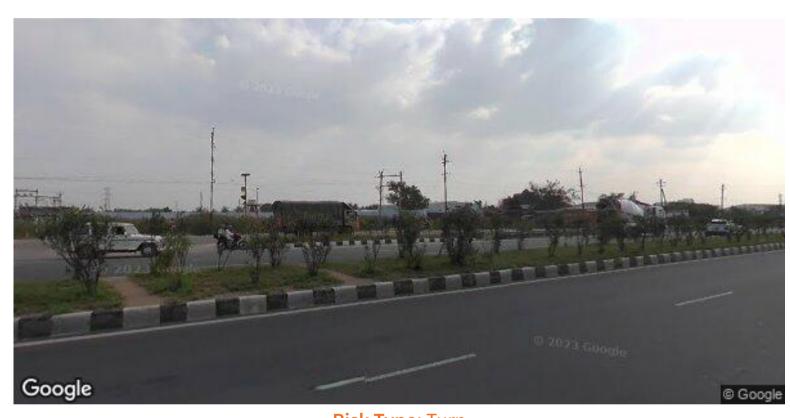
Risk Type: Turn
Risk Level: Medium
Speed Limit: 30 KM/Hr
Coordinates: 11.08056, 77.11935

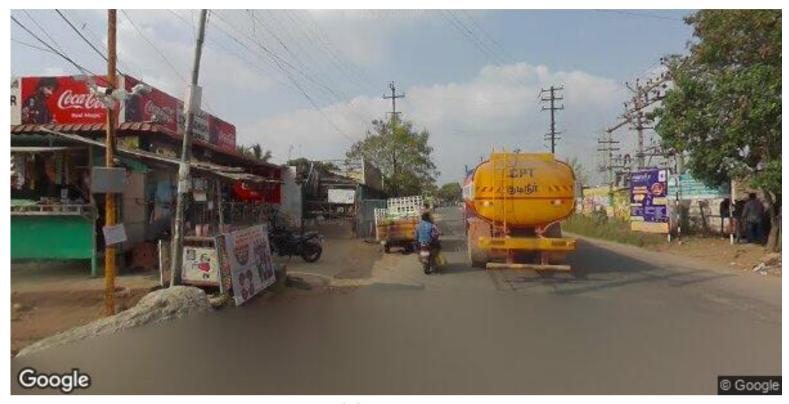
Coordinates: 11.08298, 77.12274

Risk Type: Turn
Risk Level: High
Speed Limit: 15 KM/Hr

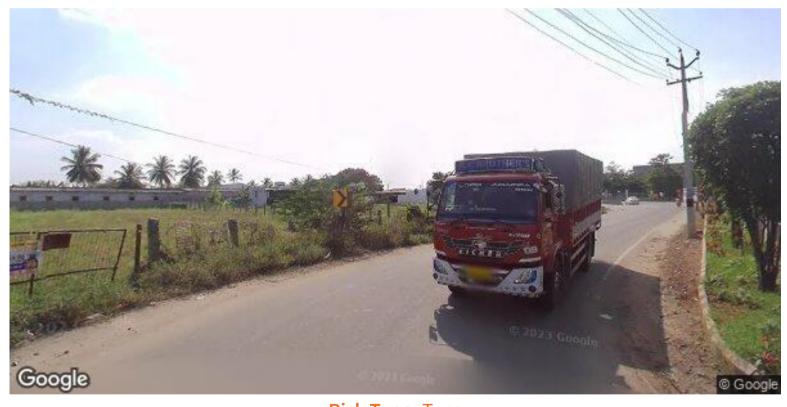
Risk Type: Turn
Risk Level: Medium
Speed Limit: 30 KM/Hr
Coordinates: 11.10521, 77.13189

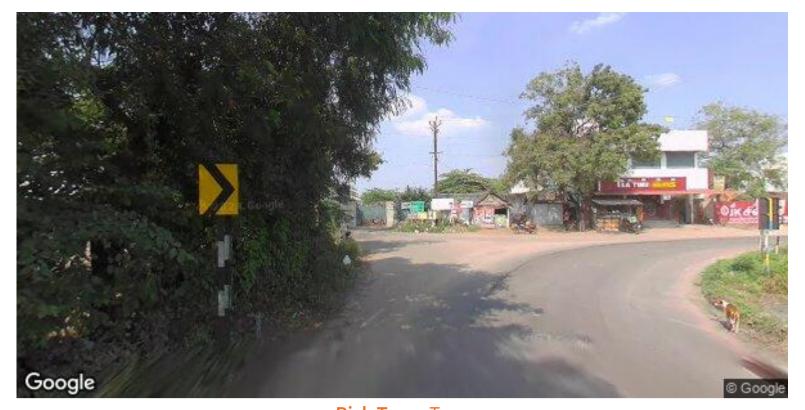
Risk Type: Turn
Risk Level: Medium
Speed Limit: 30 KM/Hr
Coordinates: 11.10851, 77.13208

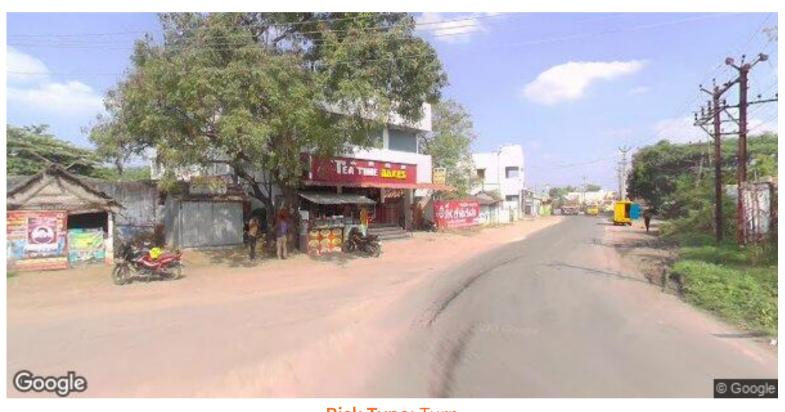
Risk Type: Turn
Risk Level: Medium
Speed Limit: 30 KM/Hr
Coordinates: 11.10863, 77.13220

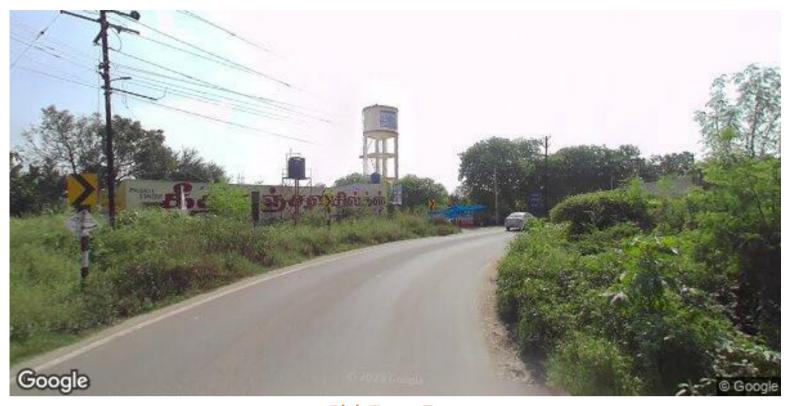
Risk Type: Turn
Risk Level: Medium
Speed Limit: 30 KM/Hr
Coordinates: 11.11054, 77.13335

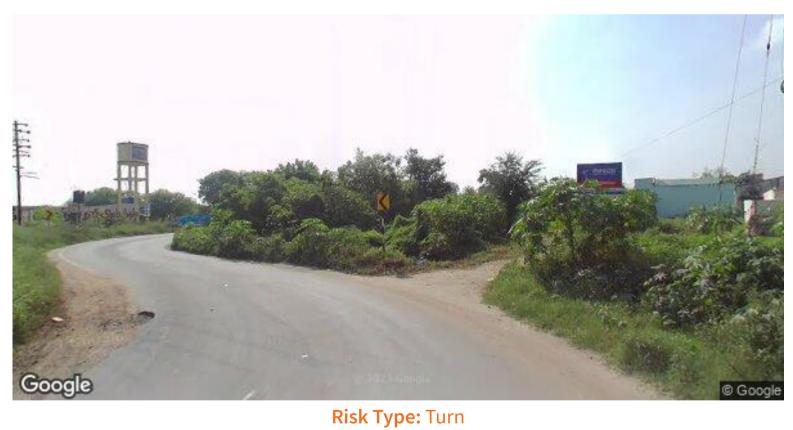
Risk Level: Medium
Speed Limit: 30 KM/Hr
Coordinates: 11.11066, 77.13307

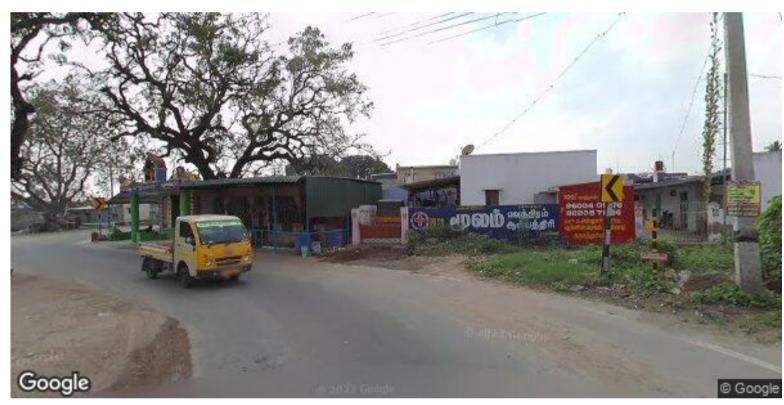
Risk Type: Turn
Risk Level: High
Speed Limit: 15 KM/Hr
Coordinates: 11.12982, 77.13901

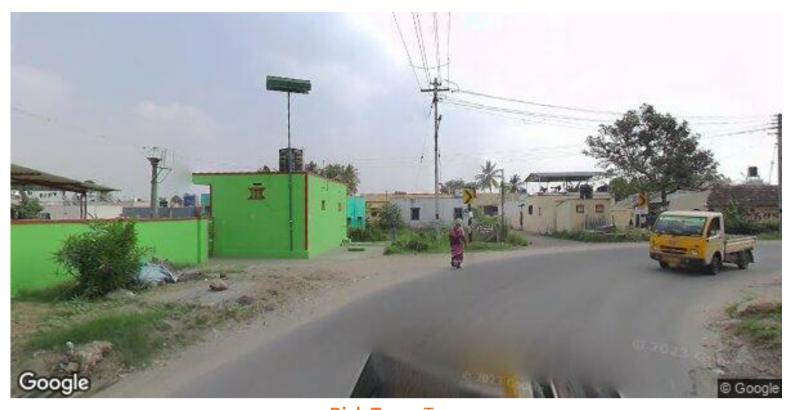
Risk Type: Turn
Risk Level: Medium
Speed Limit: 30 KM/Hr
Coordinates: 11.13017, 77.13878

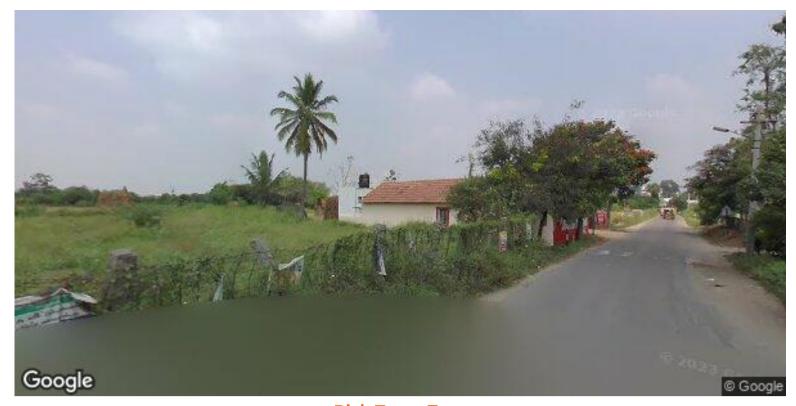
Risk Type: Turn
Risk Level: Medium
Speed Limit: 30 KM/Hr
Coordinates: 11.13022, 77.13839

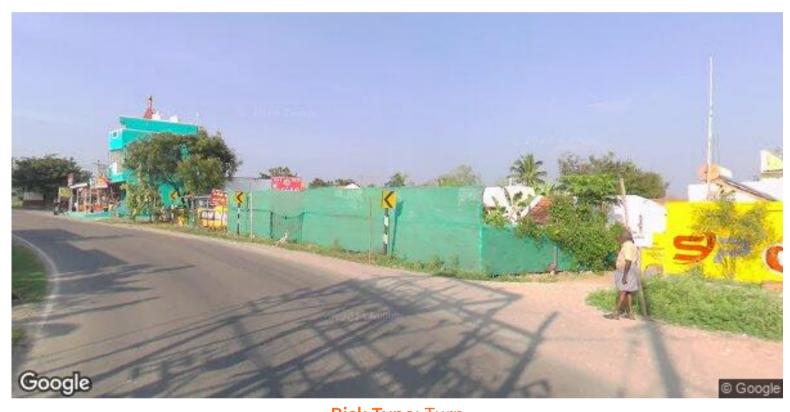
Risk Type: Turn
Risk Level: Medium
Speed Limit: 30 KM/Hr
Coordinates: 11.13314, 77.13841

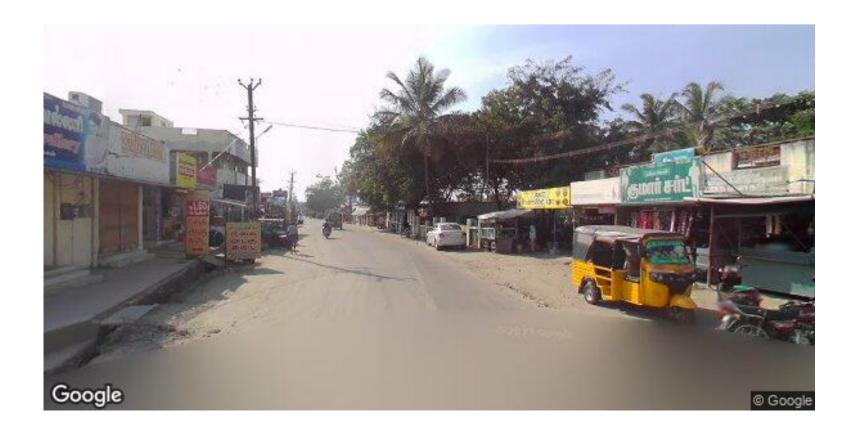
Coordinates: 11.14431, 77.13584

Risk Type: Blind Spot
Risk Level: Blind Spot
Speed Limit: 10 KM/Hr

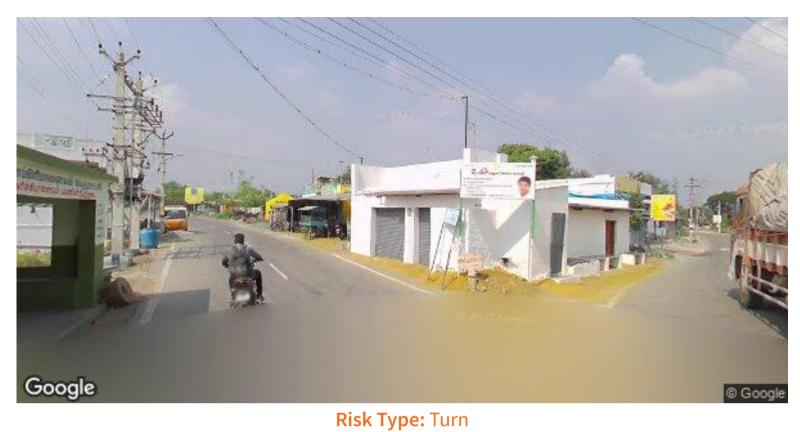
Risk Type: Turn
Risk Level: Medium
Speed Limit: 30 KM/Hr
Coordinates: 11.14602, 77.12554

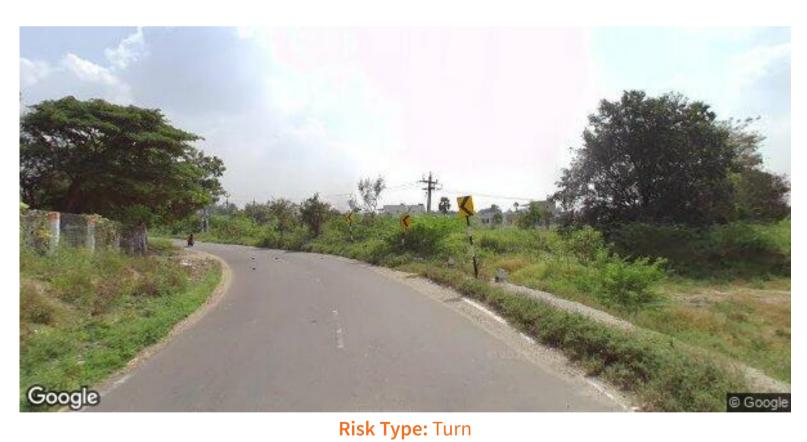
Risk Level: Medium
Speed Limit: 30 KM/Hr
Coordinates: 11.14937, 77.12182

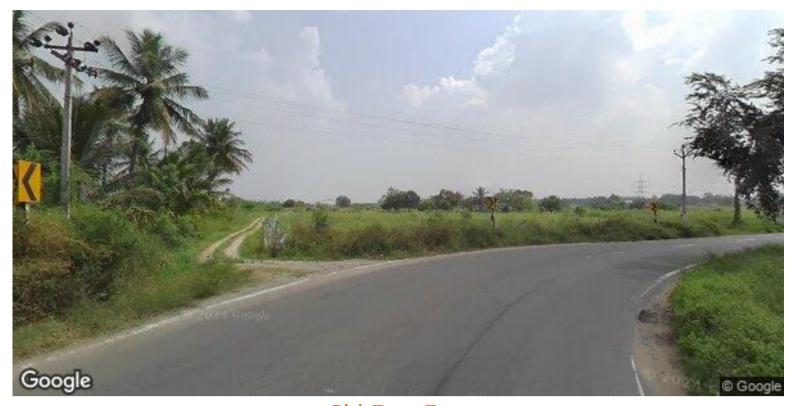
Risk Type: Turn
Risk Level: Medium
Speed Limit: 30 KM/Hr
Coordinates: 11.15275, 77.12071

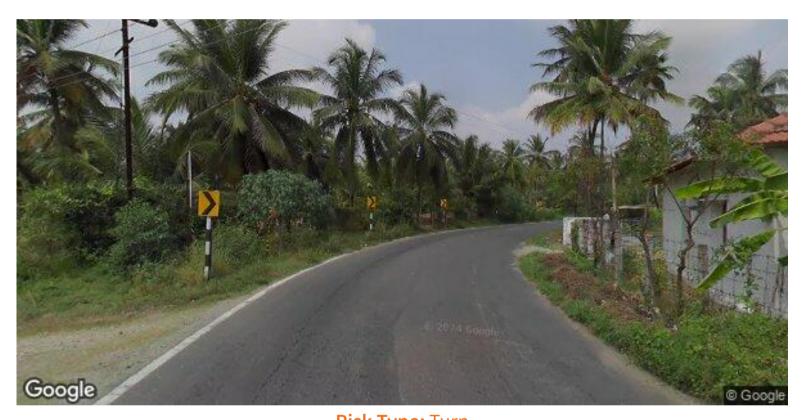
Risk Type: Turn
Risk Level: Medium
Speed Limit: 30 KM/Hr
Coordinates: 11.15285, 77.12042

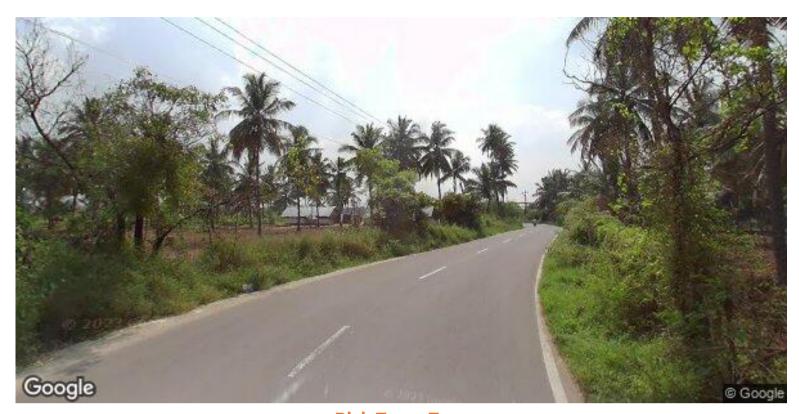
Risk Type: Turn
Risk Level: Medium
Speed Limit: 30 KM/Hr
Coordinates: 11.15391, 77.12029

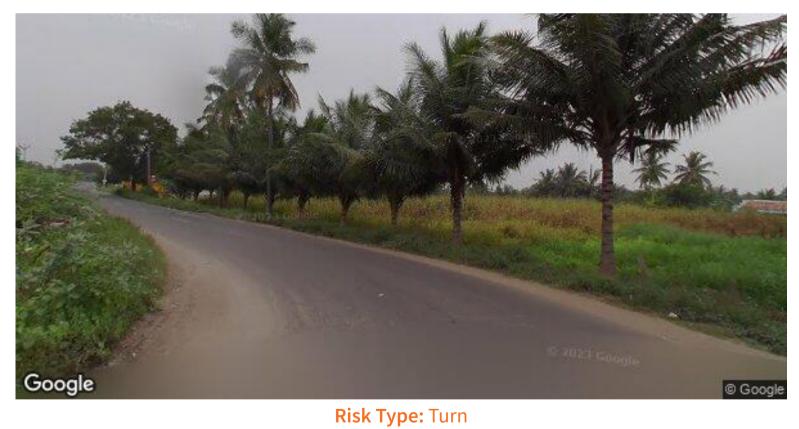
Risk Type. Turn
Risk Level: High
Speed Limit: 15 KM/Hr
Coordinates: 11.15619, 77.11569

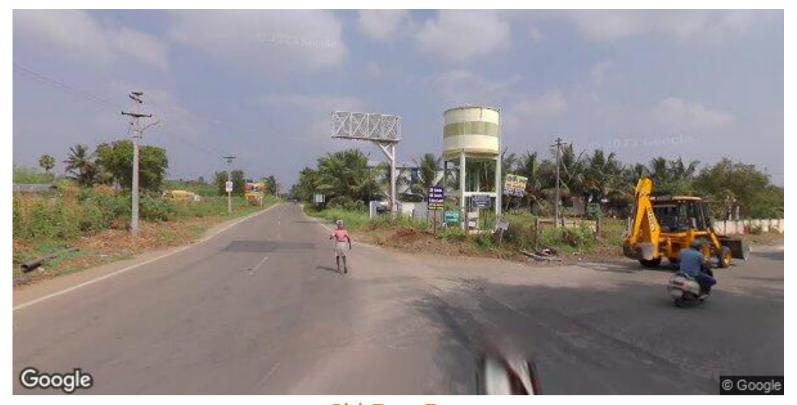
Risk Type: Turn
Risk Level: Medium
Speed Limit: 30 KM/Hr
Coordinates: 11.16327, 77.11434

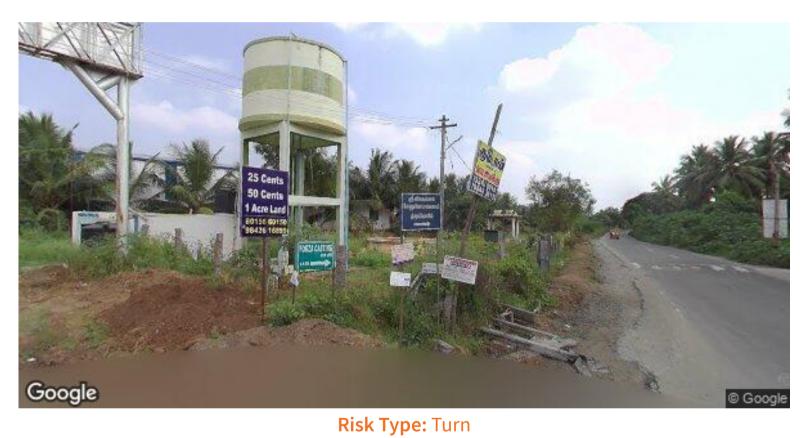
Risk Level: High
Speed Limit: 15 KM/Hr
Coordinates: 11.16333, 77.11440

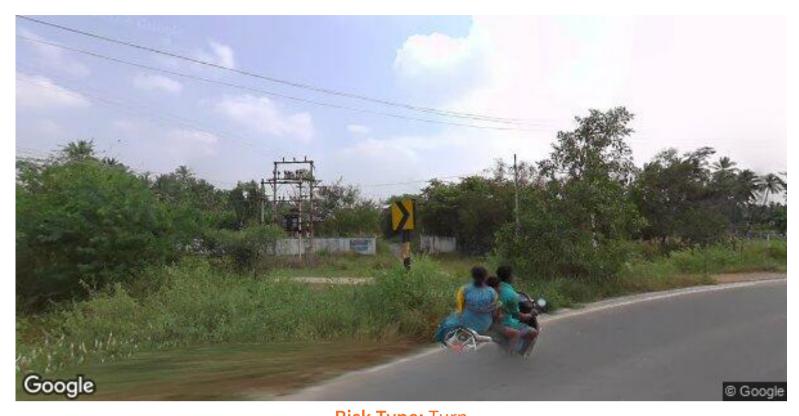
Risk Type: Turn
Risk Level: Medium
Speed Limit: 30 KM/Hr
Coordinates: 11.16704, 77.11365

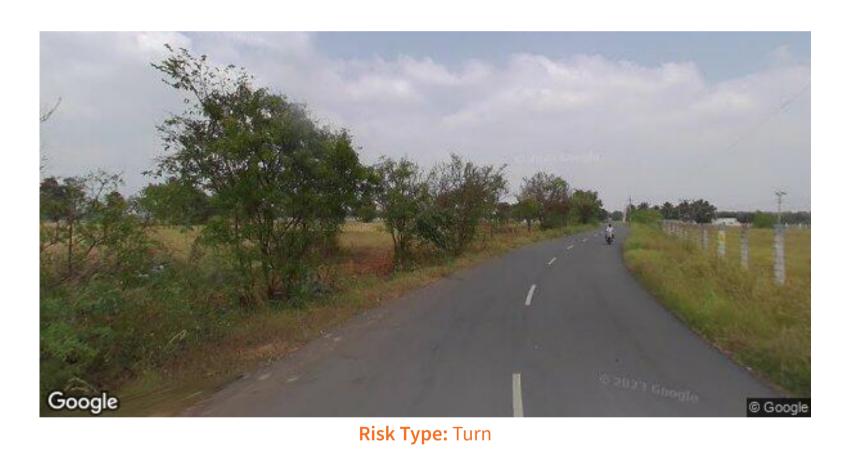
Risk Level: Medium
Speed Limit: 30 KM/Hr
Coordinates: 11.17324, 77.10860

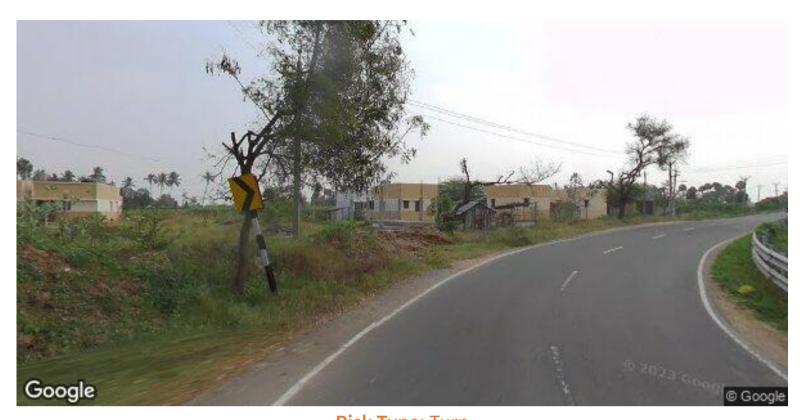
Risk Type: Turn
Risk Level: Medium
Speed Limit: 30 KM/Hr
Coordinates: 11.20658, 77.10414

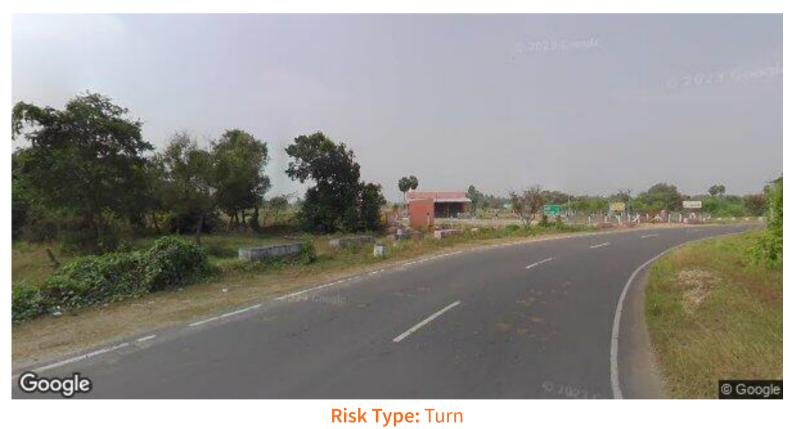
Risk Type. Turn
Risk Level: Medium
Speed Limit: 30 KM/Hr
Coordinates: 11.20687, 77.10318

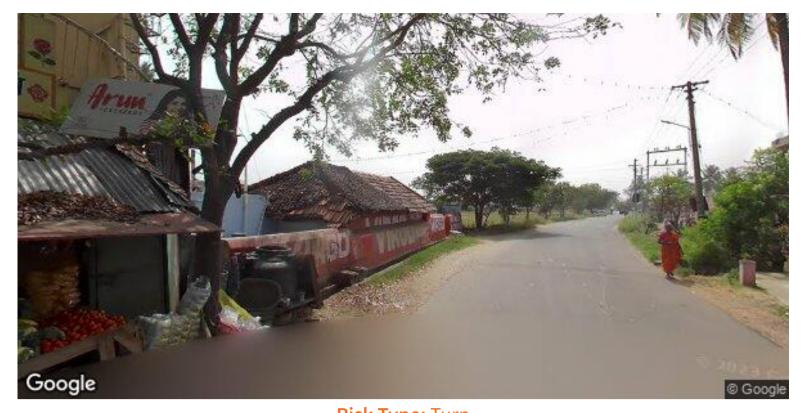
Risk Type: Turn
Risk Level: Medium
Speed Limit: 30 KM/Hr
Coordinates: 11.21484, 77.10252

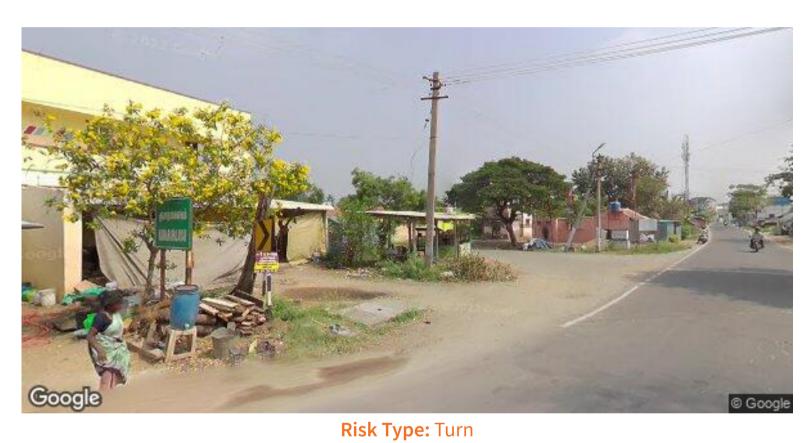
Risk Type: Turn
Risk Level: High
Speed Limit: 15 KM/Hr
Coordinates: 11.21497, 77.10243

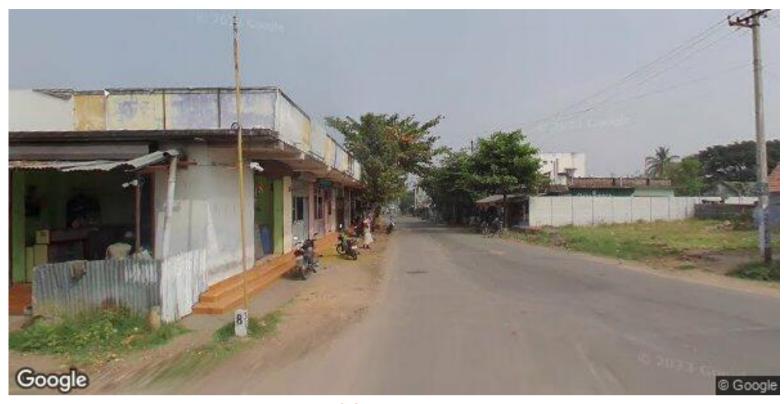
Risk Type: Turn
Risk Level: High
Speed Limit: 15 KM/Hr
Coordinates: 11.21530, 77.10157

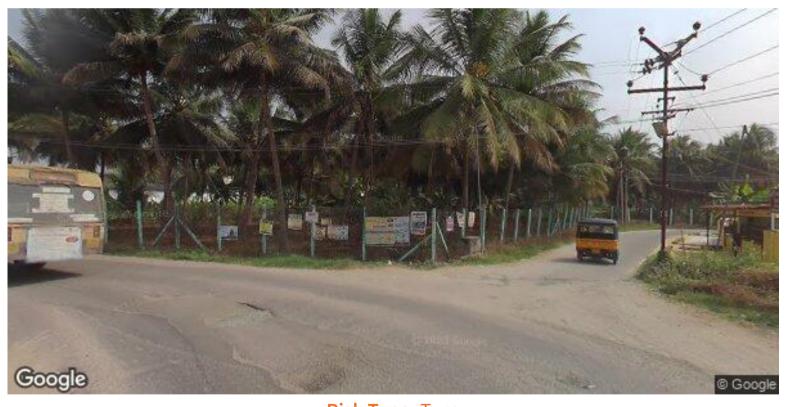
Risk Type: Turn
Risk Level: High
Speed Limit: 15 KM/Hr
Coordinates: 11.22823, 77.10600

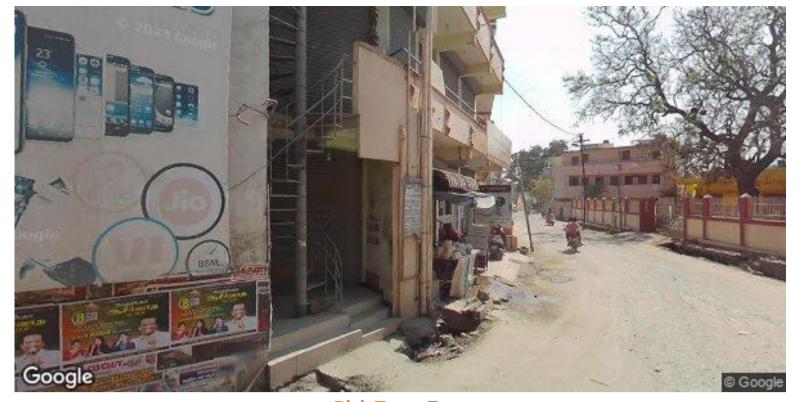
Risk Type: Turn
Risk Level: Medium
Speed Limit: 30 KM/Hr
Coordinates: 11.23306, 77.10441

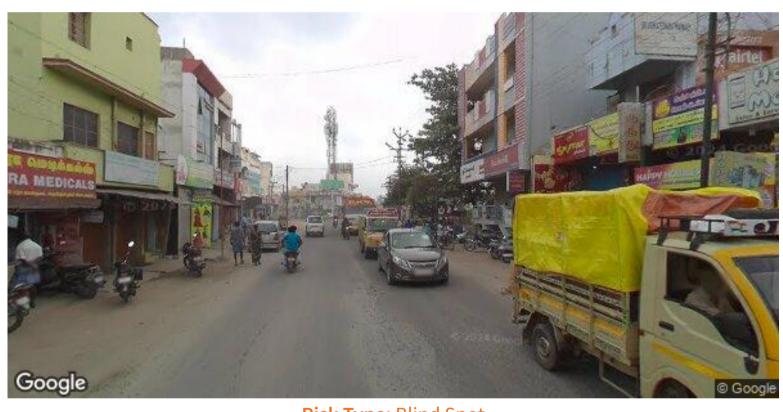
Risk Type: Blind Spot
Risk Level: Blind Spot
Speed Limit: 10 KM/Hr
Coordinates: 11.23322, 77.10441

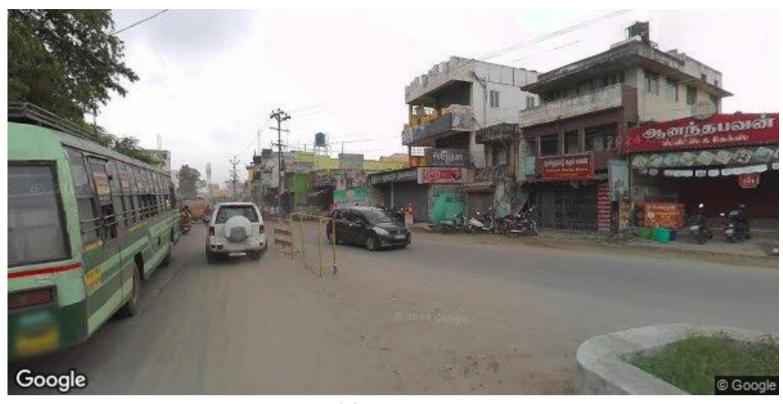
Coordinates: 11.23339, 77.10290

Risk Type: Turn
Risk Level: Medium
Speed Limit: 30 KM/Hr

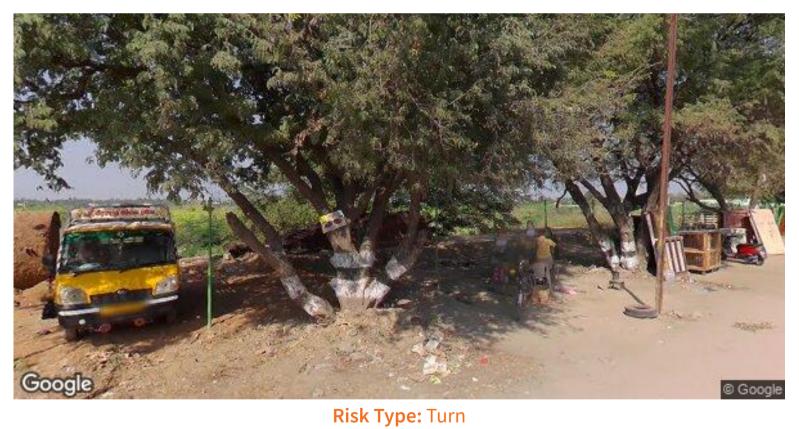
Coordinates: 11.23311, 77.09973

Risk Type. Turn
Risk Level: High
Speed Limit: 15 KM/Hr
