# JOURNEY RISK MANAGEMENT (JRM) STUDY

# IOCL Coimbatore Terminal to Shree Lalitha Oil Company

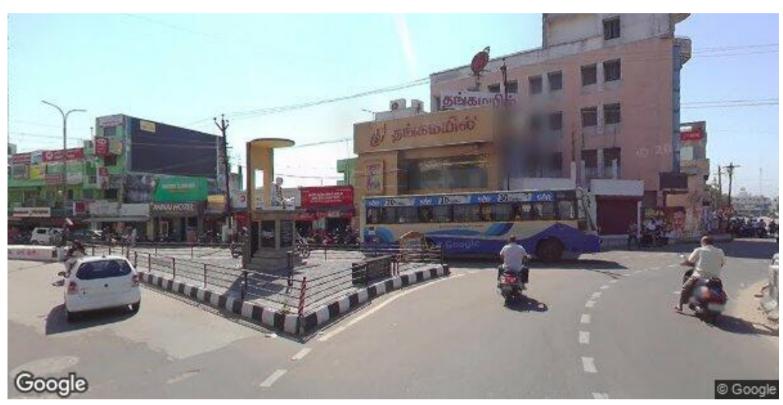
**Coordinates:** 10.66197, 77.00818

Risk Type: Roundabout
Risk Level: High
Speed Limit: 15 KM/Hr

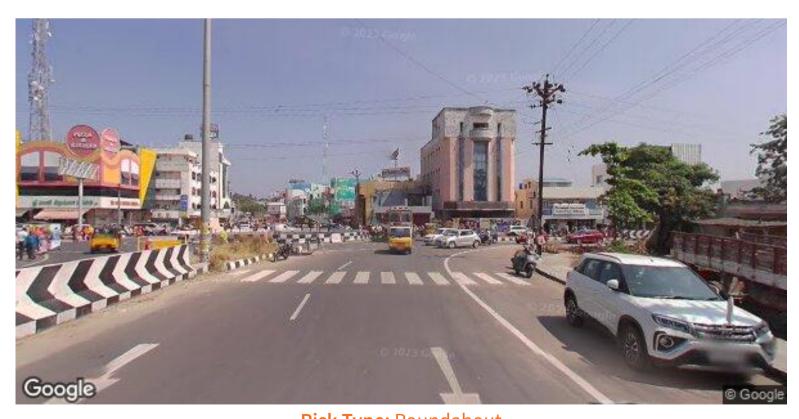
**Coordinates:** 10.66176, 77.00771

Risk Type: Roundabout
Risk Level: High
Speed Limit: 15 KM/Hr

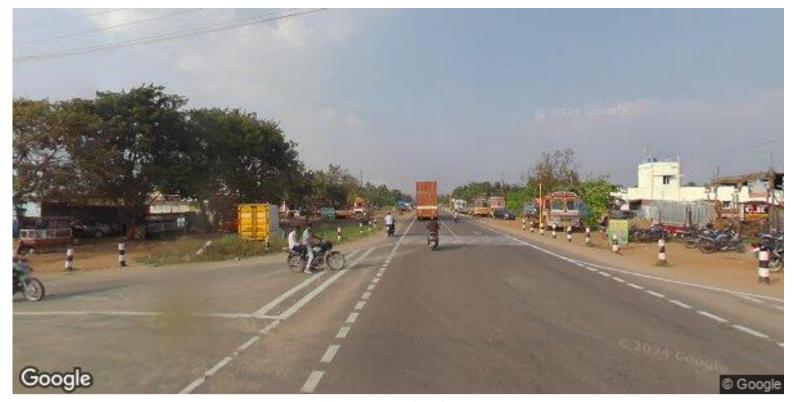
**Coordinates:** 11.03211, 77.07640

Risk Type: Blind Spot Risk Level: Blind Spot Speed Limit: 10 KM/Hr

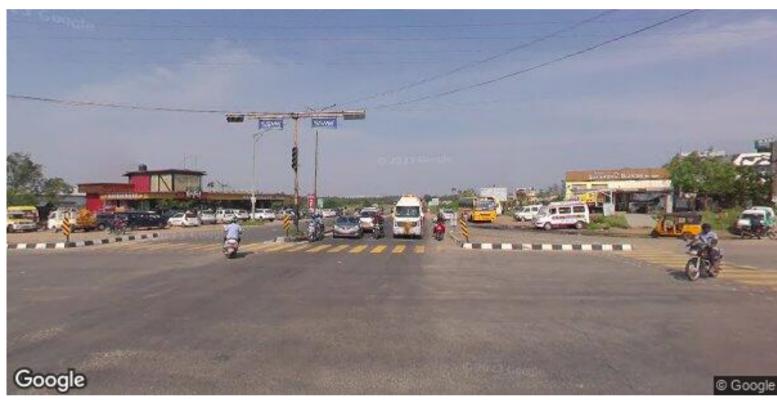
**Coordinates:** 10.91785, 76.98617

Risk Type: Blind Spot
Risk Level: Blind Spot
Speed Limit: 10 KM/Hr

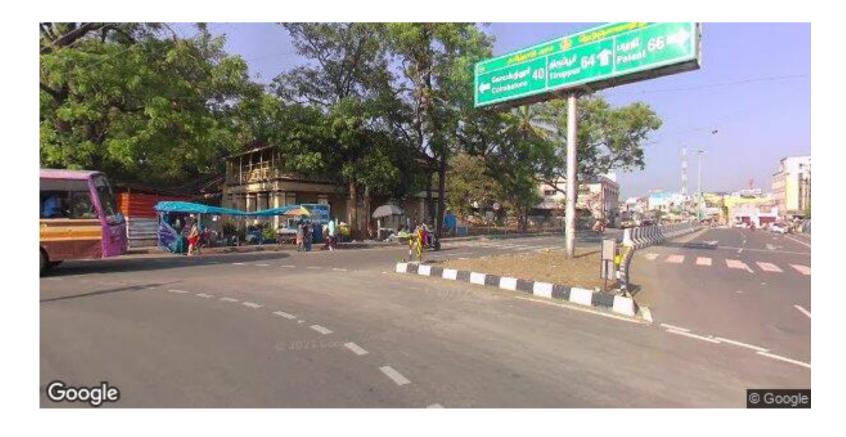
**Coordinates:** 10.66172, 77.00697

Risk Type: Turn
Risk Level: Medium
Speed Limit: 30 KM/Hr

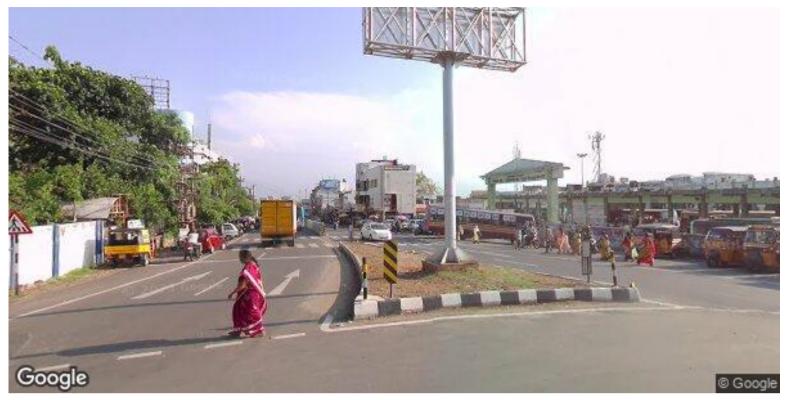
**Coordinates:** 10.66167, 77.00688

Risk Type: Turn
Risk Level: High
Speed Limit: 15 KM/Hr

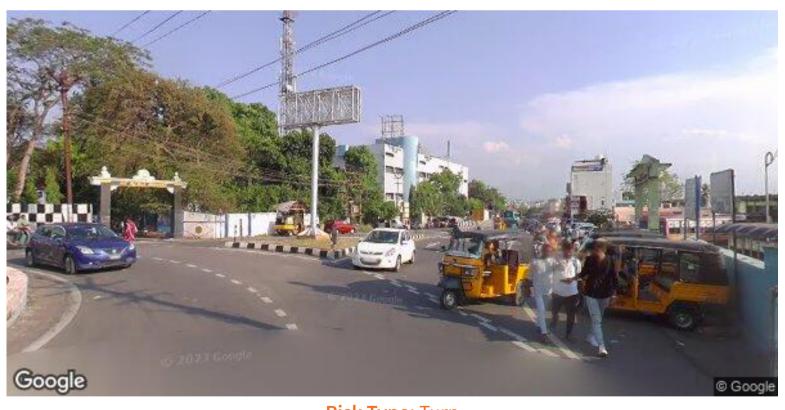
**Coordinates:** 10.66173, 77.00675

Risk Type: Turn
Risk Level: Medium
Speed Limit: 30 KM/Hr

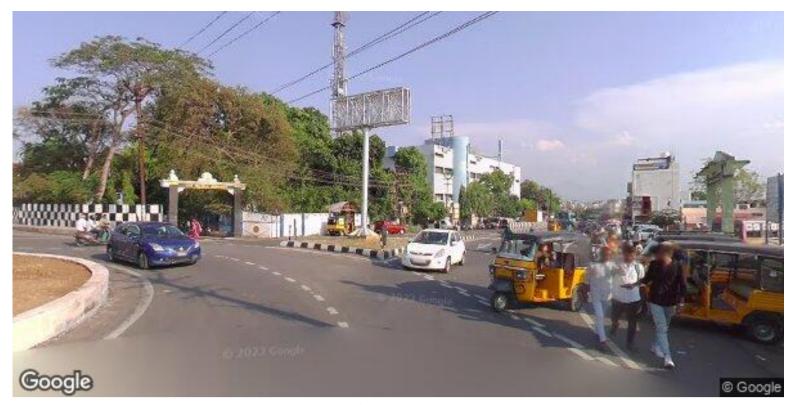
Risk Type: Turn
Risk Level: Medium
Speed Limit: 30 KM/Hr
Coordinates: 10.66175, 77.00674

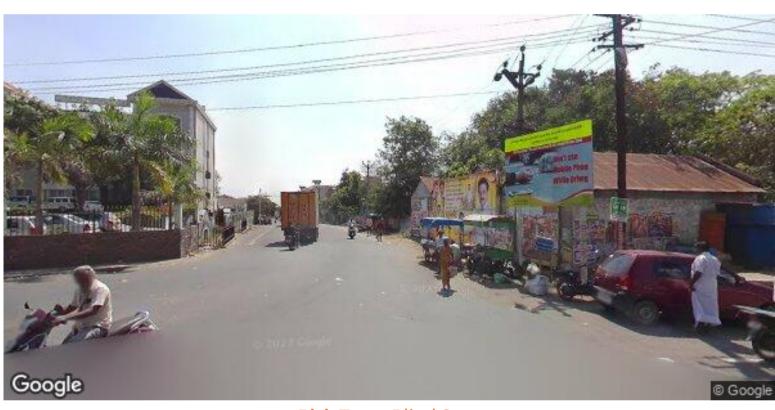
Risk Type: Blind Spot
Risk Level: Blind Spot
Speed Limit: 10 KM/Hr
Coordinates: 10.66318, 77.00202

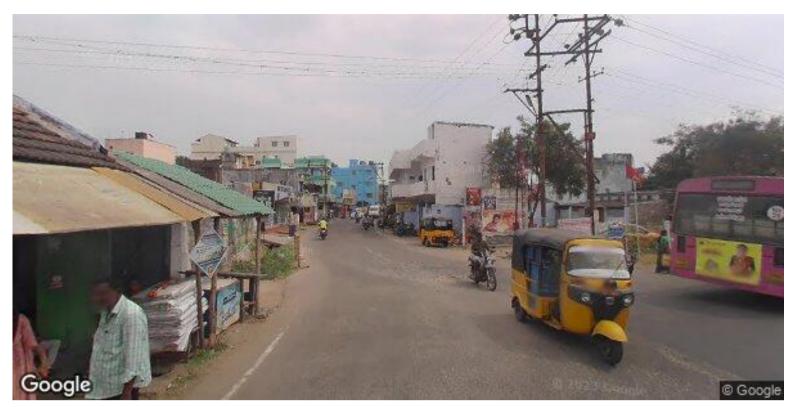
**Coordinates:** 10.66026, 77.00309

Risk Type: Turn
Risk Level: High
Speed Limit: 15 KM/Hr

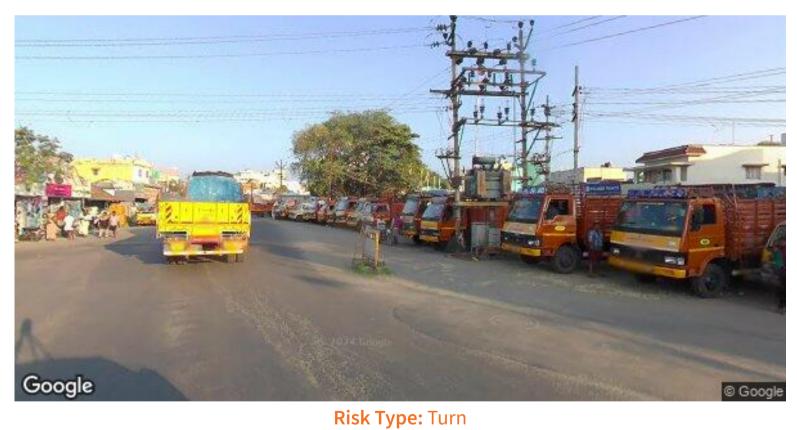
**Coordinates:** 10.65535, 77.00337

Risk Type: Turn
Risk Level: High
Speed Limit: 15 KM/Hr

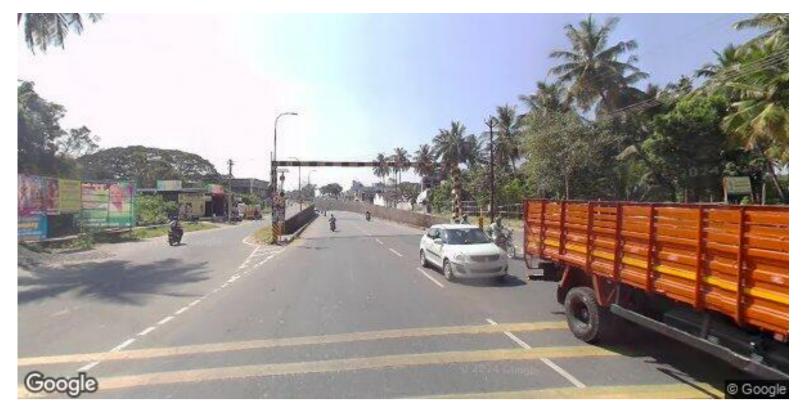
Risk Type: Turn
Risk Level: Medium
Speed Limit: 30 KM/Hr
Coordinates: 10.65103, 76.98757

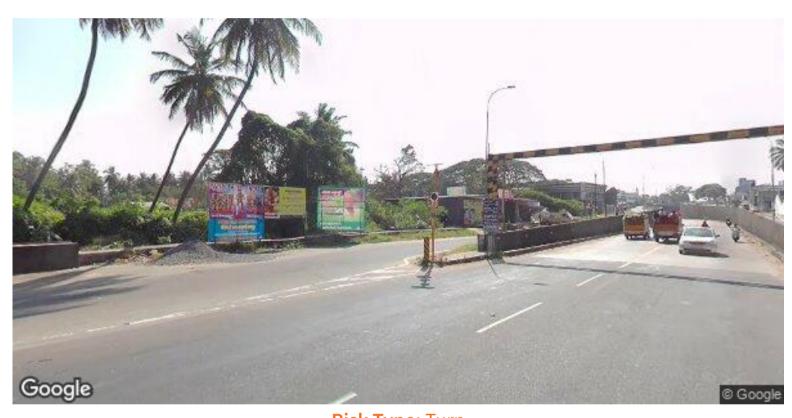
Risk Type: Turn
Risk Level: Medium
Speed Limit: 30 KM/Hr
Coordinates: 10.65105, 76.98749

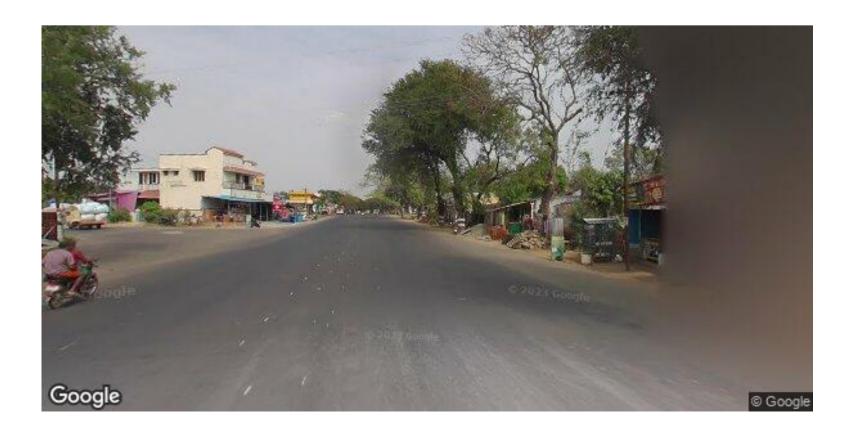
**Coordinates:** 10.64513, 76.97243

Risk Type: Blind Spot Risk Level: Blind Spot Speed Limit: 10 KM/Hr

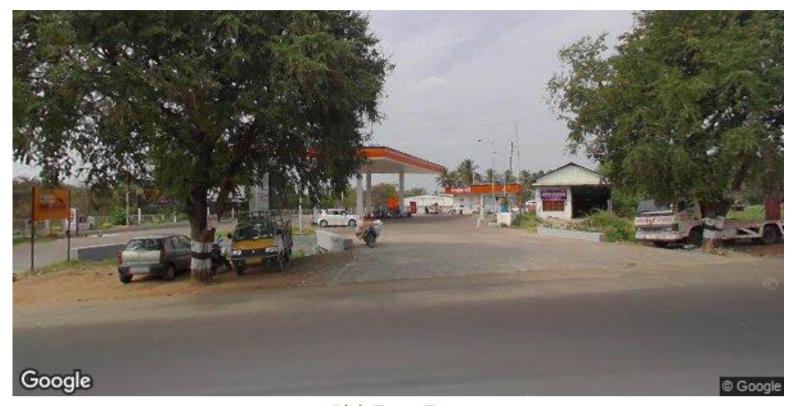
**Coordinates:** 10.64533, 76.97234

Risk Type: Turn
Risk Level: Medium
Speed Limit: 30 KM/Hr
