# JOURNEY RISK MANAGEMENT (JRM) STUDY

#### Salem Terminal To SIVA SAKTHI AGENCY

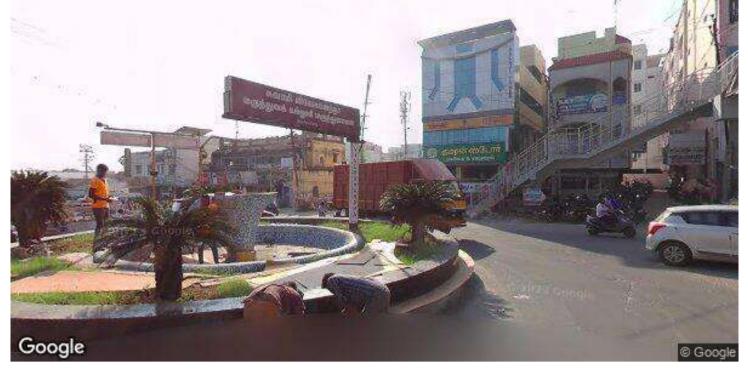
Risk Type: Roundabout
Risk Level: High
Speed Limit: 15 KM/Hr
Coordinates: 11.38395, 77.89480

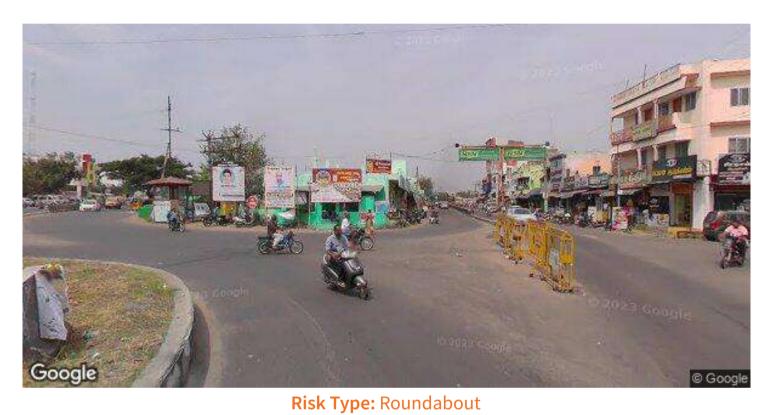
Risk Level: High
Speed Limit: 15 KM/Hr
Coordinates: 11.00535, 77.56114

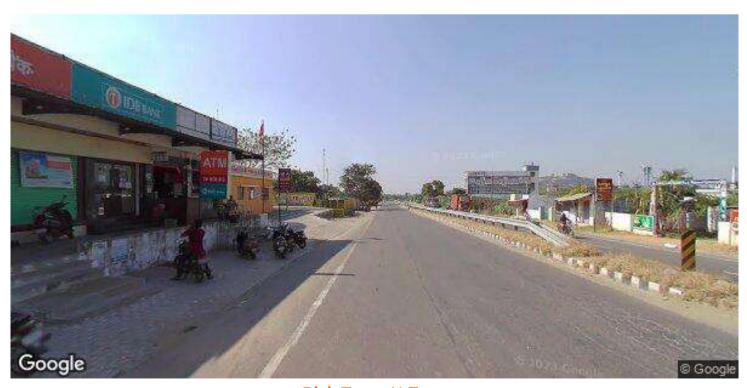
Risk Type: U-Turn Risk Level: High

**Speed Limit:** 10 KM/Hr **Coordinates:** 11.0185643, 77.5453777

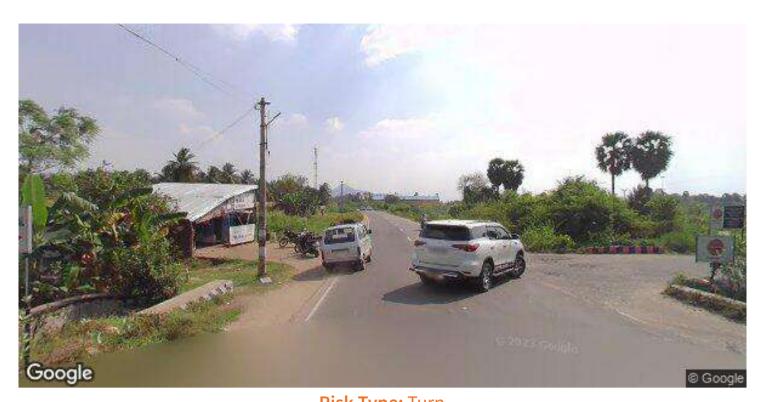
Risk Type: Turn
Risk Level: High
Speed Limit: 15 KM/Hr
Coordinates: 11.44029, 77.87544

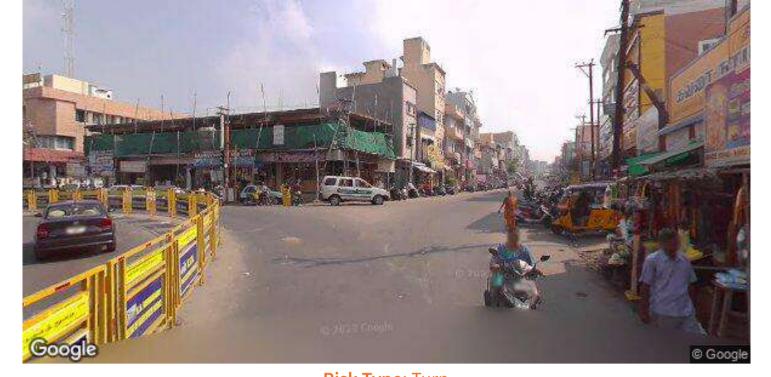
Risk Type: Turn
Risk Level: Medium
Speed Limit: 30 KM/Hr
Coordinates: 11.37862, 77.89488

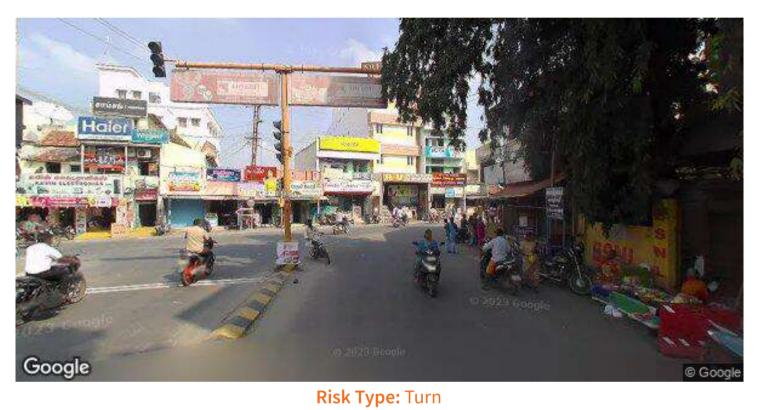
Risk Level: Medium
Speed Limit: 30 KM/Hr
Coordinates: 11.37831, 77.89450

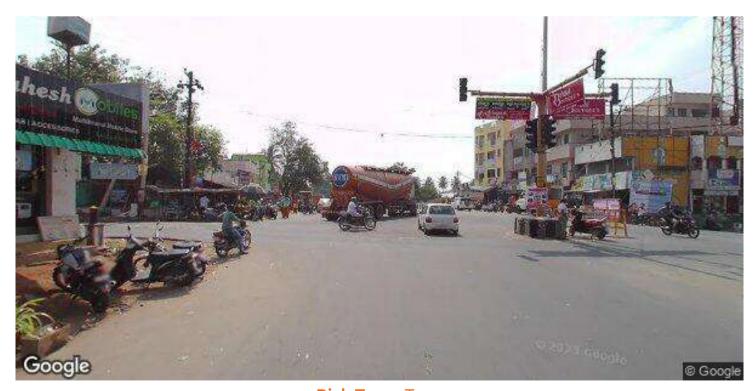
Risk Type: Turn
Risk Level: Medium

Speed Limit: 30 KM/Hr Coordinates: 11.36616, 77.88885

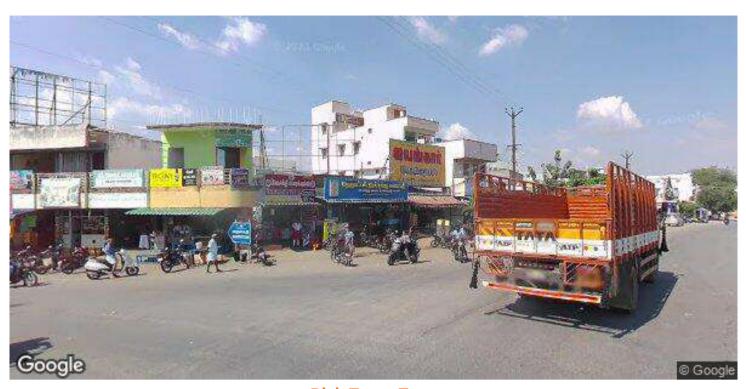
Risk Type: Turn
Risk Level: Medium
Speed Limit: 30 KM/Hr
Coordinates: 11.36602, 77.88875

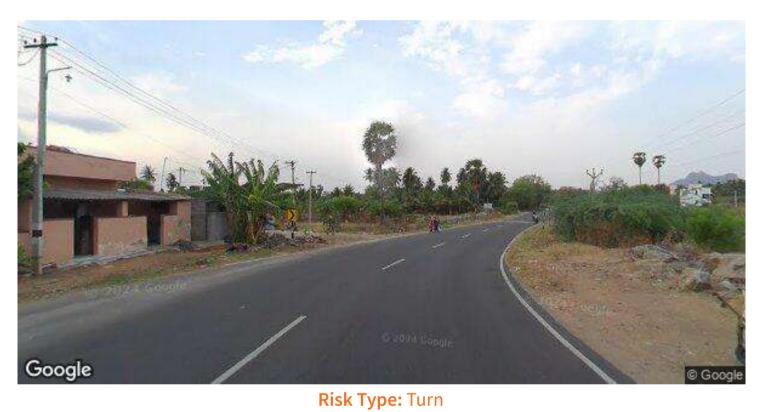
Risk Level: Medium
Speed Limit: 30 KM/Hr
Coordinates: 11.33882, 77.86218

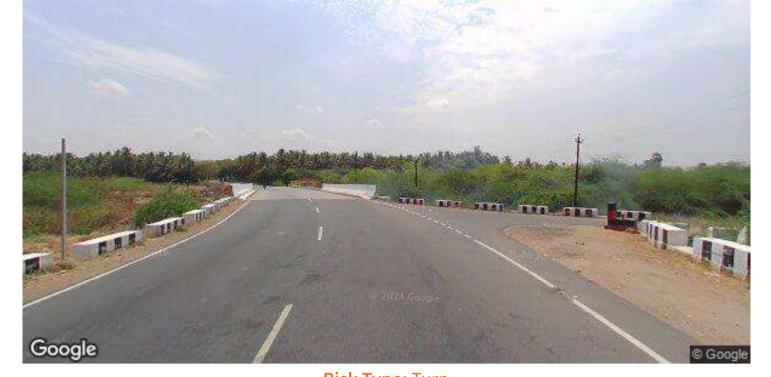
Risk Type: Turn
Risk Level: Medium
Speed Limit: 30 KM/Hr
Coordinates: 11.31747, 77.84240

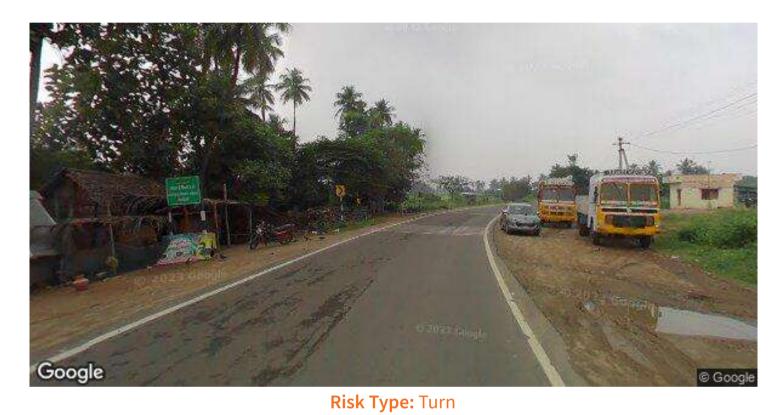
Risk Level: Medium
Speed Limit: 30 KM/Hr
Coordinates: 11.30951, 77.77608

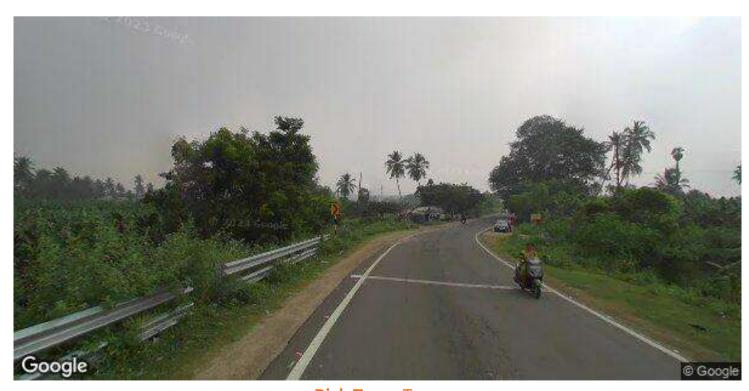
Risk Type: Turn
Risk Level: Medium

Speed Limit: 30 KM/Hr Coordinates: 11.31118, 77.77139

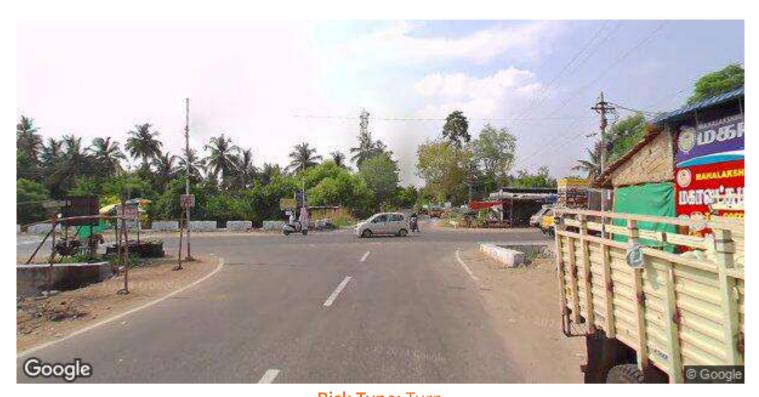
Risk Type: Turn
Risk Level: High
Speed Limit: 15 KM/Hr
Coordinates: 11.29473, 77.74685

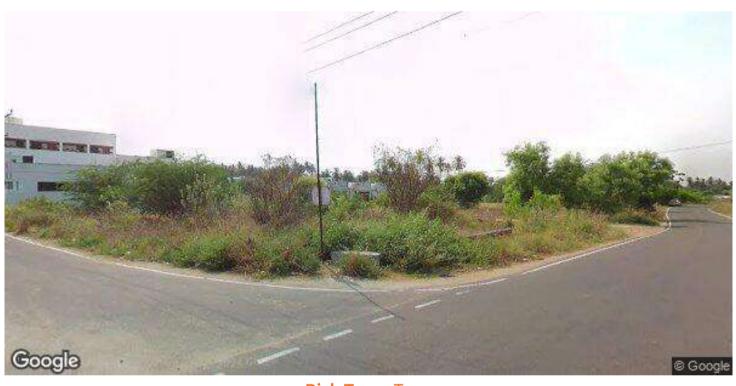
Risk Type: Turn
Risk Level: High
Speed Limit: 15 KM/Hr

**Coordinates:** 11.29133, 77.74660

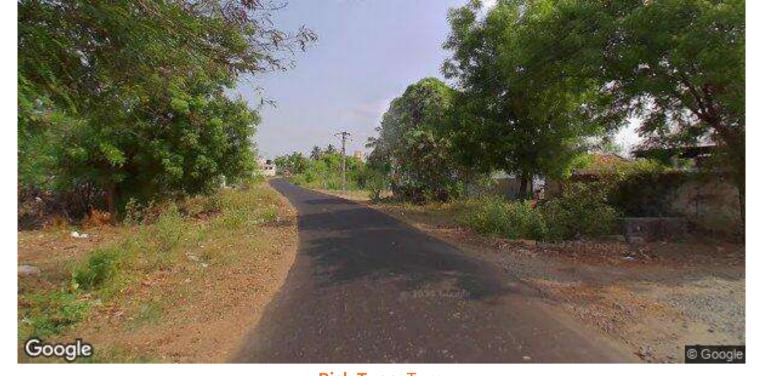
Risk Type: Turn
Risk Level: Medium
Speed Limit: 30 KM/Hr
Coordinates: 11.28844, 77.74319

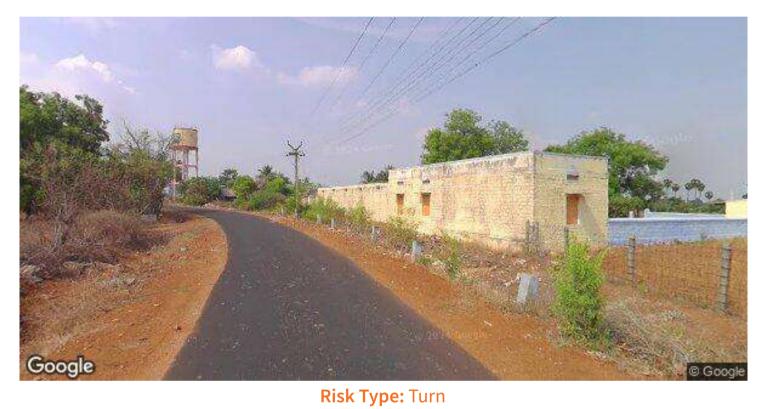
Risk Level: Medium
Speed Limit: 30 KM/Hr
Coordinates: 11.28558, 77.74271

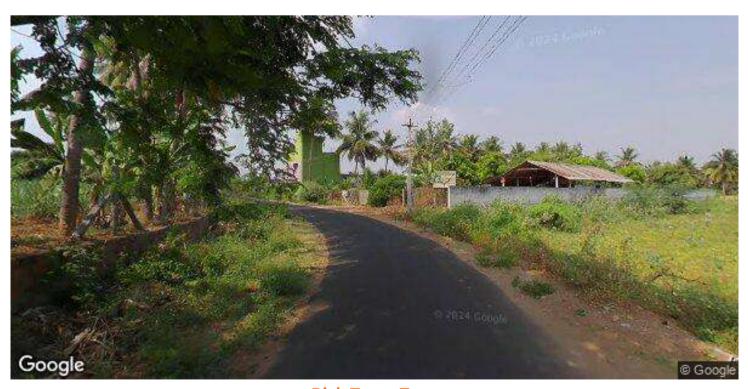
Risk Type: Turn
Risk Level: Medium

Speed Limit: 30 KM/Hr Coordinates: 11.27326, 77.72991

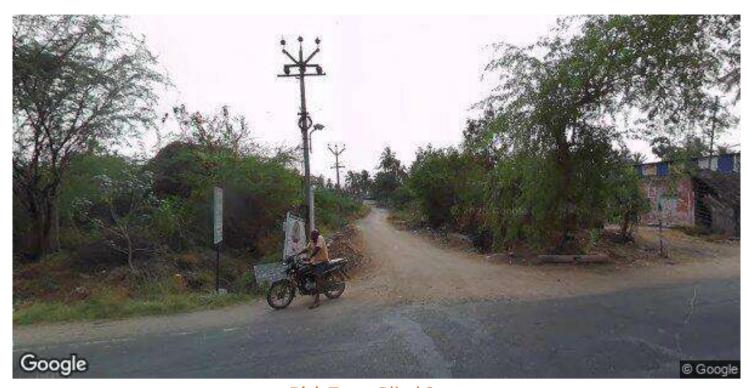
Risk Type: Blind Spot
Risk Level: Blind Spot
Speed Limit: 10 KM/Hr
Coordinates: 11.27330, 77.72711

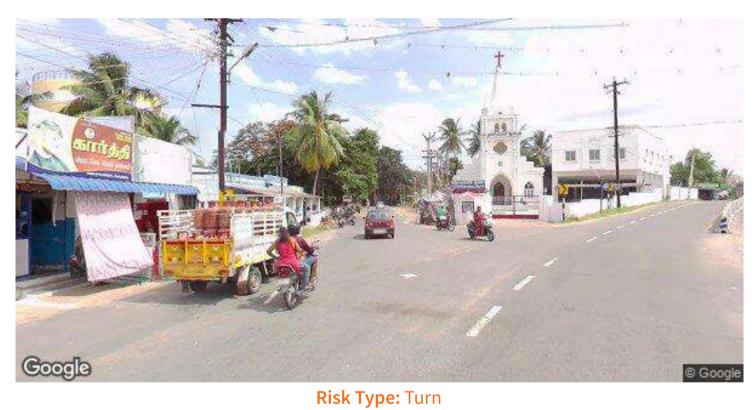
Risk Level: Medium
Speed Limit: 30 KM/Hr
Coordinates: 11.23054, 77.71796

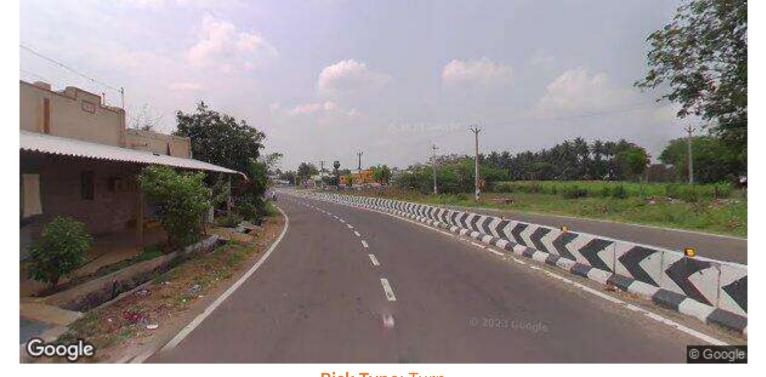
Risk Type: Turn
Risk Level: Medium
Speed Limit: 30 KM/Hr
Coordinates: 11.22387, 77.71385

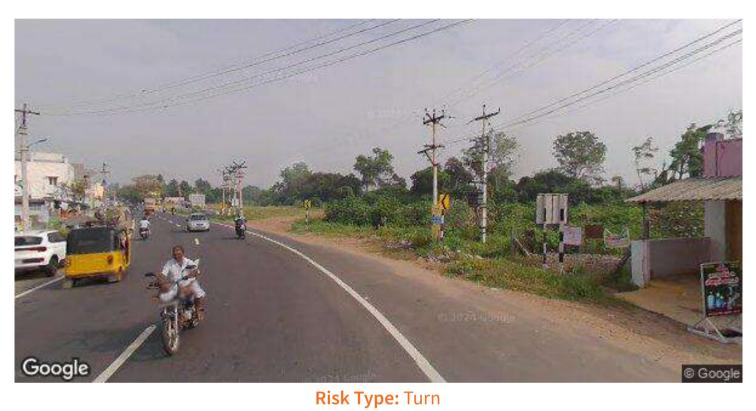
Risk Level: Medium
Speed Limit: 30 KM/Hr
Coordinates: 11.16078, 77.70122

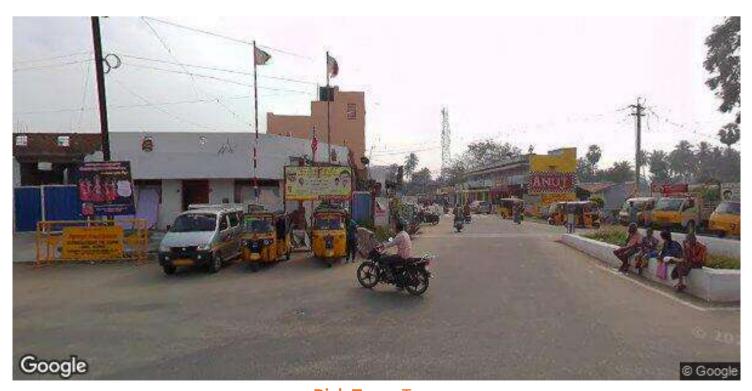
Risk Type: Turn
Risk Level: Medium

Speed Limit: 30 KM/Hr Coordinates: 11.15953, 77.70067

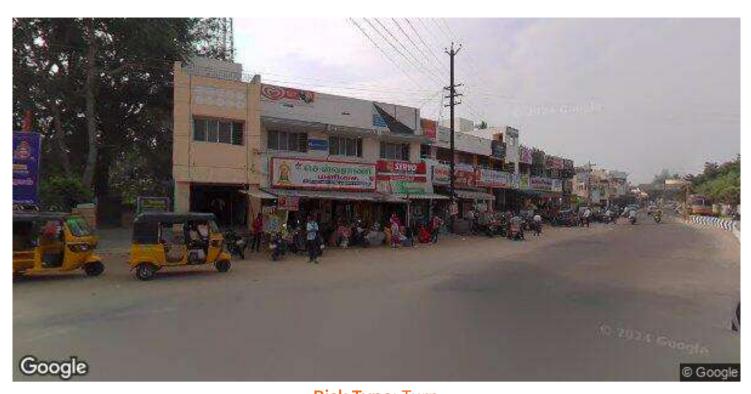
Risk Type: Turn
Risk Level: High
Speed Limit: 15 KM/Hr
Coordinates: 11.15944, 77.70068

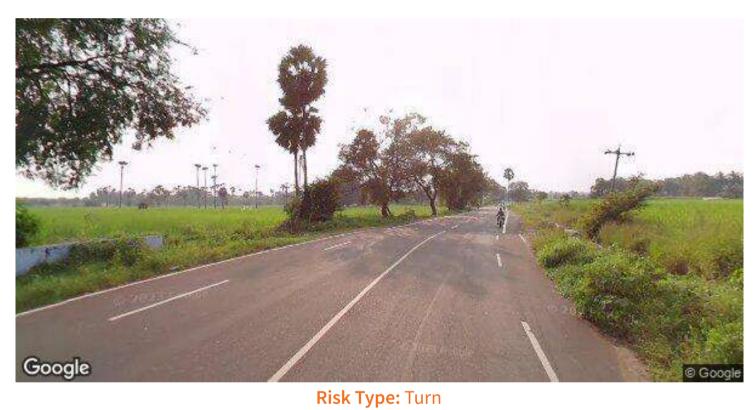
Risk Level: Medium
Speed Limit: 30 KM/Hr
Coordinates: 11.11918, 77.67766

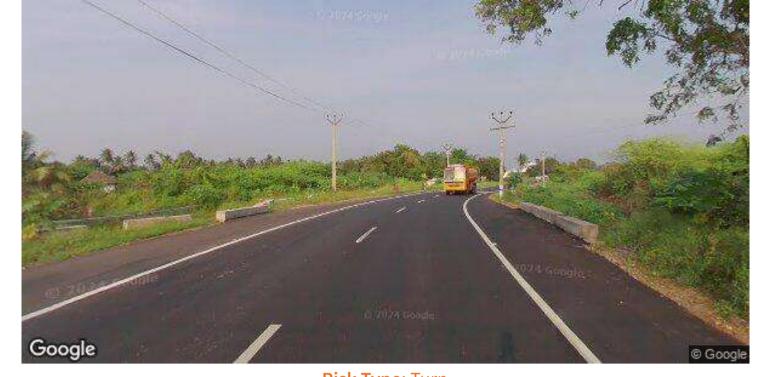
Risk Type: Turn
Risk Level: Medium
Speed Limit: 30 KM/Hr
Coordinates: 11.11740, 77.67198

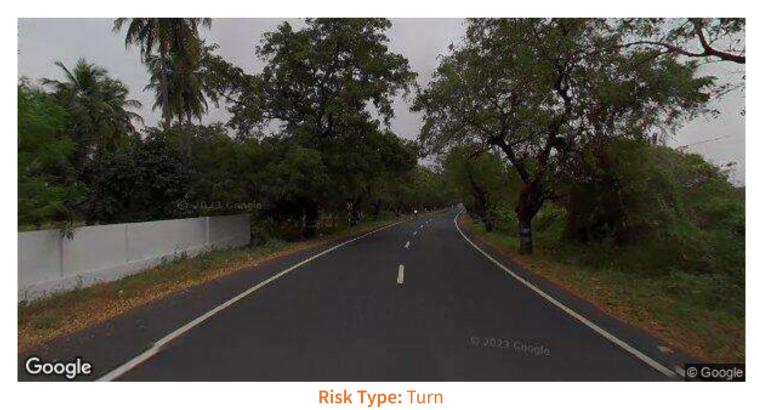
Risk Level: Medium
Speed Limit: 30 KM/Hr
Coordinates: 11.10481, 77.67060

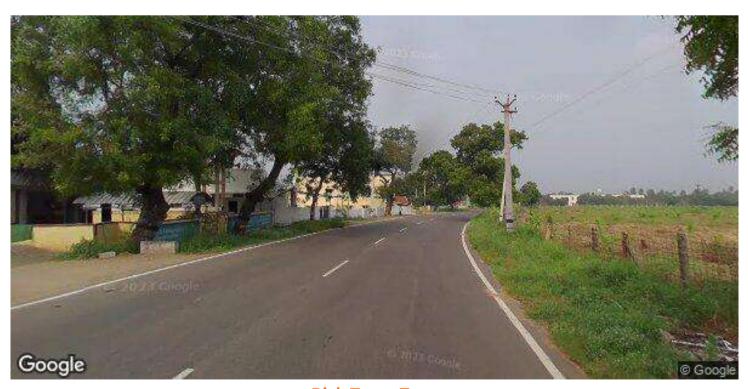
Risk Type: Turn
Risk Level: Medium

Speed Limit: 30 KM/Hr Coordinates: 11.09509, 77.66612

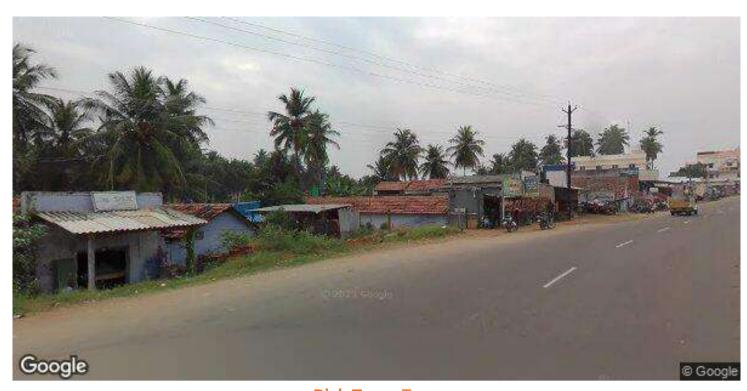
Risk Type: Turn
Risk Level: Medium
Speed Limit: 30 KM/Hr
Coordinates: 11.08730, 77.66436

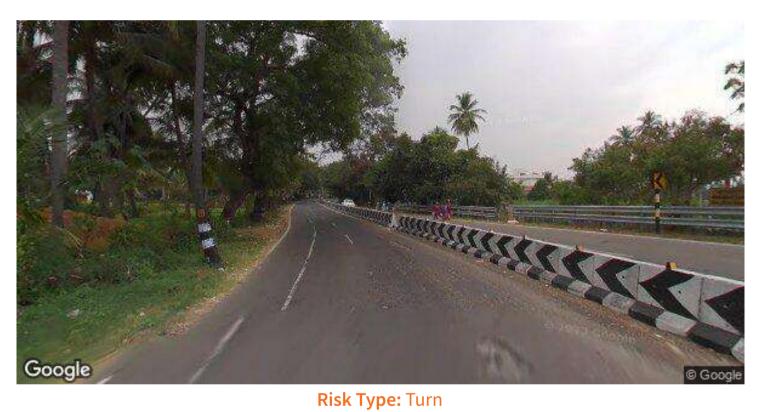
Risk Level: Medium
Speed Limit: 30 KM/Hr
Coordinates: 11.08282, 77.65837

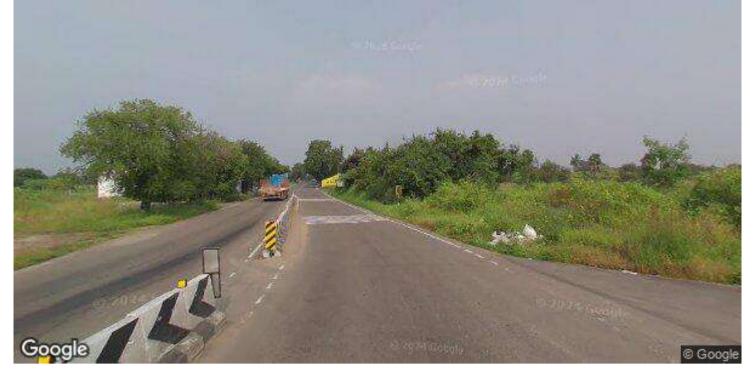
Risk Type: Turn
Risk Level: High
Speed Limit: 15 KM/Hr

**Coordinates:** 11.06189, 77.63943

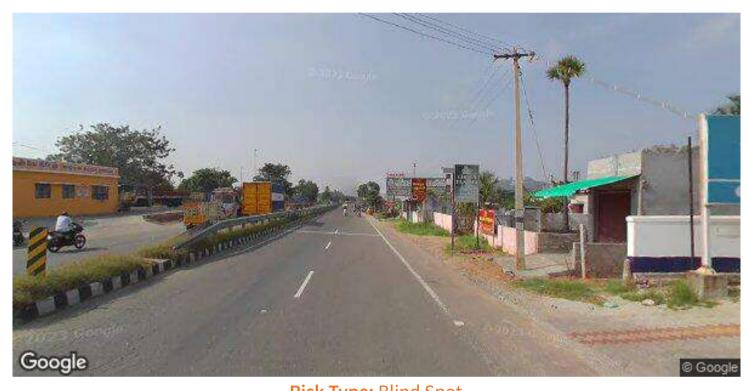
Risk Type: Blind Spot
Risk Level: Blind Spot
Speed Limit: 10 KM/Hr

**Coordinates:** 11.01864, 77.54544
