JOURNEY RISK MANAGEMENT (JRM) STUDY

IOCL Coimbatore Terminal to Sre Muthukumaran Traders

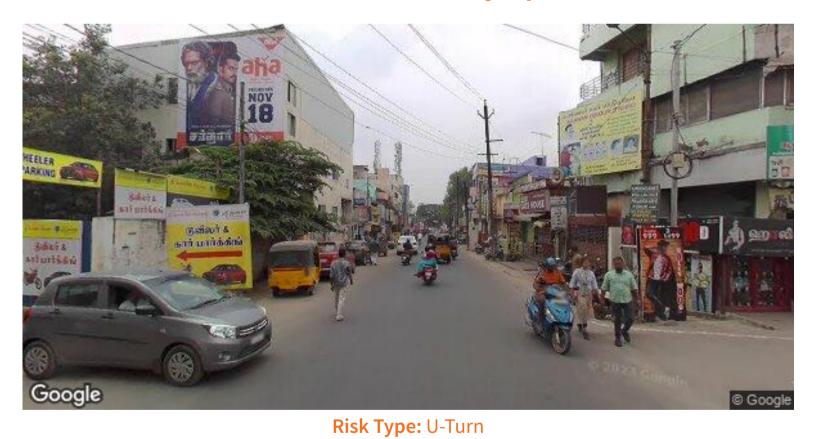
Coordinates: 10.9924704, 76.9606424

Risk Level: High
Speed Limit: 10 KM/Hr

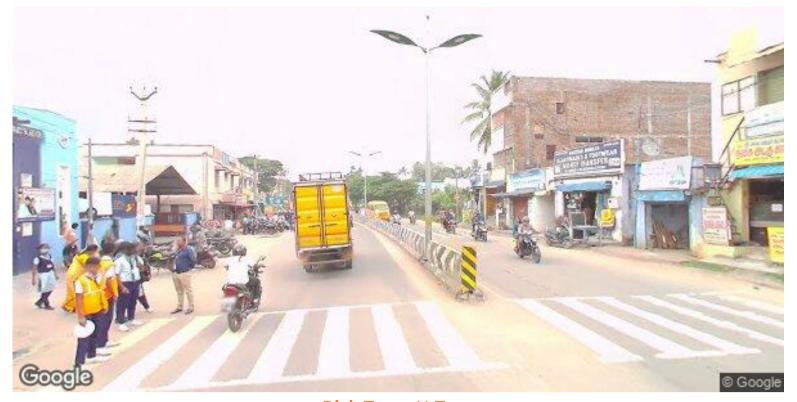
Coordinates: 10.9840022, 76.9252982

Risk Type: U-Turn
Risk Level: High
Speed Limit: 10 KM/Hr

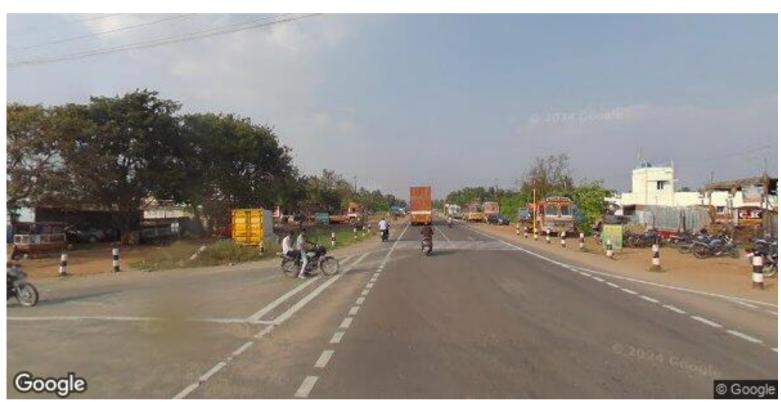
Coordinates: 11.03211, 77.07640

Risk Type: Blind Spot
Risk Level: Blind Spot
Speed Limit: 10 KM/Hr

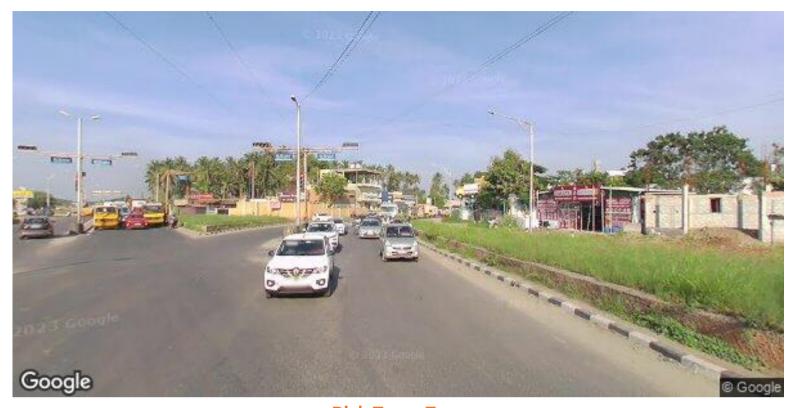
Risk Type: Turn
Risk Level: Medium
Speed Limit: 30 KM/Hr
Coordinates: 11.00737, 77.07049

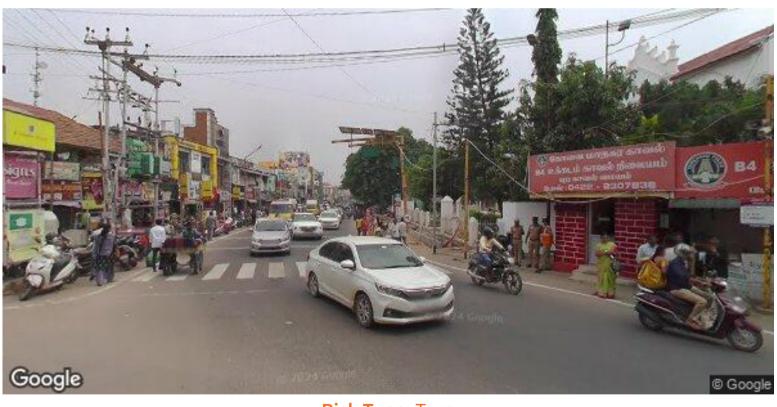
Coordinates: 10.99353, 76.96082

Risk Type: Turn
Risk Level: High
Speed Limit: 15 KM/Hr

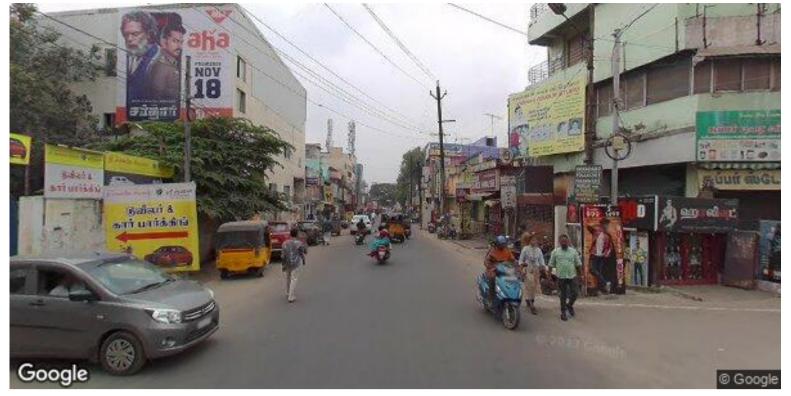
Coordinates: 10.99247, 76.96064

Risk Type: Turn
Risk Level: High
Speed Limit: 15 KM/Hr

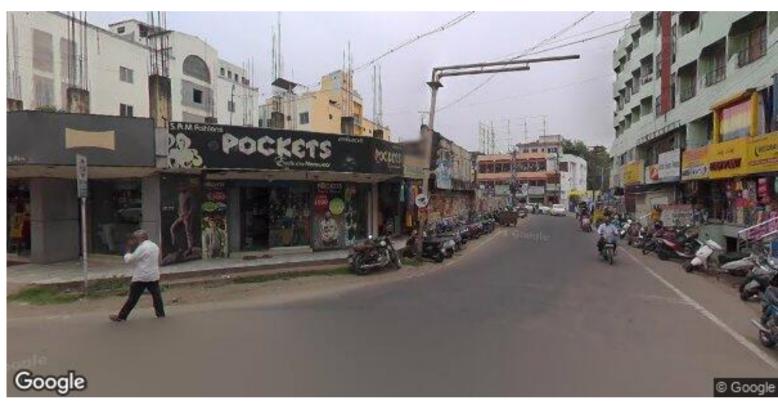
Coordinates: 10.99240, 76.96003

Risk Type: Turn
Risk Level: High
Speed Limit: 15 KM/Hr

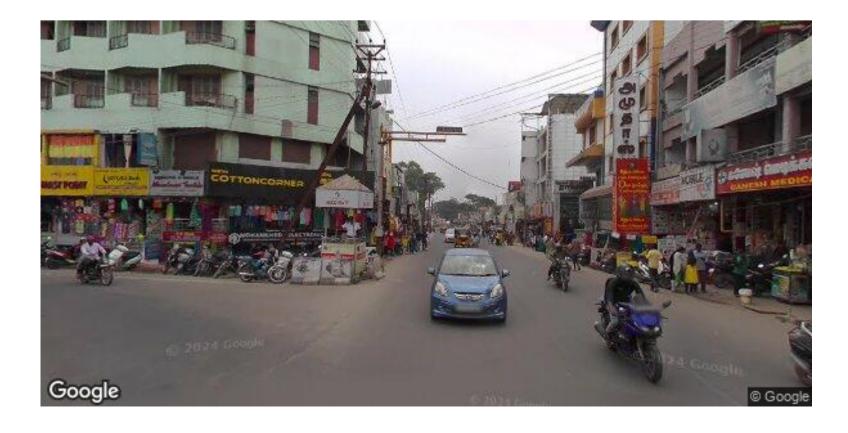
Coordinates: 10.99247, 76.96001

Risk Type: Turn
Risk Level: High
Speed Limit: 15 KM/Hr

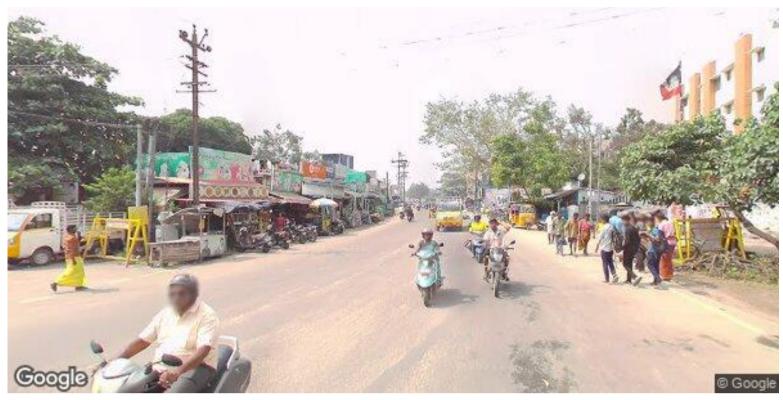
Coordinates: 10.99220, 76.95053

Risk Type: Turn
Risk Level: Medium
Speed Limit: 30 KM/Hr

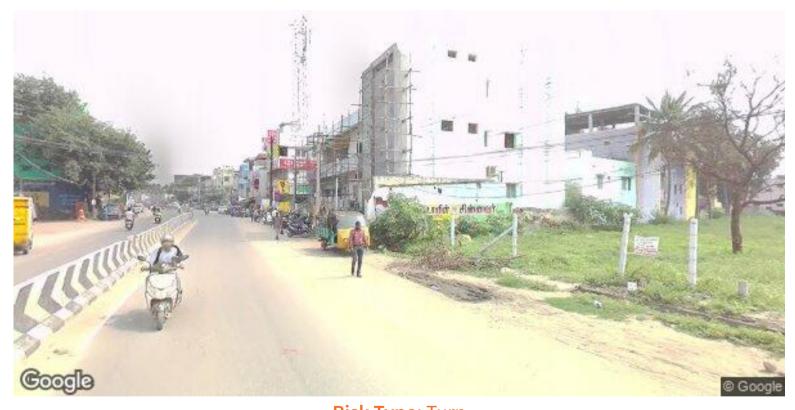
Risk Type: Turn
Risk Level: Medium
Speed Limit: 30 KM/Hr
Coordinates: 10.98807, 76.93652

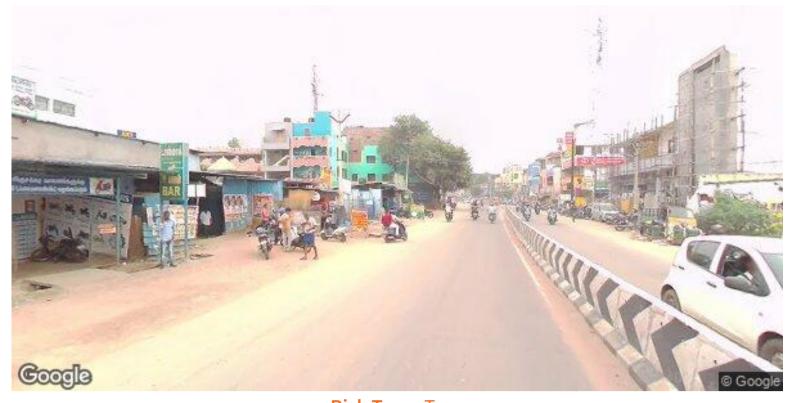
Risk Type: Turn
Risk Level: Medium
Speed Limit: 30 KM/Hr
Coordinates: 10.98812, 76.93646

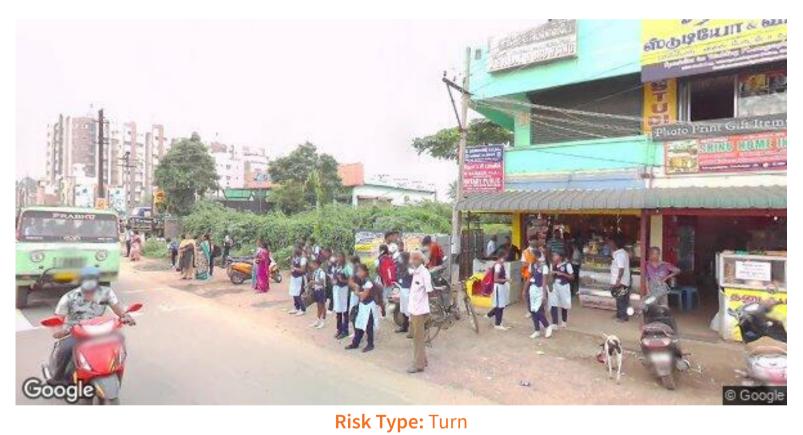
Risk Level: High
Speed Limit: 15 KM/Hr
Coordinates: 10.98400, 76.92530

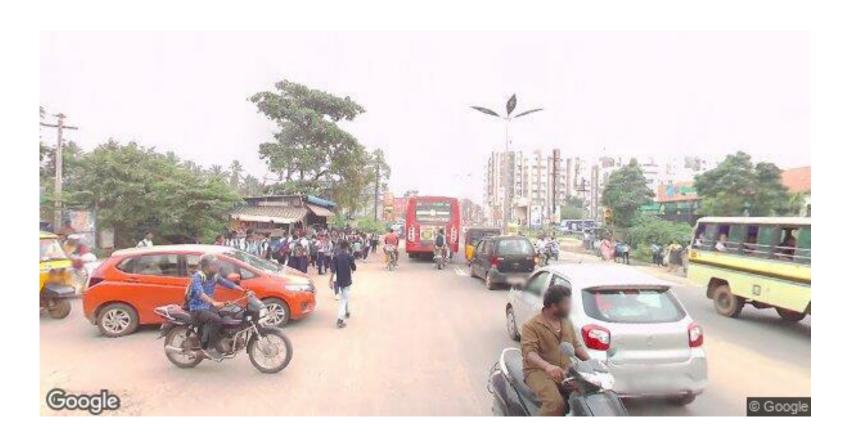
Coordinates: 10.98406, 76.92530

Risk Type: Blind Spot Risk Level: Blind Spot Speed Limit: 10 KM/Hr
